Preliminary Arborist Report

644 & 675 Piercy Road
San Jose, CA

October 27, 2022

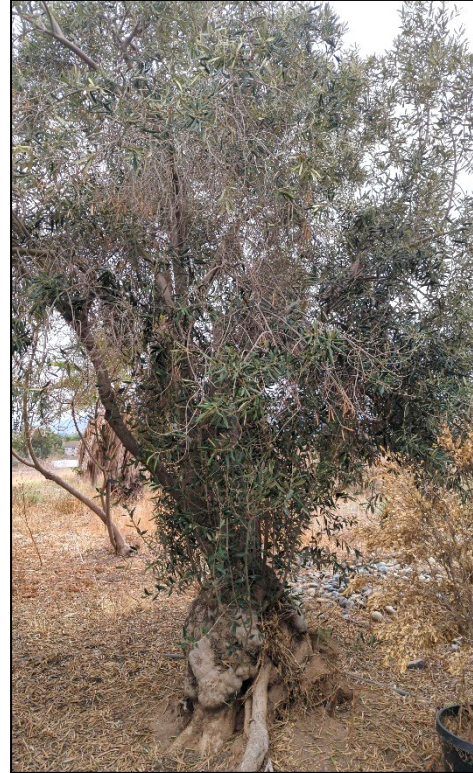
- Crape myrtle #4 (4 inch diameter) was in poor condition. The crown of the tree was sparse, and the trunk had a decay column from ground level to 4 feet.
- Olive #16 was in fair condition. The tree had multiple trunks at ground level with an unusually swollen trunk base and some twig dieback throughout the crown of the tree.
- Valley oak #31 was an off-site tree in good condition growing along Piercy Road. There was chain link and barbed wire wrapped loosely around the 21 inch diameter trunk. A tire swing was attached to a large lateral branch on the south side of the tree.
- California pepper #21 was in good condition. The 12 inch diameter trunk bows to the west and utility lines pass through the crown of the tree.

Photo 3. Olive #16 had a swollen base and dead twigs throughout the crown of the tree.
