### 3.3 Walk Audit Results

### 3.3.1 Walk Audit Key Findings

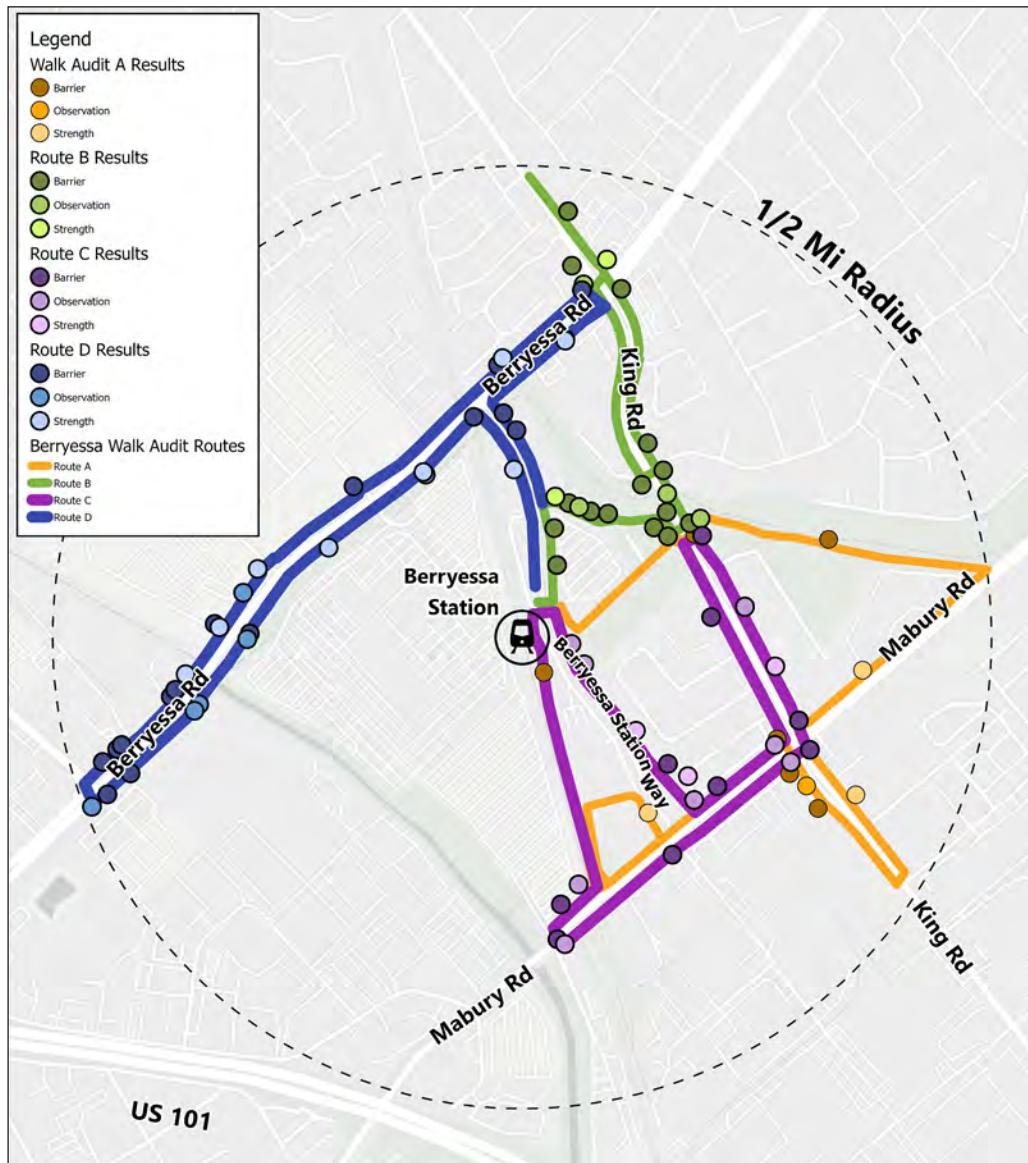
Figure 3.24  
Walk Audit Results

- There are several sidewalk gaps and narrow and or cracked sidewalks.
- There is a need for additional wayfinding signage leading to and from the station.
- There is a lack of a safe bike lane near the station on Berryessa Road.
- Vehicular speeds on Mabury Road are high.
- There is a need for additional trash clean up surrounding the station area.
- There are several blind driveways, making it hard for trucks to see pedestrians traveling on the sidewalk.
- Short timers for long crossing distances make safely crossing intersections challenging, particularly for seniors.
- Vehicles parked in the bike lane along Berryessa Road interrupt bicycle travel.

- There is good tree canopy and shade present on some pedestrian paths.
- There are wide sidewalks in some areas with pleasant walking conditions.

- There is an opportunity to create a future multi-use next to the BART alignment and connecting to the Upper Penitencia Creek.
- There is an opportunity to implement a high visibility crosswalk at Mabury Road and King Road.
- Additional bus shelters with seating can be implemented at bus stops in the station area.

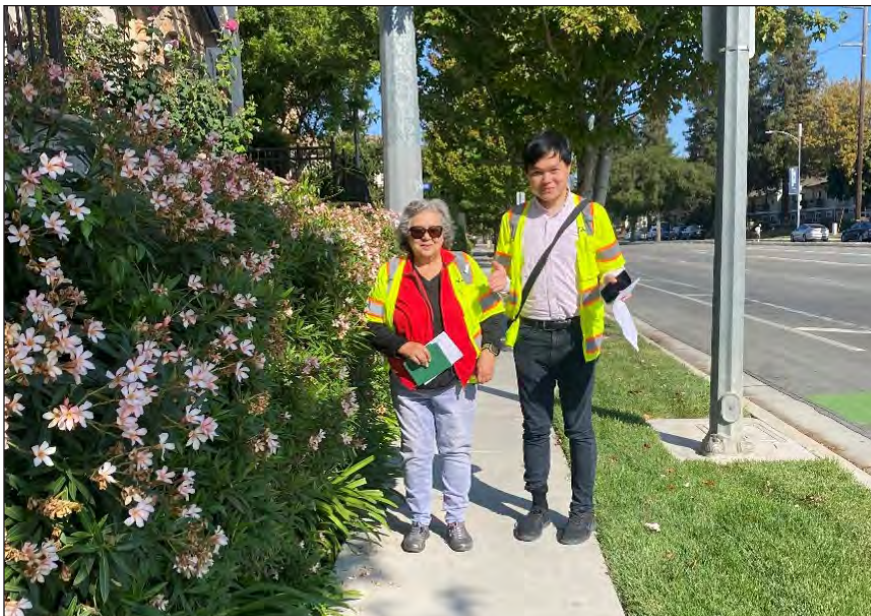
**Figure 3.25**  
Walk audit participants evaluating sidewalk conditions along Mabury Road
