Preliminary Tree Report
Columbus Park

August 2021

Columbus Park
San Jose CA

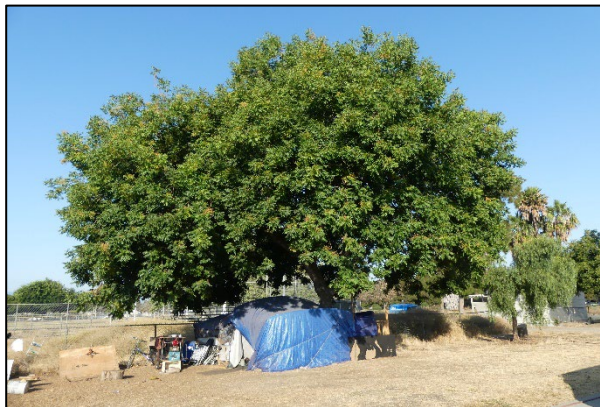
Several trees located on Irene Street could not be tagged due to the presence of temporary structures around the trunk (Photo 1). Such trees were given a number, then assessed and mapped in normal manner. Trunk diameters were estimated. These trees are noted in the ***Tree Assessment Form***.

Photo 1. Structures were present around the base and lower trunk of this Chinese pistache as well as several others in the area.

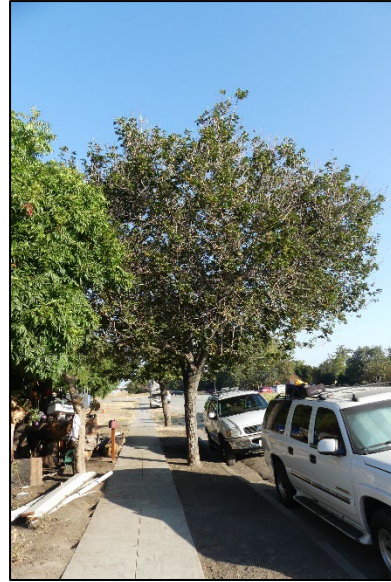
Norway maple was the most frequently occurring species with 22 trees. Maples were planted as street trees along Asbury, Walnut, Spring and Irene Streets (Photo 2). Trees were mature in development with trunk diameters between 8 and 18 in. Lack of irrigation has resulted in the death of seven trees and the poor condition of another 11. Norway maples #101, 116 and 177 were in fair condition while tree #205 was in good condition. Trees of this species can be expected to continue to decline in health due to lack of irrigation.

Photo 2. Typical Norway maple street tree. Note extensive twig dieback.

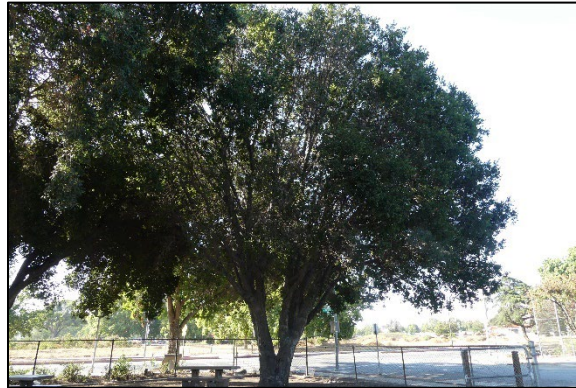
Photo 3. Coast live oak #148 had trunks of 26 and 25 in. and was in fair condition.

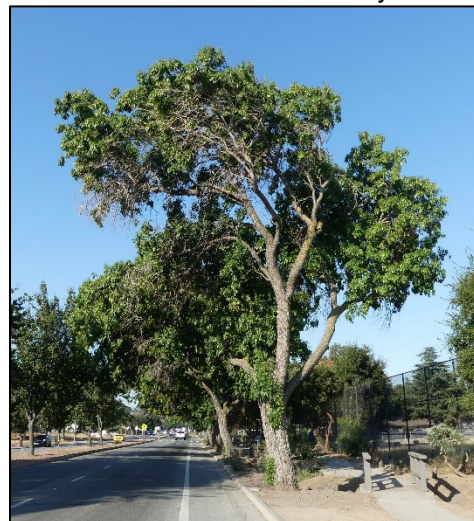
Twelve Modesto trees were present: 11 on Taylor Street and tree #203 on Asbury Street. All were street trees located between the sidewalk and curb (Photo 4). All were mature in development. Trunk diameters ranged from 24 to 32 in. It appeared that more trees had been present at one time as there were gaps in the canopy and trees had asymmetric crowns. Tree condition was generally fair (9 trees). Ashes #154 and 196 were in poor condition. Tree #154 had a cracked scaffold branch over the sidewalk that was ready to fail at any time. Modesto ash #134 was in good condition.

Photo 4. Looking west along Taylor Street at Modesto ash #133.

133	Modesto ash	27	Yes	3	Low	Street tree; multiple attachments @ 8'; scaffold branch failure; one-sided to W.
134	Modesto ash	24	Yes	4	Moderate	Street tree; codominant trunks @ 12'; multiple attachments above.
135	Marina madrone	6,5	No	4	Moderate	Codominant trunks @ base; crown lifted.
136	Coast live oak	7,6	Yes	3	Low	Base embedded in fence; crown lifted.
137	Callery pear	7	No	4	Moderate	Typical form & structure.
138	Callery pear	10	No	3	Low	Typical form & structure but with bowed out stems; some twig dieback.
139	Callery pear	11	No	3	Low	Typical form & structure but with very bowed out stems.
140	Callery pear	7	No	3	Low	Typical form & structure; crown lifted.
141	Callery pear	9	No	3	Low	Typical form & structure; bowed out stems.
142	Mexican fan palm	26	Yes	5	High	7' brown trunk.

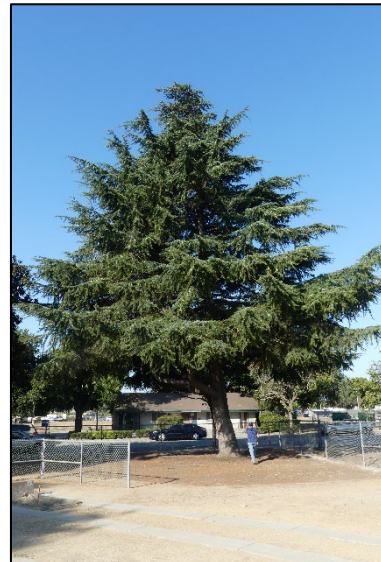
Photo 5. Looking west at Deodar cedar #146.

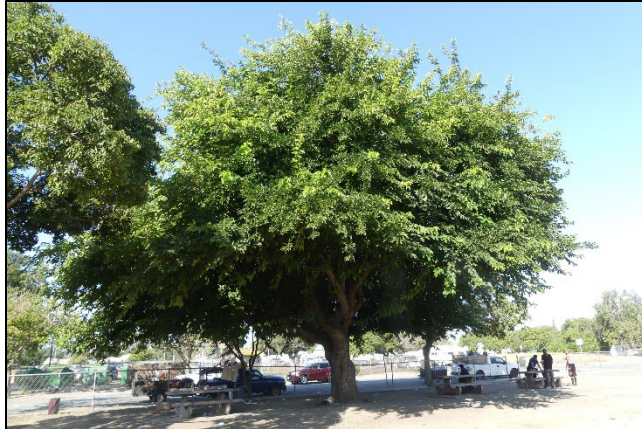
- Mulberry #165 was located near Spring St. It was 42 in. and in fair condition, having decay in the trunk and a history of topping (Photo 6). Trees #200 and 201 were located near the intersection of Taylor and Walnut Streets. They were 20 and 16 in. in diameter. Both were in fair condition.

Photo 6. Looking west at mulberry #165.

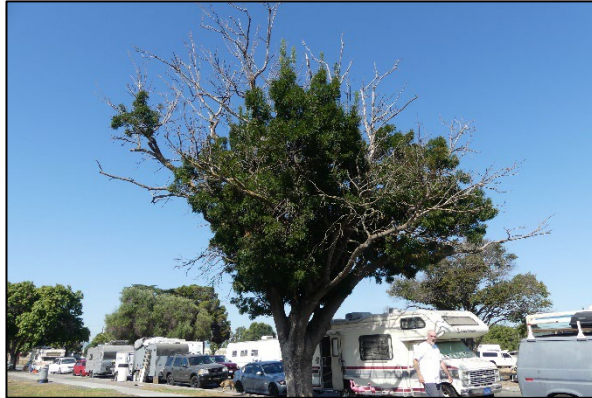
Photo 7. Looking northwest at Raywood ash #204. Note the extensive dieback in the crown.

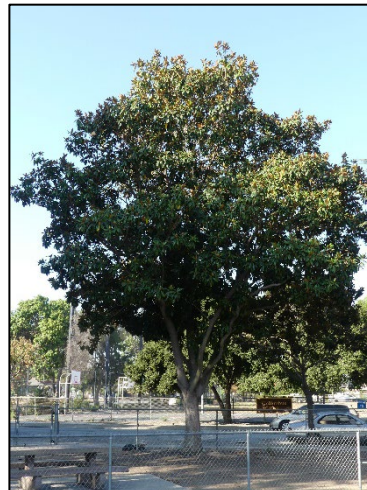
Photo 8. Looking west at southern magnolia #147.

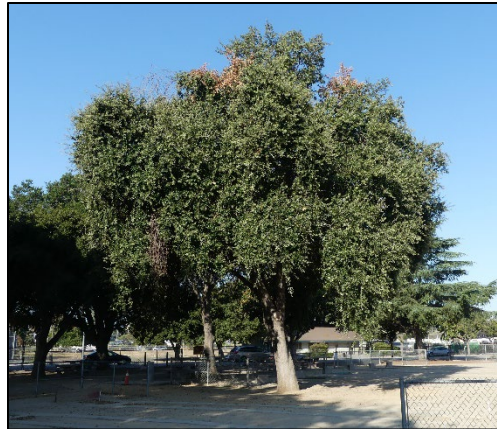
- Valley oaks #150 and 151 were located next to one another and were 24 and 28 in. respectively (Photo 9). Both were in fair condition. Valley oak #180 was 15 in. and in fair condition. Valley oak #198 was 14 in. and in good condition. It was located at the intersection of Walnut and Taylor Streets.

Photo 9. Looking west at valley oak #151. Note dead branches in upper crown.

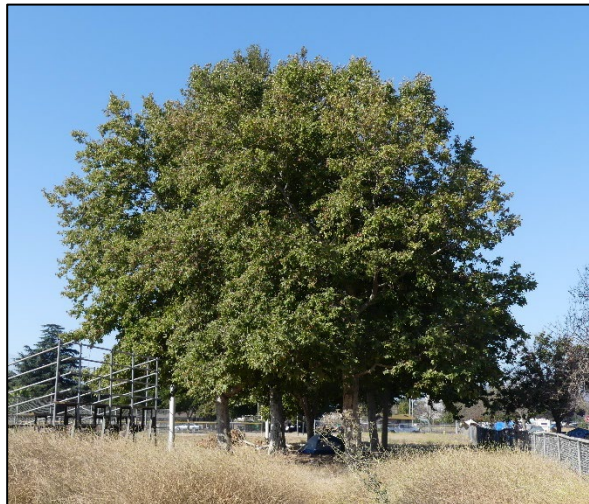
- Western redbud #191 was a large, multi-stem shrub in excellent condition.
- Western sycamores #170, 171, 172 and 173 formed a grove along Asbury Street (Photo 10). Trees were mature in development with trunks diameters between 14 and 29 in. Trees #172 and 173 were in good condition while #170 and 171 were excellent.

Photo 10. Looking west at grove of western sycamores.
