ARBORIST REPORT

February 16, 2023
Rev. February 23, 2023
6484.00

380 N. First St.
San Jose, CA

MSASA Properties LLC

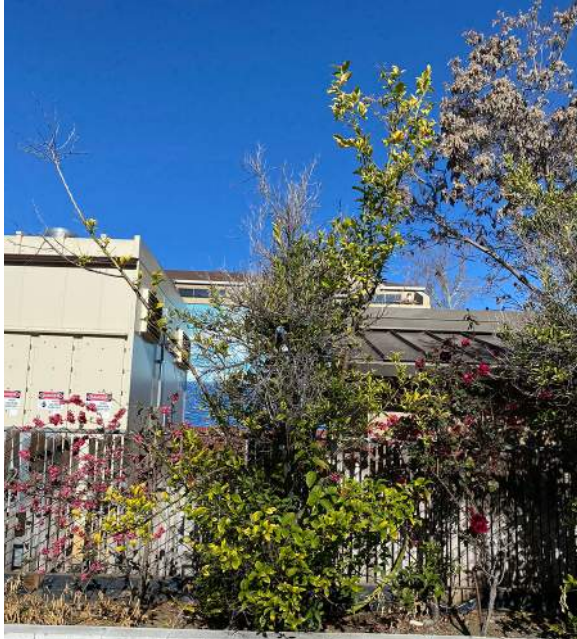
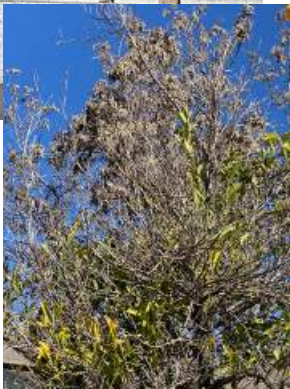
There are four citrus trees growing in a raised planter along the side of the property. Trees 11, 12, and 14 are in moderate health and shape with some crown dieback. Tree 13 appears to have so much dieback it is in decline and is recommended for removal. If any of these trees are to be retained, the raised soil level should be maintained.

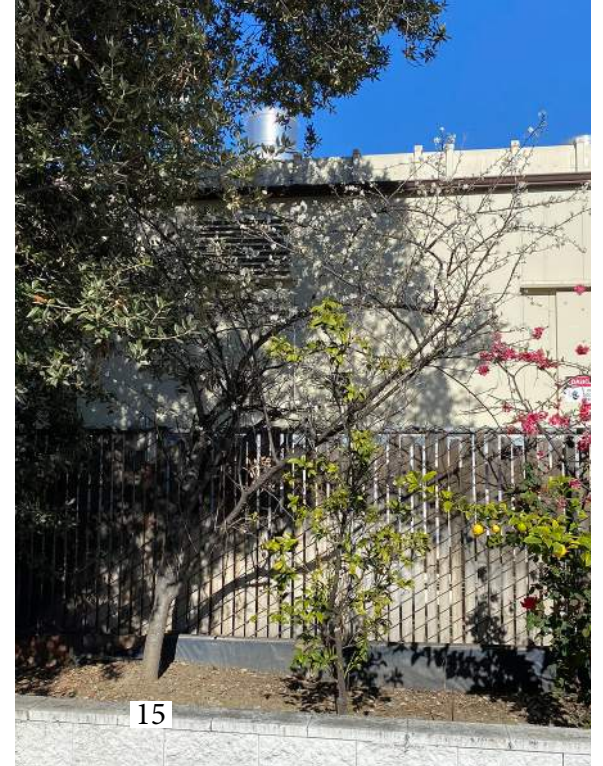
15

There is a pear tree in the raised planter that is in moderate health and shape. It is being shaded by the adjacent holly oak and is leaning away from it. If this tree is to be retained, the raised soil level should be maintained.
