ARBORIST REPORT

740 West San Carlos Street Mixed Use

San Jose, California

MARCH 26, 2015

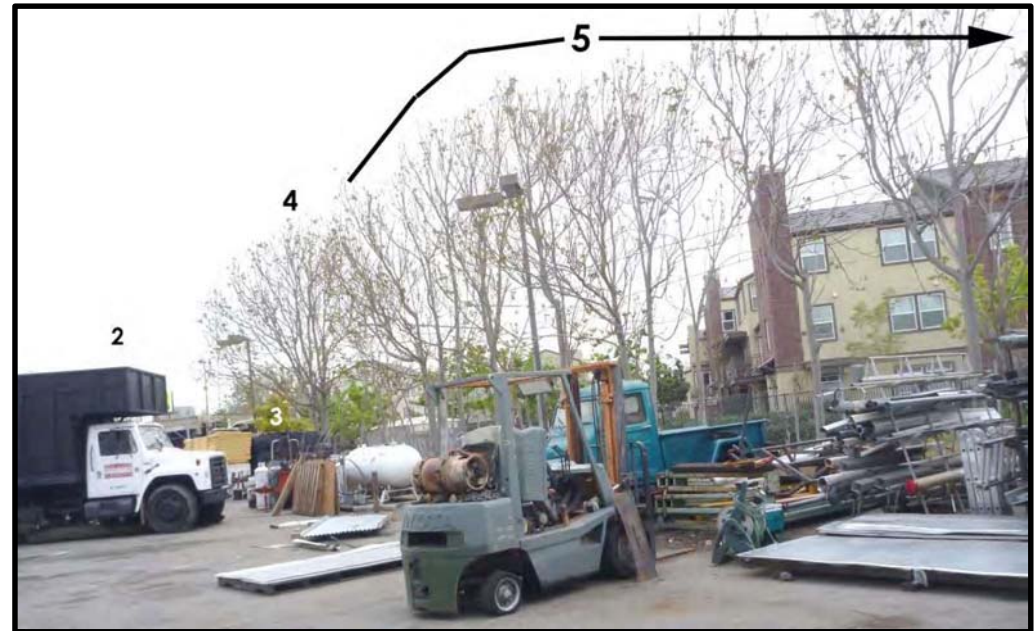
Cover photo: The southeast perimeter of the site with the individual and groups of **Tree-of-Heaven trees labeled as #2, 4 and 5 with avocado #3** in between. All photos in this report were taken by D. Ellis on March 25, 2015.

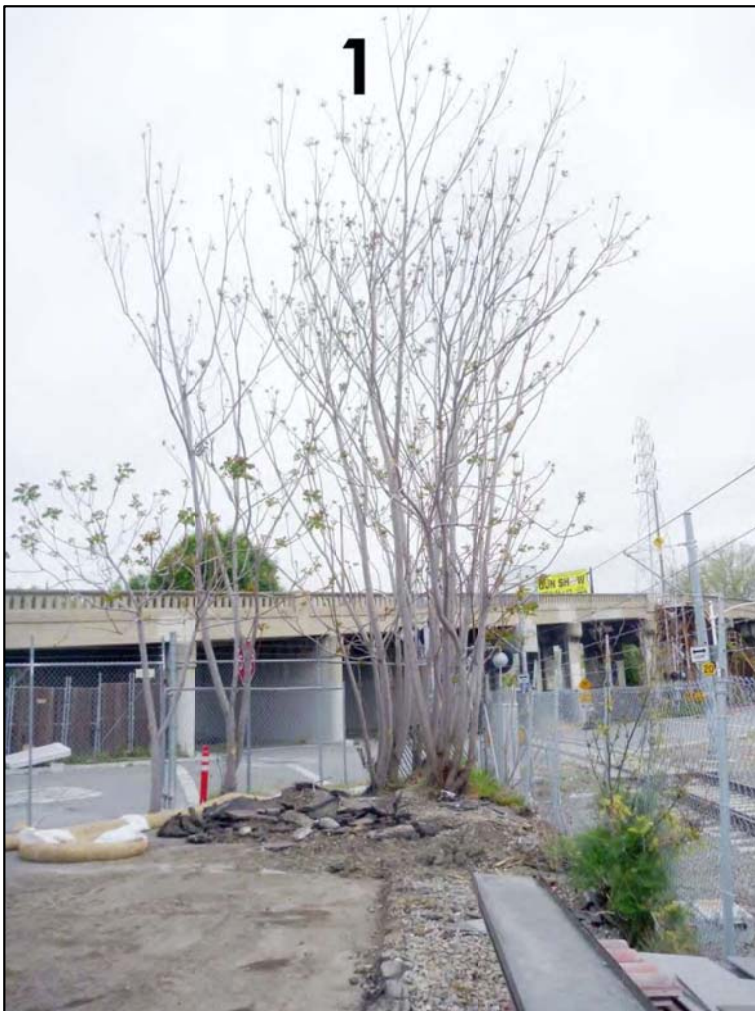
Left photo: **Tree-of-Heaven #1** (5 clumps of 19 trunks, 3 to 8 inches in diameter) at the very northeast corner of the site.

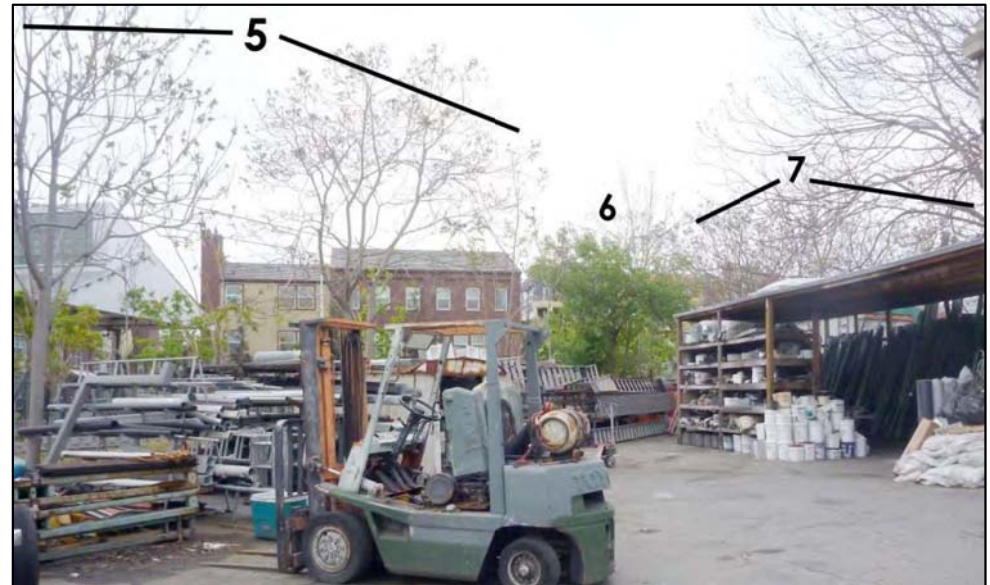
Right: **Tree-of-Heaven #5 and #7** (groups of trunks, as with tree #1) and **almond #6** along the south perimeter of the site.

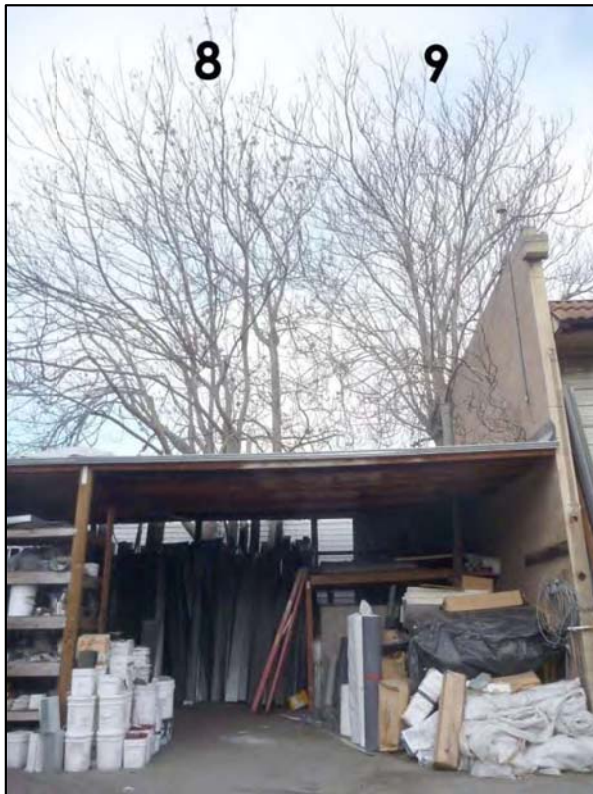
9	Tree-of-Heaven	12	42*25	80	50	Poor	Not tagged because inaccessible between structures. Trunk diameter is estimate.	3	5	6
10	Tree-of-Heaven	18	40*30	85	60	Poor	Roots of tree causing massive asphalt damage. Trunk pressing against the adjacent cyclone fence.	4	7	13
11	Chinese pistache	3,4,4, 5	22*22	90	40	Fair/Poor	Stump sprout from previous tree that was cut down.	3	4	5

Left photo: **Tree-of-Heaven trees #8 and 9**, squeezed between a storage shed and the building behind.

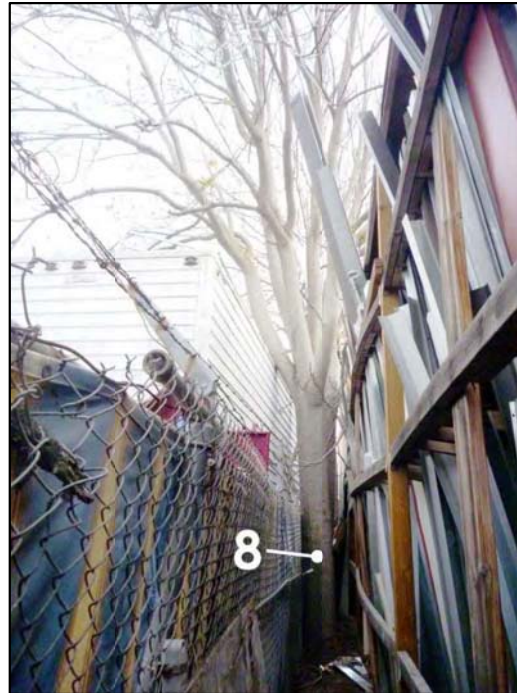
Tree #	Species & Common Name	Trunk Diam. @3ft.	Size	CONDITION		Preservation Suitability	Notes	TREE ROOT PROTECTION DISTANCES		
				Vigor	Structure			3xDBH	5xDBH	OTZ
1	<i>Ailanthus altissima</i> , Tree-of-Heaven	19x3-8	40*30	80	40	Poor	Five clumps of trunks; all appear to be stump sprouts.	3	4	5
2	Tree-of-Heaven	3,3,2	15*7	60	40	Poor	Stump sprout tree. Not tagged because trunks are inaccessible behind pile of building materials.	3	4	5
3	<i>Persea americana</i> , avocado (edible)	5,4	15*10	80	60	Poor		3	4	6
4	Tree-of-Heaven	18,9	35*25	80	50	Poor	Stump sprout tree.	6	9	17
5	Tree-of-Heaven	39x2-11	22-35 * 6-25	50-80	20-60	Poor	The most common trunk diameter is around 6 inches in this long row of sucker and stump sprout trunks.	3	4	5
6	<i>Prunus amygdalus</i> , Almond (edible)	7	22*18	80	50	Poor	Volunteer.	3	4	6
7	Tree-of-Heaven	7*2-12	12-30 * 4-25	50-80	20-50	Poor		3	5	6
8	Tree-of-Heaven	12,14,19	45*35	85	50	Poor	Causing massive asphalt damage around root collar .	8	13	16

Center: close-up of lower trunk of **Tree-of-Heaven #8**.

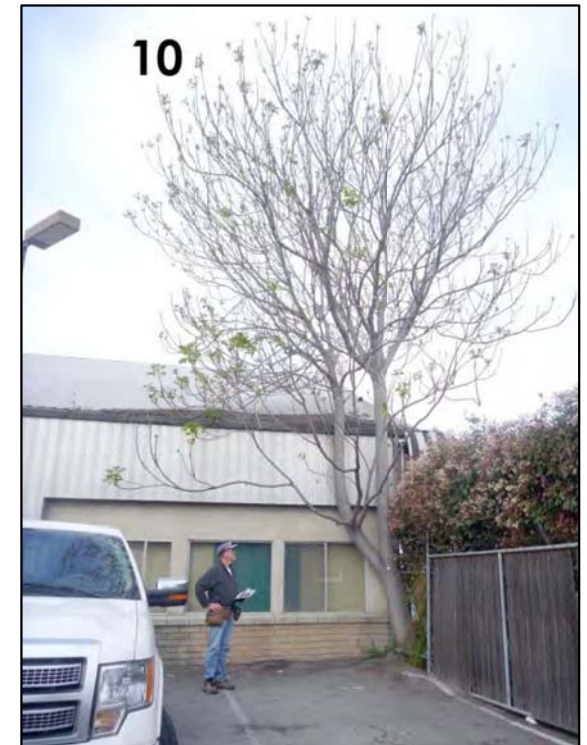
Right: **Tree-of-Heaven #10** near one of the commercial buildings, close to West San Carlos Avenue.

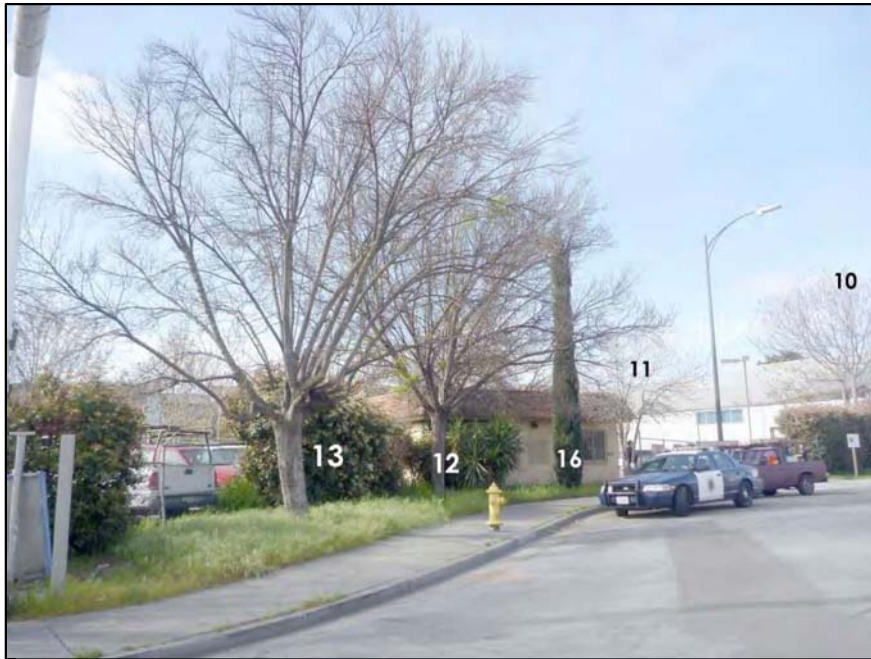
Left photo: **Tree-of-Heaven #10, Chinese pistache #11, Raywood ash #12 and 13 and Italian cypress #16** near the building at 740 West San Carlos Avenue. The ash trees may be City Street Trees

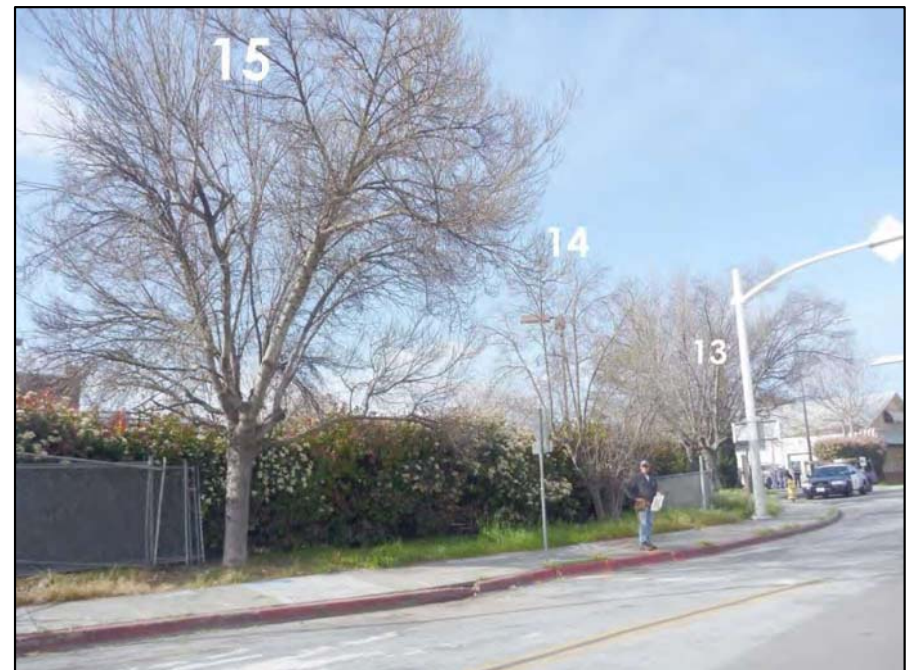
Right: **Raywood ash #13-15** along West San Carlos Avenue. These ash trees may be City Street Trees.

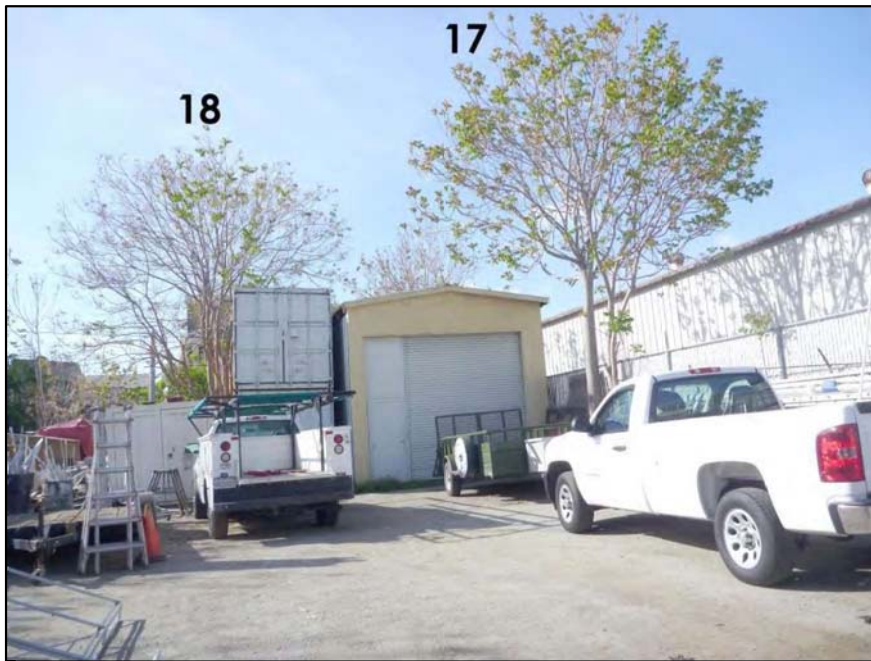
Upper Left: **Tree-of-Heaven #17 and 18** at the southwest corner of the site.

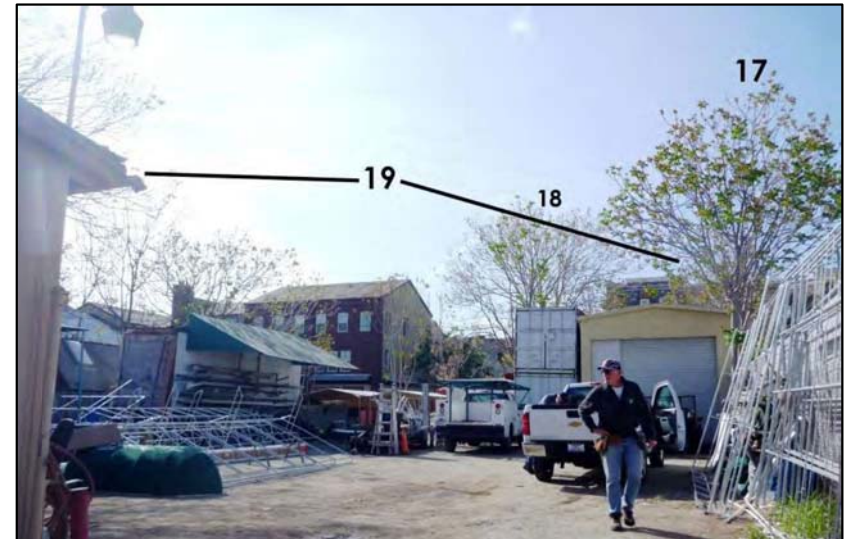
Upper Right: **Tree-of-Heaven #17, 18 and the large group of trunks #19** at the southwest corner of the site.

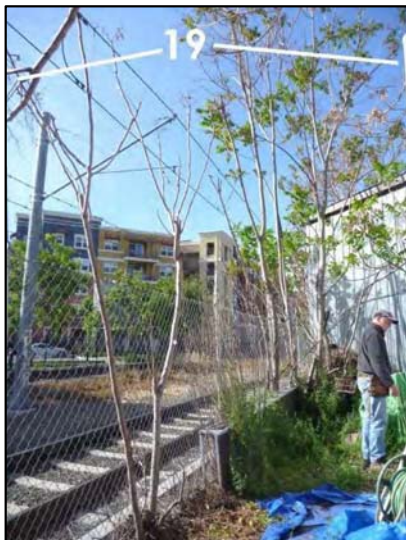
Lower Left: close-up of some of the trunks labeled as **Tree-of-Heaven #19**.

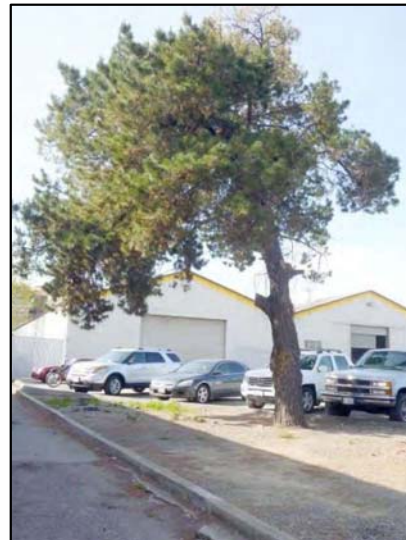
Lower Right: **west neighbor's large Monterey pine** along the west perimeter of the site, near the northwest corner and West San Carlos Avenue.
