EVERGREEN • EAST HILLS VISION STRATEGY

EIR APPENDIX L

**PHASE I & II
ENVIRONMENTAL SITE ASSESSMENT
ARCADIA PROPERTY
SAN JOSE, CA 95122**

July 7, 2005
File No. 56815/ENV

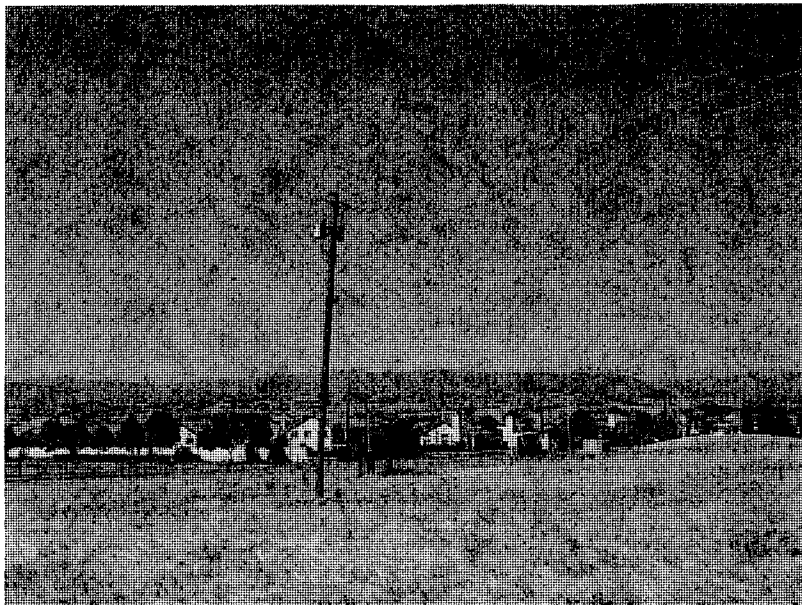
Photo 1.
View looking southwest at water well and City of San Jose water tank (middle right) in south portion of North property.

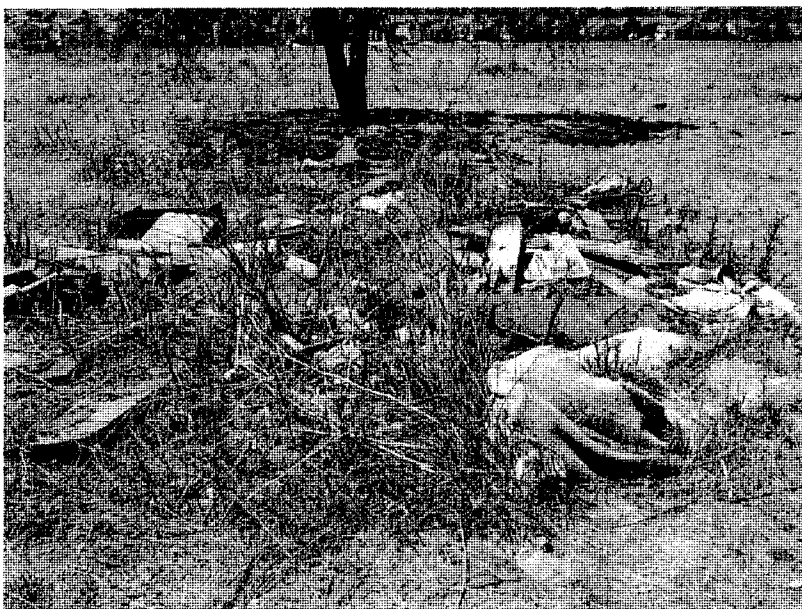
Photo 2.
View looking south at solid waste and debris on east side of access road on North property.

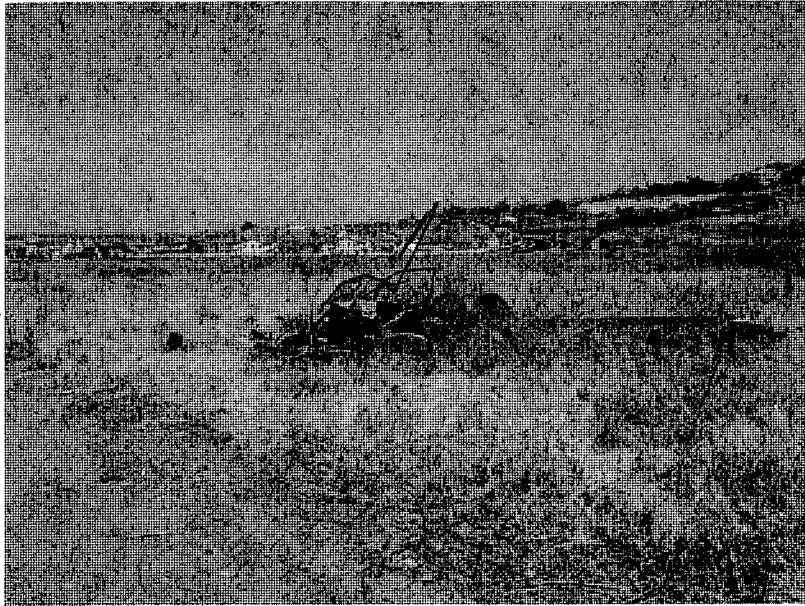
Photo 1.
View looking north at debris pile of metal, wood, and tires on east side
of access road on North property.

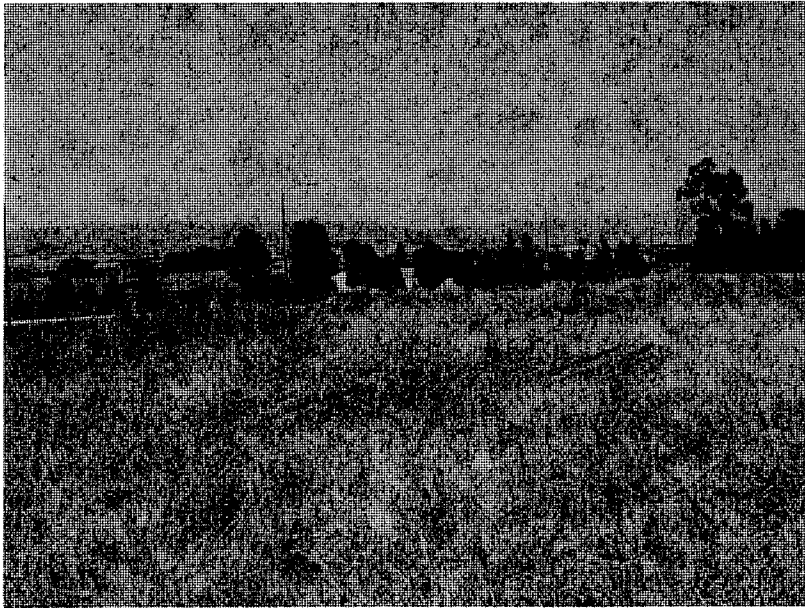
Photo 2.
View looking southwest at soil mounds with wood and concrete debris in the
southwest portion of the North property.

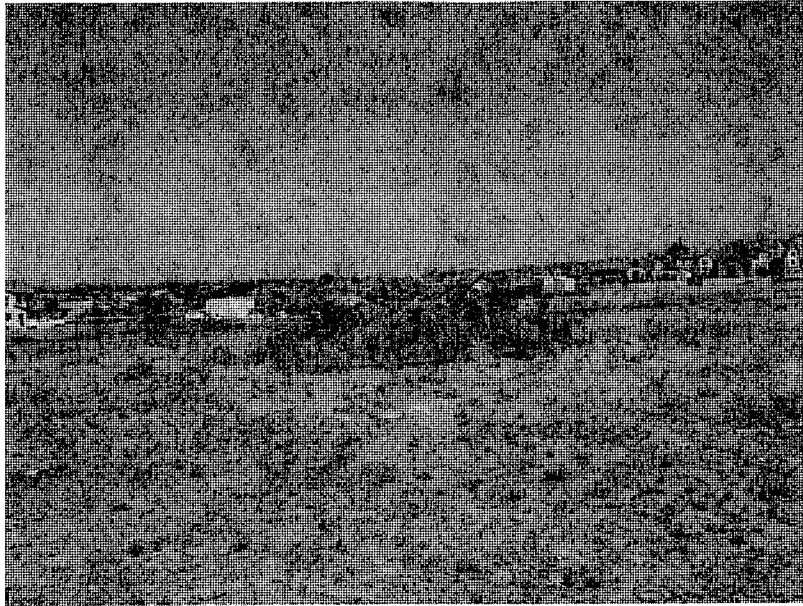
Photo 1.
View looking northwest at soil piles with wood, metal, and plastic debris in the northwest portion of the North property.

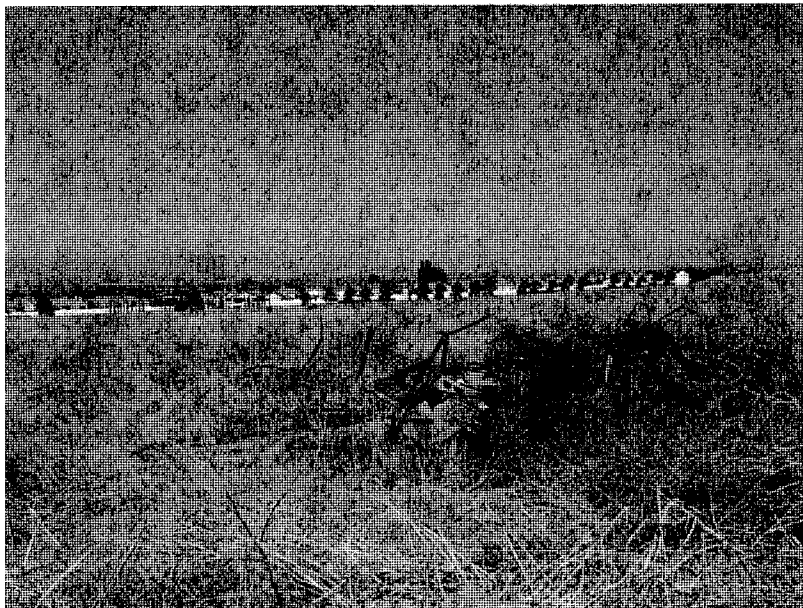
Photo 2.
View looking northwest at debris pile of wood, metal, and concrete in the central portion of the South property.

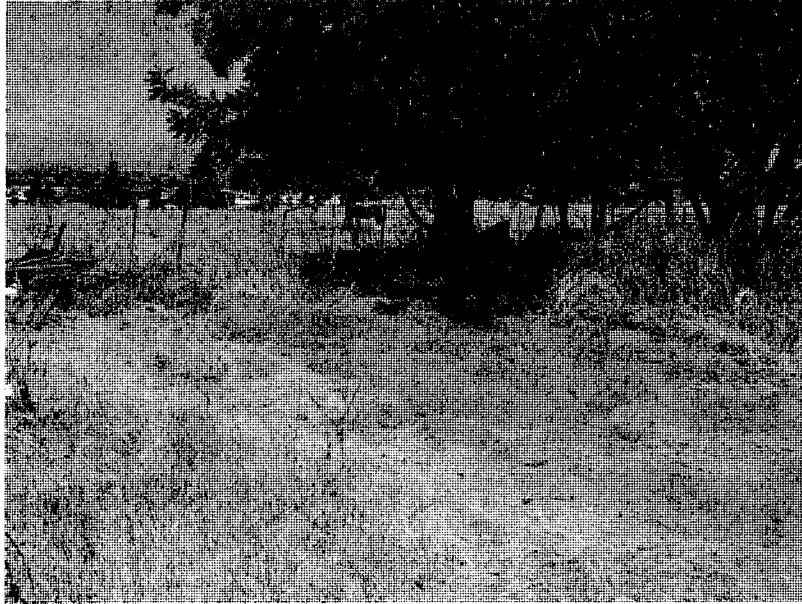
Photo 1.
View looking northwest at the area of scattered debris in the northeast portion of the South property.

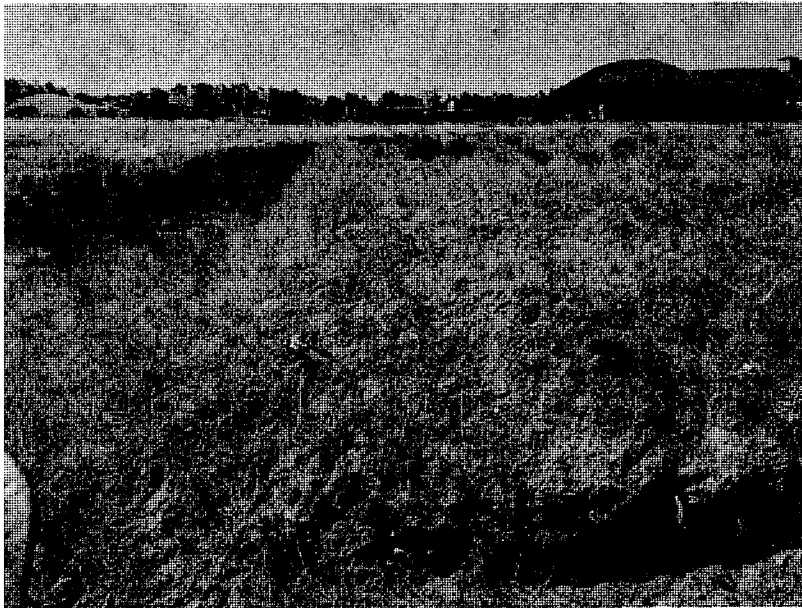
Photo 2.
View looking south at area of fill and grading in the south portion of the South property.
