# Kielty Arborist Services LLC

January 4, 2017, Revised July 26, 2017

Site: 15980 Carlton Avenue, San Jose CA

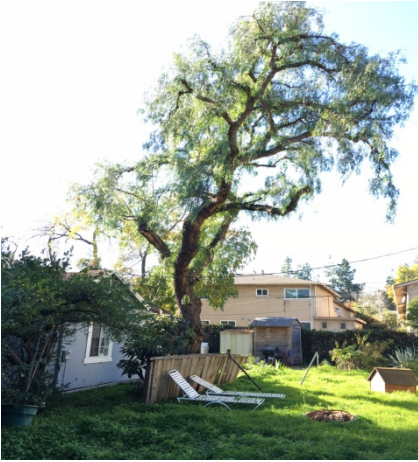
**Showing tree #3**

Tree #3- This tree is a California pepper tree (*Schinus molle*) with a diameter of 26.3. The tree is in poor condition as a history of limb loss is seen throughout the tree's canopy. Also the tree has been heavily pruned in the past in order to make clearance for an existing home. The pruning cuts have caused decayed areas throughout the tree's canopy. Limb loss will continue to occur as a result.

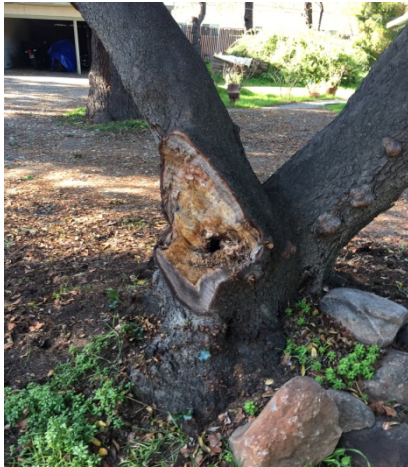
**Showing tree #4**

Tree #4 is a large carob tree (*Ceratonia siliqua*) with an added diameter of 26.6. The tree is in poor condition as a large leader has failed at the height of 1 foot from grade. This tree has also been topped in the past (poor maintenance). Decay is visible at the trees base. This tree is at a high risk for tree failure and should be removed regardless of the proposed construction.

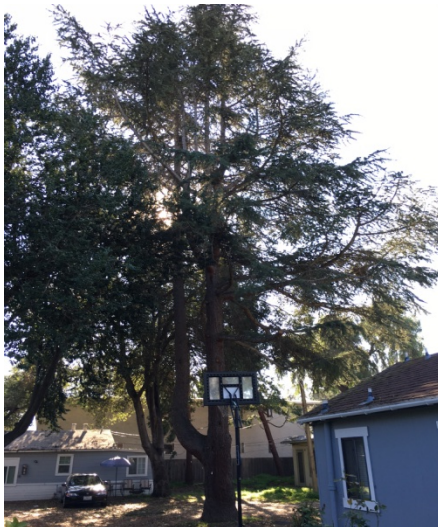
**Showing tree #5****Kielty Arborist Services**

Tree #5 is a large deodar cedar tree (*Cedrus deodara*) with a diameter of 32.4 inches. This tree is in poor condition because of its poor form. The tree has lost its apical dominance at the height of 8 feet as the tree is codominant. At 35 feet the tree has also been topped. Multiple leaders are now suppressing each other as a result. This is not the trees natural growth form and as a result limb failure is now at a higher risk.

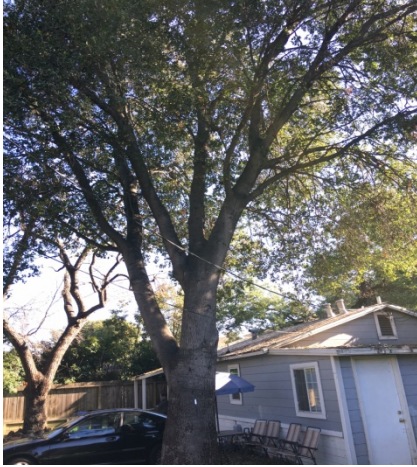
#### **Showing tree #6**

Coast live oak tree #6 has a diameter of 27.9 inches. This tree received a fair condition rating of 65. The tree is codominant at 7 feet and is heavy over an existing building.

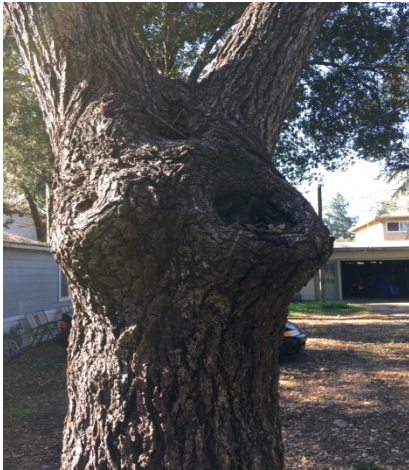
#### **Showing tree #7**

Black walnut tree #7 has a diameter of 25.7 inches. This tree was given a poor condition rating of 30. The tree has poor vigor and poor form. The tree is codominant at 7 feet with decay at 6 feet. This tree is in decline and should be removed regardless of construction.

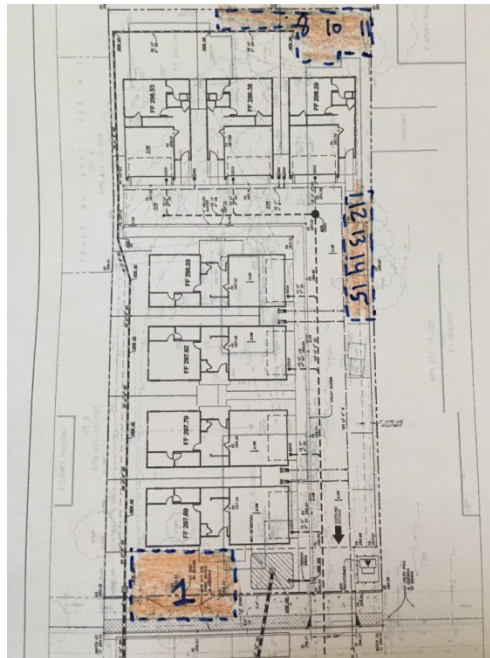
**Showing recommended tree protection fencing locations**

Tree protection zones should be established and maintained throughout the entire length of the project. Fencing for the protection zones should be 6 foot tall metal chain link supported by metal poles the support poles should be spaced no more than 10 feet apart on center. The location for the protection fencing should be as close to the dripline as possible still allowing room for construction to safely continue. Signs should be placed on fencing signifying "Tree Protection Zone - Keep Out". No materials or equipment should be stored or cleaned inside the tree protection zones. Areas outside the fencing but still beneath the dripline of protected trees, where foot traffic is expected to be heavy, should be mulched with 4 to 6 inches of chipper chips. Below is a diagram showing the recommended tree protection fencing locations. The existing driveway on the east side of the property is to stay in place as long as possible as the driveway offers protection to the neighbor's trees.
