Preliminary Arborist Report

**2700 Booksin Avenue
San Jose, CA**

**PREPARED FOR
SummerHill Homes
3000 Executive Parkway, Suite 450
San Ramon, CA 94583**

October 28, 2016

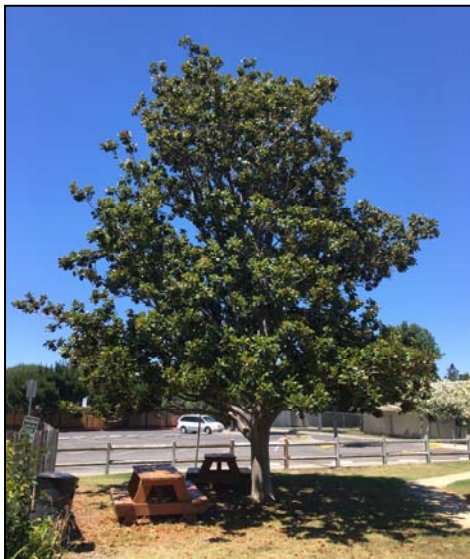
Six southern magnolia trees were assessed, two (2) were in good condition (#54 and 83), three were in fair condition (#45, 71 and 72) and one was in poor condition (#55). The southern magnolias were semi mature with trunk diameters ranging from 10” to 18”. The magnolias were characterized by having multiple attachments, sparse crowns and dieback. Tree #83 was the best performing magnolia with good form and structure (Photo1).

Photo 1. Tree #83 was performing well in a turf area with regular access to irrigation water.

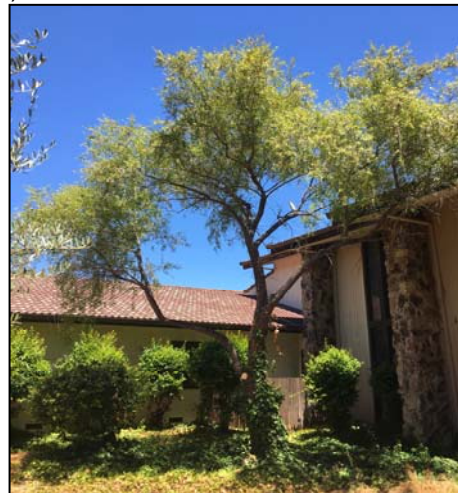
Six mayten trees were assessed, two were in fair condition (#61 and 81) and four were in poor condition (#65, 74, 85 and 88). The typical mayten tree had dieback, poor form and structure and two (#65 and 66) had been poorly pruned (Photo 2).

Photo 2. Tree #66 was typical of the mayten with over pruning, poor form and structure.

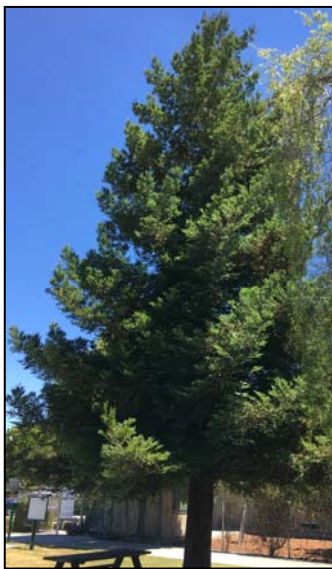
Photo 3. (Left) – Tree #75 was in good health and had vigorous growth.

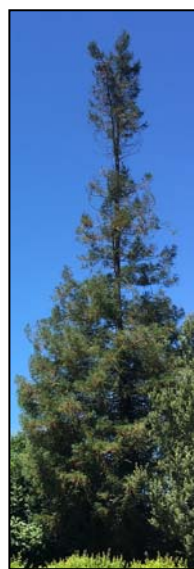
The five coast redwoods that were assessed were mature, with diameters ranging from 17” to 52”. Three (3) were in good condition (#67, 68 and 75), one was in fair condition (#57) and one was in poor condition (#62). The smallest of the five coast redwoods (#75) was the healthiest and most vigorous. Tree #75 was planted in a turf area, which contributed to the good health and vigor of the tree. Coast redwoods #57, 62, 67 and 68 ranged from having healthy vigorous growth to having dieback, chlorosis and drought stress (Photos 3 and 4).

Photo 4. (Right) – Tree #62 had dieback, was drought stressed and the base and trunk were engulfed in ivy.

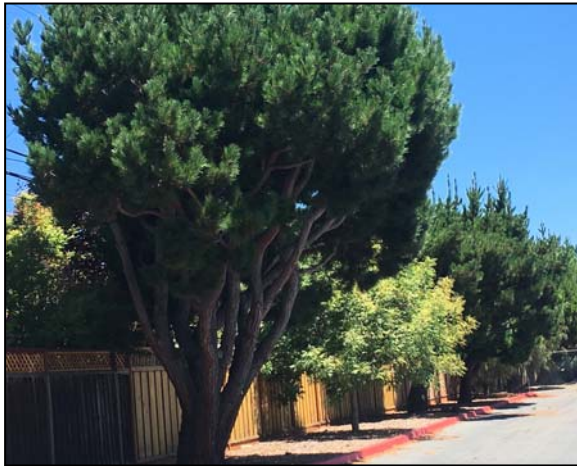
Four (4) mature Italian stone pines (#48, 49, 51 and 52) lined the north side property line. Their diameters ranged from 20” to 36”. The pines had been topped at ten feet on the northern side for powerline clearance (Photo 5).

Photo 5. Italian stone pines #48, 49, 51 and 52 had been topped for powerline clearance.
