**Tree Inventory, Assessment,
And
Protection**

**201 Delmas Avenue
San Jose, CA 95110**

**September 3, 2015
Revised
January 14, 2016
Revised
April 15, 2016**

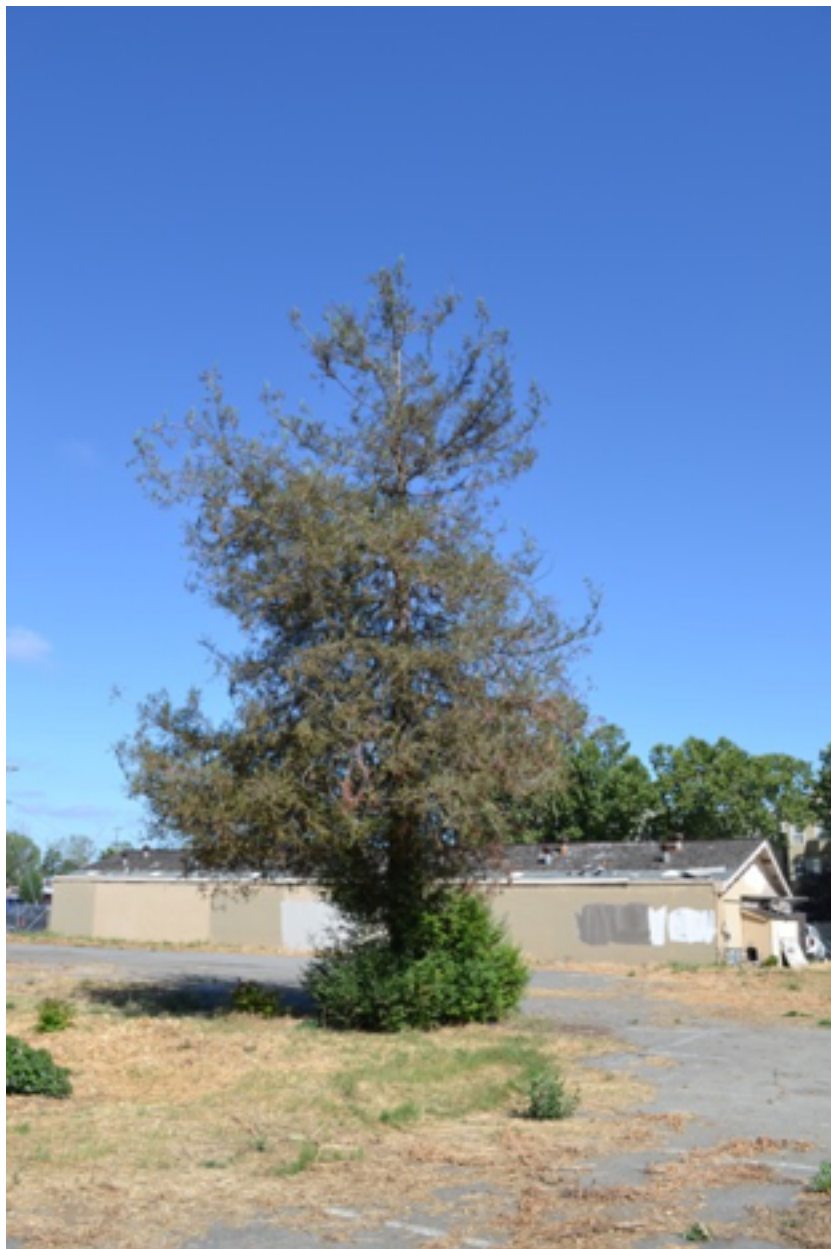
C2: Coast redwood 498

All the trees have poor suitability for preservation with the exception of the coast live oak and the Canary Island pine. The pepper and coast redwood are failing while the tree of heaven are an invasive plant not suitable to retain. I considered the coast live oak to be the best tree suited for retention with good suitability and the Canary Island pine is a large tree that would require some mitigation to help reduce the risk of codominant stem failure. The Canary Island pine has fair suitability for preservation.

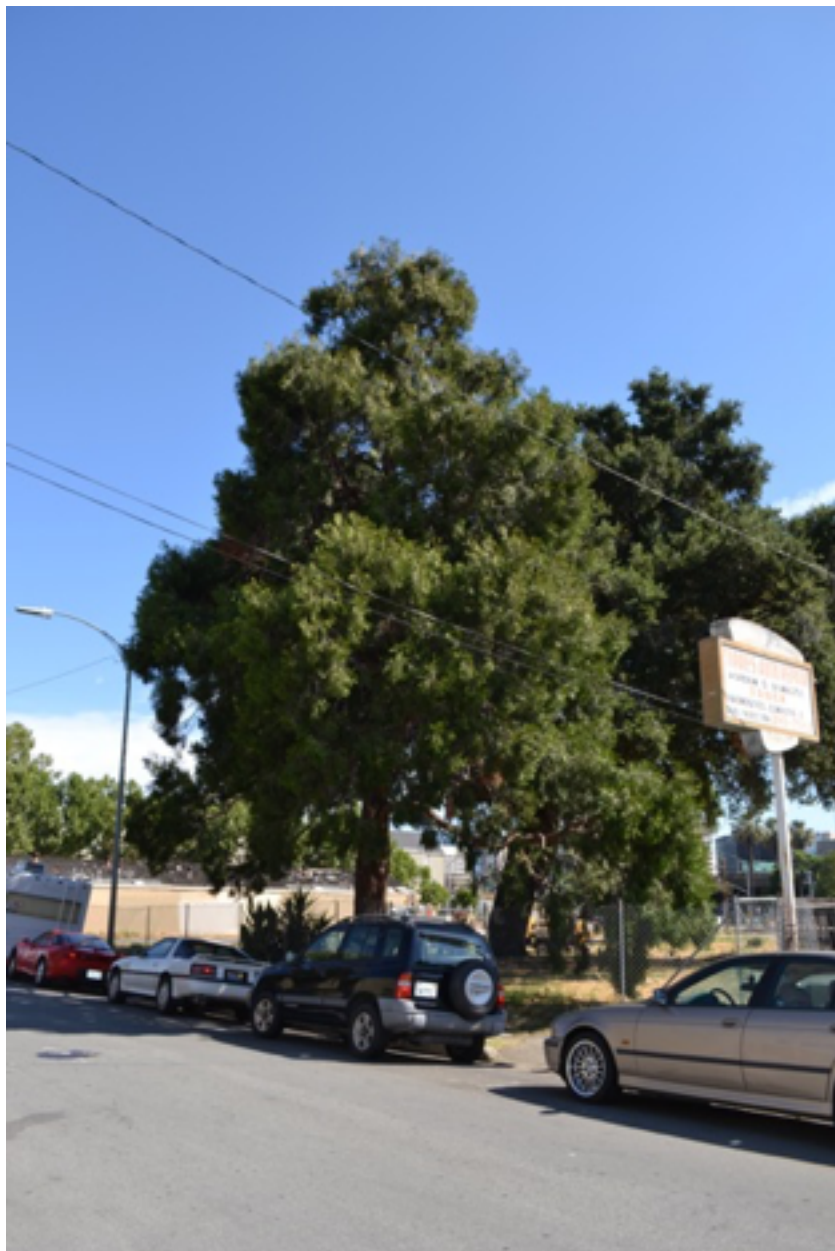
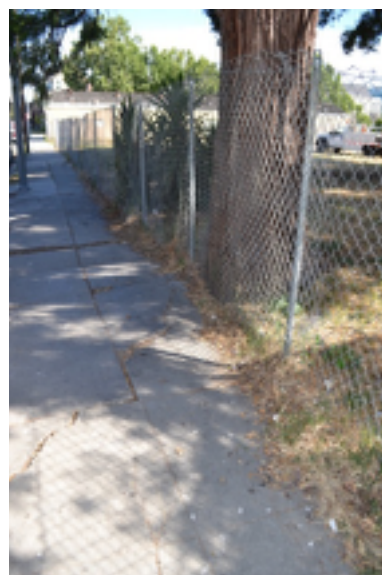
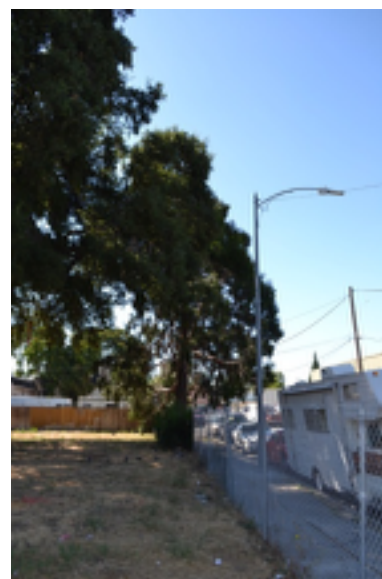
C4: Incense cedar 499

Most of the trees are in fair condition with some problems. The Canary Island pine has codominant stems originating about 25 feet up the tree and the incense cedar has a lean and is crowded by the coast live oak. The coast live oak is the only tree I considered to be in good condition with normal foliar color, size and density. Structurally the coast live oak has two defects or conditions that could be problematic which are codominant stems and a corrected lean but overall this tree is in good shape. The coast redwood and the Peruvian pepper are both in poor condition with defects and conditions that cannot be mitigated.

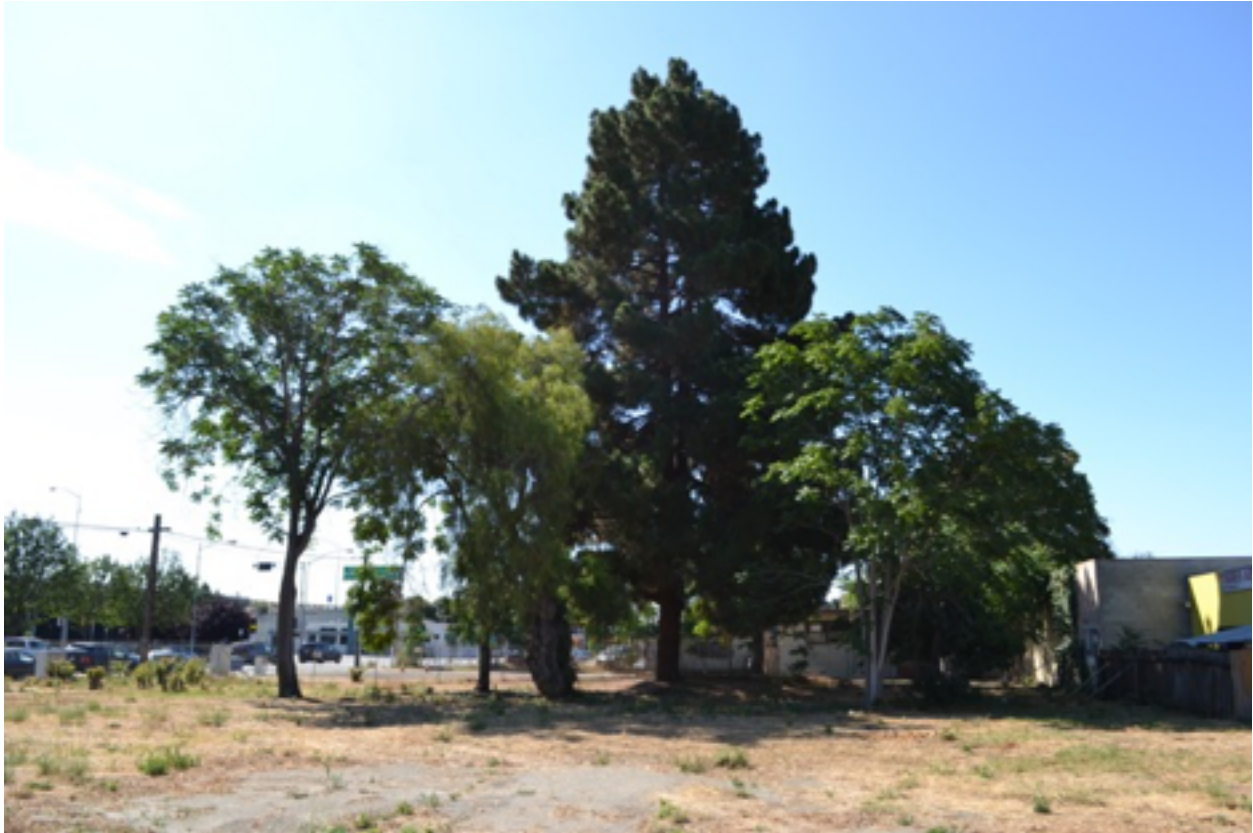
C5: Trees 492 to 497

Canary Island pine in the middle
