# Tree Survey

February 21, 2017

I am retained by LHB & Associates for Rotten Robbie #67 to provide this tree survey for the proposed project pursuant to guidelines for documentation of trees defined in the City of San Jose Ordinance - Municipal Code, Title 13, Chapter 13.32, Tree Removal Controls. Trees 56-inches in circumference (17.83-inches in diameter) and greater are documented measured at 24-inches above grade. This tree evaluation is conducted within the City guidelines defined and subject to city review.

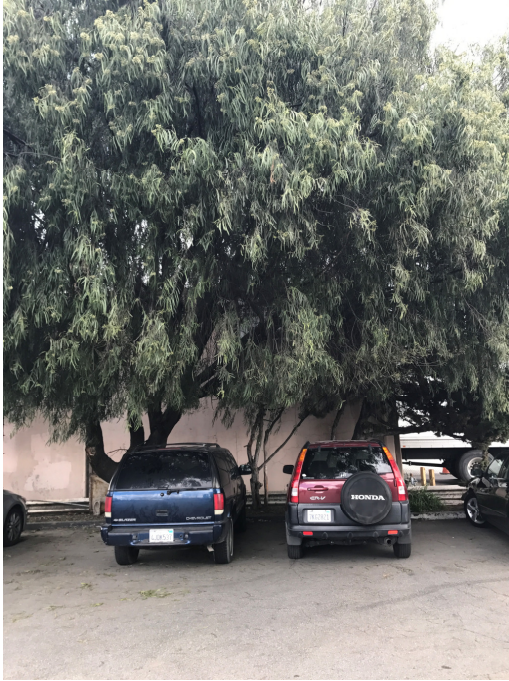
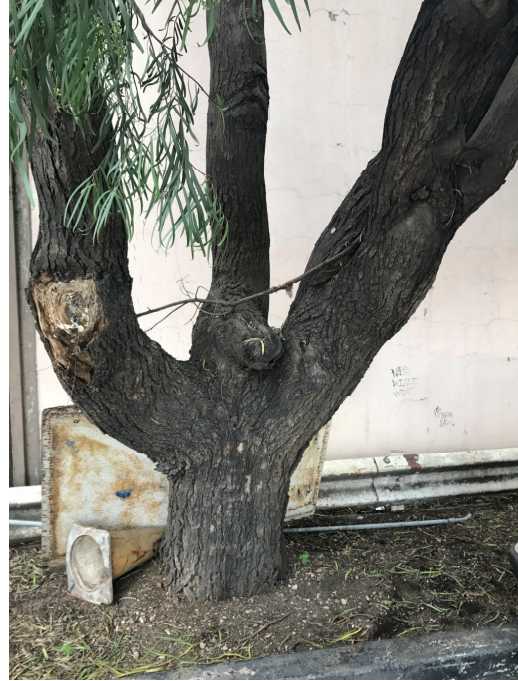
### Tree #424

Tree No.	Species	~Size @ 24"	<sup>1</sup> Health Vigor		<sup>3</sup> Const. Impacts	Remove	<sup>2</sup> Retention Rating	Comments
422	Hollywood juniper <i>Juniperus chinensis</i> `Torulosa`	12-5	Fair		High	X	Fair-Poor	Plans call for tree removal to facilitate construction.
424	Australian willow <i>Geijera parviflora</i>	15-19-13*	Fair		High	X	Fair-Poor	Plans call for tree removal to facilitate construction.
