Kielty Arborist Services LLC

April 16, 2018

Site: Hemlock Apartments, San Jose

At your request on Friday, March 30, 2018, I visited the above site to inspect and comment on the trees on site. An apartment building is proposed for this site and as required a tree survey and a tree protection plan is needed for the nearby trees to be retained

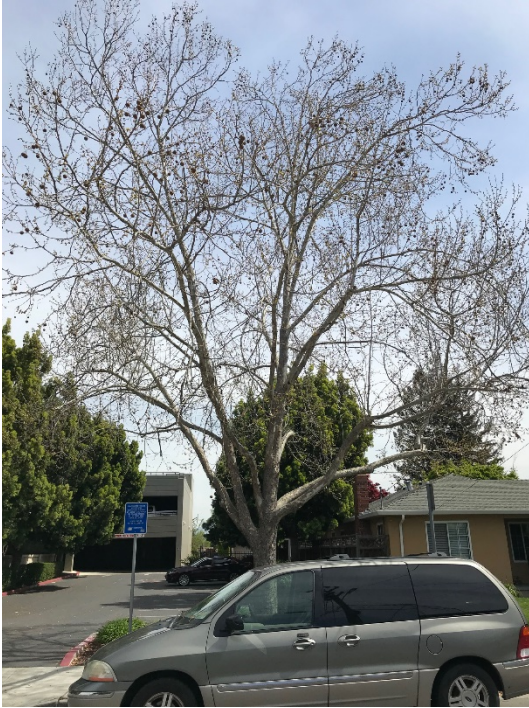
The trees on site are a mix of imported trees, there are no trees native to San Jose on site. All of the trees are proposed for removal to facilitate the proposed construction. The neighbor's London plane tree #1 and African fern pine trees #2-4 will be retained for this project. The neighbor's London plane tree is in good condition. Because this species has a good tolerance to construction impacts, it is recommended to maintain a no excavation zone of 6 times the tree's diameter (9 feet) from this tree in order to keep the tree in good health. Tree protection fencing will need to be placed at 10 times the tree's diameter (14 feet) where possible during the construction process in order to protect the root zone from potential compaction.

Showing neighboring London plane tree

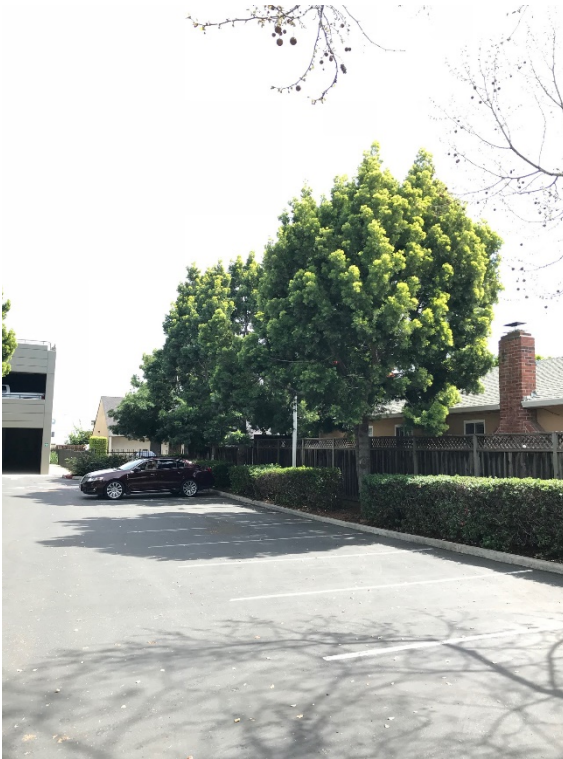
African fern pine trees #2-4 are located on the neighbor's property to the north in a small planting strip between a parking lot and the property line. These trees are in fair condition and provide screening for the property. The existing foundation on the property likely acted as a root barrier for these trees. Roots underneath the existing foundation are expected to be minimal to nonexistent. Tree protection fencing for these trees should extend off of the property line fence and out to the existing foundation to protect what roots are growing in this area. Impacts are expected to be minimal.

Showing African fern pine trees on neighboring property

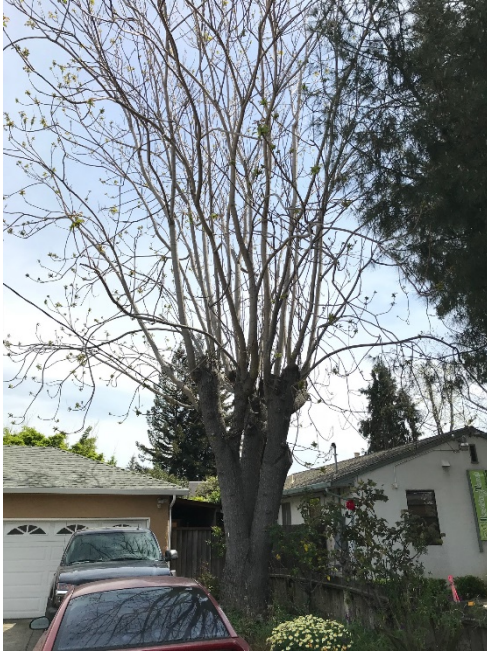
Tree of heaven #6 is in poor condition. This tree has been topped in the past at 15 feet. The remaining growth after 15 feet consist of epicormic water sprout growth. These water sprouts do not develop proper branch to trunk unions and can easily fail in normal weather conditions. Also, topping trees promotes decay where the original topping cuts took place. Because this tree was topped in the past it is now a hazard to the property. This species is an invasive species and is on the city of San Jose's list of Unsuitable Trees for this area.

Showing topped tree #6

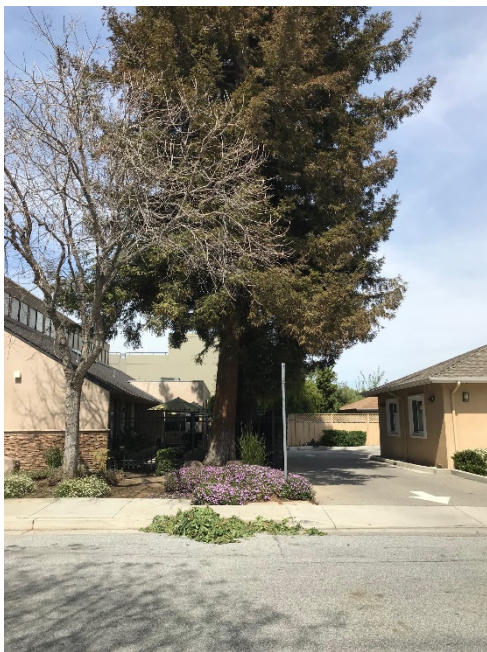
Redwood trees #7-10 are located on the east side of the property and are in fair to good condition. The tops of the redwood trees are exhibiting drought stressed symptoms. These trees have a restricted root zone due to the existing building and adjacent neighboring building. Also, the existing hardscapes near the trees are restricting root growth. The available soil for root growth near these trees is highly compacted. There is not enough room to support the future growth of these trees and is likely the reason these trees are showing drought stress symptoms.

Showing restricted root zone for redwood trees
