San José-Santa Clara
Regional Wastewater Facility
Reporting Period June 1 – October 31, 2018

Pond A18

2018 Annual Self-Monitoring Report

Order No. R2-2005-0003

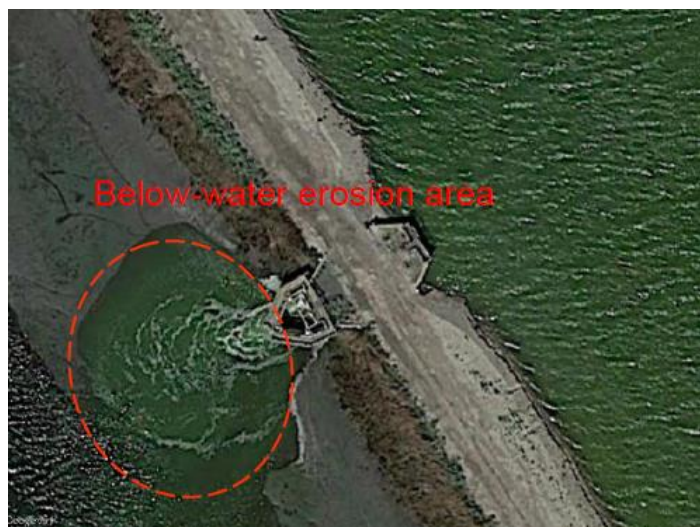
Figure 23. Google Earth satellite imagery details the erosion on the outboard side of the southern hydraulic structure

reconstruction of this structure in the summer of 2015, the southern structure was used to pulse water into and out of the pond to maintain pond water elevation and water quality. This pulsing of water exacerbated bank erosion and active scouring/slumping on the outboard levee proximal to the southern structure (Figure 23; Figure 24).

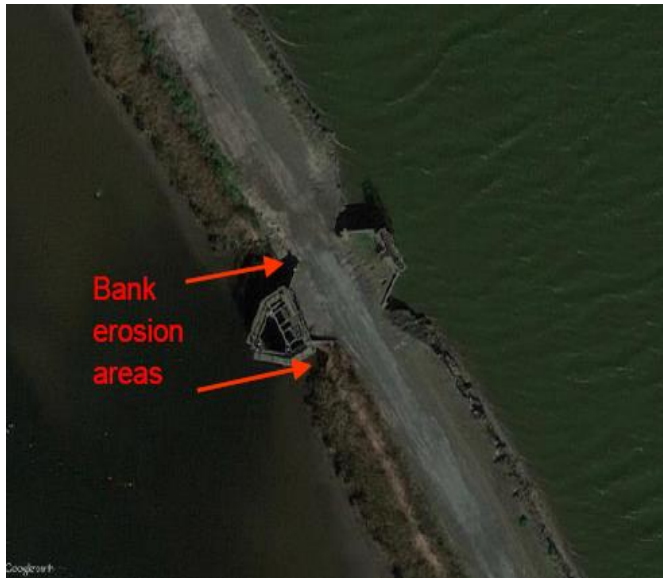
Figure 24. Bank erosion areas at the southern hydraulic structure

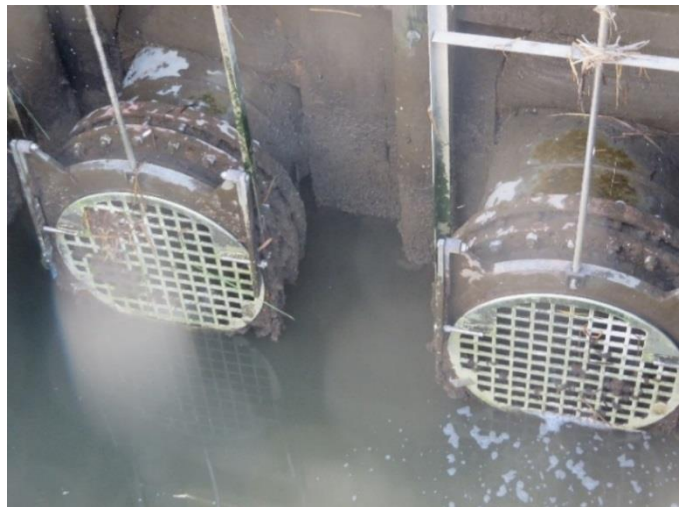
Figure 25. Steel flap gates were replaced with slotted fish screens to allow for inflow while preventing fish passage

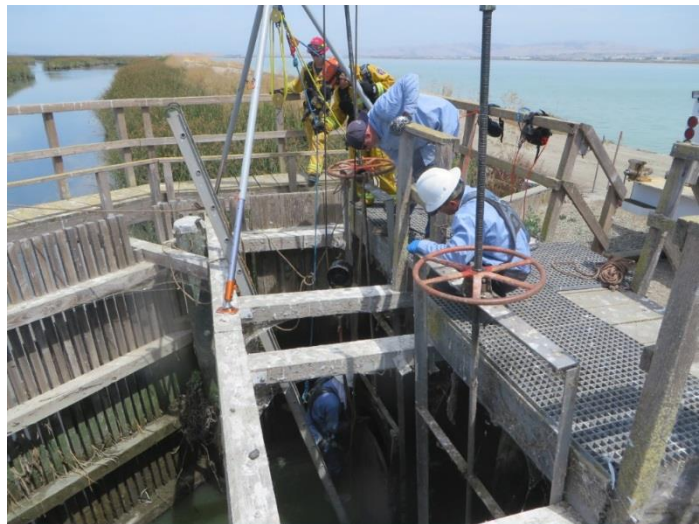
Figure 26. City personnel replacing the slotted fish screens to allow for outflow through the southern structure

Sweetwater Construction was awarded the construction contract, and in advance of their mobilization on-site, City personnel replaced the fish screens with the steel flap gates to allow for outflow through the southern structure (Figure 26).

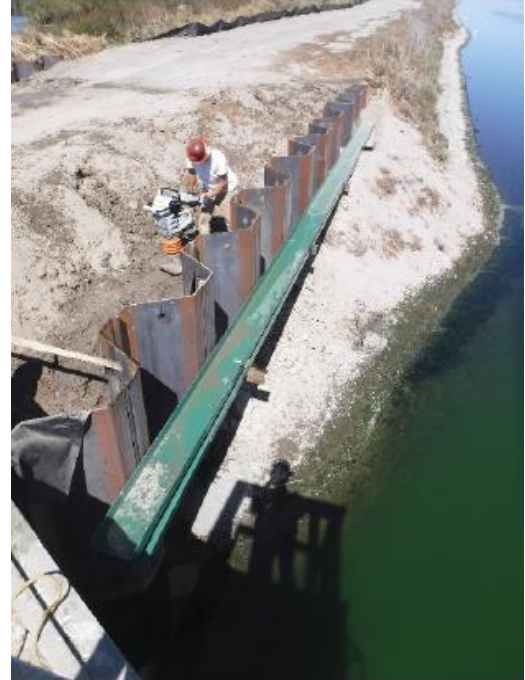
Figure 28. Walers affixed to sheet piles

driven approximately 40 feet down below the top of the levee surface elevation. 30- to 40-foot long walers were then affixed to the outboard side of the sheet pile rows, and reinforced with concrete entombed tie-rods

connected to the opposing sheet pile to strengthen the repair and reduce the required depth of the sheet piles (Figure 27; Figure 28). The levee crown was re-graded, and excavated areas back-filled to complete the levee restoration.

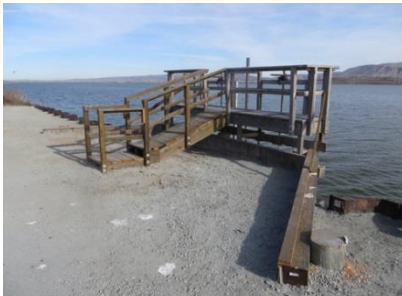
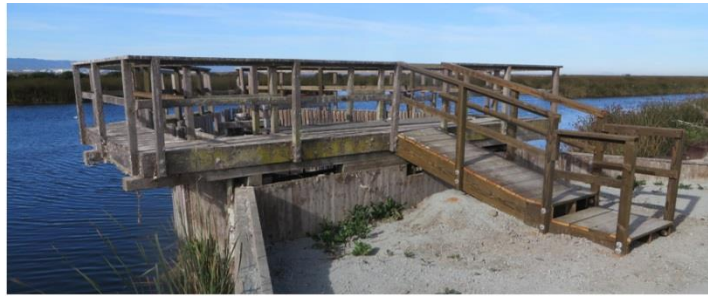
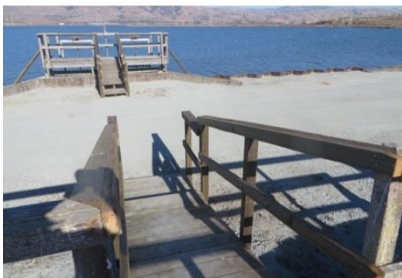
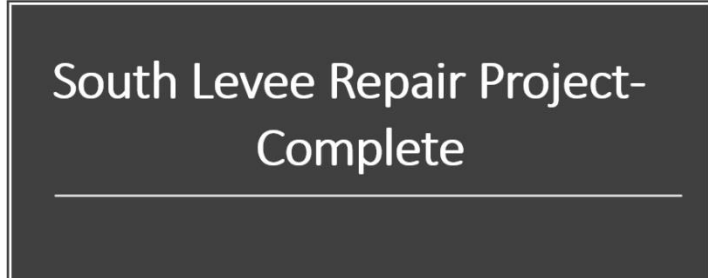
Figure 29. Repaired south levee images upon project completion

Once the project concluded on September 24 (Figure 29), the City again contracted Hydrosience to provide consultation to further develop the City’s monitoring methodology and reporting of the repair project’s ongoing condition. The City continues to monitor the mechanical and geotechnical vulnerabilities of the pond’s southern structure, and adjust operations to minimize sediment transport, scour and levee erosion.
