**200 Park Avenue
San Jose, California**

Arborist Report

Project #4189-01

July 24, 2018

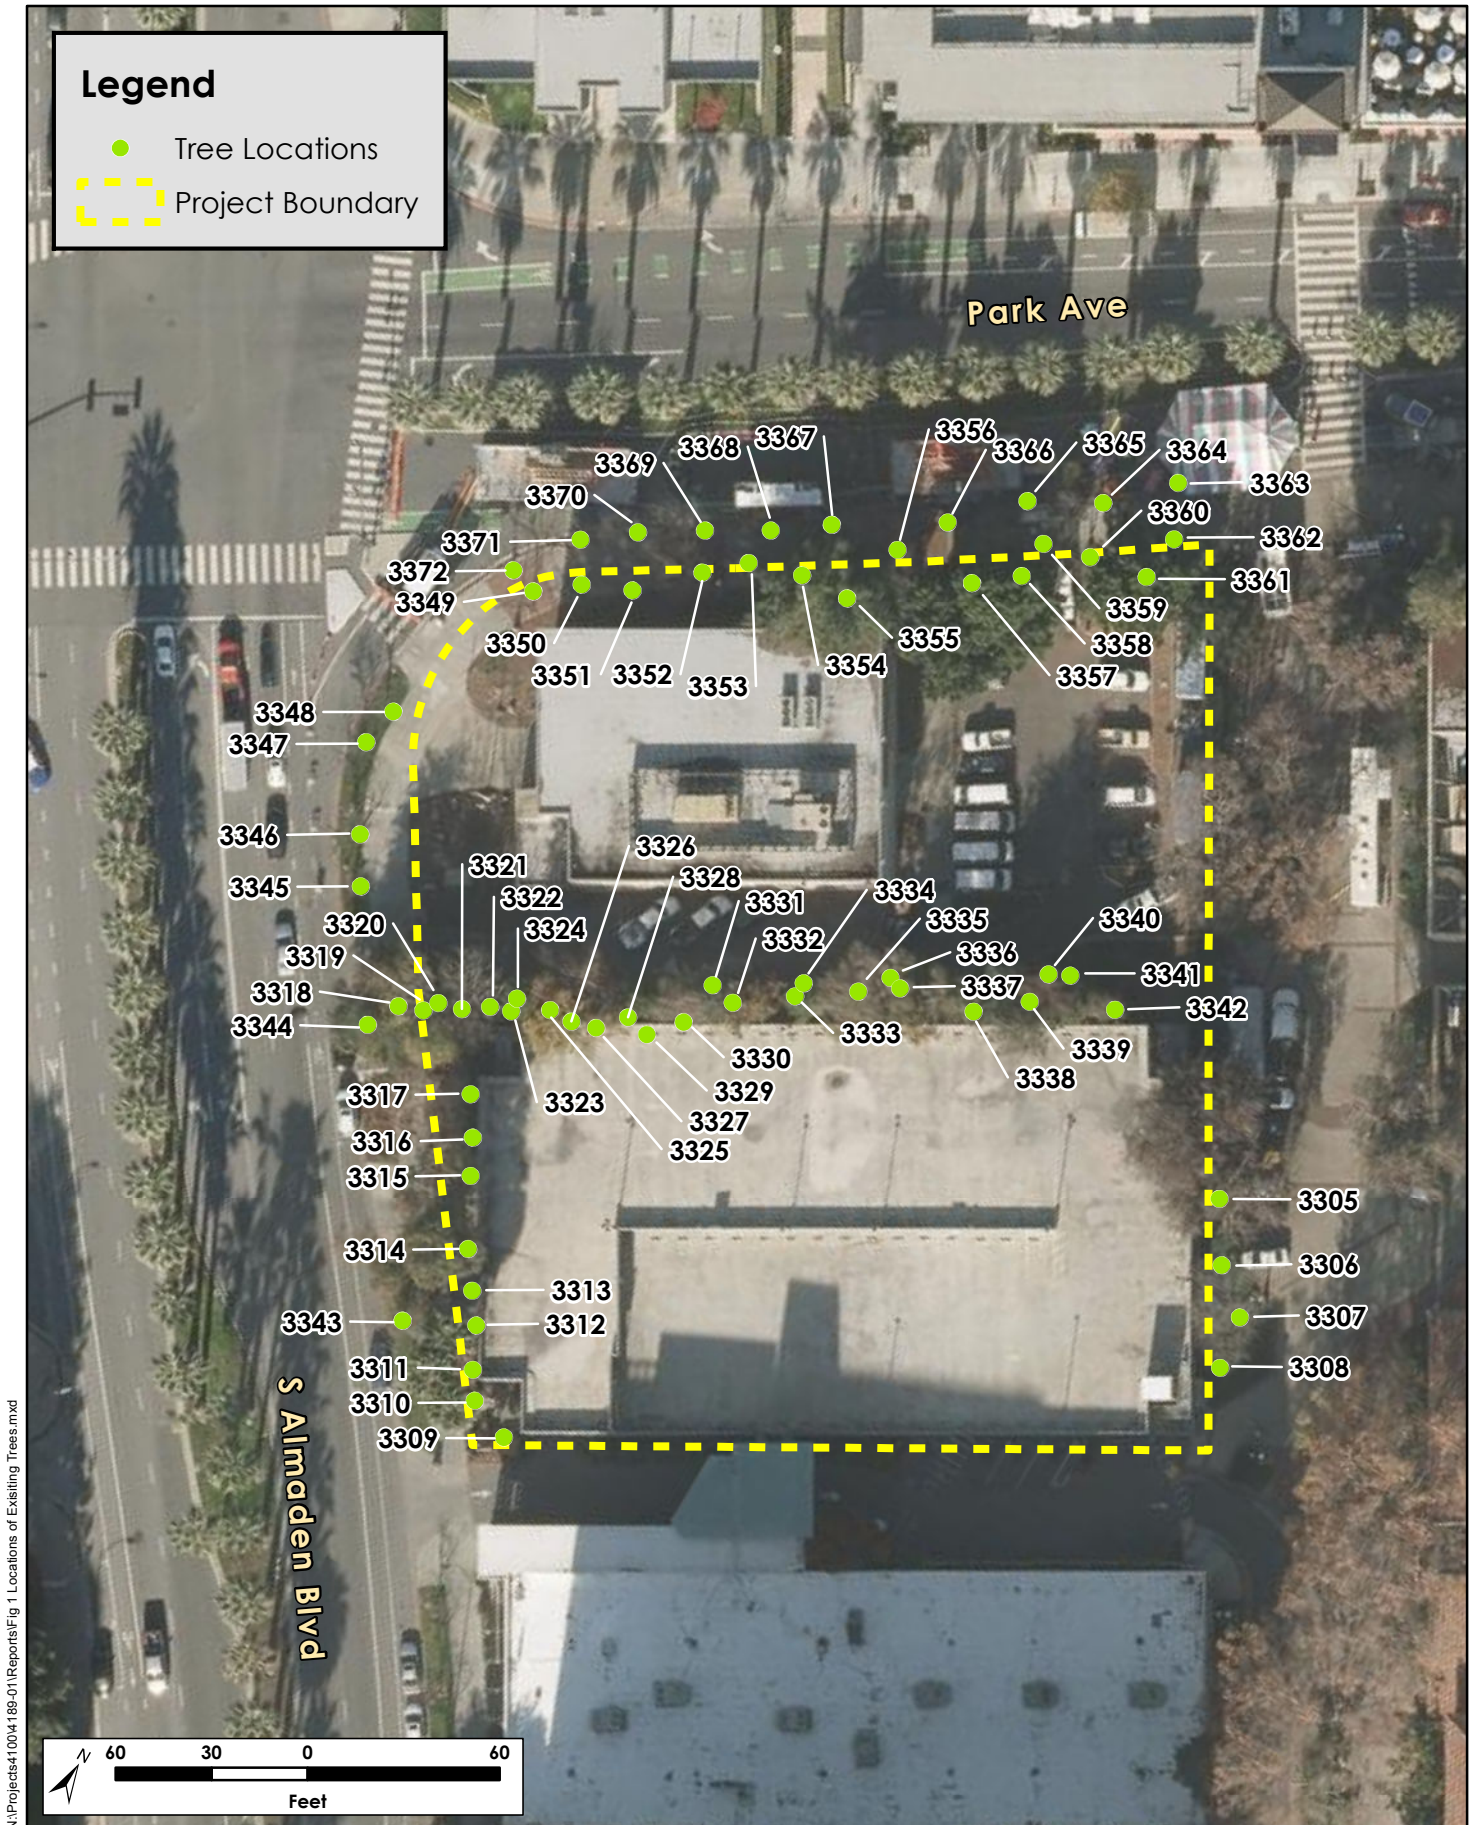
Figure 1. Locations of Existing Trees
200 Park Avenue Arborist Report (4189-01)
July 2018

Sixty-eight trees were identified on the site and immediately adjacent to the site along the street frontages of Park Avenue and South Almaden Boulevard (Figure 1). Descriptions of each tree including DBH, protected status, and tree condition score are included in Appendix C. Table 2 provides a summary of the 68 trees, representing 11 species, that were assessed. Of the 68 trees that were surveyed, 33 may require a permit for removal from the City of San José (see Section 3.4 below). The most common trees site were thornless honey locust (*Gleditsia triacanthos 'inermis'*) and Chinese elm (*Ulmus parvifolia*), comprising 43% and 19% of trees respectively.
