# ARBORIST REPORT

Revised: July 31, 2017  
4849.00

PROJECT  
Stevens Creek Executive Park

PREPARED BY  
HMH  
1570 Oakland Road  
San Jose, CA 95131  
Jake Minnick  
ISA Certified Arborist #WE-11830A

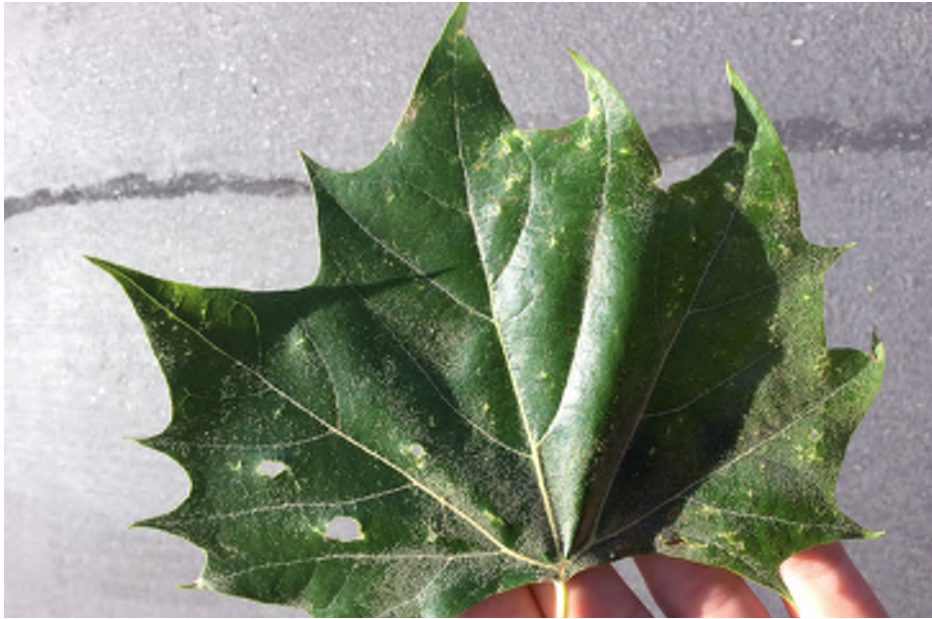
**Observations:** Much like many of the London plane trees in the bay area, the ones on this site have been inundated with sycamore scale. All London planes onsite exhibit various levels of stress indicated by the severity of the sycamore scale symptoms. It should be noted that although sycamore scale does tend to stress these trees out and may shorten the overall lifespan, it does not singlehandedly lead to the death of the tree.

Typical moderate sycamore scale leaf damage on the London planes.

**Recommendations:** Continue to monitor the condition of the heavily defoliated specimens.

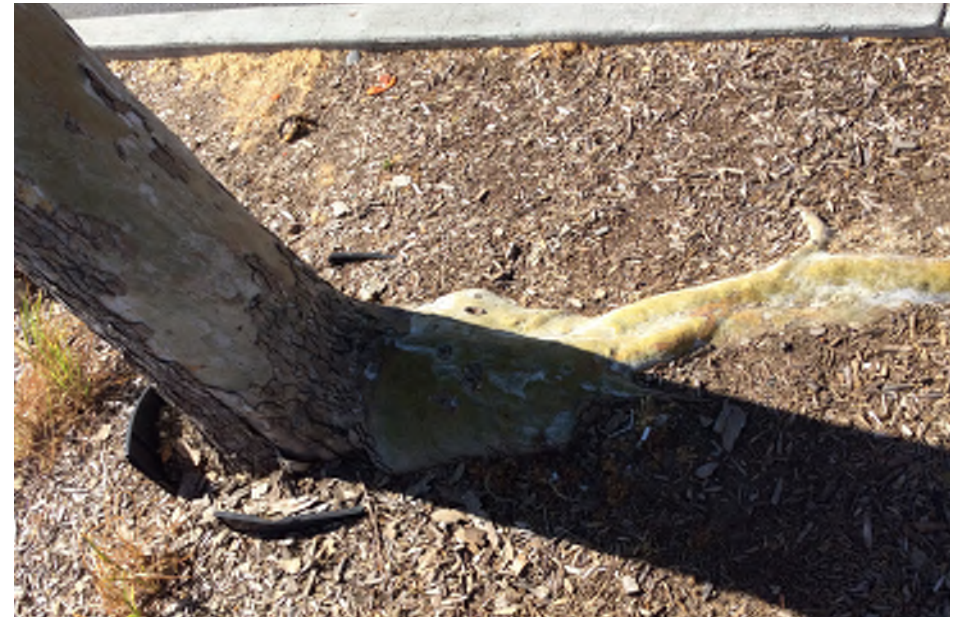
Typical root girdling damage from the incorrect installation of root barriers.

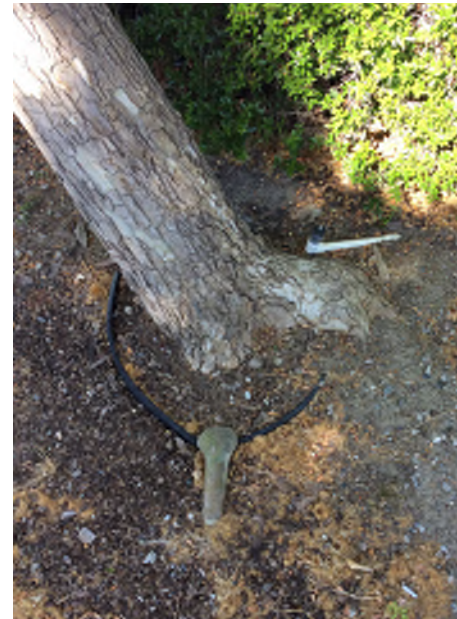
Another root girdling example.

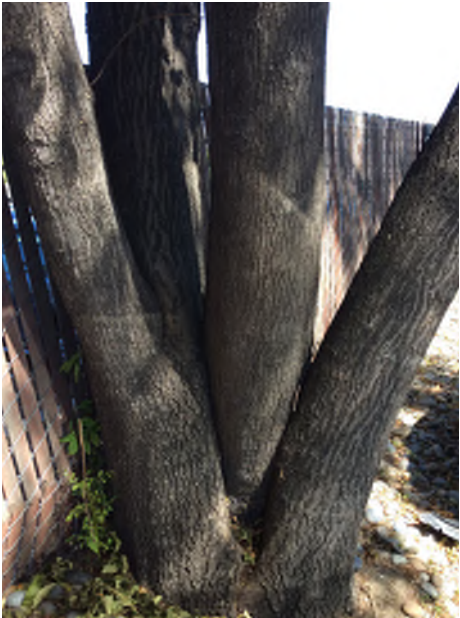
**Observations:** There are many mature shamel ash trees located within the limit of work on this site. Most of the shamel ashes are planted in unsuitably small parking lot finger islands and buffer strips. In many of these locations the trunk and structural roots have broken up the vertical concrete curbs and asphaltic concrete as they have expanded in girth over the years. As with most shamel ash trees in this area, many attachments of equal size that originate at acute angles are common. For this reason, shamel ashes canopies should be annually reduced/thinned to reduce the likelihood of failure at the attachment point.

Typical structural deficiencies in several of the ashes.

**Recommendations:** Reduce canopy mass on mature specimens. Investigate the possibility of providing more root space in the critical root zone if trees are to remain.

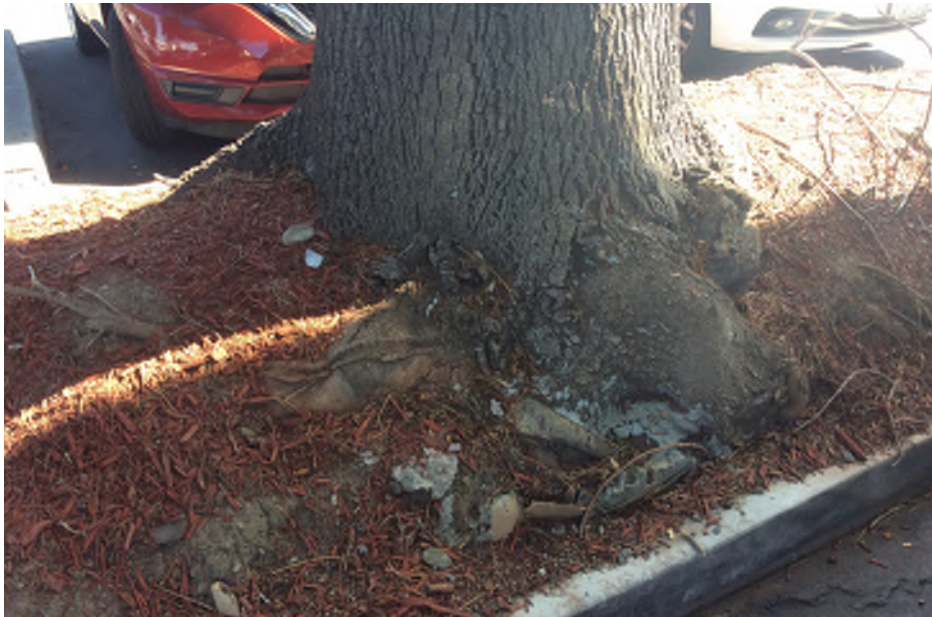
Typical damage from ash trees planted in confined finger islands and parking lot buffer strips.
