Tree Report
329, 341, 353 Page Street

Prepared for:
Charities Housing
1400 Parkmour Avenue, Suite 190
San Jose CA 95126

Prepared by:
HortScience, Inc.
325 Ray Street
Pleasanton CA 94566

July 27, 2017

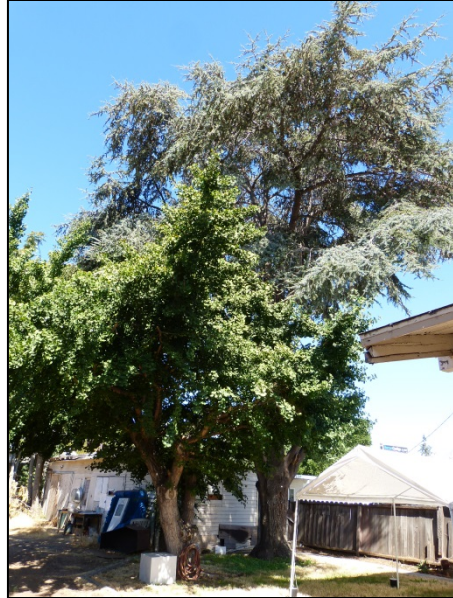
- Lemon bottlebrush #70 and 71 were in front of the home at 329 Page Street. Both trees were mature in development. Both were within 1' of the house foundation. Tree #70 was 13" and in fair condition while #71 was 10" and in poor condition.
- Ginkgo #72 was in the rear yard of 329 Page Street (Photo 1). This 24" tree was in poor condition due to a history of topping and crown reduction pruning. Several sets of codominant attachments were present.

Photo 1. Ginkgo #72 (foreground) and blue Atlas cedar (#73). Note small overall size of ginkgo and flat-topped form of the cedar.

- Blue Atlas cedar #73 was also in the rear yard of 329 Page Street (Photo 1). The tree was mature in development, 30" in diameter and in fair condition. Large branches had been stubbed back.
- Avocado #82 was a small tree in front of 341 Page St. Trunk diameter was 4'. Condition was good.
- Orange #83 was also in front of 341 Page Street. It was a large shrub in good condition.
- Lemon #84 was in the rear yard of 341 Page Street. It was also a large shrub but in poor condition.
- Calif. pepper #85 was in the front yard of 353 Page St. (Photo 2). This mature tree was 24" in diameter and in good condition. The crown was somewhat vase-shaped.

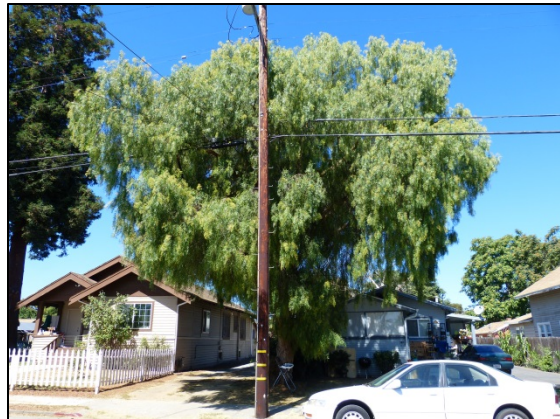
Photo 2. Looking across Page St. at Calif. pepper #85.

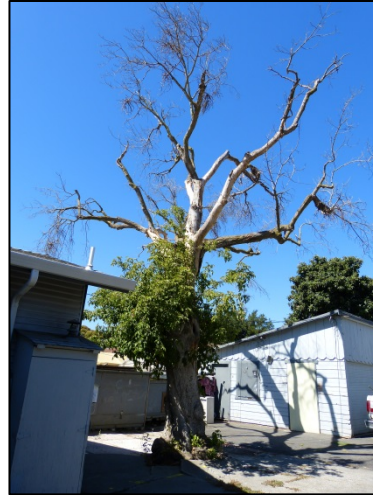
Photo 3. Boxelder #87.

- Boxelder #87 was 30" and largely dead (Photo 3). Only a few small sprouts were present.
