**Harker School**  
**Union Avenue campus**

**Preliminary Tree Report**

March 1, 2018

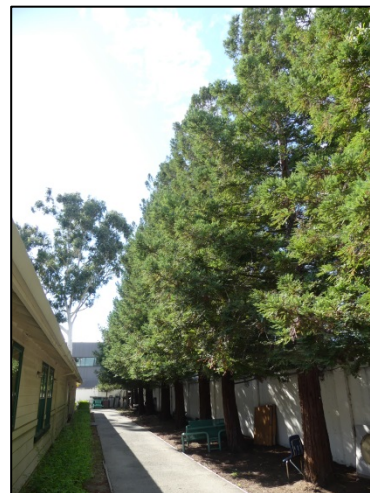
Coast redwood was the most frequently occurring species with 32 trees (Photo 1). Trees were and in development with trunk diameters between 9-inches and 23-inches. Trees formed a long continuous row on the west and northwest property line. Tree condition was generally good (20 trees). Ten trees were in fair condition while #153 and 154 were excellent. The primary determinant to tree condition was canopy density, likely associated with soil moisture stress (or the lack of it). Tree trunks were approximately 4-feet from the wall along the property line. Trees had been side-trimmed to clear the nearby electrical conductors.

**Photo 1.** Looking south along west property at coast redwoods.

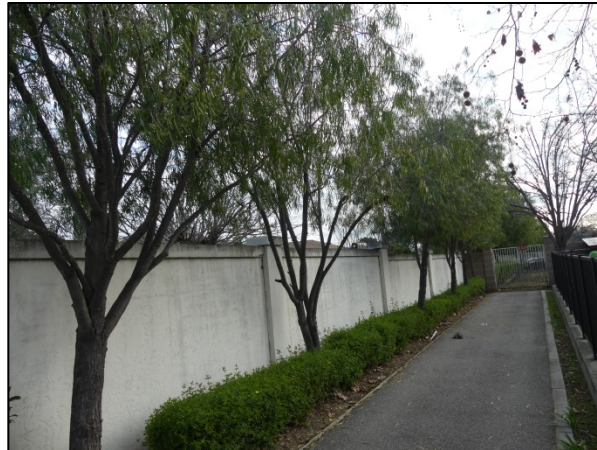
Twenty-six (26) Australian willows were located along the north and southeast property lines (Photo 2). Trees were generally located in a 4-foot wide planting strip between property line and sidewalk. Trees on the north had been side-trimmed to clear overhead power lines. Australian willows ranged from 6-inches to 11-inches in diameter.

**Photo 2.** Looking along the north property line.

Condition was generally fair (14 trees) and poor (11). Australian willow #27 was in good condition. As is typical of the species, many trees were not vertically oriented but leaned and bowed away from the vertical. Poor branch attachments were common.

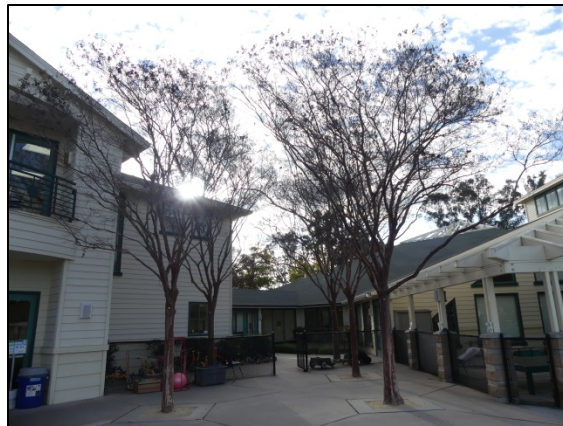
Twenty-three (23) crepe myrtles were planted in small groups across the site, often in small pavement cut-outs (Photo 3). Trees were mature in development. Trunk diameters varied from 7 to 10 inches. Tree condition was a mix of excellent (16 trees) and good (7).

**Photo 3.** Typical crape myrtles installed in pavement cut-outs.

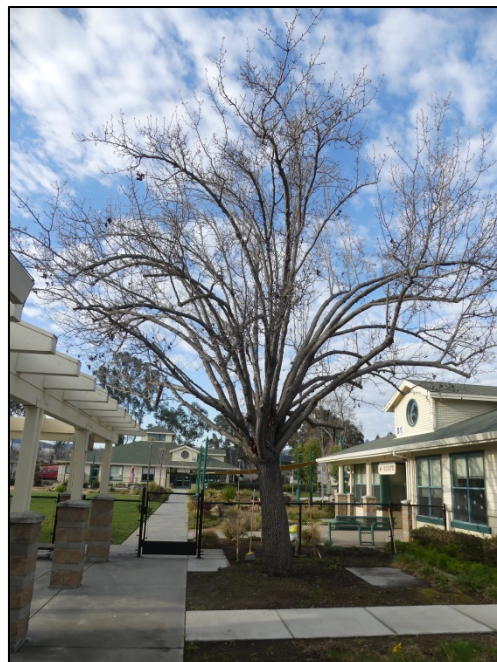
Twenty (20) Callery pears were present. Trees were semi-mature and mature in development (Photo 4). Trunk diameters ranged from 6-inches to 18-inches. Tree condition was a mix of poor (11 trees) and fair (9). As is typical of the species, scaffold branches arose at one point on the trunk. Over time, these limbs bend away from vertical and are more likely to fail. A number of trees had one or more branch failures. Others had been pruned to reduce limb length.

**Photo 4.** Typical unpruned Callery pear. Note that all branches originate at one point on the trunk.

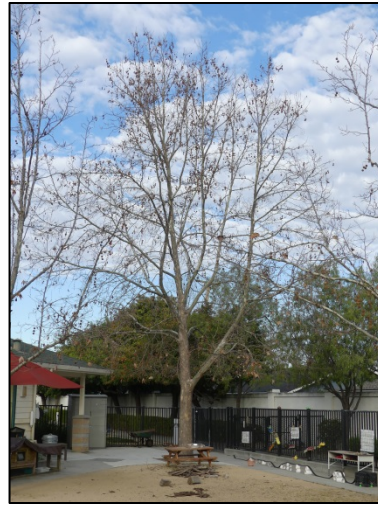
**Photo 5.** London plane #17.

Eleven (11) London plane were in excellent (7 trees), good (2) and fair (2) condition (Photo 5). Trunk diameters varied between 4-inches and 19-inches. Planes had oval or rounded form which is typical of the species. Some trees appeared drought-stressed.
