**PHASE I ENVIRONMENTAL SITE ASSESSMENT**

<b>TYPE OF SERVICES</b>	Phase I Environmental Site Assessment
<b>LOCATION</b>	1580 South 10 <sup>th</sup> Street San Jose, California
<b>CLIENT</b>	Starbird Consulting, LLC
<b>PROJECT NUMBER</b>	1117-1-1
<b>DATE</b>	April 30, 2019

**Subject: Pre-Demolition Hazardous Material Survey- UPDATED SEP 2019**  
**1580 S 10<sup>th</sup> Street,**  
**San Jose, CA 95112**  
**Millennium Project No. 3100.2004**

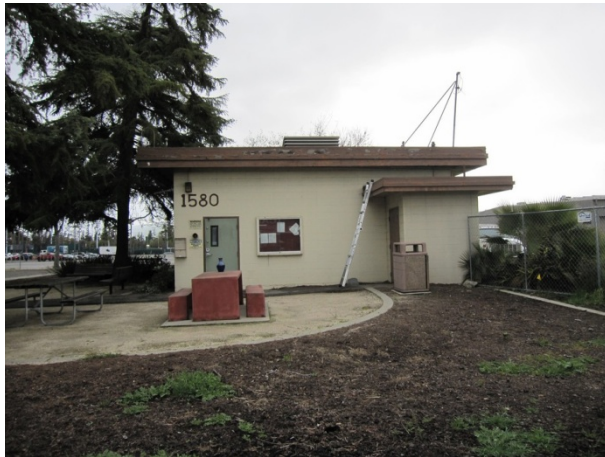
Photograph 1. View of the on-site building looking east.

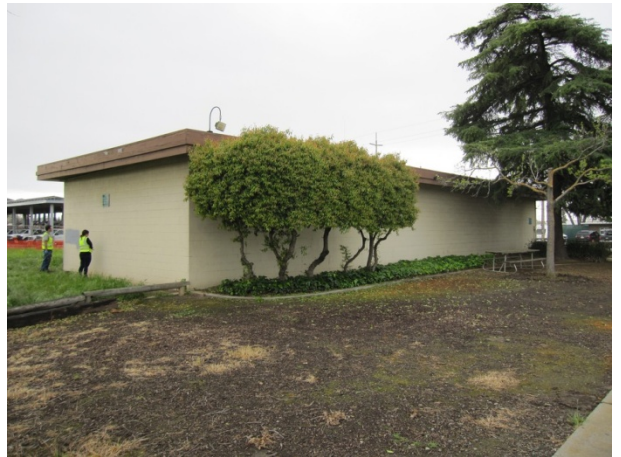
Photograph 2. View of the on-site building looking southwest.

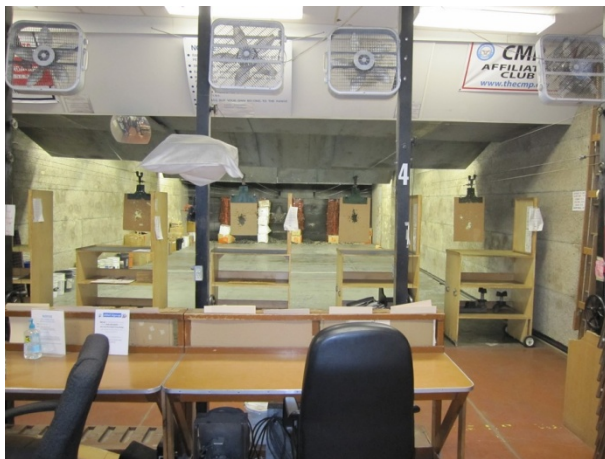
Photograph 3. Interior of firing range.

- Due to high levels of lead containing dust found via lead wipes and continued lead dust generated onsite, it is recommended that the floors be cleaned via wet methods and/or HEPA vacuum to limit the amount of dust tracked off site more frequently. In addition, a sticky mat placed at the entrance would also prevent lead dust from being distributed outside or offsite.

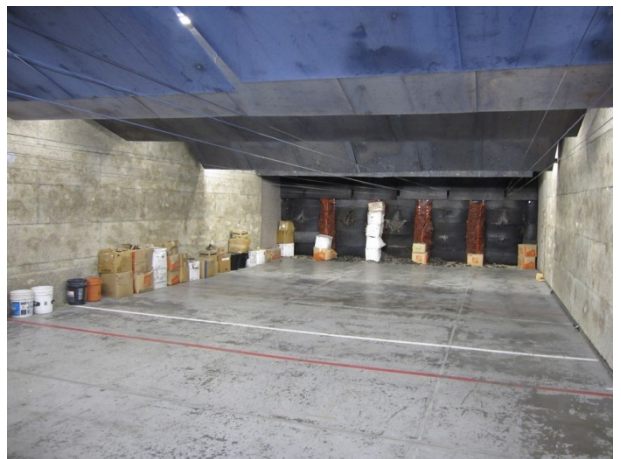
Photograph 4. Interior of firing range.

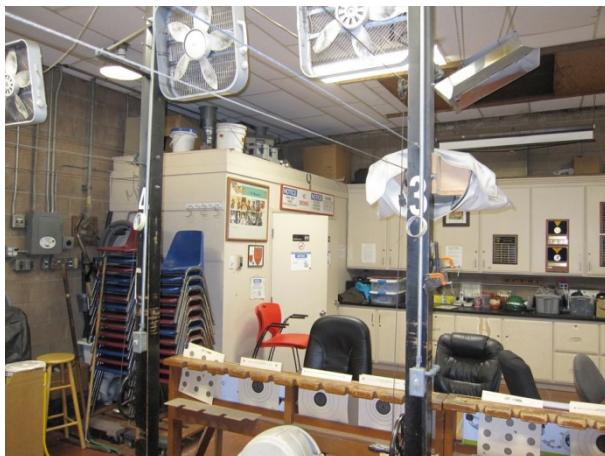
Photograph 5. Restrooms and seating area.

- Joint compound (2% chrysotile) and associated drywall (non-detect) limited to the restrooms has been reported via composite 400 Point Count analysis to contain <0.25% asbestos by weight - estimated to be approximately 500 square feet. **See recommendations.**

- Relative to the amount of drywall/joint compound samples collected, only one sample resulted in detectable asbestos (joint compound). For the inspection, due to all drywall systems considered as homogenous, all drywall is considered as having asbestos-containing joint compound in the restrooms. However, supplemental sampling can be performed to re-assess and re-define homogeneous areas. It is recommended that supplemental drywall sampling be performed to narrow down homogenous drywall systems with asbestos-containing joint compound.

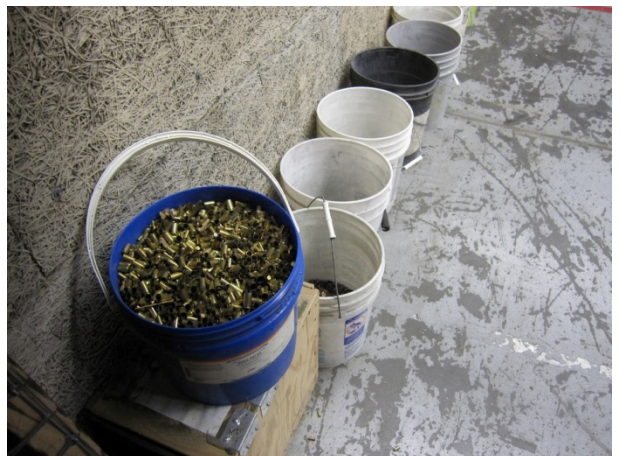
Photograph 6. Collected lead and brass debris.

Lead and brass debris from discharged ammunitions is collected within plastic buckets for off-Site recycling. Spent HEPA vacuum filters are disposed as hazardous waste. No other hazardous materials were observed on-Site during our visit.
