**699 West San Carlos**

Arborist Tree Report

April 2018

**April 10, 2018**

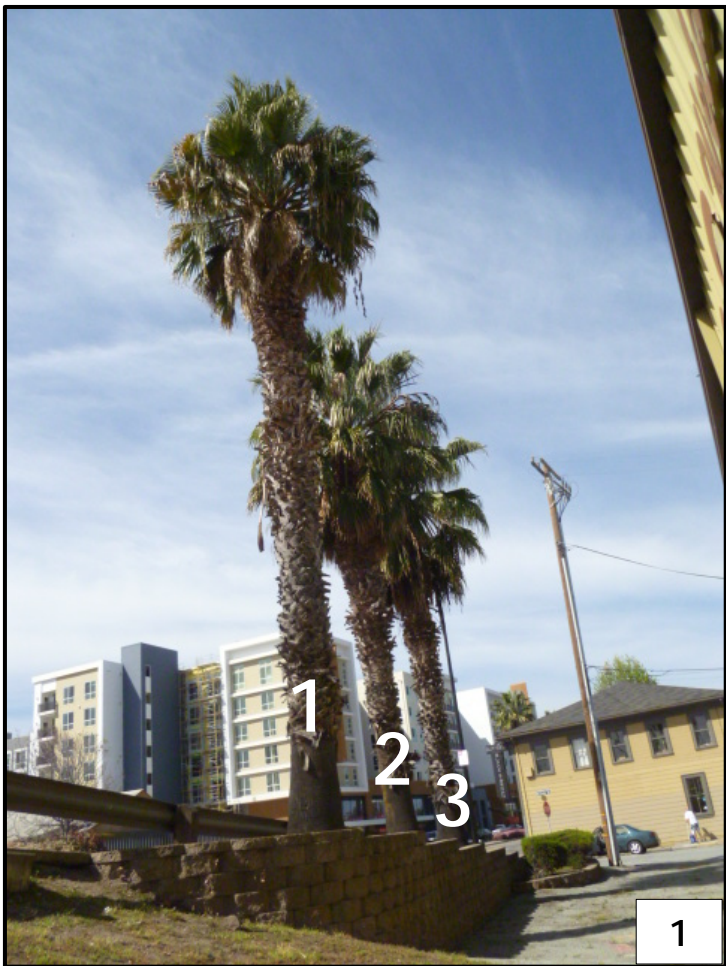
Trees 1, 2 and 3 are California fan palms. All three were observed to be in fair to good overall condition. Fronds of tree 1 exhibited a micronutrient deficiency whereas the fronds of trees 2 and 3 were a healthy green color. All three trees displayed dead fronds with minor trunk wounds. The trunk diameters of these palms qualified them as Ordinance-Size Trees in the city of San Jose.

Photo 1. Trees 1, 2 and 3 as viewed from the subject property.

1. Authorization is required from the city of San Jose prior to scheduling the removal of Ordinance-Size Trees from the property. Other conditions may apply and it is the responsibility of the Owner to understand and comply with those conditions.

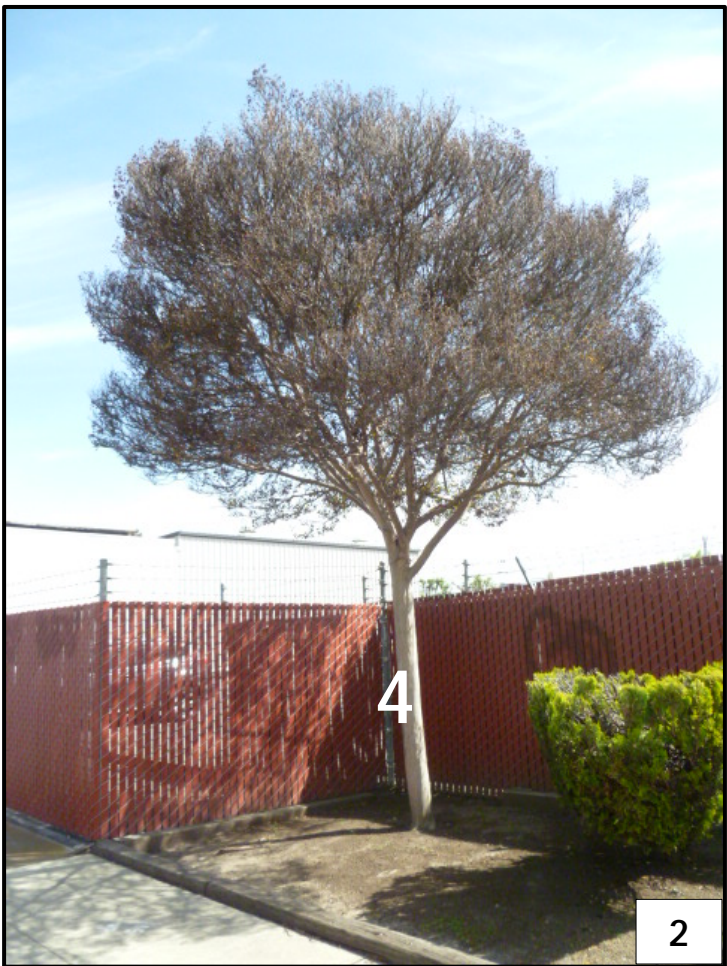
Tree 4, a crape myrtle, was just breaking dormancy; new leaves were beginning to emerge. Structurally, branch attachments were observed to be narrow angled and located very close to one another. The canopy was dense and balanced with a trunk displaying animal scratch marks. This tree is not an Ordinance-Size Tree.

Photo 2. Single tree 4 is shown when viewed from the sidewalk.
