Arborist Report

397 Blossom Hill Road Mixed-Use Project Environmental Assessment

**397 Blossom Hill Road
Arborist Report**

Project #4198-01

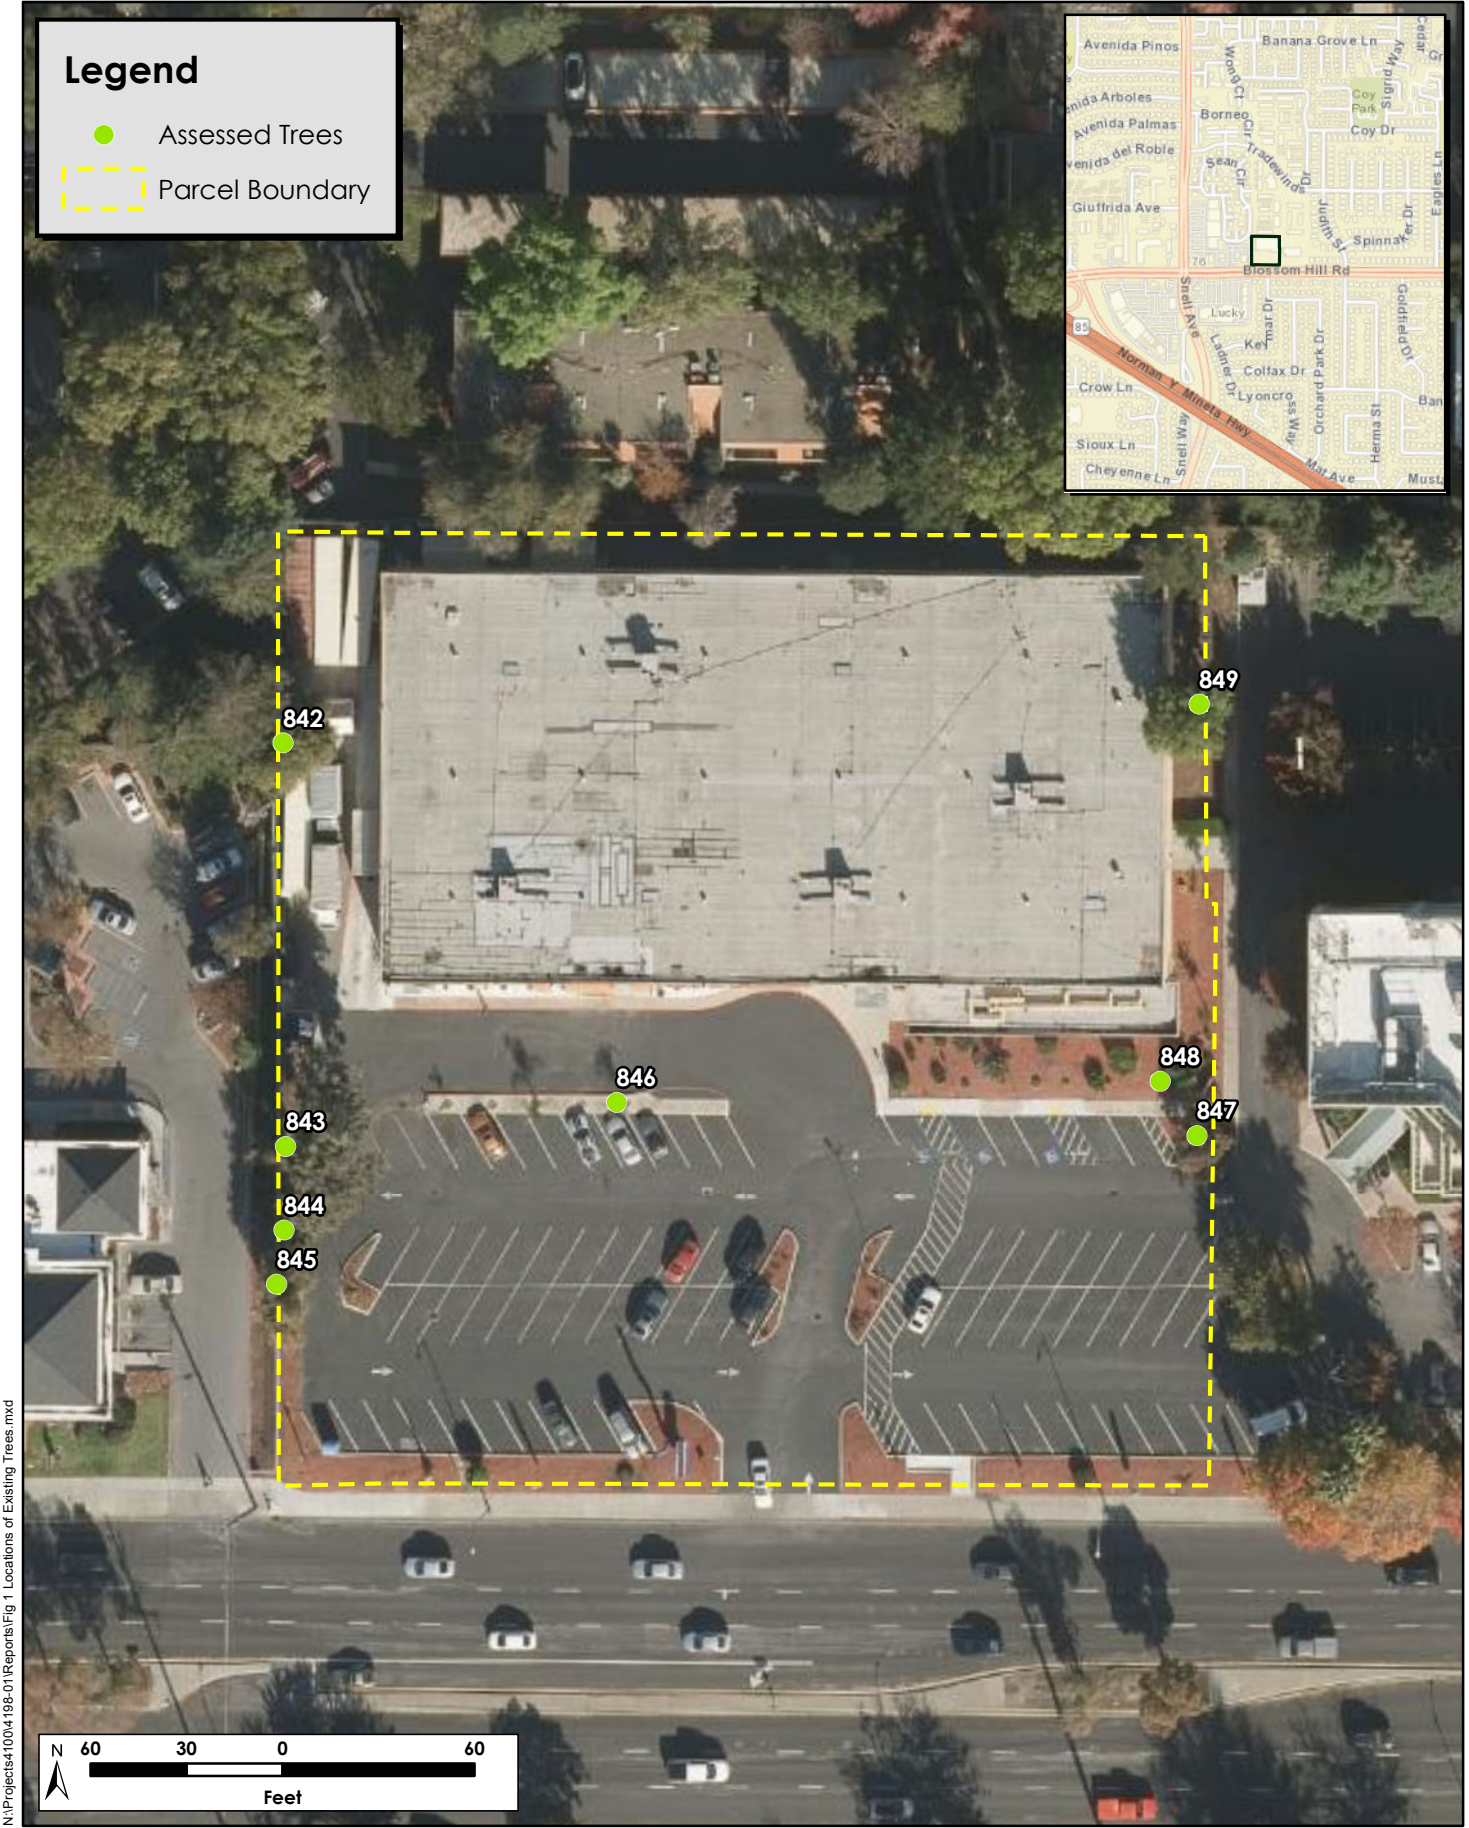
Figure 1. Locations of Existing Trees
397 Blossom Hill Road – Arborist Report (4198-01)
June 2018

Eight trees were identified on the site (Figure 1). Descriptions of each tree are included in Appendix C (Tree Assessment), including DBH, tree health and structural scores, and protected status. Table 2 provides a summary of the assessed trees, which represent six species. Of the eight trees located on the site, six (75%) met the City of San Jose's criteria for ordinance-sized trees (see Section 3.4 below). Seven of the eight trees on the site (88%) were in good condition while the remaining tree was in fair condition due to poor structure and decay.

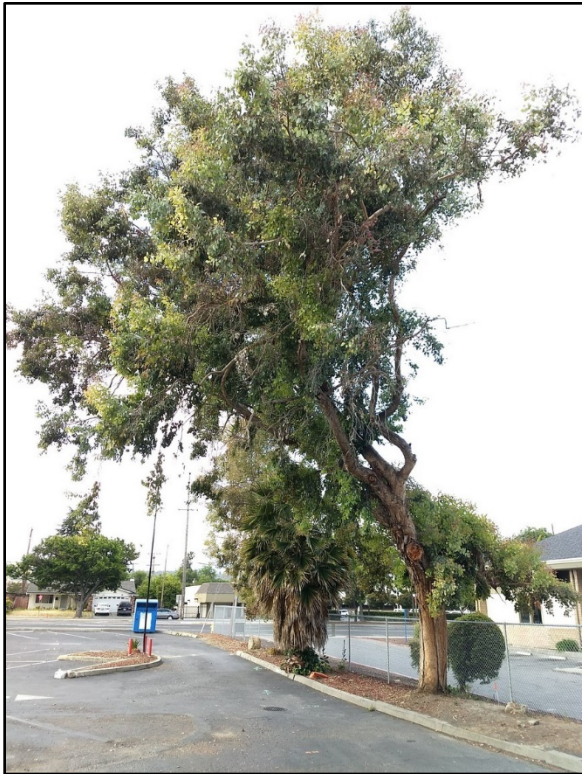
Of the eight trees (six species) on the site, only one tree is listed by the California Invasive Plant Council (Cal-IPC, 2018) as moderately invasive; that is one Mexican fan palm (*Washingtonia robusta*), tree #844.

Photo 1. Silver dollar eucalypt (*Eucalyptus polyanthemos*) and Mexican fan palm (*Washingtonia robusta*), tree #'s 843 and 844.

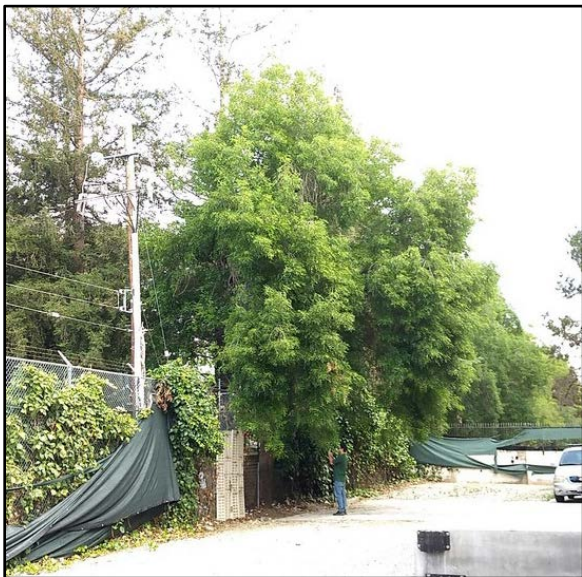
Photo 2. Green ash (*Fraxinus pennsylvanica*), tree # 842.

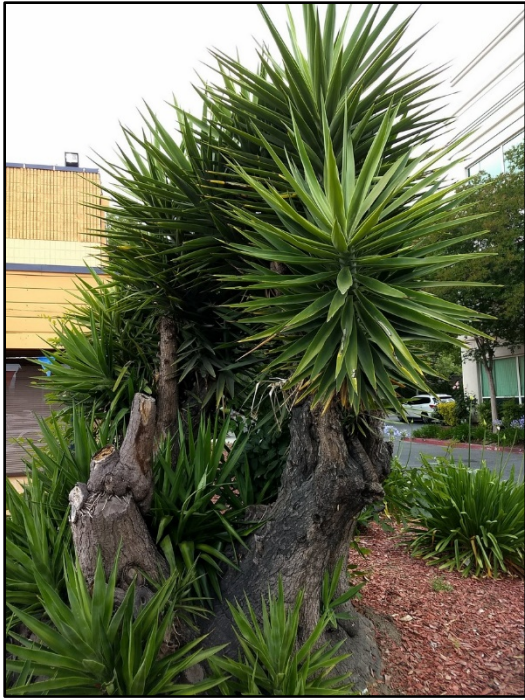
Photo 3. Cabbage palm (*Cordyline australis*), tree # 848.
