Tree Evaluation

2375-2395 Bascom Ave. Tree Recommendations

2375-2395 S Bascom Ave.

Revised – April 15, 2020

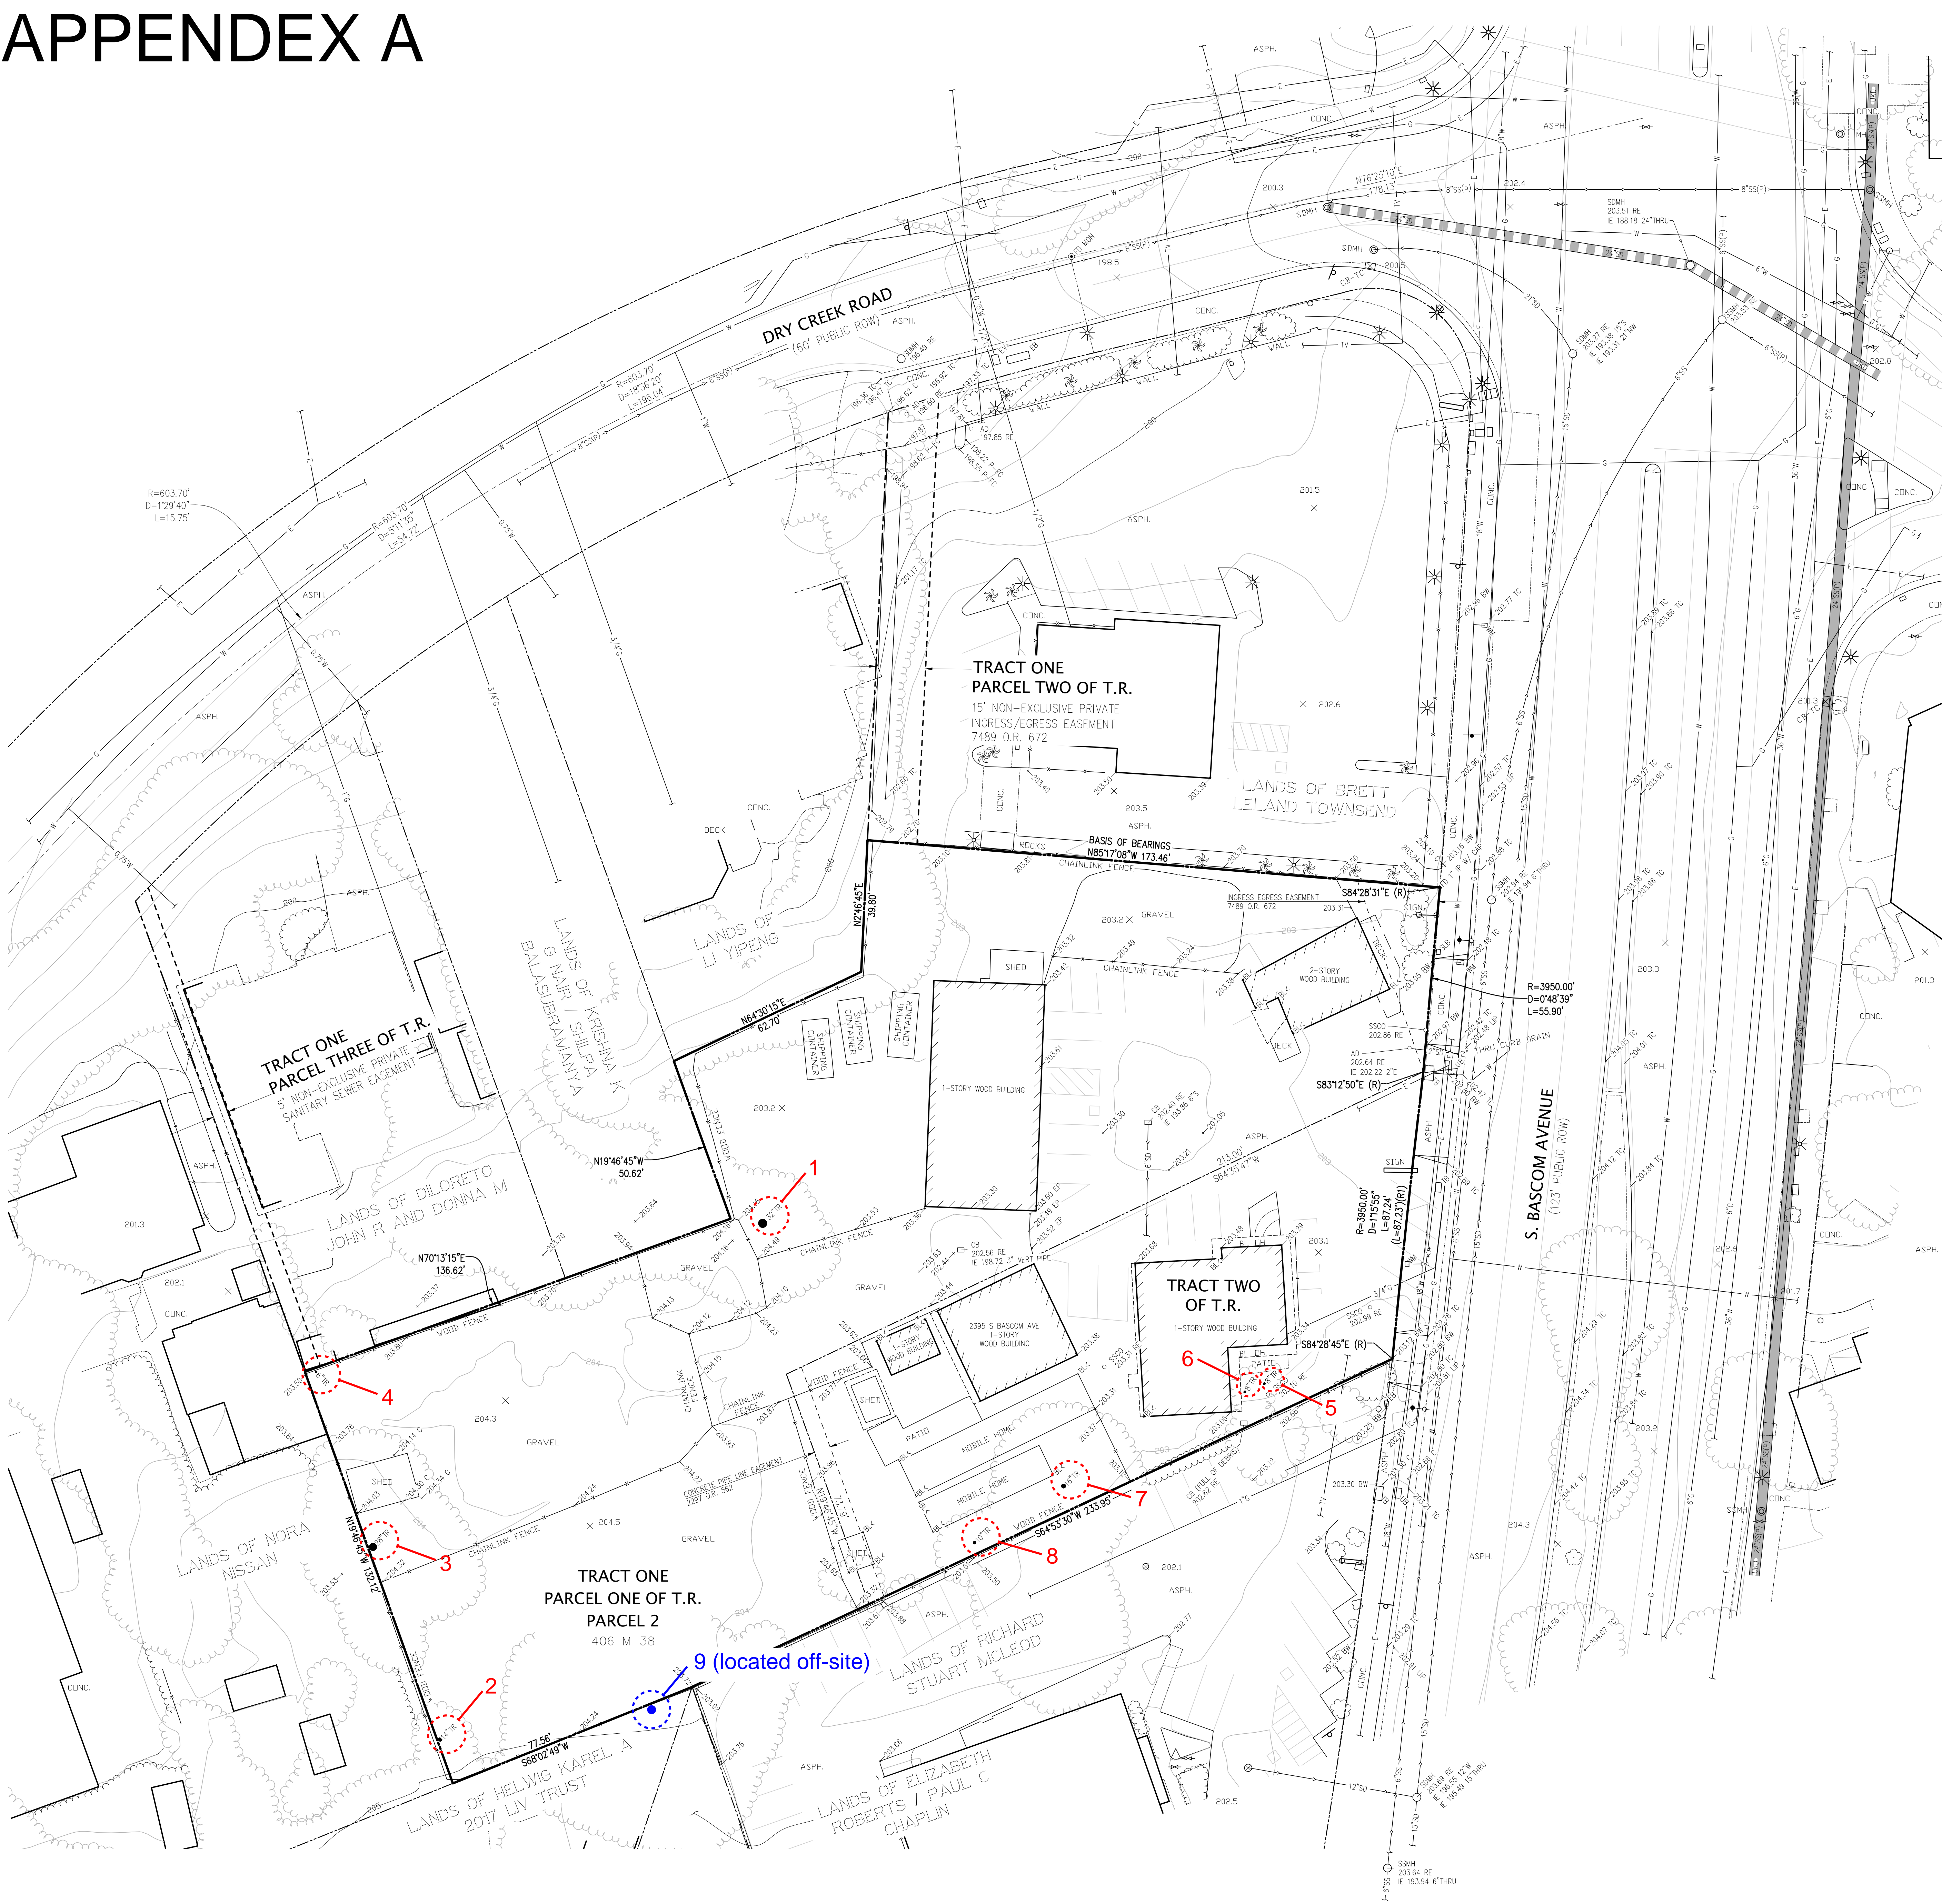
APPENDIX A

At the site of construction there are 4 Coast Live Oaks (*Quercus agrifolia*) at the western portion of the property. 2 of these oaks on the northwestern corner and the southwestern corner have been proposed for removal. There are also 1 Deodar cedar (*Cedrus deodara*), 1 avocado tree (*Persea americana*), and 2 privet trees (*Ligustrum lucidum*) located on the Eastern portion of the property proposed for removal. (Appendix A: Site Overview)

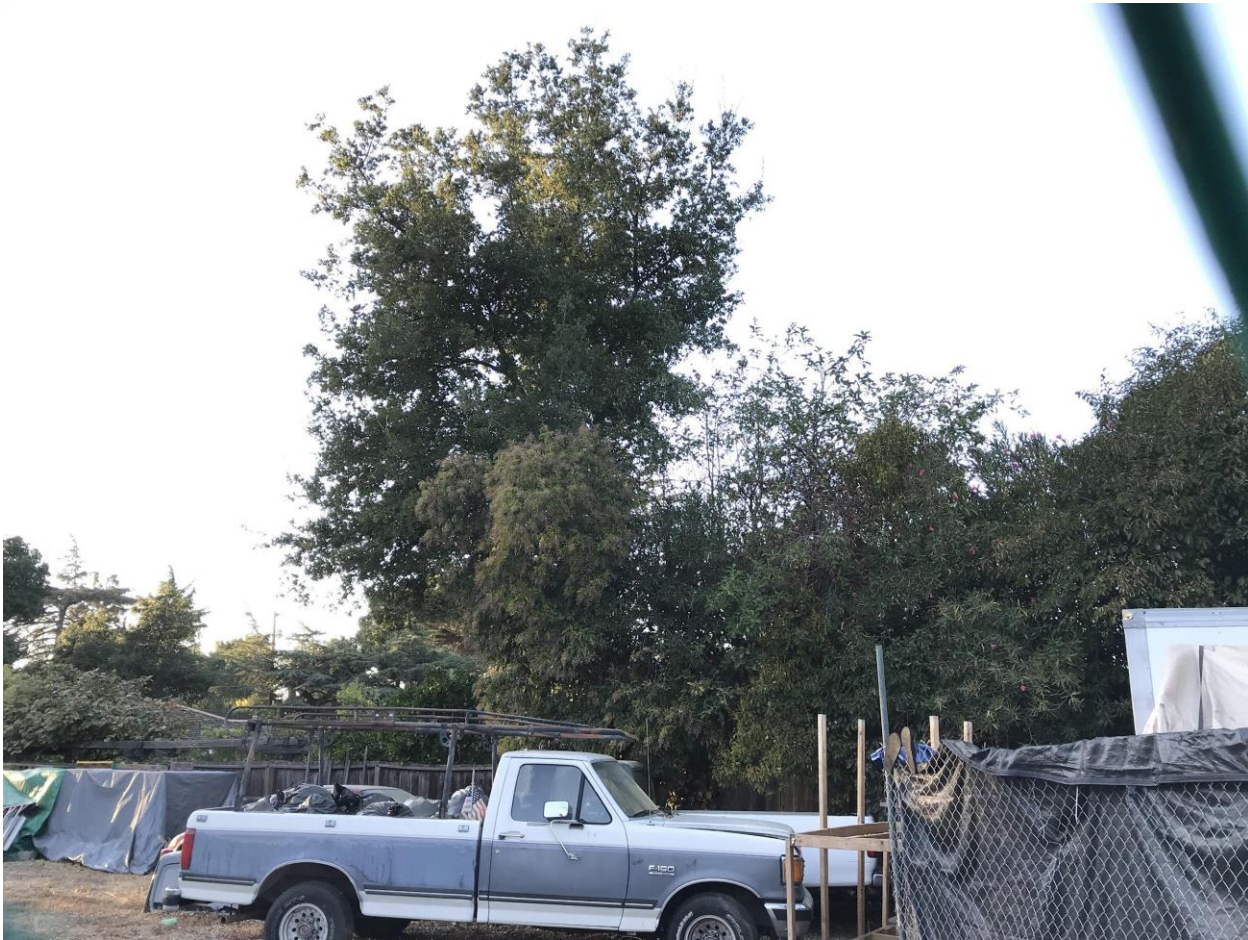
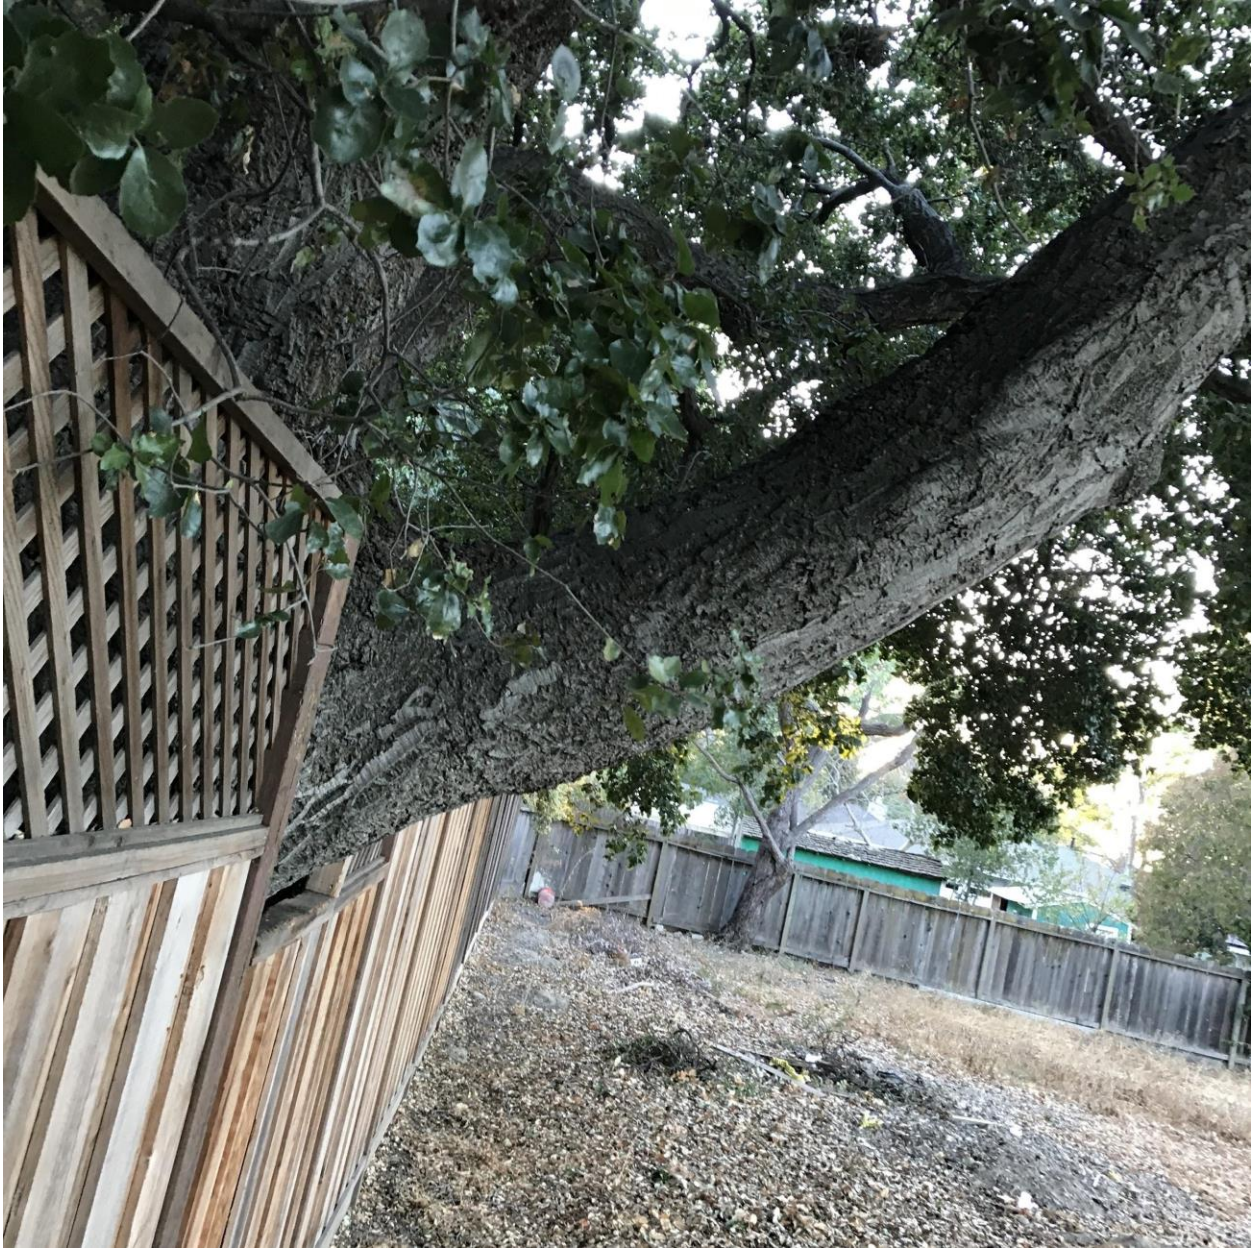
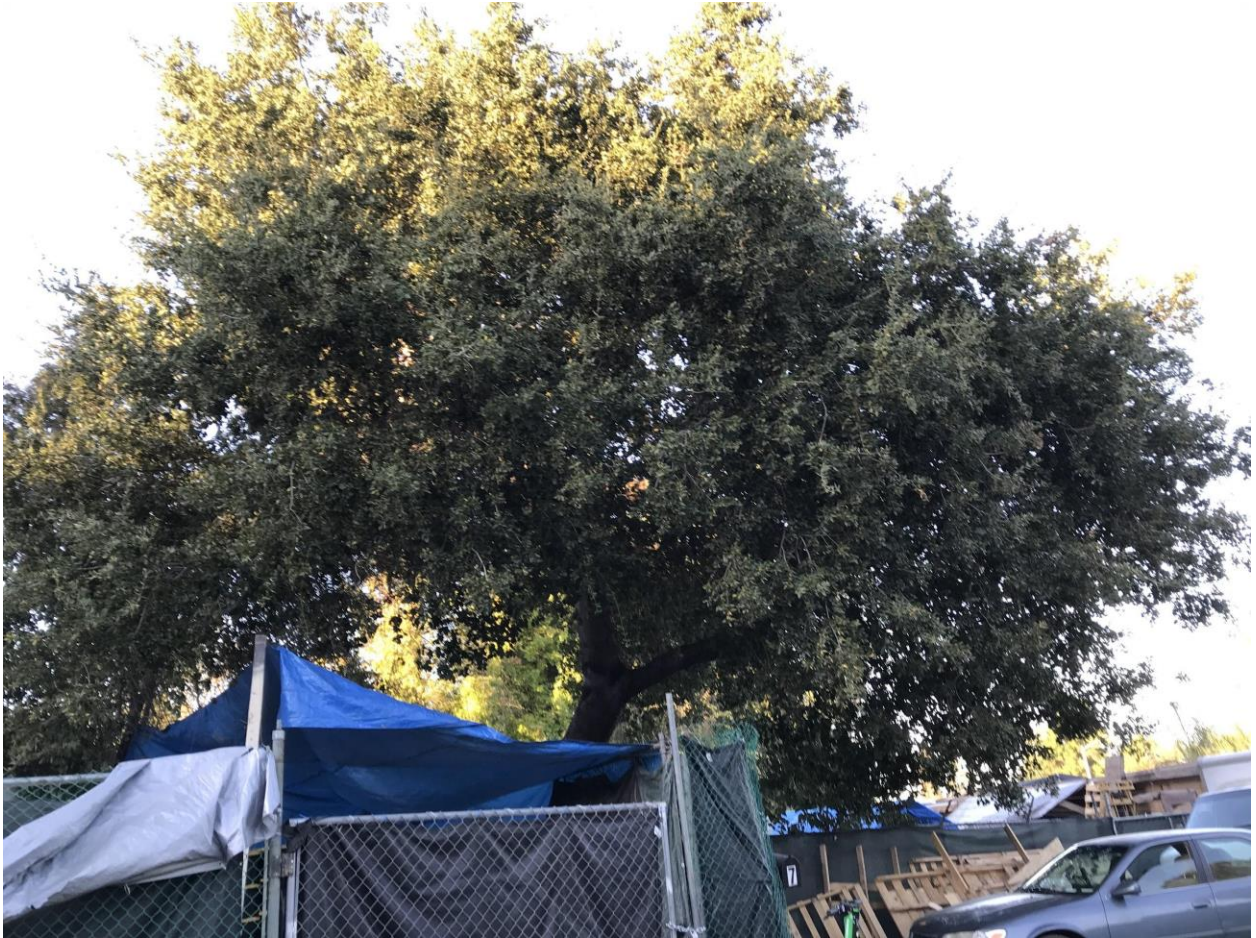
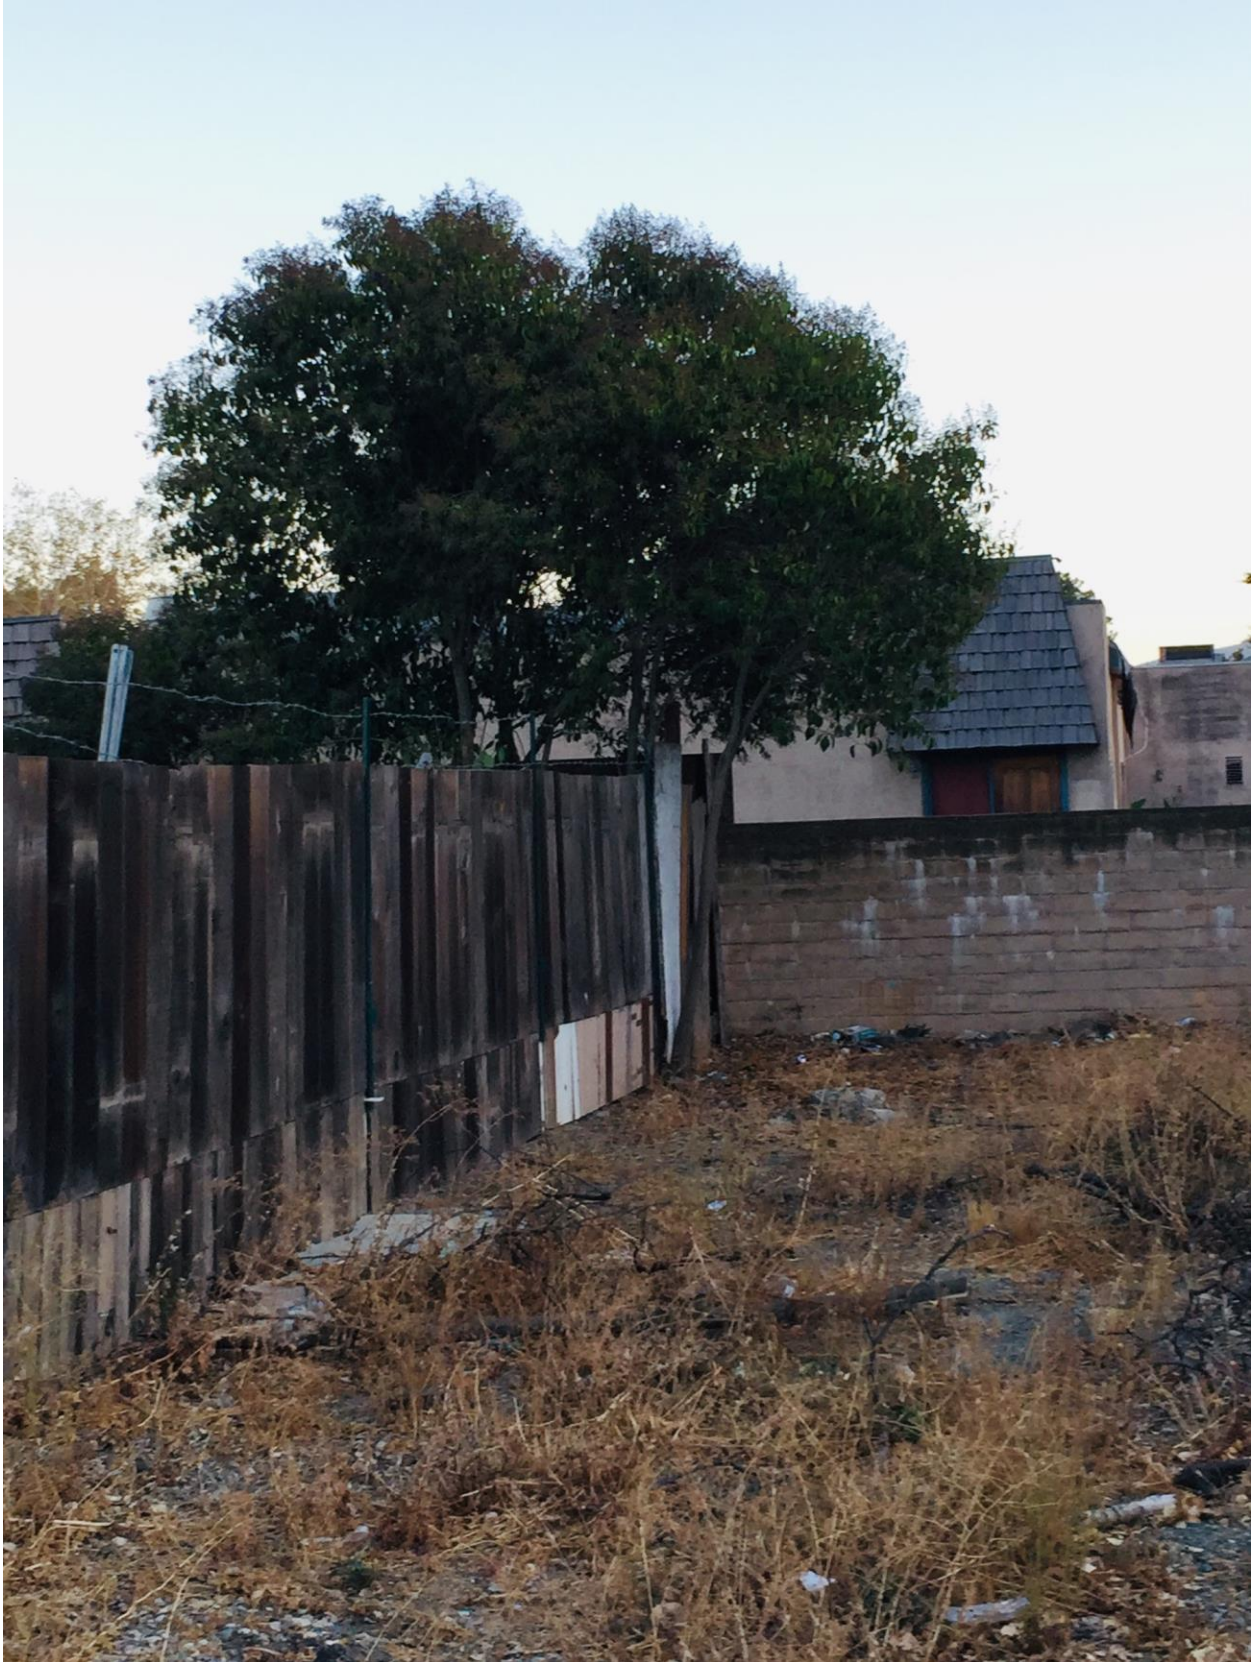
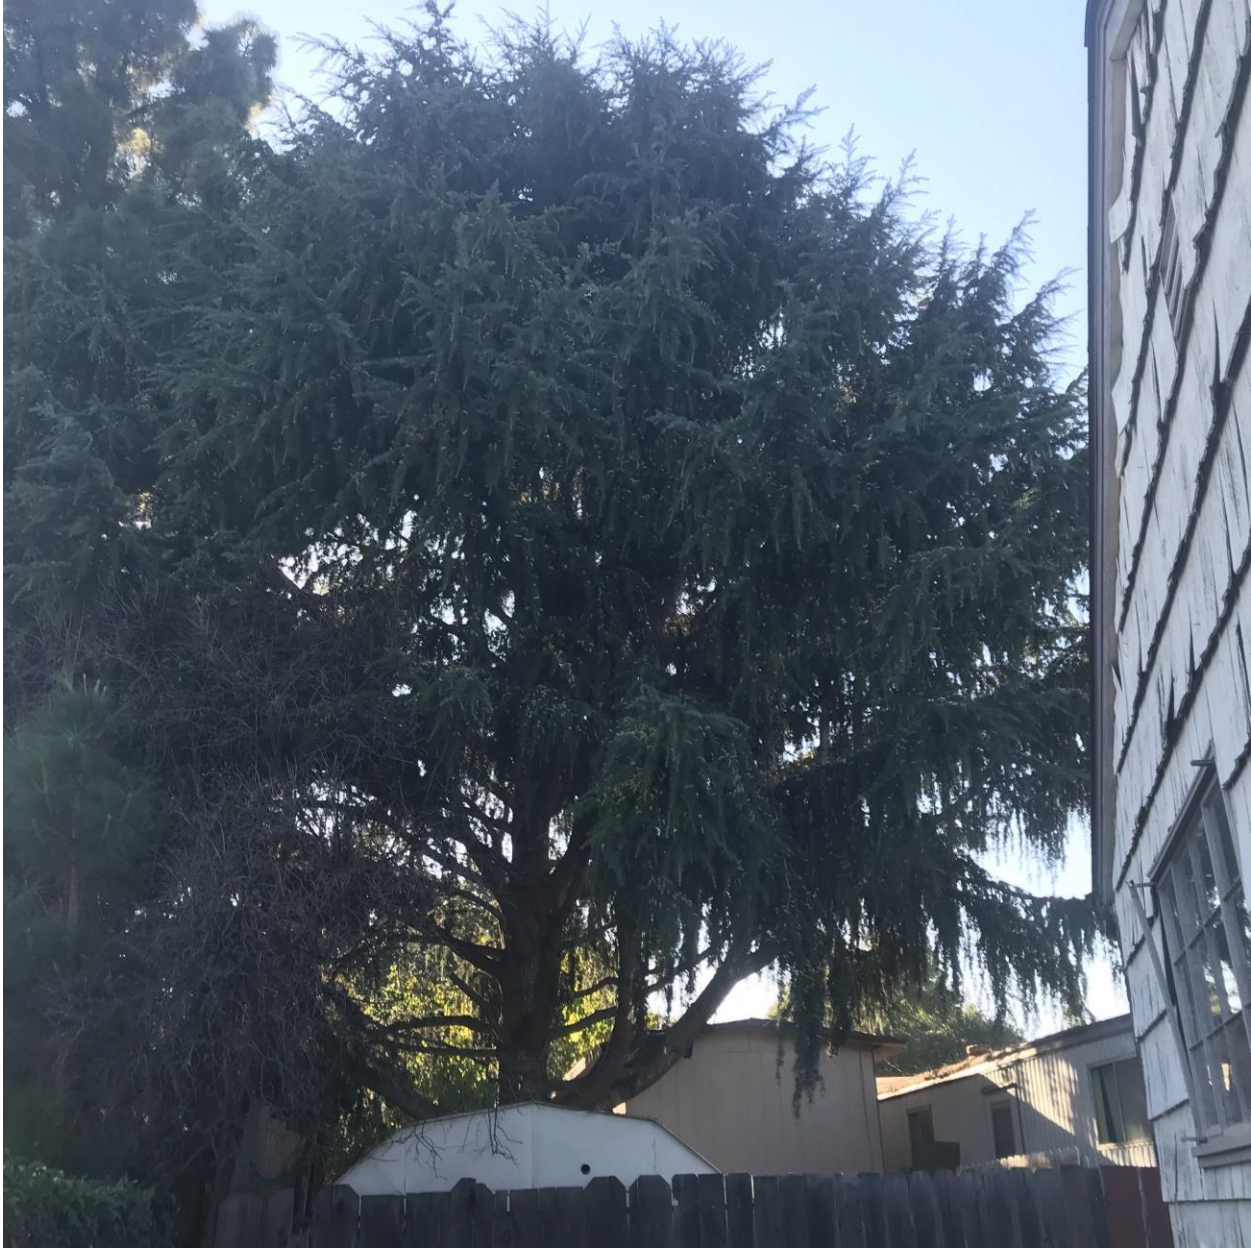
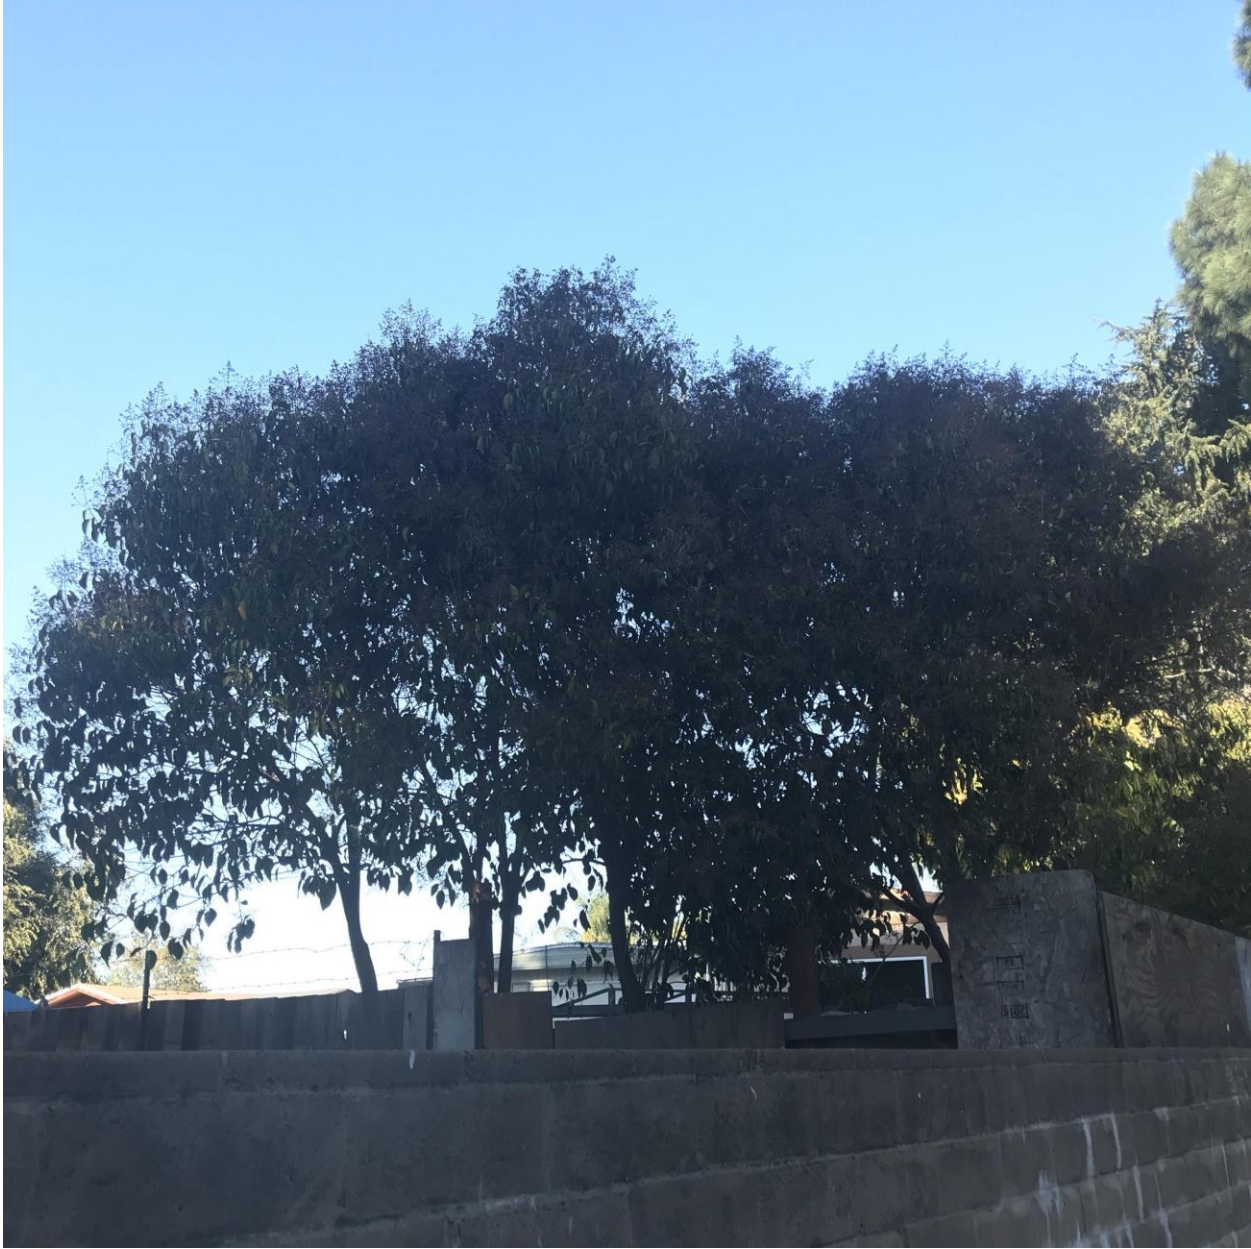
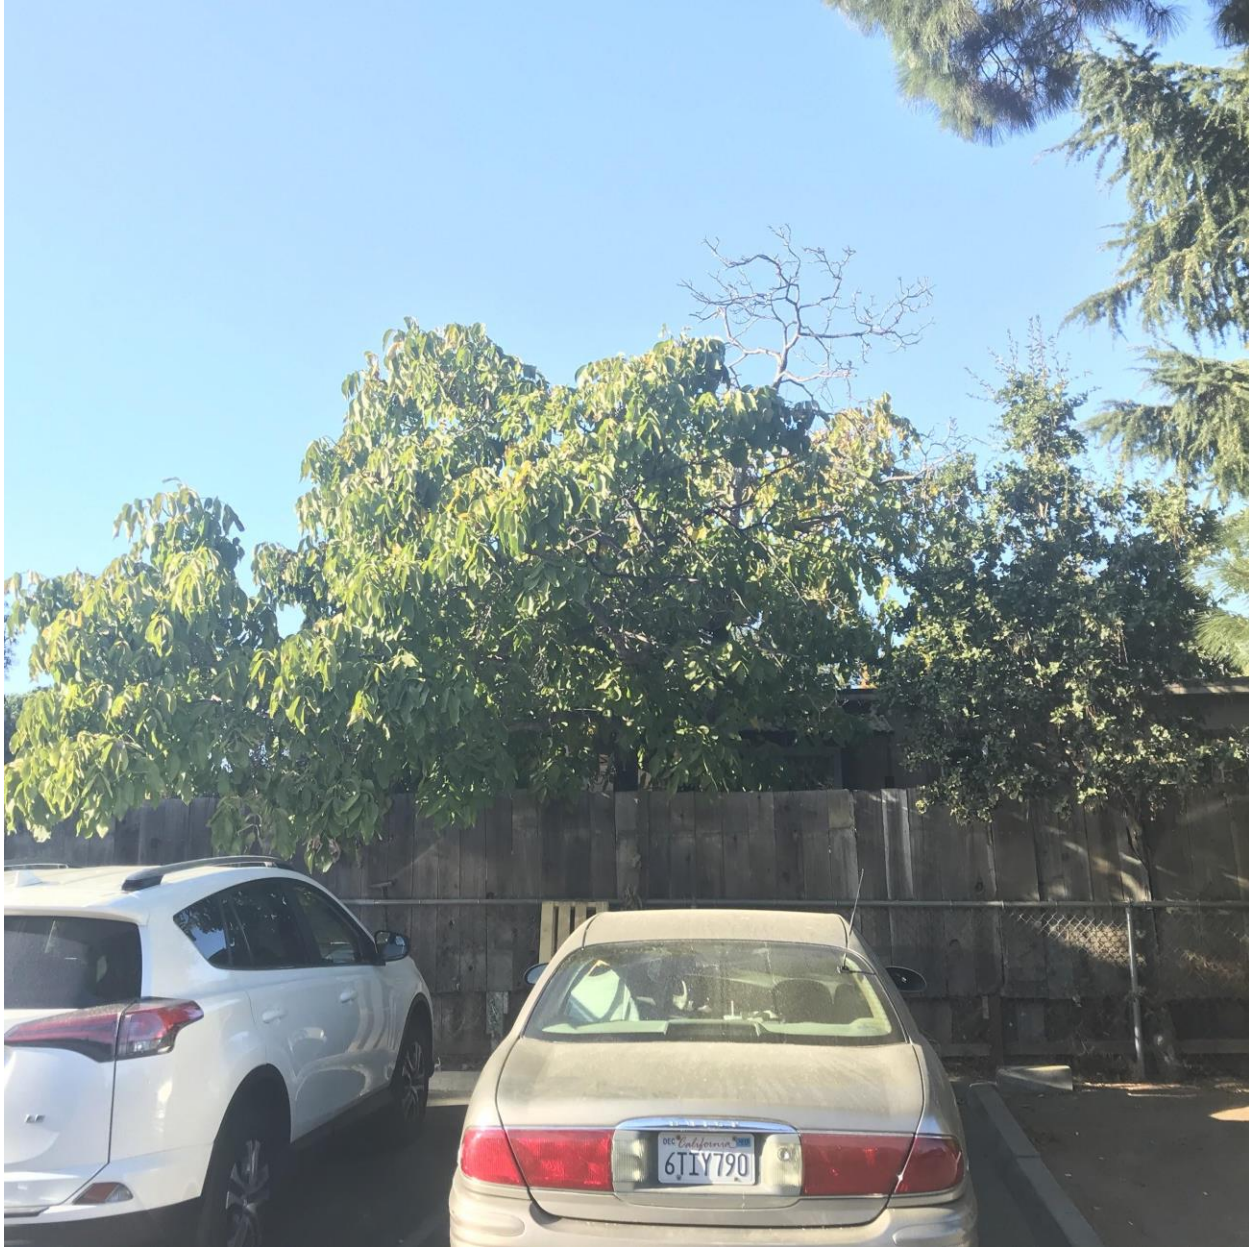
APPENDIX B: TREE PHOTOGRAPHS

The Coast Live Oak (*Quercus agrifolia*) on the adjacent property likely suffers from a western bark beetle infestation. Trunk can be seen to have damage from wood boring insect. In addition, the canopy has signs of dieback as well as a white powdery substance on the foliage (Appendix B: tree photographs).

Analysis of this data clearly shows that the construction poses a slight potential threat to the health, safety and general welfare of the Coast Live Oak (*Quercus agrifolia*) on the adjacent property due to its proximity within the CRZ. Extreme caution should be taken when pruning roots. With all cuts made being proceeded by washing of the root and then sealing the wound in burlap. I'll pruning to take place on the trees canopy should be to the minimum extent possible.
