# ARBORIST REPORT

## TREE IMPACT ASSESSMENT

JANUARY 10, 2020

MITZI PLACE, 4146 MITZI DRIVE, SAN JOSE

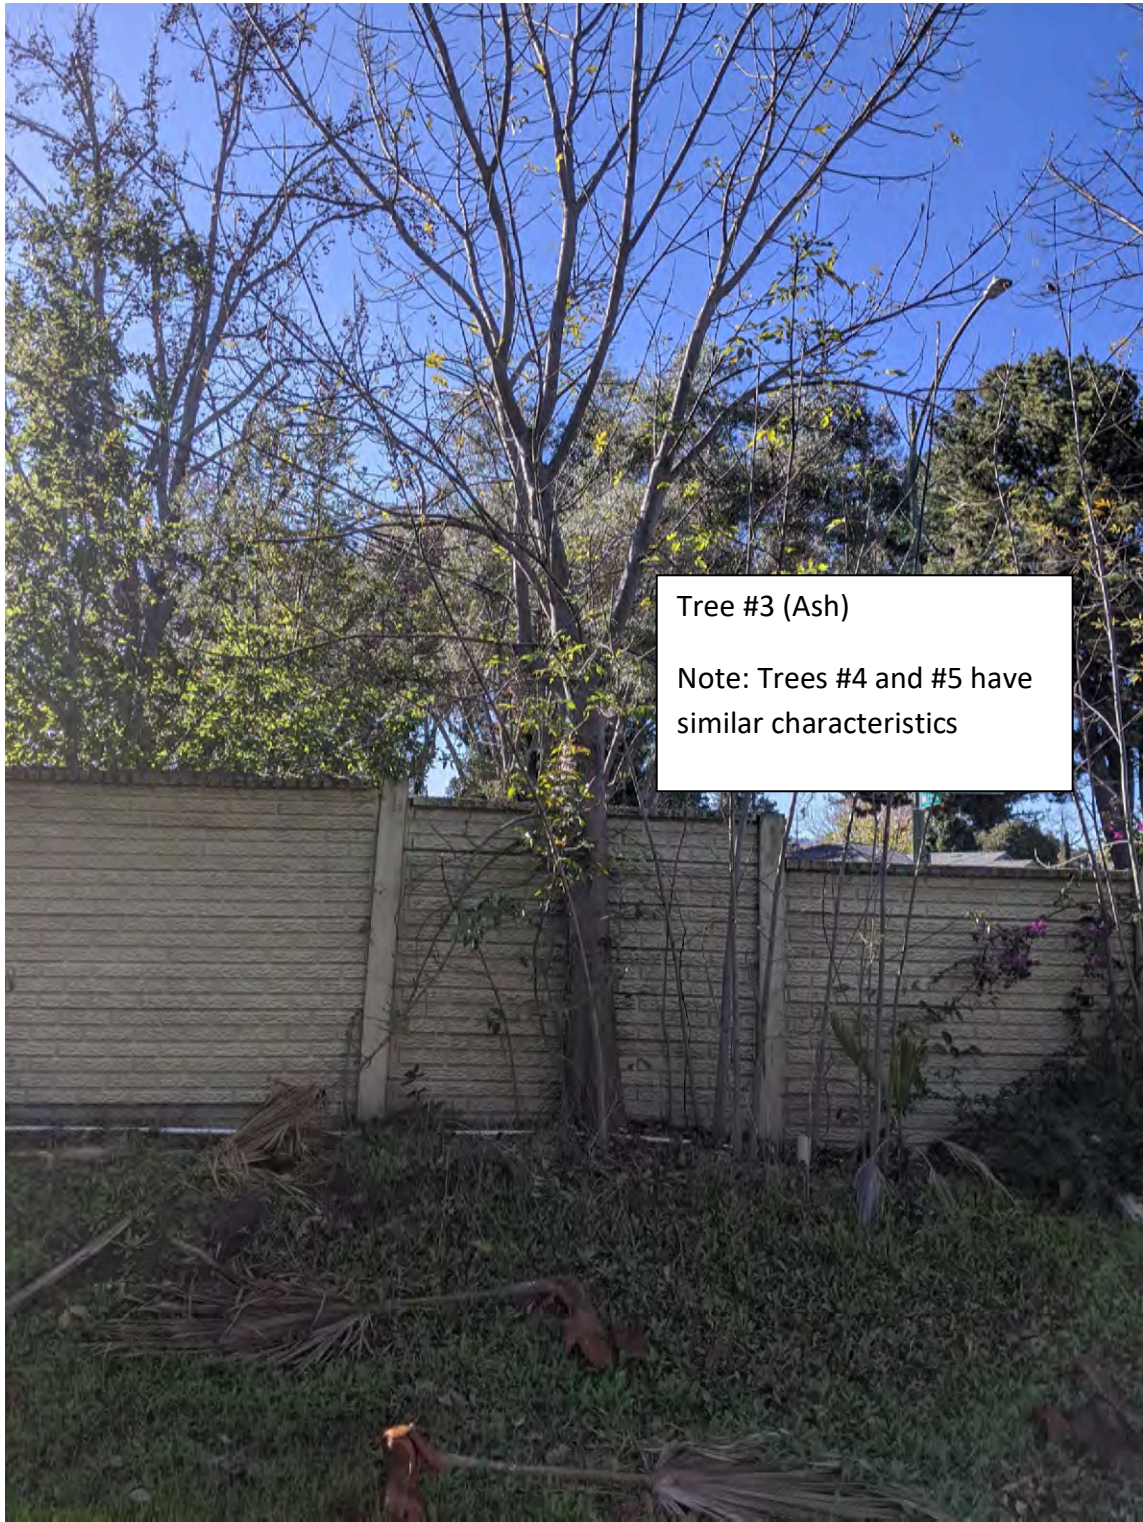
Tree #3 (Ash)

Note: Trees #4 and #5 have similar characteristics

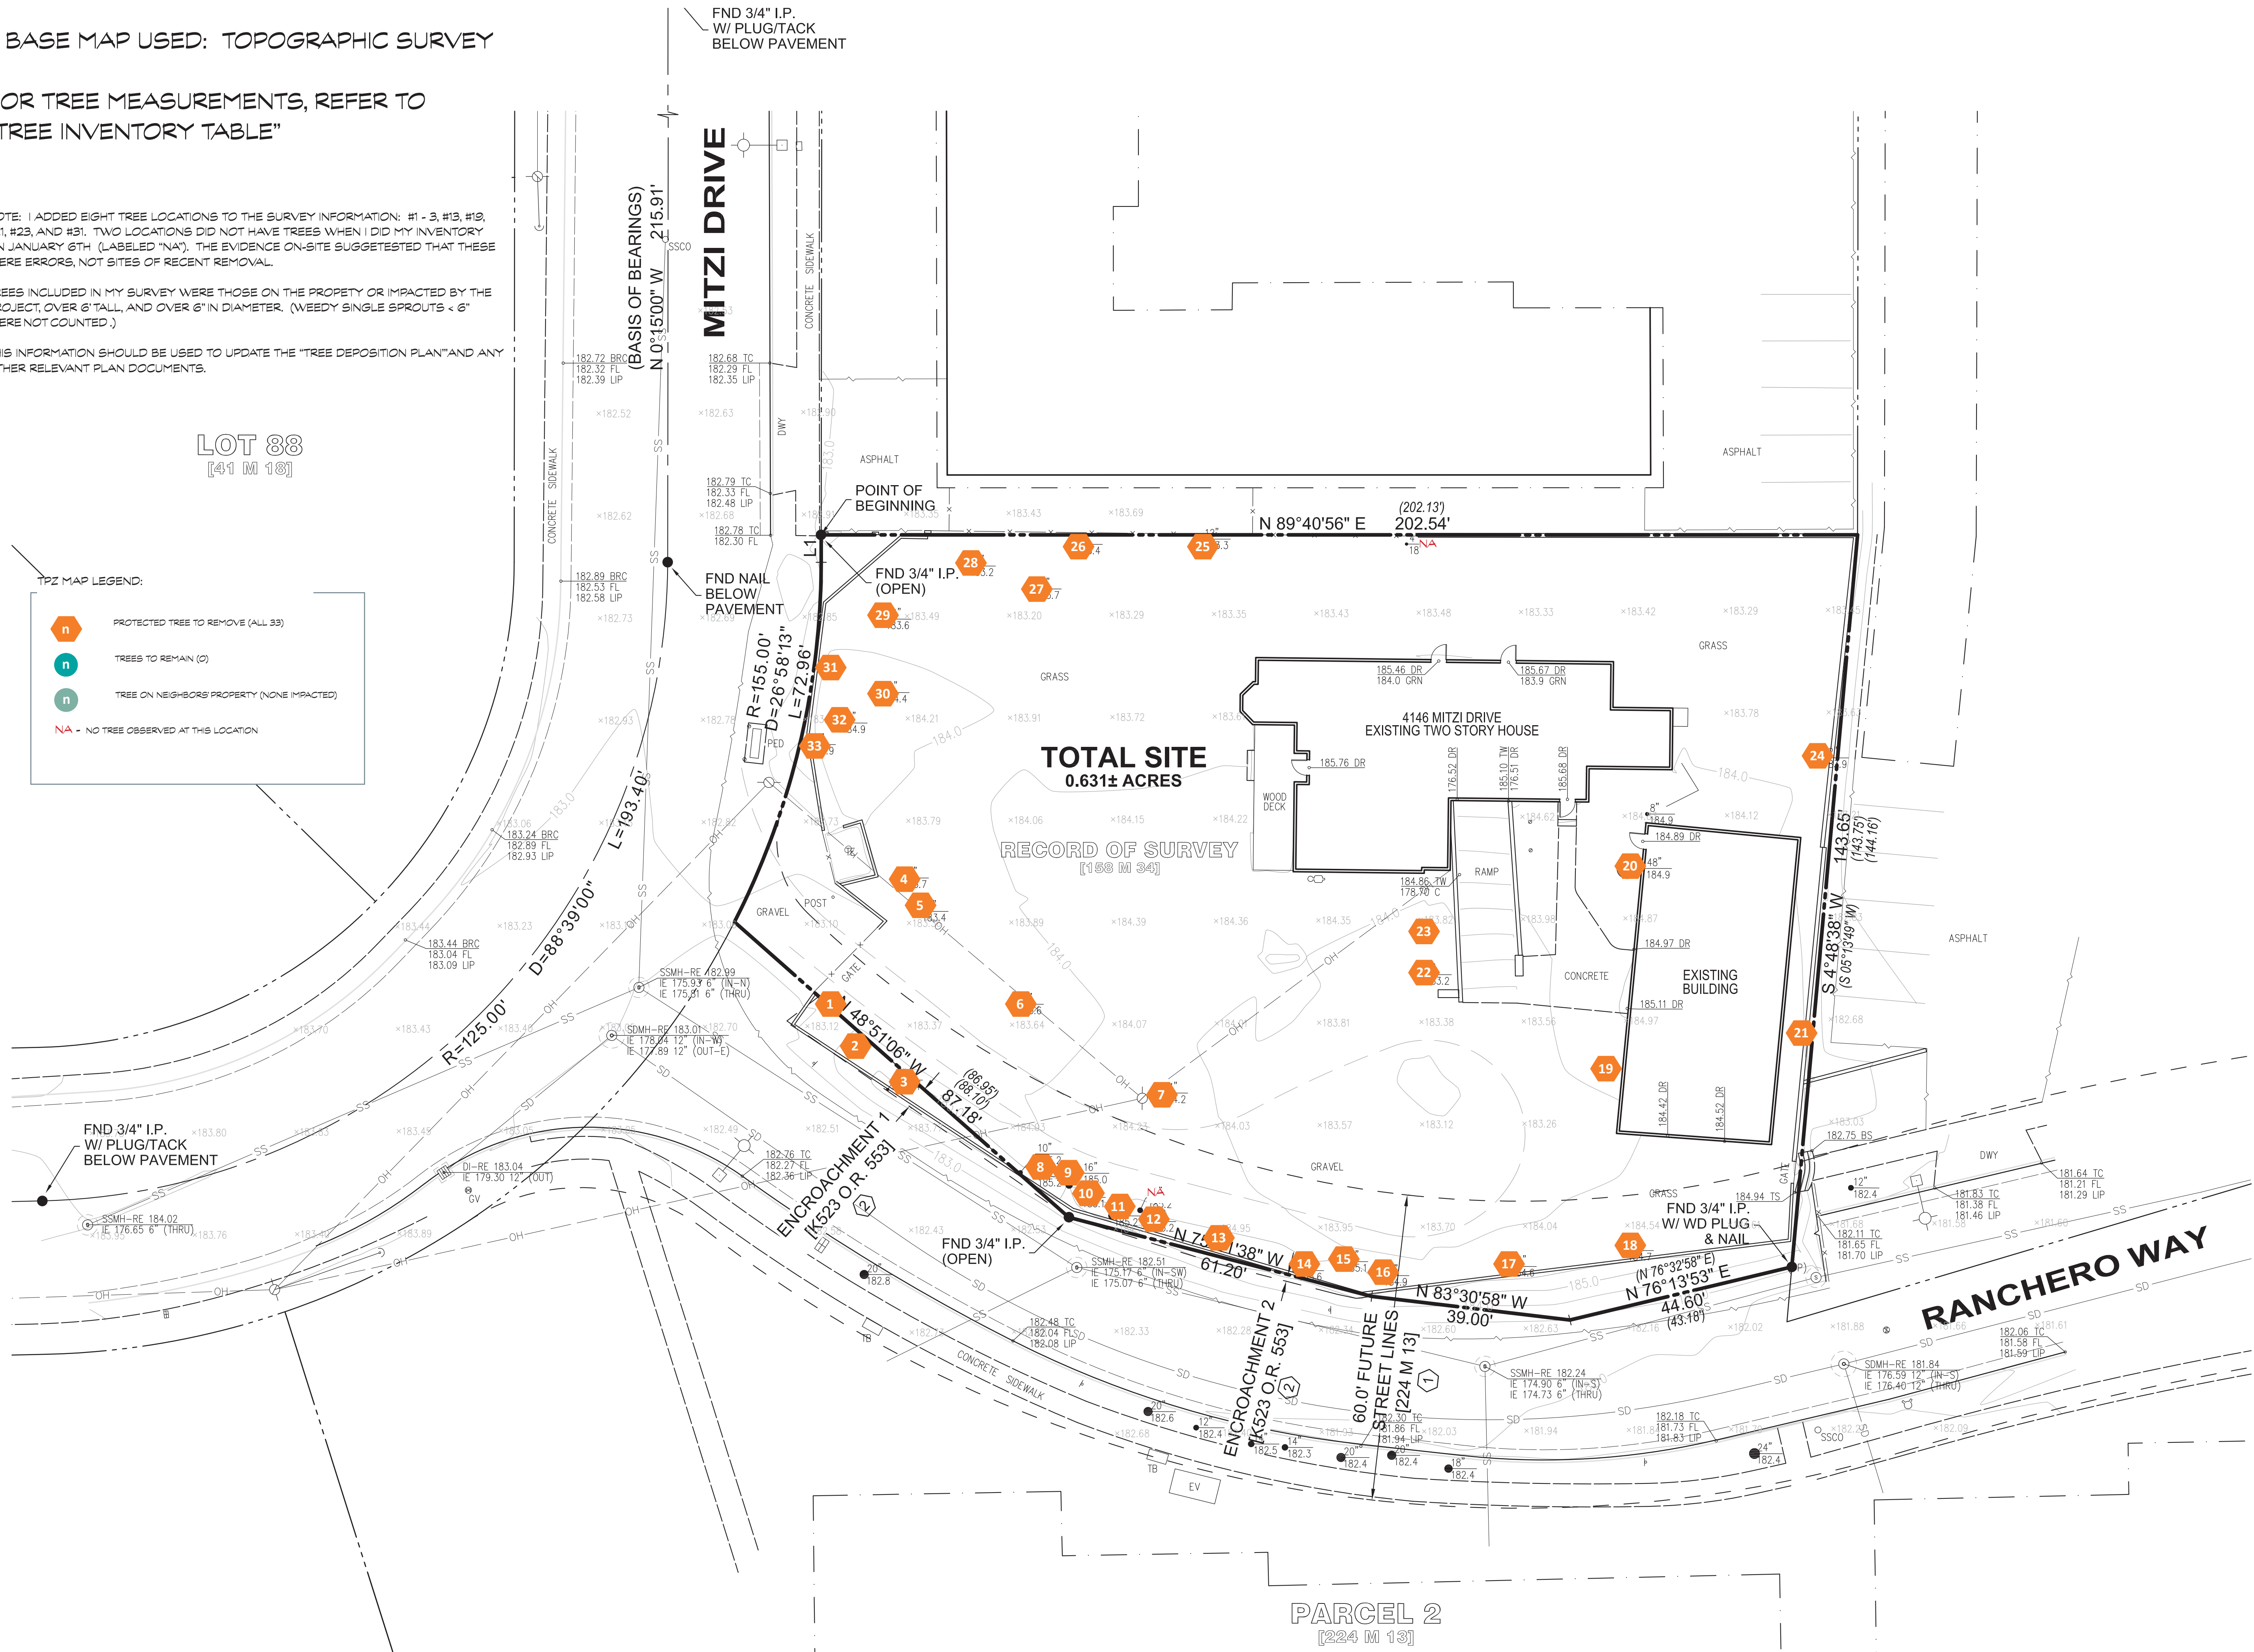
TREE MAP  
4146 MITZI DRIVE, SAN JOSE, CA

NOTE: I ADDED EIGHT TREE LOCATIONS TO THE SURVEY INFORMATION: #1 - 3, #13, #19, #21, #23, AND #31. TWO LOCATIONS DID NOT HAVE TREES WHEN I DID MY INVENTORY ON JANUARY 6TH (LABELED "NA"). THE EVIDENCE ON-SITE SUGGESTED THAT THESE WERE ERRORS, NOT SITES OF RECENT REMOVAL.

THIS INFORMATION SHOULD BE USED TO UPDATE THE "TREE DEPOSITION PLAN" AND ANY OTHER RELEVANT PLAN DOCUMENTS.
