Tree Survey

Little Portugal Gateway Mixed-Use Project Initial Study/MND

September 3, 2019

Site: 1661-1665 Alum Rock Avenue, San Jose CA

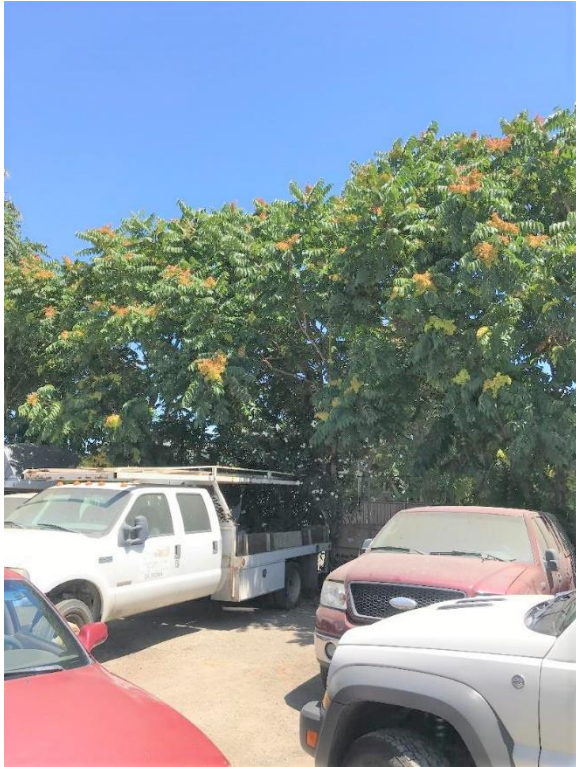
The majority of the trees on site are in poor condition due to no maintenance or poor maintenance. Many invasive tree of heaven trees (*Ailanthus altissima*) were located on the site. This species is extremely invasive and encouraged for removal by most municipalities (including San Jose). Coast live oak trees #17 and #18 were the only native trees found on site. Because this is a multifamily/commercial lot a permit is required to remove a tree of any size. A tree removal permit is required if the tree is ordinance-size. A permit adjustment is required if the tree is smaller than ordinance size. My count shows 6 trees measuring greater than 12 inches in diameter (ordinance size). Tree #23 is a street tree that will also need a permit to be removed.

Showing Ailanthus trees (tree of heaven) at property line.
