June 16, 2020
Revised July 14, 2020

Knox-Goodrich Building
34-36 S. First Street
San Jose, California

PRESERVATION PLAN

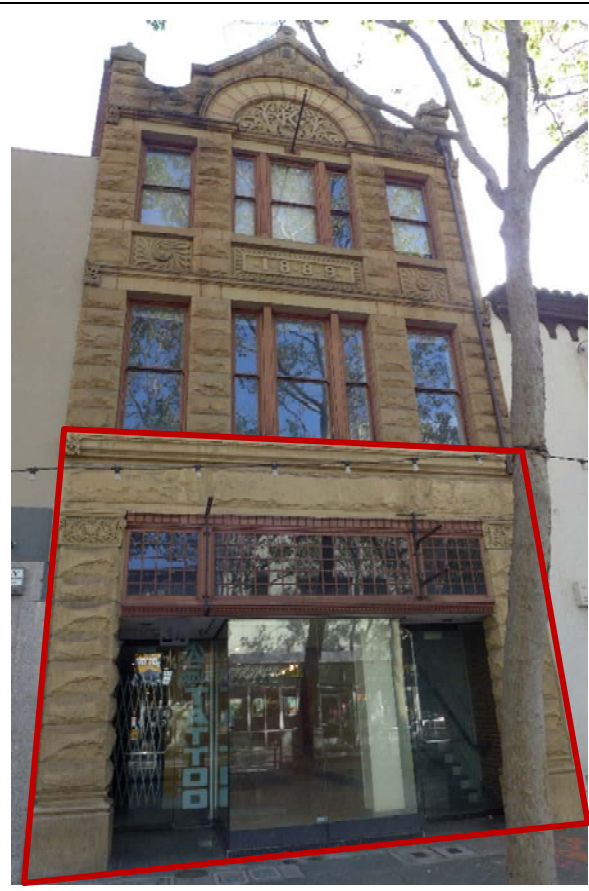
<p>1. Reference photograph of South First Street façade.</p> <p>Over the years modifications at the ground floor resulted in the loss of the stone below the second-floor windows and the original storefront assembly (non-original material is outlined in red). The recreated first floor stonework is a faux stone installed in the late 1980s, painted to match the stone at the upper levels.</p>

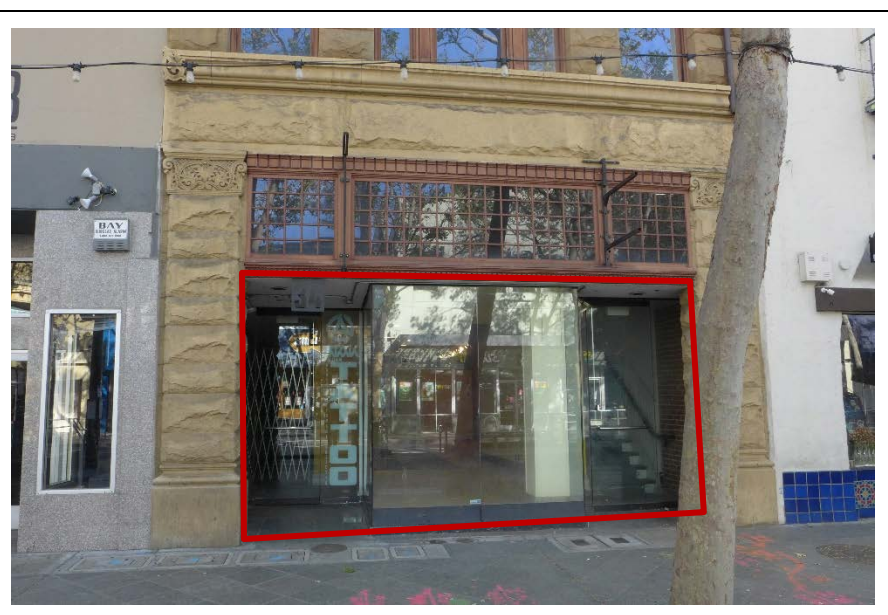
<p>2. Reference photograph of storefront. Lower storefront to be replaced as part of the rehabilitation project and the transom is to remain. Red box identifies the storefront elements to be replaced with a contemporary and compatible system. See the Secretary of the Interior's Evaluation section of this report for in-depth review of proposed storefront.</p>

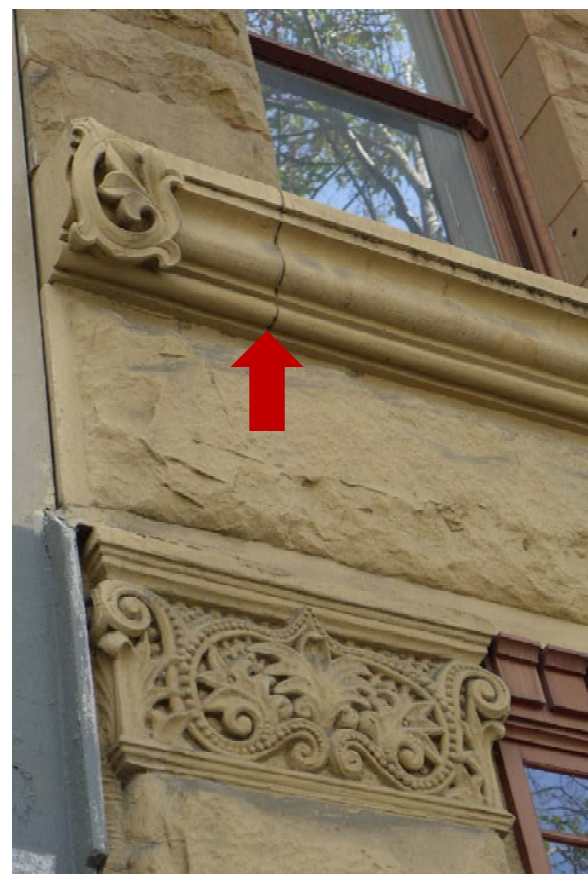
<p>3. Many of the joints between the stones are open or deteriorated. This is a typical condition that occurs at stones that project from the face of the building. The decorative bands that project at each floor have many open joints.</p> <p>Refer to N.P.S. <i>Technical Preservation Services, Brief 2, "Repointing Mortar Joints in Historic Masonry Buildings"</i> for guidance on repointing.</p> <p>Review extent of joint repair with historic architect prior to undertaking work.</p>

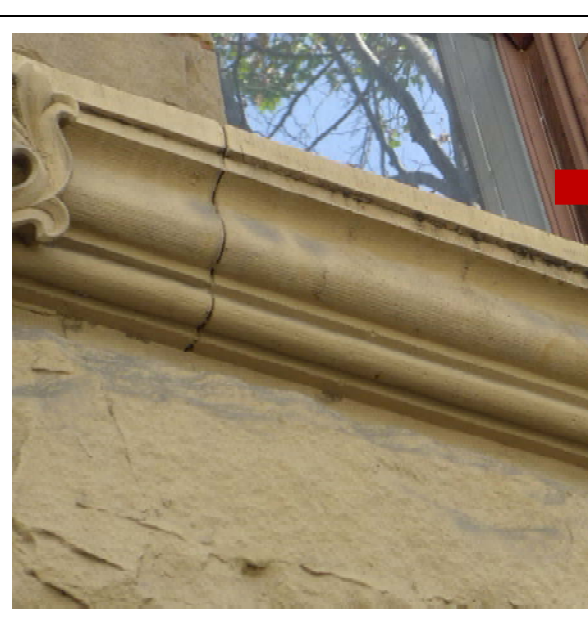
<p>4. Anchor visible at window jamb. Remove anchor if it is determined to be ferrous metal. Leaving the ferrous metal in the stone could damage the stone as it deteriorates.</p> <p>Review procedures for removal of anchor and patching of stone with historic architect prior to undertaking the work.</p>

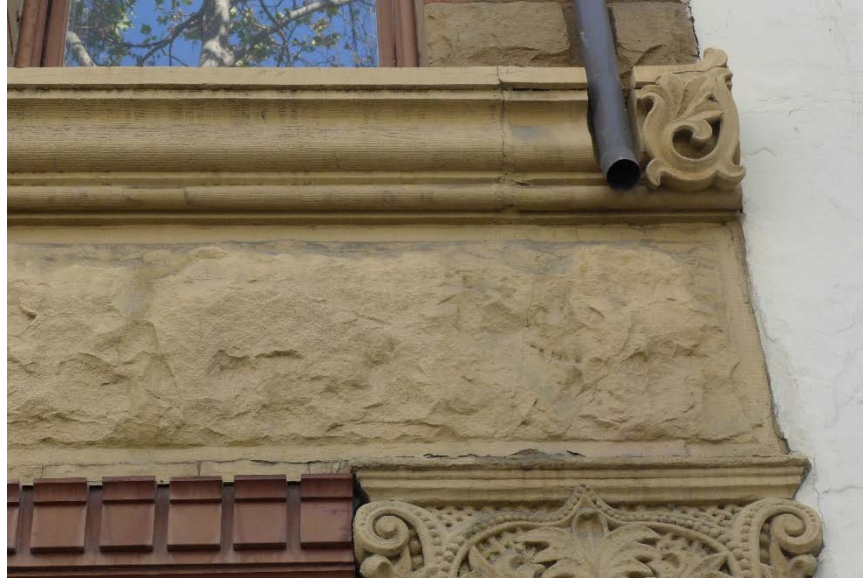
5. Dirt on surface. This is a typical condition that occurs on the surface of the stone face. Areas where the buildup of the soiling is especially visible are locations where water can run down the surface when it rains.

Front (south) façade to be cleaned as part of the rehabilitation project. Gentlest means possible to be used. Review cleaning protocols with historic architect.

Prior to cleaning the front façade refer to N.P.S. *Technical Preservation Services, Brief 1, "Assessing Cleaning and Water-Repellent Treatments for Historic Masonry Buildings"* and *Technical Preservation Services, Brief 6, "Dangers of Abrasive Cleaning to Historic Buildings."*

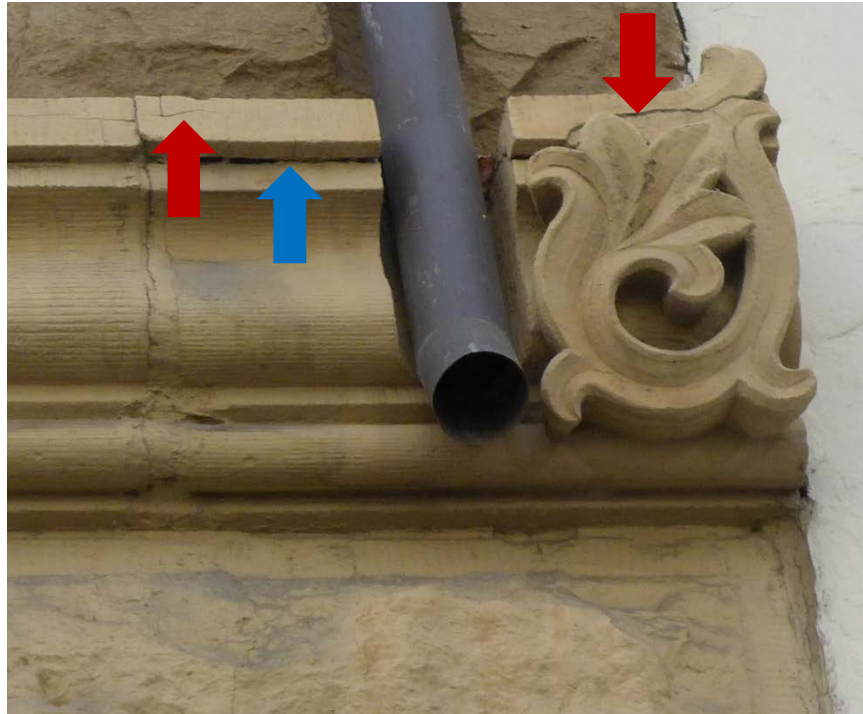
6. Cracks at the decorative band and ornamental end element (red arrows). Open joints are visible at the underside of the decorative band (blue arrow). Between the cracking and separation at the joint this end stone should be reviewed to ensure it is sound and that no pieces will spall off onto the sidewalk below.

Refer to N.P.S. *Technical Preservation Services, Brief 47* "Maintaining the Exterior of Small and Medium Size Historic Buildings."

Review planned crack and spall repairs with historic architect.

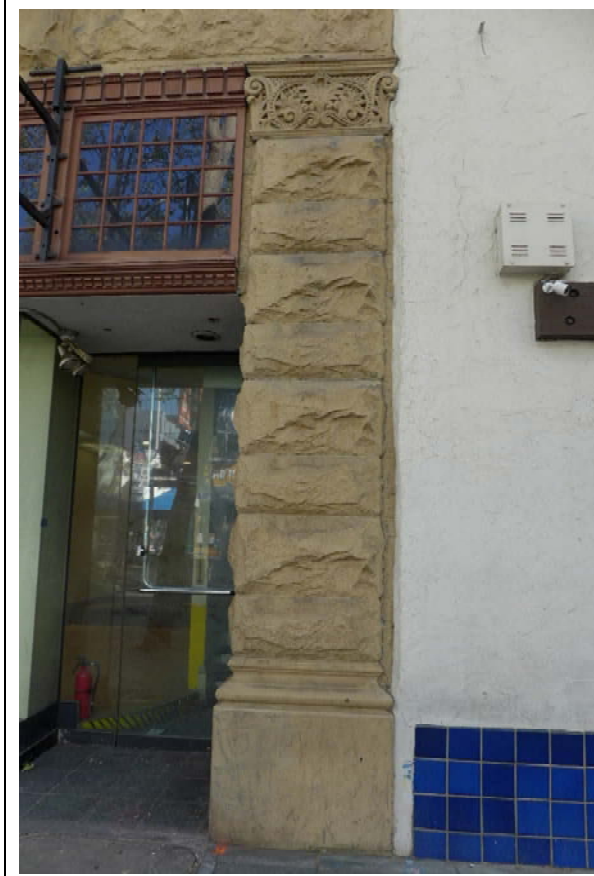
7. Reference photograph. Dirt on surface. Condition typical on stone and faux stone.

Front (south) façade to be cleaned as part of the rehabilitation project. Gentlest means possible to be used. Review cleaning protocols with historic architect.

Prior to cleaning the front façade refer to N.P.S. *Technical Preservation Services, Brief 1, "Assessing Cleaning and Water-Repellent Treatments for Historic Masonry Buildings."*

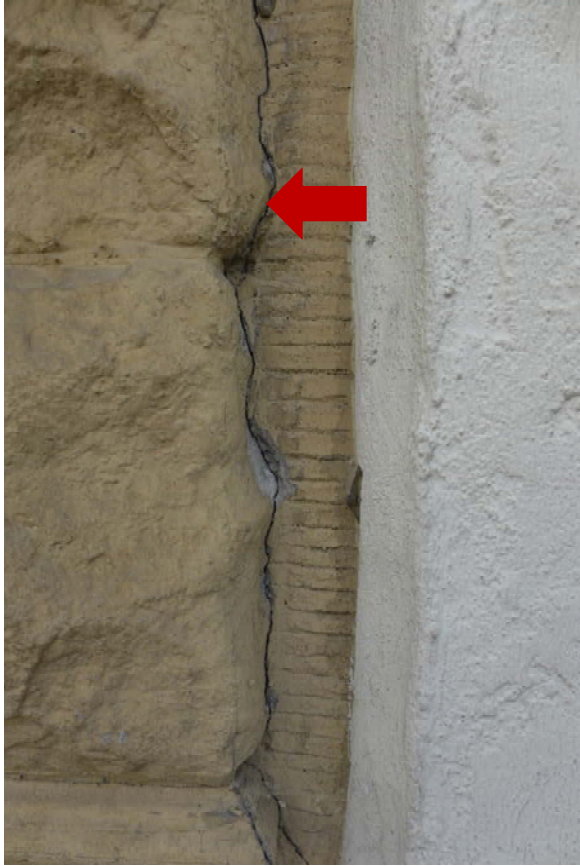
<p>8. Joint between the first-floor replacement stone and the adjacent building is open.</p> <p>Seal joint and paint to match surrounding surface.</p> <p>Review planned repair with historic architect prior to undertaking work.</p>

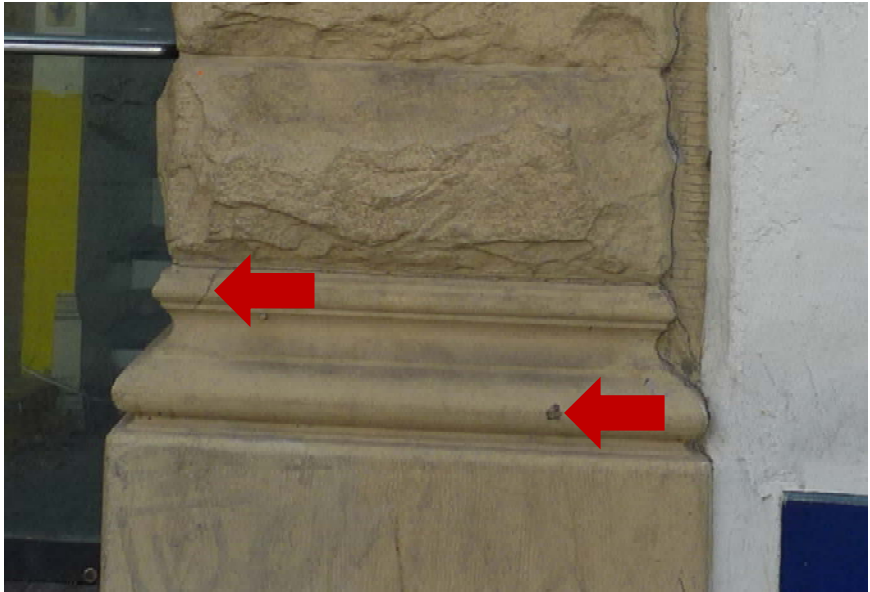
<p>9. Chip at lower base (front façade, east side) and hairline crack at corner of the base.</p> <p>Review repair with historic architect prior to undertaking work.</p>

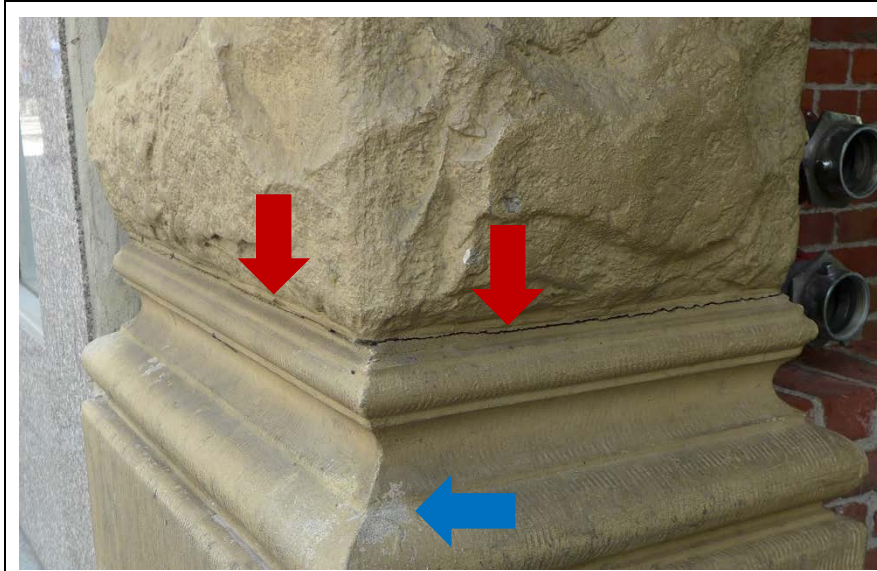
10. Crack between the faux stone elements at the base (red arrow).

Coating on the corner is damaged (blue arrow).
Recoat the faux stone at the first floor of the structure.

Fill open joint and painted.

Review repair with historic architect prior to undertaking work.

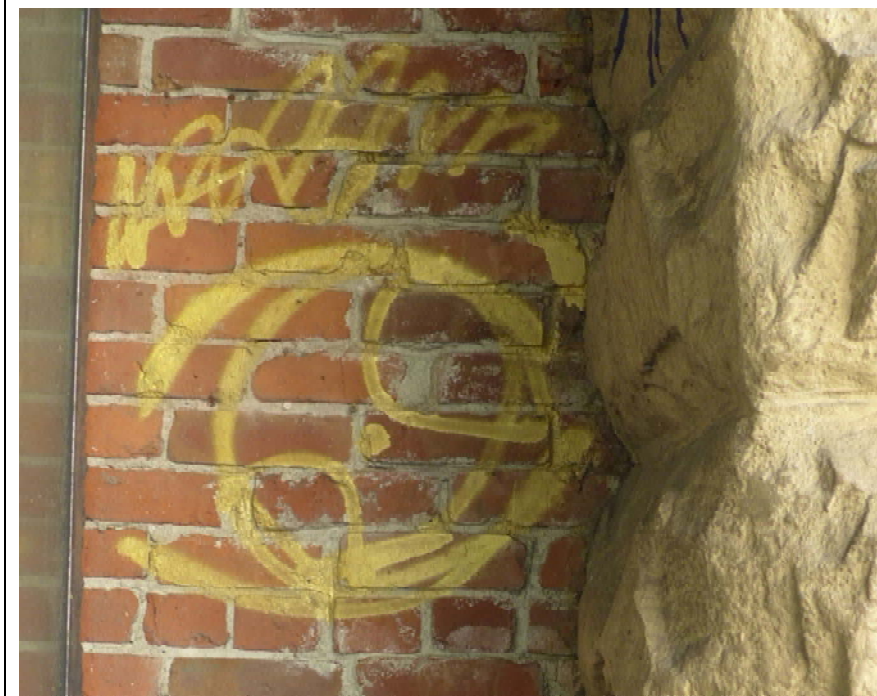
11. Graffiti on the brick at the eastern side of the entry alcove.

Remove the graffiti.

Review graffiti removal protocols with historic architect prior to undertaking work.

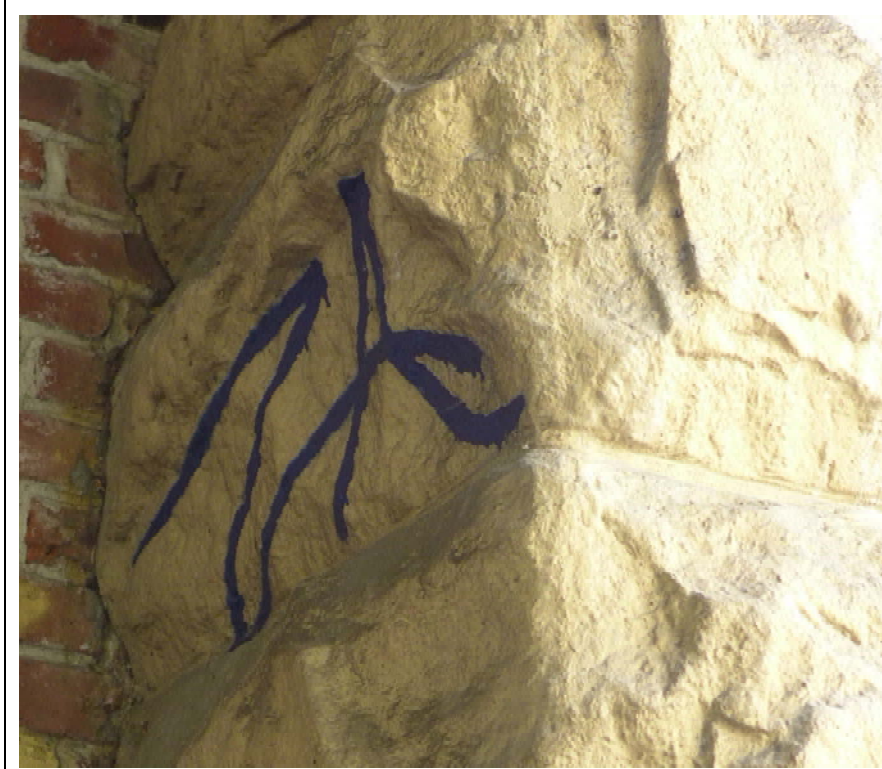
12. Graffiti on the faux stone surface at the eastern side of the entry alcove.

Remove the graffiti.

Review graffiti removal protocols with historic architect prior to undertaking work.

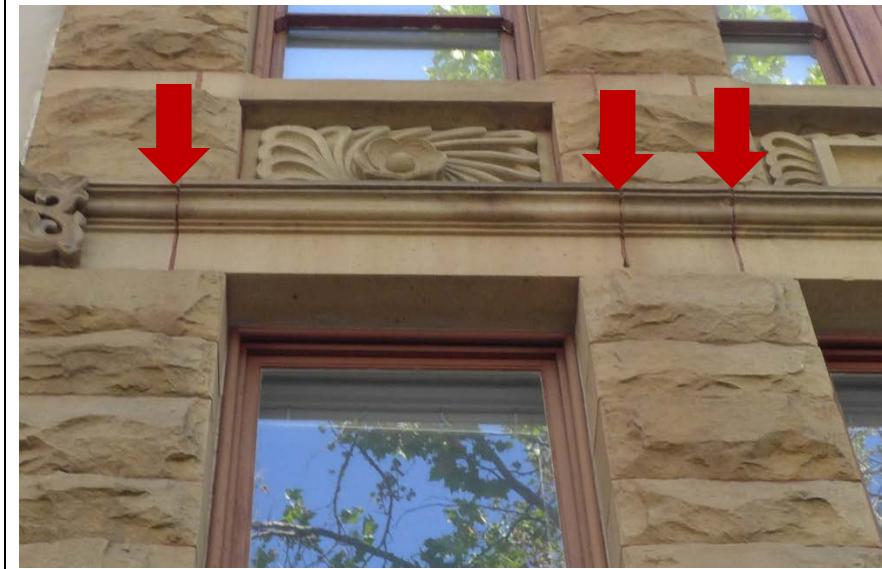
13. Open vertical joints at the horizontal bands.

Repoint.

Review extent of joint repair with historic architect prior to undertaking work.

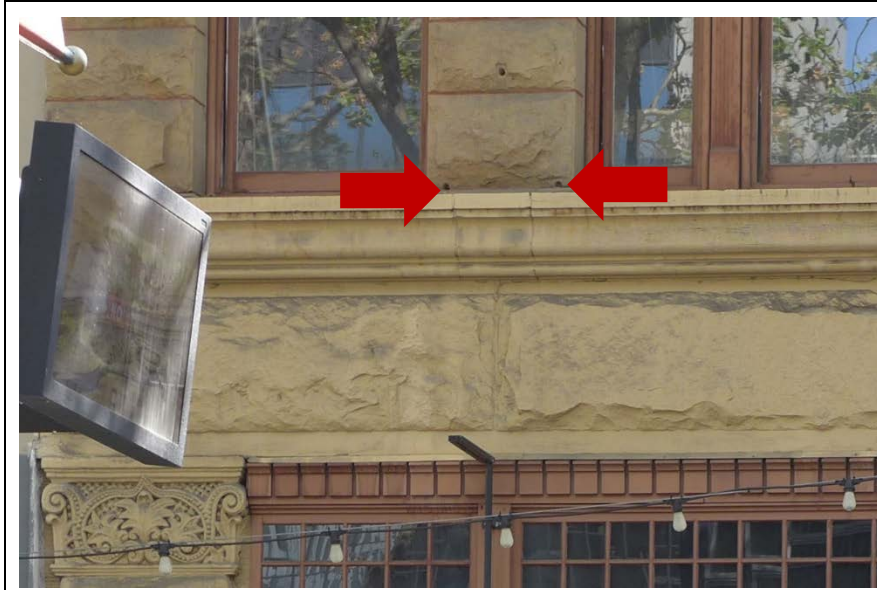
14. Holes at lowest stone above decorative band.

Patch stone.

Review planned repairs to be completed with historic architect prior to beginning work.

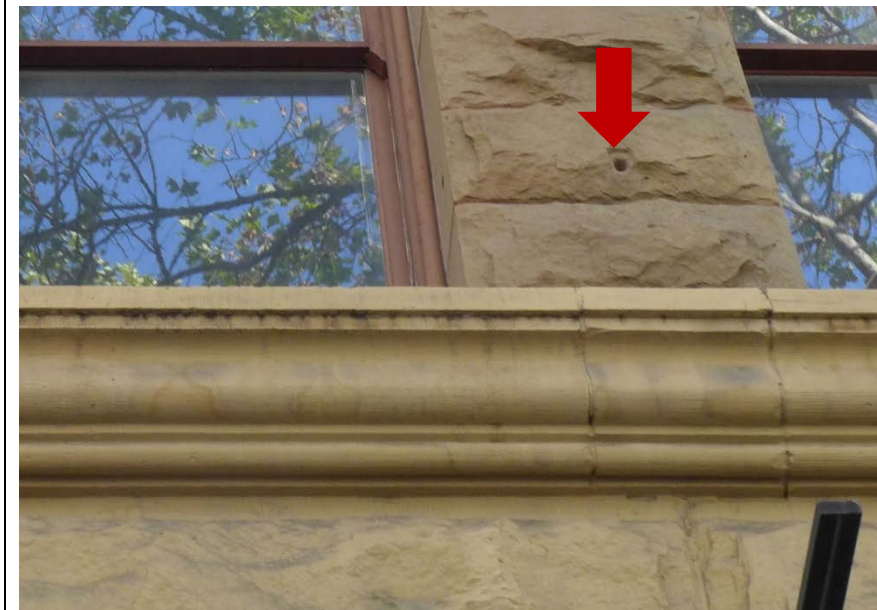
15. Hole in the middle of the stone. Patch stone.

Review planned repairs to be completed with historic architect prior to beginning work.

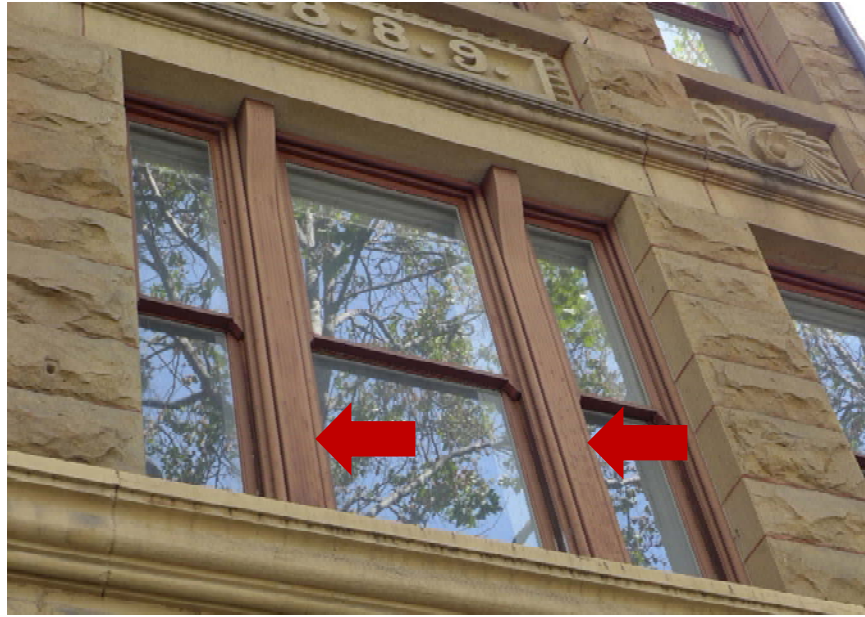
16. Minor discoloration and paint wear on the window sashes and frames. Overall, the windows appear to be in excellent condition. As paint is the first line of defense in protecting the wood, the painted surface should be maintained. Repaint windows and frames.

While it does not appear any notable deterioration or damage is occurring at the windows the N.P.S. *Technical Preservation Services, Brief 9, "The Repair of Historic Wooden Windows,"* should be reviewed prior to any window work including repainting.

If window scope goes beyond repainting, review repairs with historic architect prior to undertaking the work.

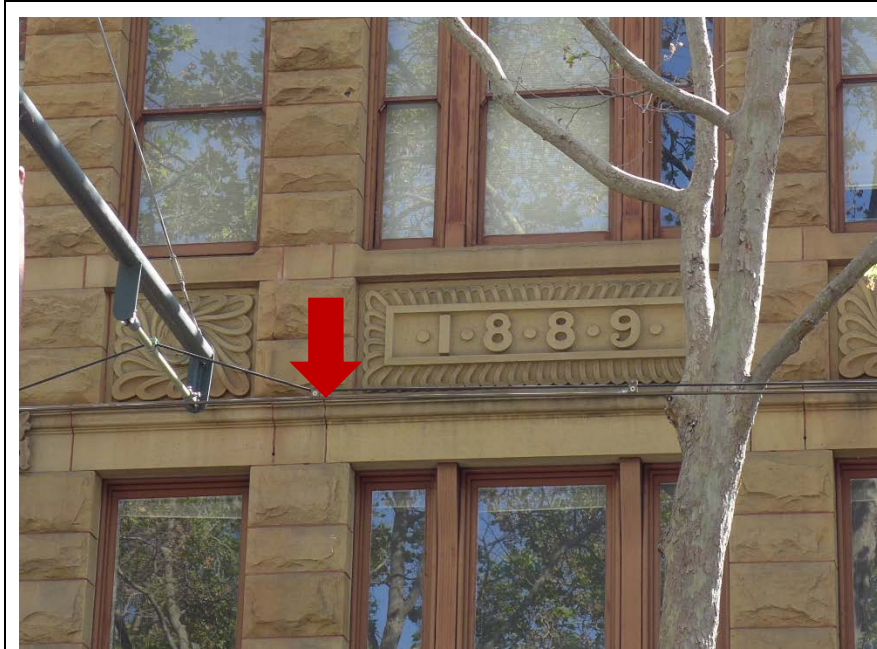
17. Open joints at the vertical band. The open joint condition is typical at vertical joints at the decorative bands between the floors.

Refer to N.P.S. *Technical Preservation Services, Brief 2, "Repointing Mortar Joints in Historic Masonry Buildings"* for guidance on repointing.

Review extent of joint repair with historic architect prior to undertaking work.

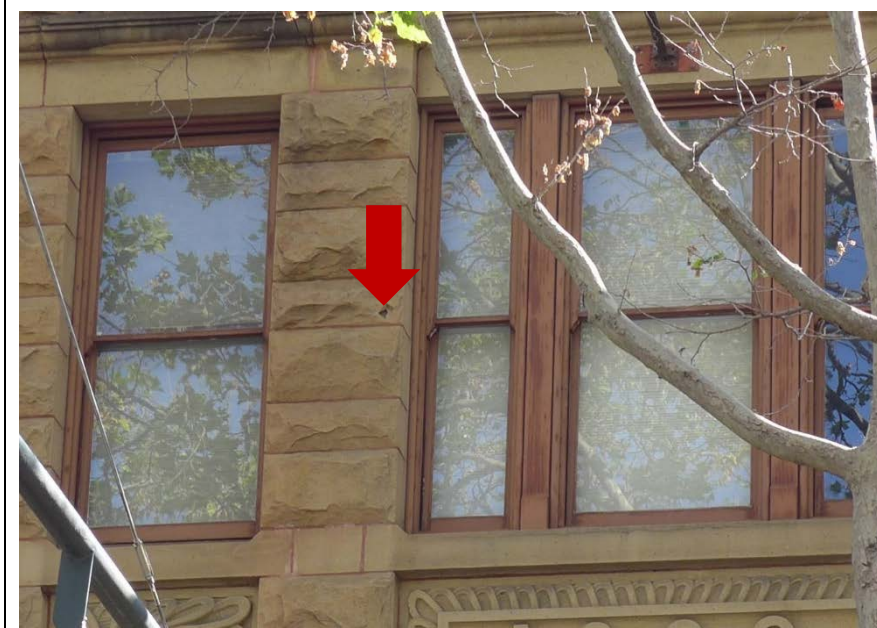
18. Damage, spalling at the face of the stone.

Review spall repair procedures with historic architect prior to undertaking any repair.

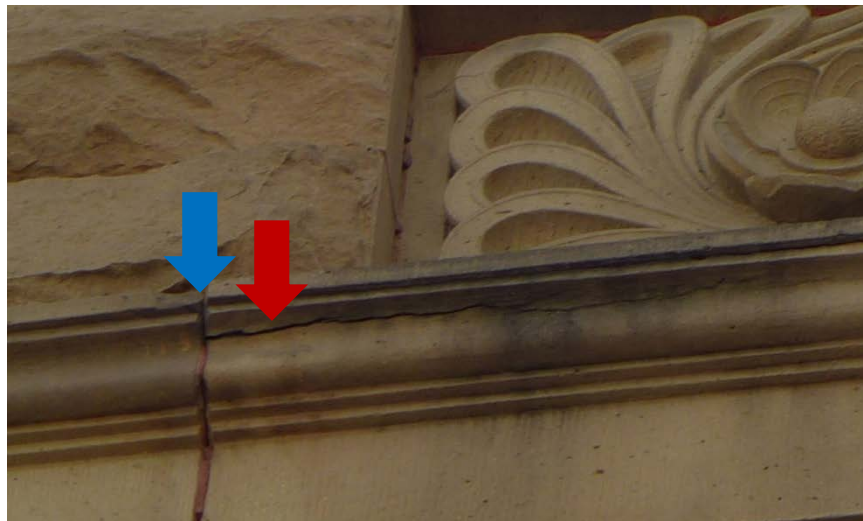
19. Crack (red arrow). Condition only present at level above second floor windows. Deteriorated mortar joints (blue arrow).

The deteriorated and open joints are typical at decorative horizontal bands.

Review crack repair of stone element with historic architect prior to undertaking any repairs.

Review extent of joint repair with historic architect prior to undertaking work.

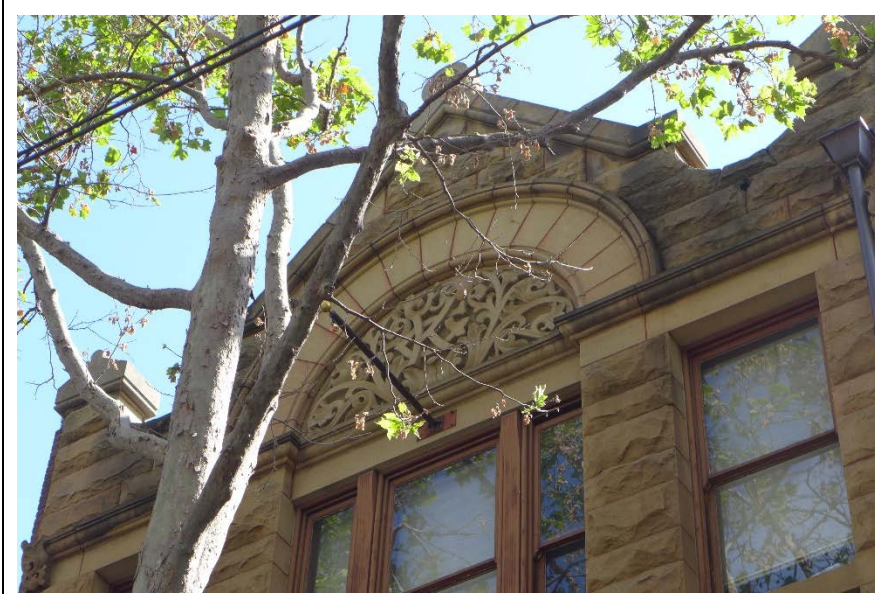
20. Heavier staining at the top of the structure. Clean surface staining.

Front (south) façade to be cleaned as part of the rehabilitation project. Gentlest means possible to be used. Review cleaning protocols with historic architect.

Prior to cleaning the front façade refer to N.P.S. *Technical Preservation Services, Brief 1, "Assessing Cleaning and Water-Repellent Treatments for Historic Masonry Buildings"* and *Technical Preservation Services, Brief 6, "Dangers of Abrasive Cleaning to Historic Buildings."*

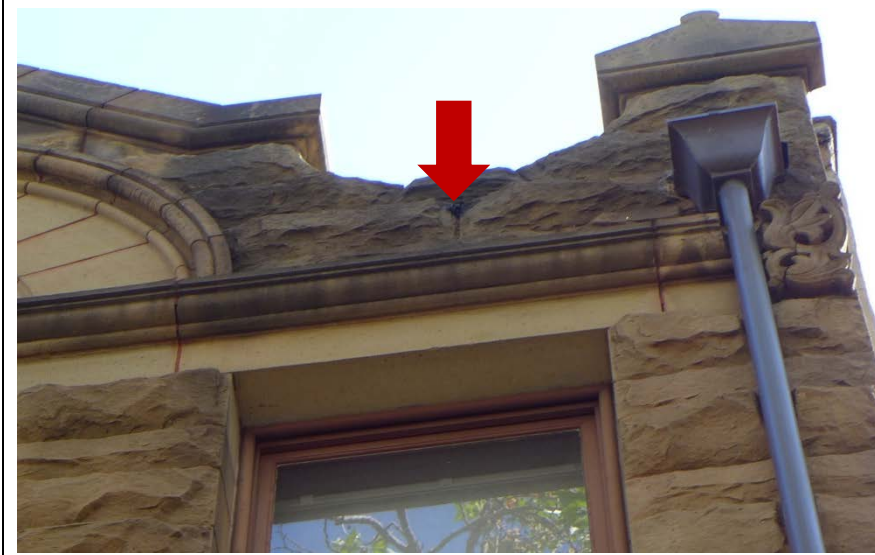
21. Deteriorating anchor at the joint. Remove anchor and patch the joint and stone if necessary.

Review removal and patching procedures with historic architect prior to undertaking planned work.

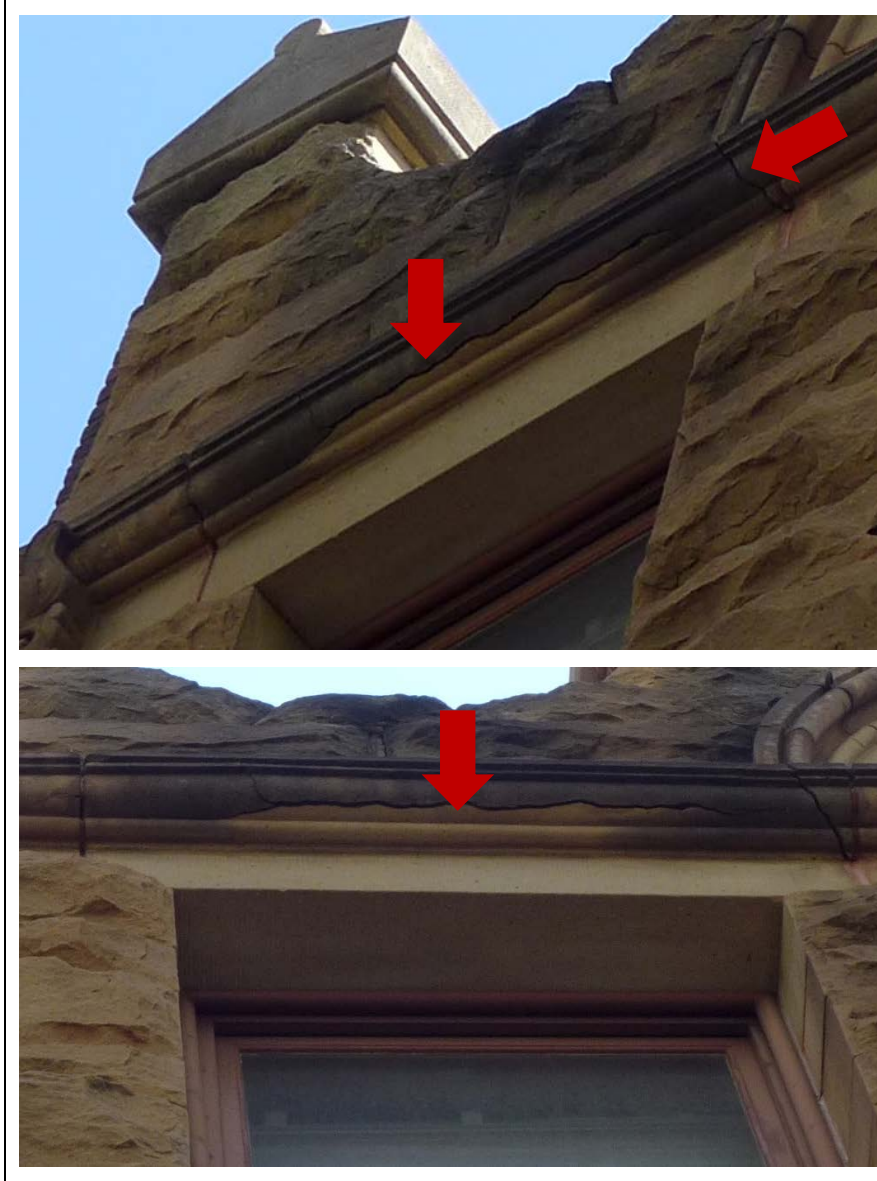
22. Crack and open joint.

Review crack repair of stone element with historic architect prior to undertaking any repairs.

Review extent of joint repair with historic architect prior to undertaking work.

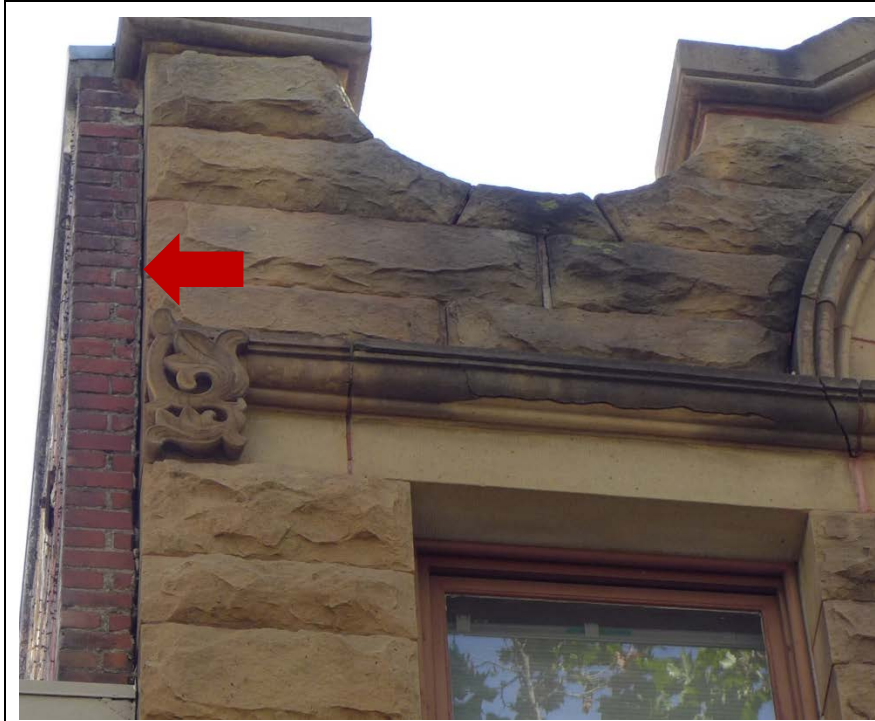
23. Between the brick face of the western wall and the stone face of the front (south façade) there is an open joint.

This condition should be reviewed by a structural engineer who is experienced in working on historic structures. Any proposed repair or stabilization proposed by the structural engineer should be reviewed by the historic architect. At a minimum the joint should be sealed to prevent water infiltration.

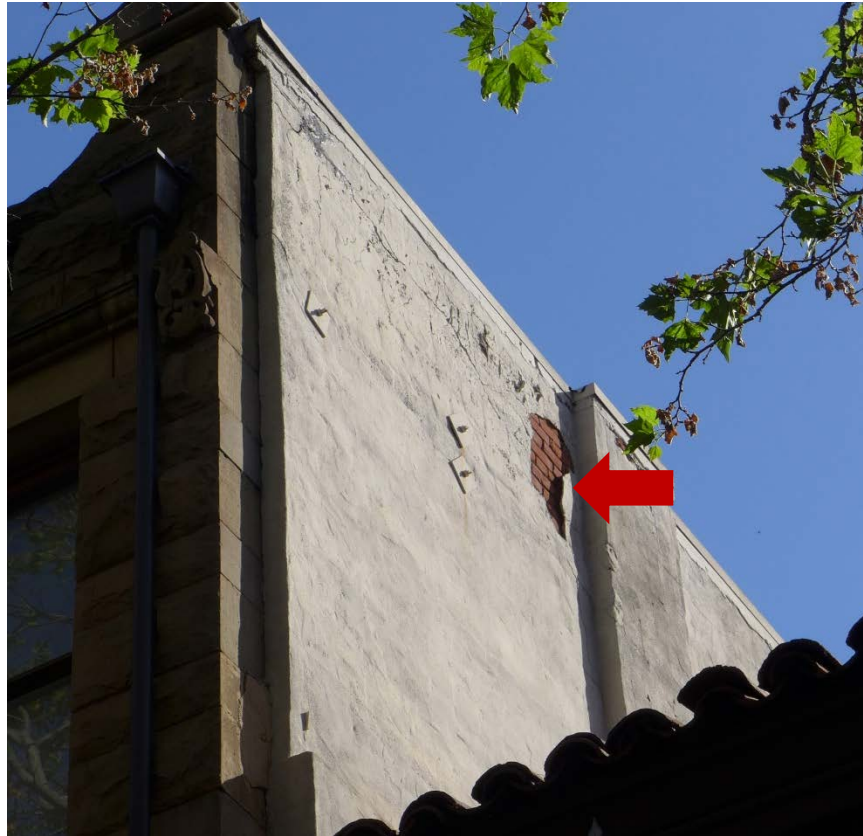
25. The stucco covered brick on the east side of the structure, viewed from the public-right-of-way (South First Street).

The stucco parge coat has one visible area of failure where bricks are exposed. Other areas, near the top of the parapet wall appear to show signs of cracks in the stucco parge coat surface.

Review repairs to the stucco parge coat with historic architect prior to undertaking work.

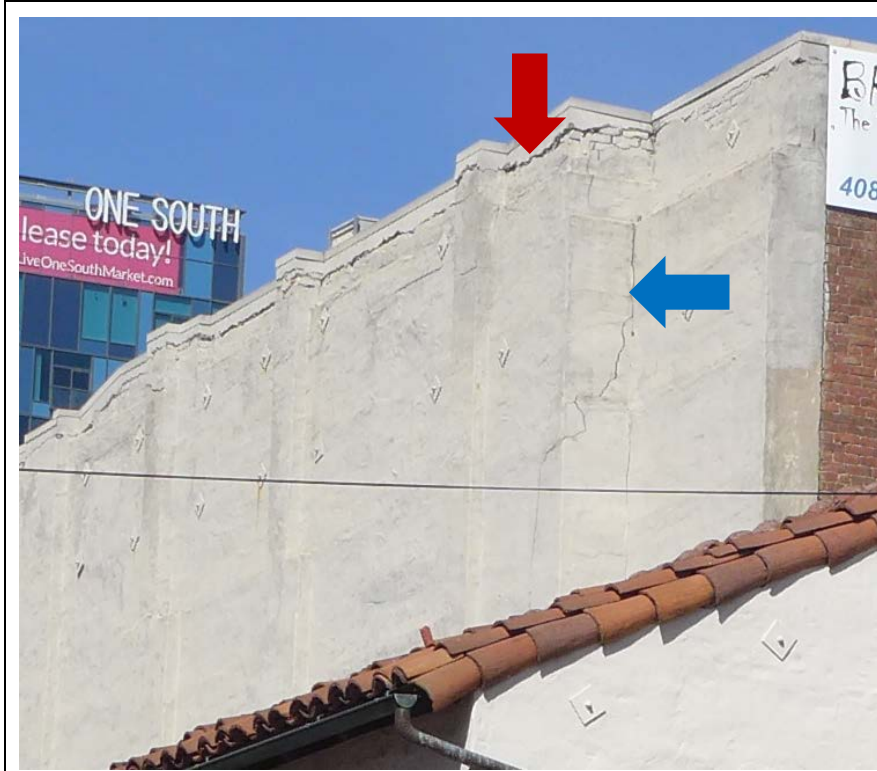
27. Damage to the upper portion of the parge coat (red arrow). This condition is typical along the length of the parapet on the east side of the structure. Limited cracking below the parapet level (blue arrow).

Review repairs to the stucco parge coat with historic architect prior to undertaking work.

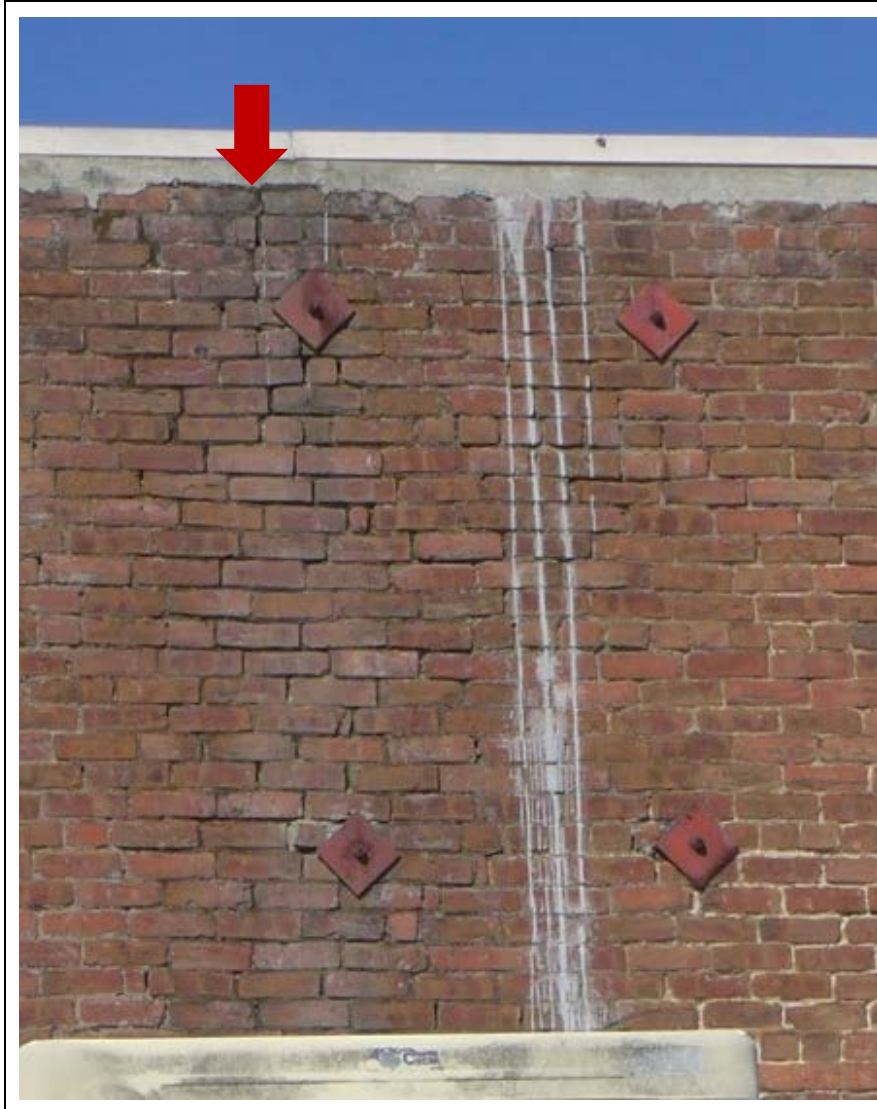
29. Mortar is missing near the center of the rear (north) wall. A structural engineer should review and recommend any required repairs for building stabilization.

If the wall was going to be exposed the recommendation would be to repoint the mortar where it is missing, but since the wall will be enclosed in the seismic gap between the two buildings there is no need to repoint the mortar joints unless there are structural concerns.

Refer to N.P.S. *Technical Preservation Services, Brief 2, "Repointing Mortar Joints in Historic Masonry Buildings"* for guidance on repointing.

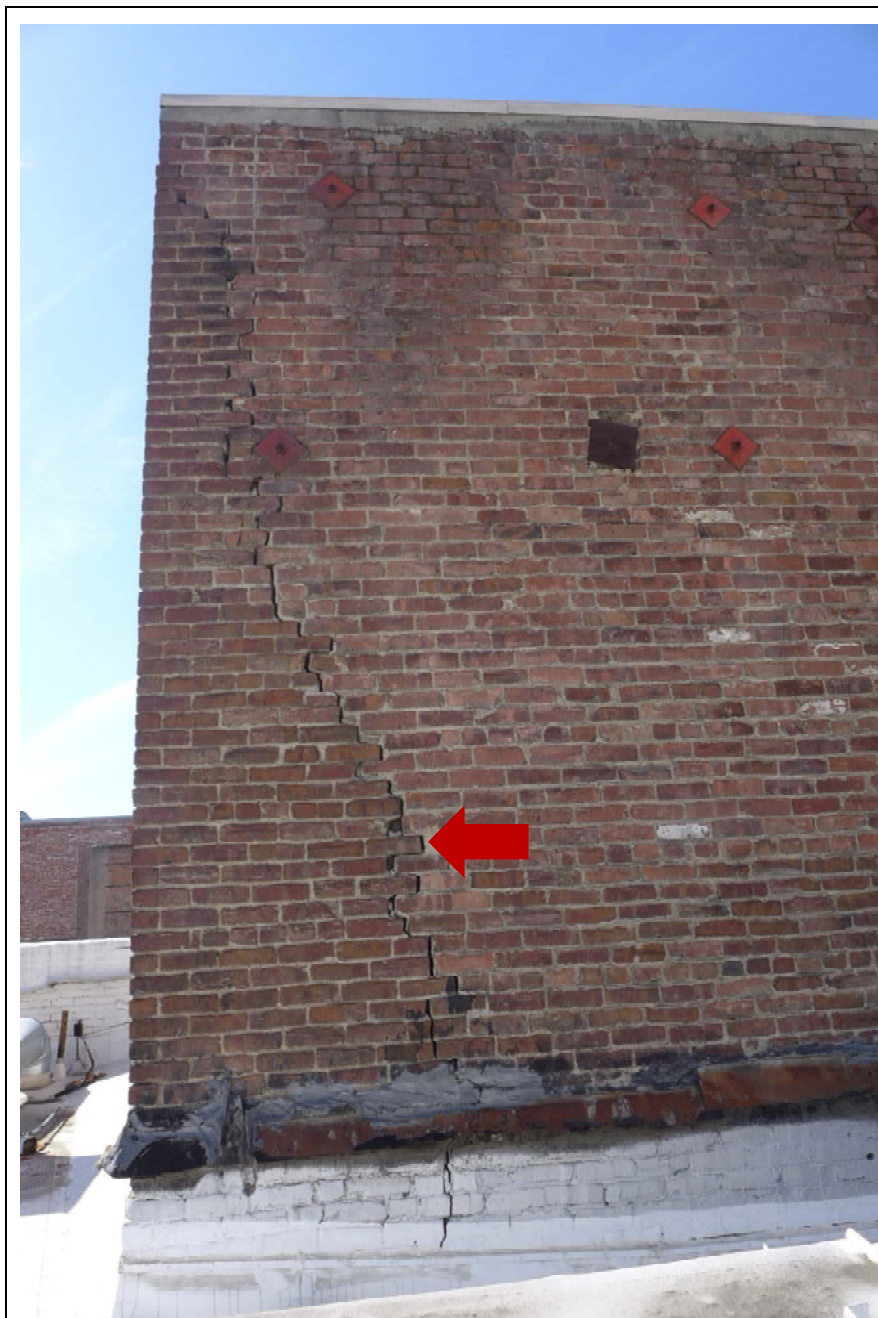
31. West side of the building viewed from the roof of the Lido Building. Only the upper portion of the exterior wall is visible.

A large crack, mostly running along the mortar joints, is present at the northern end of the building. The crack is visible at the lower levels of the structure on the interior.

A structural engineer should evaluate the crack and recommend repairs. Any recommendation should be reviewed by a historic architect since they will be visible on the interior. Repairs to the crack will likely need to be completed prior to the demolition of the Lido Building, but careful scheduling and coordination with the contractor will determine the best path forward. The contractor demolishing the Lido Building should have verified experience in working with historic resources.¹³

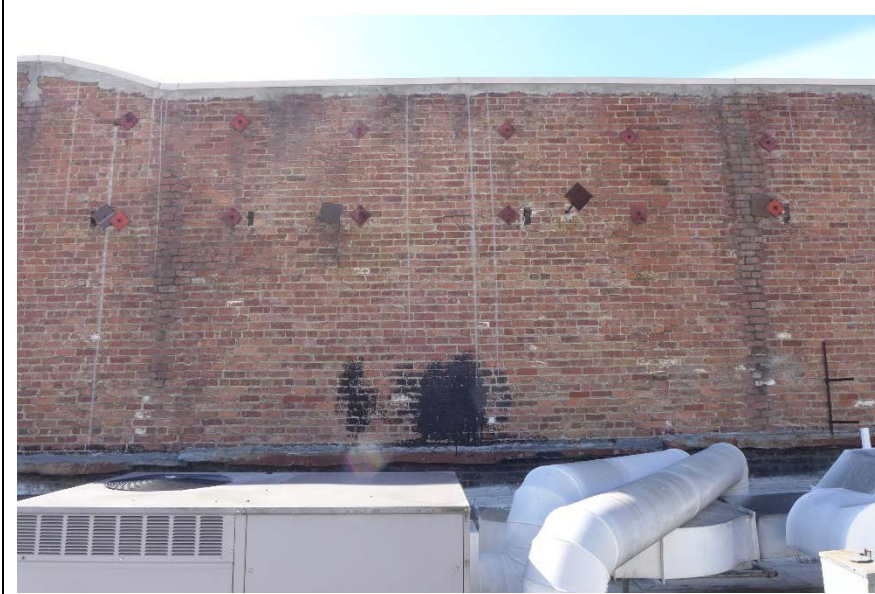
32. Reference photograph. The middle section of the west wall. No major cracks were visible. There were various eras of mortar repairs, but all joints appeared to be sound.

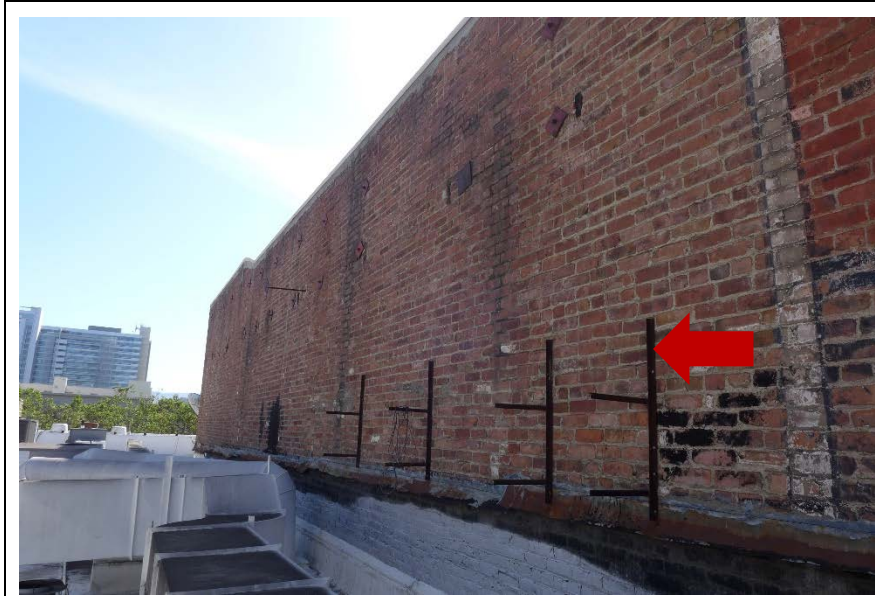
34. Reference photograph. West wall, looking north.

The metal brackets and attachments protruding from the wall will be removed. If damage to bricks occurs during their removal, the bricks should be replaced or patched. Any replacement bricks or patching should match the adjacent bricks.

Refer to N.P.S. *Technical Preservation Services, Brief 2, "Repointing Mortar Joints in Historic Masonry Buildings"* for guidance on repointing.

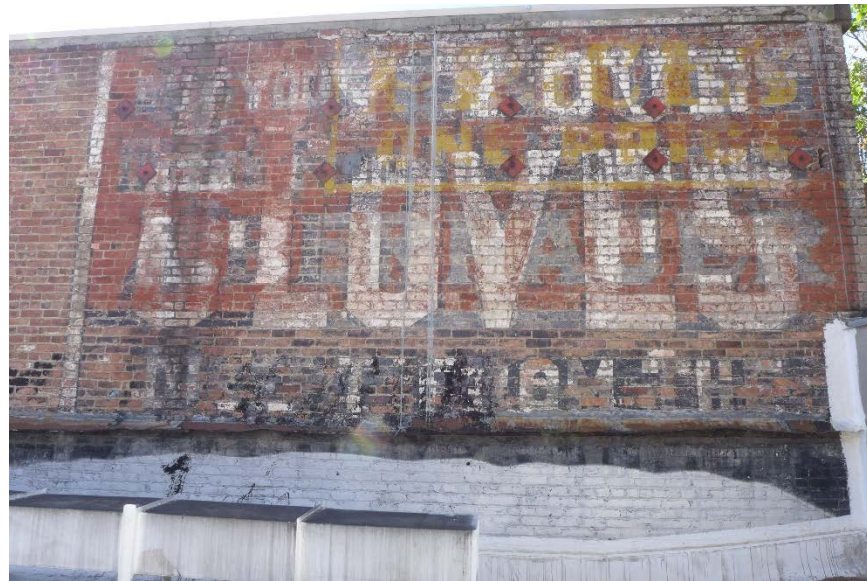
37. It appears that the sign is currently partially covered by roofing and flashing. It is unknown how long it has been that way.

The sign should be photographed with digital photos prior to any demolition work. The construction of the adjacent building and required seismic joint will have a limited impact on the ghost sign. While the ghost sign will be enclosed in the seismic gap between the two buildings, it will remain mostly untouched because of the gap. There will be anchors at select intervals installed at one location as well as sealant. The proposed work is all reversible with minimal damage to the sign.
