Appendix E3  
**Historic Resources Relocation  
Studies**

**Project:** San Jose, CA  
Site Selection Criteria for Relocation of Identified Historic Resources

RE: Downtown West Mixed Use Plan - 40 South Montgomery - Kearny  
Pattern Works Move Feasibility

RE: Downtown West Mixed Use Plan - Historic Resource Move  
Feasibility

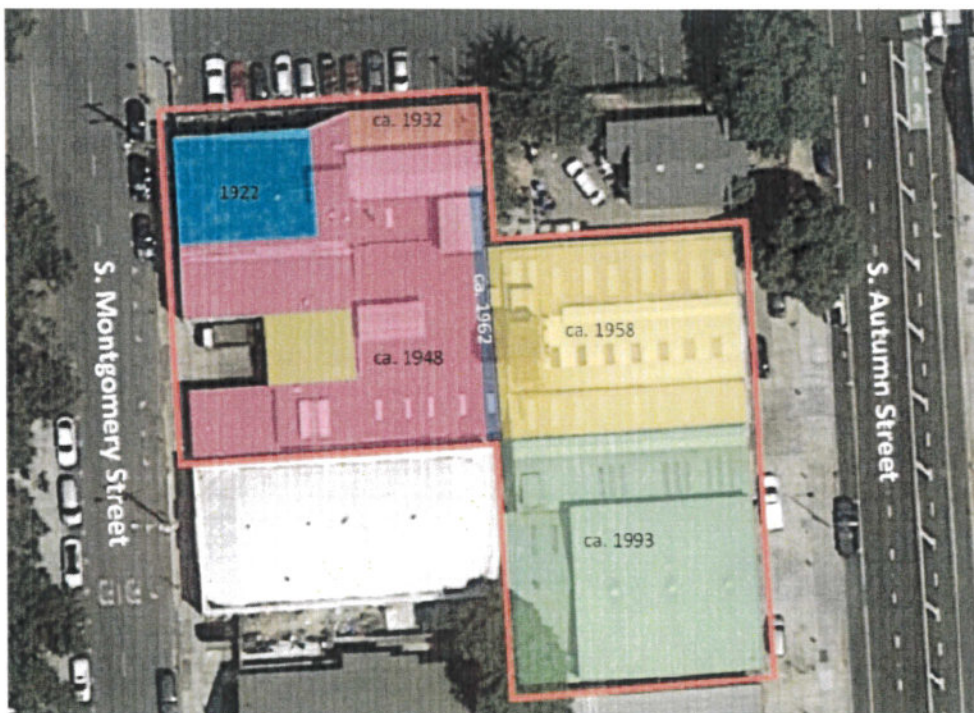
We have been asked to provide an opinion if the historic resource in the period of significance (1922,1932,1948) shown below at 40 South Montgomery and as identified by Architectural Resources Group can be relocated thirty feet directly south.

We had visited the site twice on the first week of July once looking at the exterior and once at the interior. The building has been modified over time and we noticed several failing trusses that have been shored, likely lead paint is present, typical dryrot, and so forth exists. We also noticed a brick wall south of the northeast corner in an L-shape that totals approximately thirty feet.

Other than the brick wall, the building is lightweight and although it is a hodge-podge of construction types, there is no doubt that that it can be moved at least thirty feet in not more than three sections and possibly in its entirety which will be determined upon a full investigation. Prior to the move lead paint would require abatement, the surrounding buildings carefully disconnected and demolished to their slabs, any structural deficiencies corrected, and the building stabilized for the move.

It has not been decided if existing slabs would be utilized to set the building on but that is not likely. It may be that we crib the structure in the air enabling the foundation to be constructed underneath it then subsequently lower it into place.

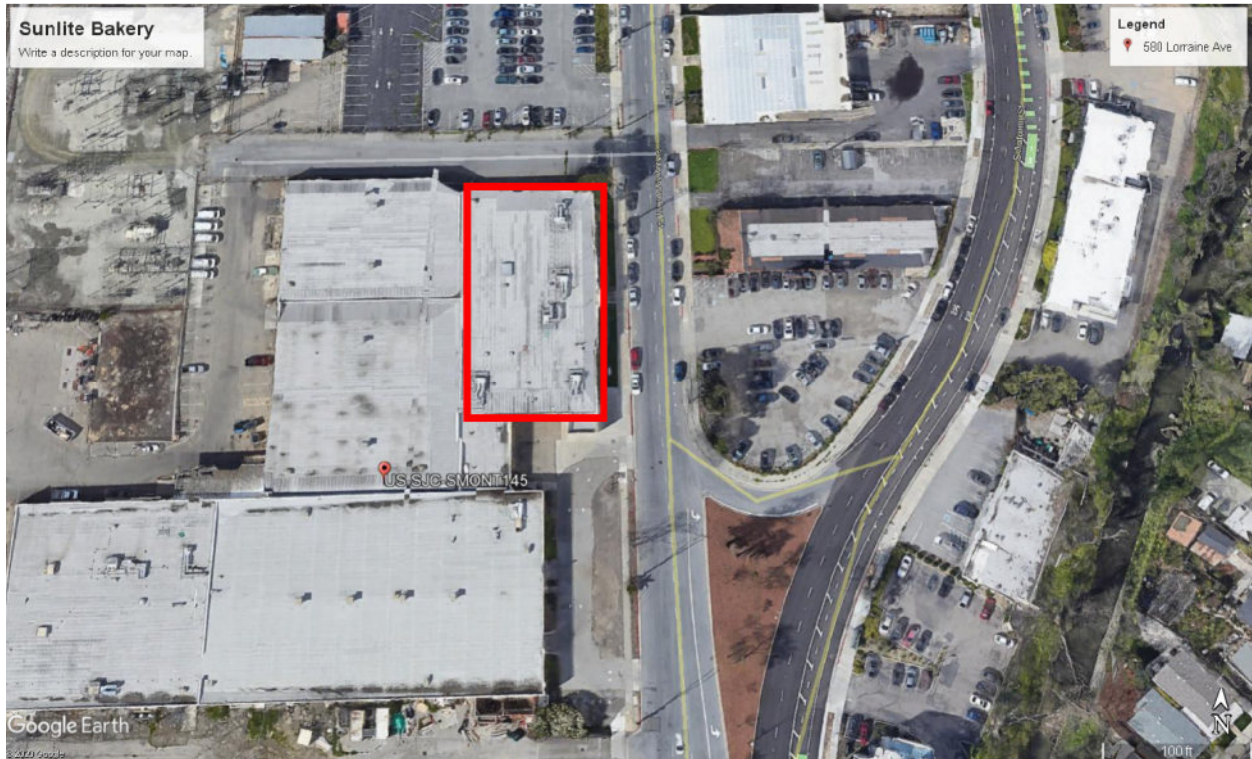
## 145 South Montgomery Figure 1

For this exercise we are assuming the portion of the historic resource of 145 South Montgomery to be relocated is the original building constructed in 1936. It is an 18,000 s.f. board-formed concrete structure with a truss roof. The building is in good condition. The concrete walls show signs of aging on the exterior with notable cracks. On April 15th had the opportunity to climb above the office area and observed that a seismic retrofit was performed fairly recently. Asbestos containing materials were noticed on duct wrap and floor tile.

The building is too large to move offsite in one piece, therefore if it were to be moved in its entirety it would require deconstruction of the roof structure and vertical cuts dicing walls into manageable sections. The dimensions of the building are 100' deep and 180' of frontage. At the southern end there is a small addition which should be removed as it is not identified as part of the resource. For the purposes of this exercise let's assume that we would take the entire structure offsite in sections. It would be prudent; wherever possible, to develop cut lines that limit disturbance of historic fabric.

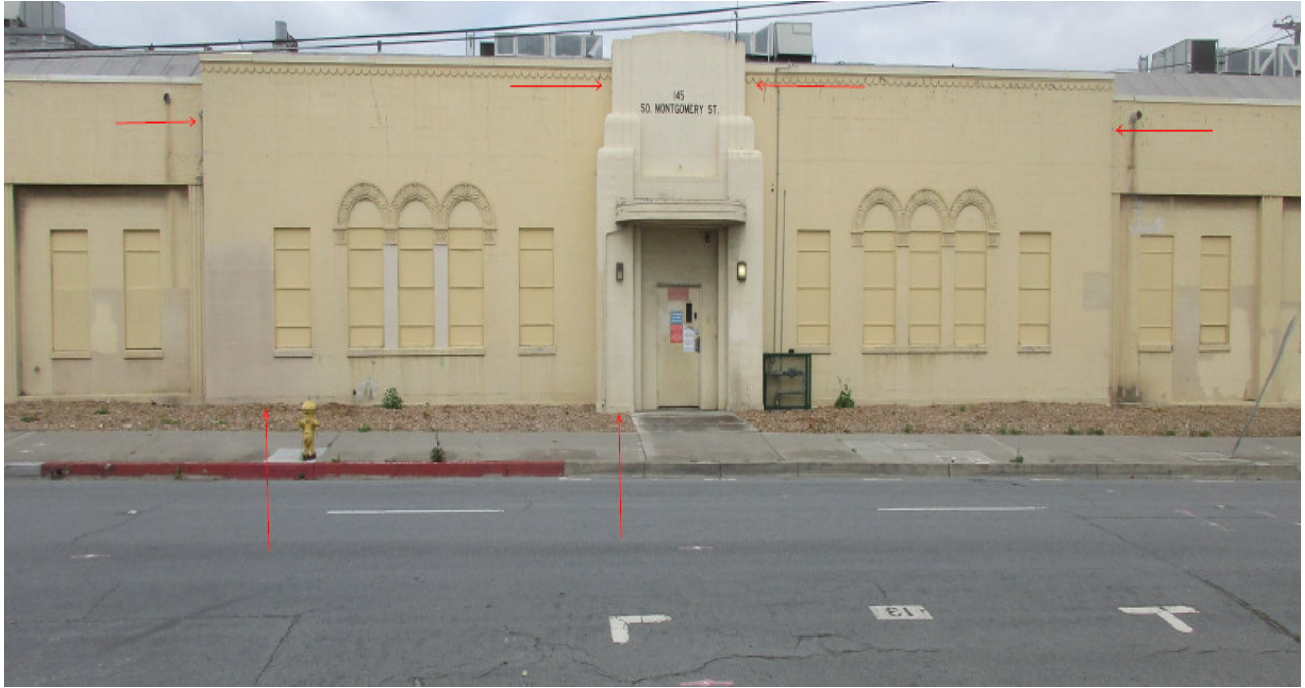
145 S. Montgomery East Façade Figure 2

The construction of the building presets several logical cut lines particularly at the façade. However the sections on either side of the entry are 33' long and the end panels 50' long making transport difficult. The arrows below denote probable cut lines.

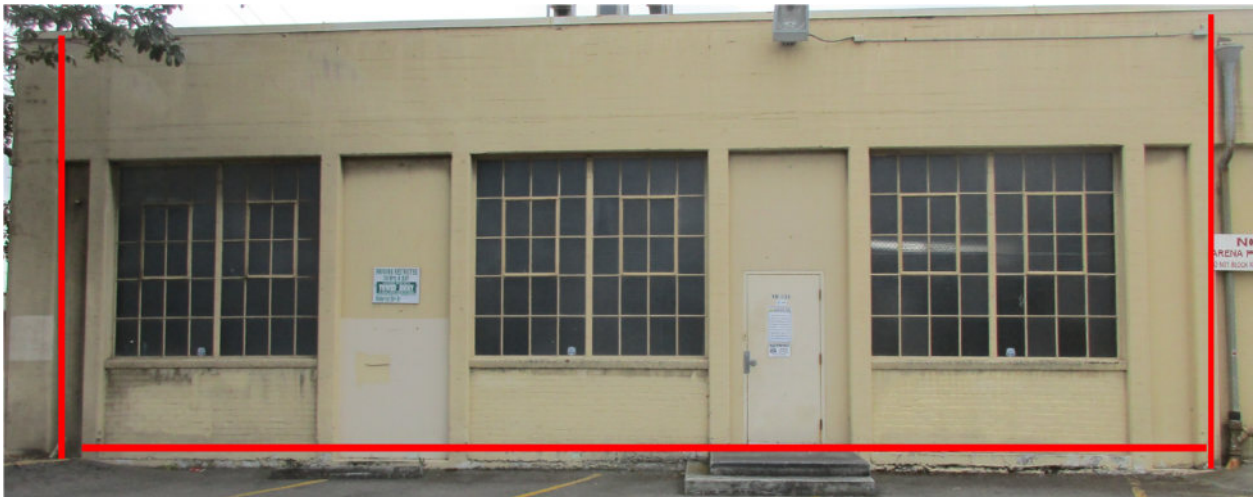
145 South Montgomery Figure 3

North Wall 50' Section Cut Lines Vertical & Horizontal

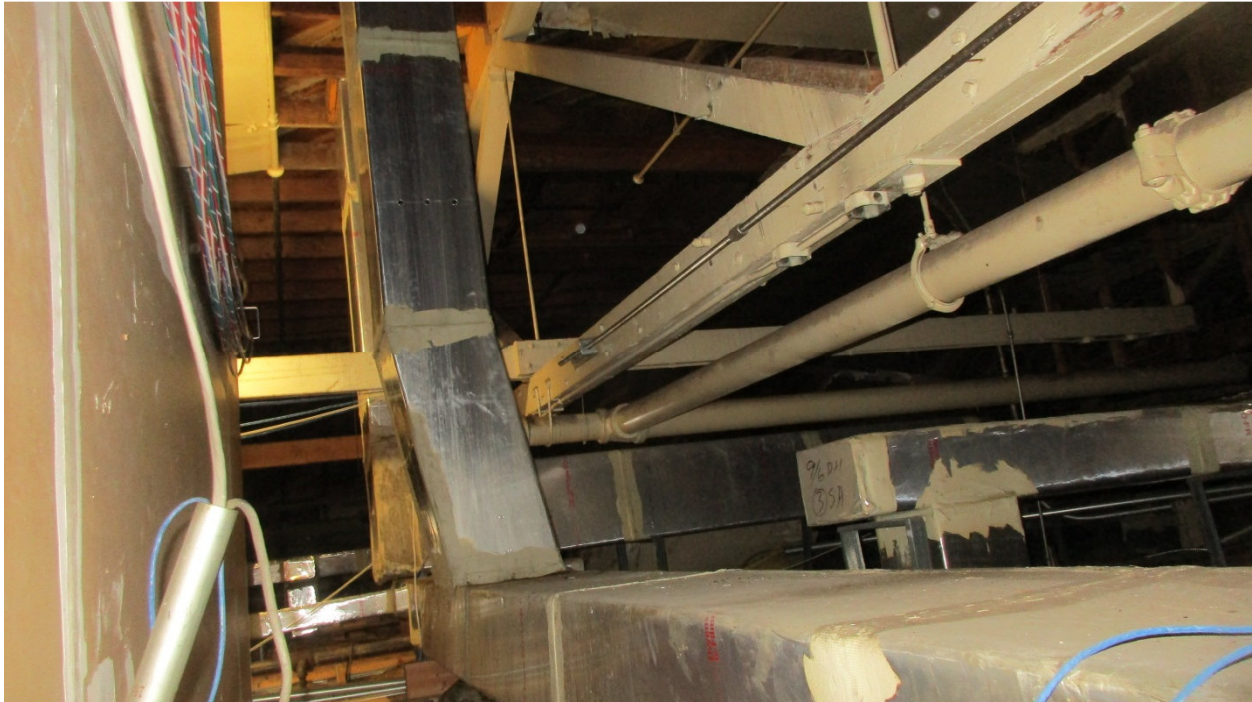
## 145 South Montgomery Figure 4 Roof Trusses

In the course of deconstruction it is inevitable that there will be damage of sheathing, trusses, and other members that are nailed together i.e. splitting and splintering.

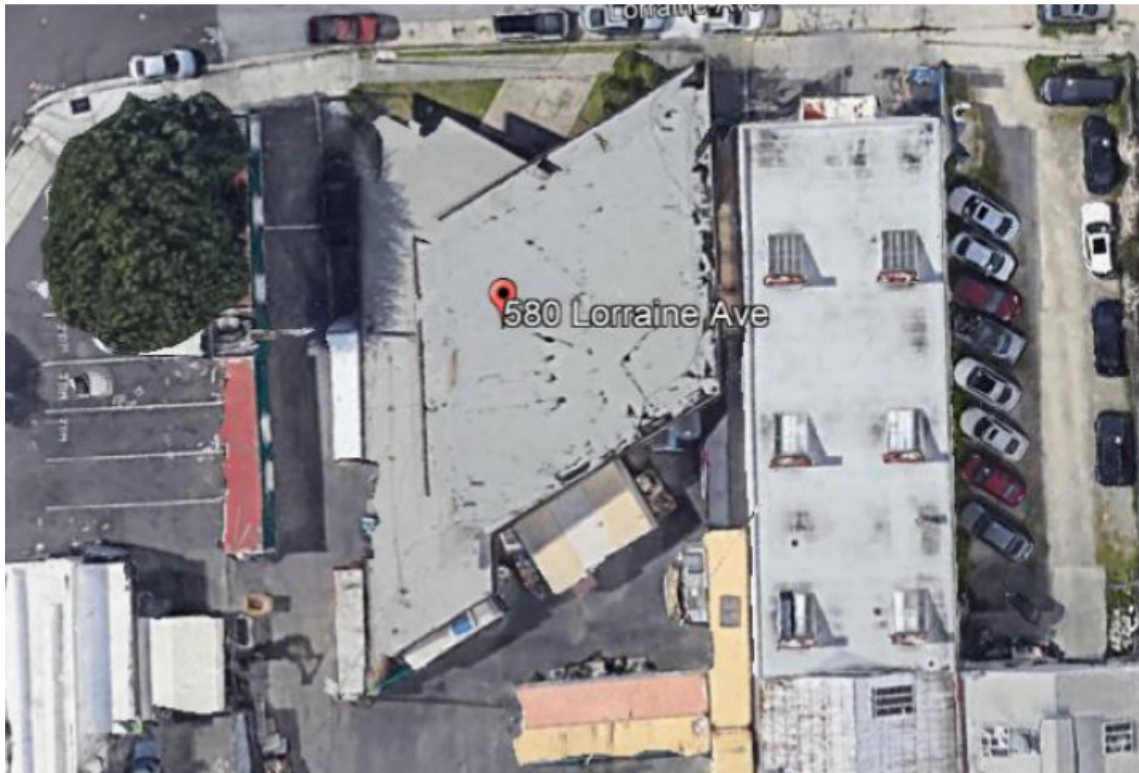
**580 Lorraine Figure 1**

The 580 Lorraine Avenue structure was built in two sections at different heights. The Hall portion of the building peaks at 24' and the Office portion 13'6". The walls are constructed of three types of masonry block in a stacked bond. The building is in good condition and looks nearly untouched since it was built with the exception of the storefront and the addition of a mezzanine. The high portion of the building is constructed with 8"x12"x16" split face block. There are concrete pilasters at

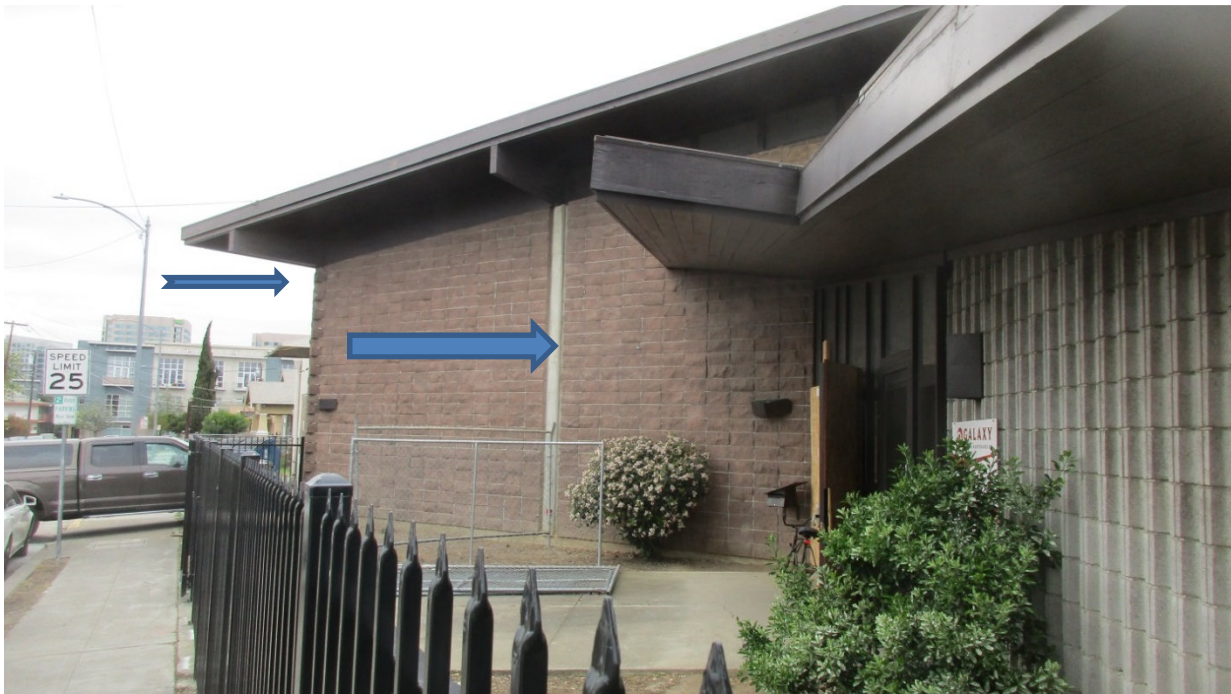
**580 Lorraine Figure 2**

intervals that support the roof beams. (See Figure 2) The main building is in the shape of a parallelogram as is the roof which slopes in a plane to the east the peak being at approximately 24'. A wood framed mezzanine level was installed at an unknown period but has not affected the integrity of the resource and can be removed. The end walls of the lower portion of the building are constructed of 8"x8"x12" grey block with the face turned opposite of the way it normally would be laid. (See Figure 3) This leads us to suspect that reinforcing is scant and the walls not stable which would be determined by testing. Testing would include rebar scans, and core tests to determine if cells are filled. The office portion has a shed roof which is irregular in shape, is 13'6" at its highest point and 8'6" at the lowest. The Office portion of the building utilizes the high portions west wall as its rear wall. In other words it is planted against the high portion. In other words the Office portion of the building does not have a separate rear wall.

The Hall portion of the structure is even more problematic. Because of the height of the structure not only would you have to cut the building vertically, (See Large Arrow Figure 2) but also horizontally (See Small Arrow Figure 2) to shorten the height of the walls for transport to reduce the amount of utility and other relocations. The likely cut point is at the ends of the walls and at the concrete pilasters. The block at the ends of the walls that is laced will likely be compromised and already show damage. If possible the cuts should be made in existing mortar joints to limit damage to historic fabric.

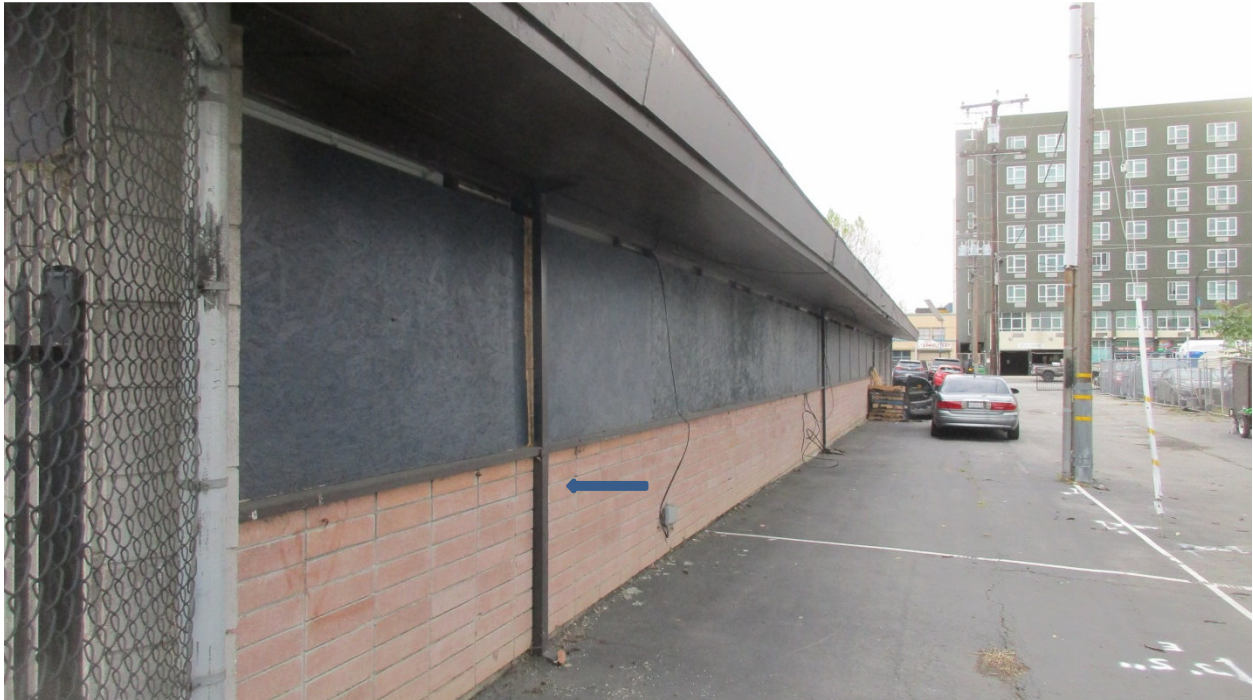
580 Lorraine Figure 4

The window wall on the west side of the building is clad with reddish Monarch sized brick below the windows in the stacked bond pattern double wide which suggests a cavity wall. We

noticed rot in certain portions of the eaves. The windows are wooden.

Moving the structure will be difficult because of its irregularities and construction make up. The block is likely unstable out of plane and if so will require significant bracing. The Office portion of the building has no rear wall, therefore if you were to move it in sections you would have to build a wall to brace it in the shape of a rectangle. Or, you could take the end walls as units and dice the window wall into sections. (See arrow Figure 4)

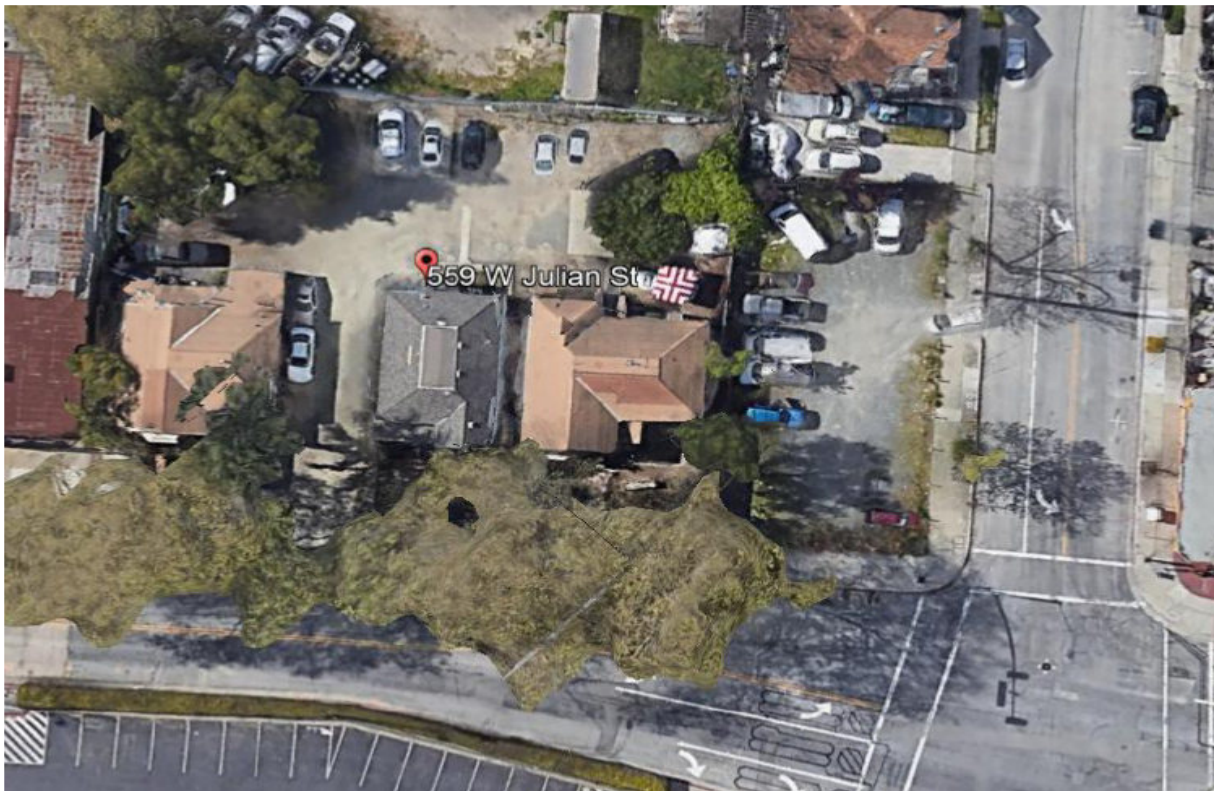
**559, 563, & 567 West Julian Street Figure 1**

The Historic Resources at West Julian Street are all wood framed structures with crawl spaces under them and are in varying degrees of poor condition. The interiors have been modernized in a cheap fashion into multiple units and will require complete gutting. The majority of interior historic fabric is missing. Two of the houses have non-historic appendages which should be removed. Certainly Lead paint and likely asbestos are present. These houses can be moved by a traditional house mover on standard equipment. The widest house is at 559 W. Julian Street (See Figure 4) at 45'. Depending on the receiver site location, it is possible that the roof structures may need to be removed to reduce the cost of moving utility lines or to make it under

In Conclusion: Although these houses are in poor condition and missing historic elements, they can be reasonably transported to a new site depending on the location.

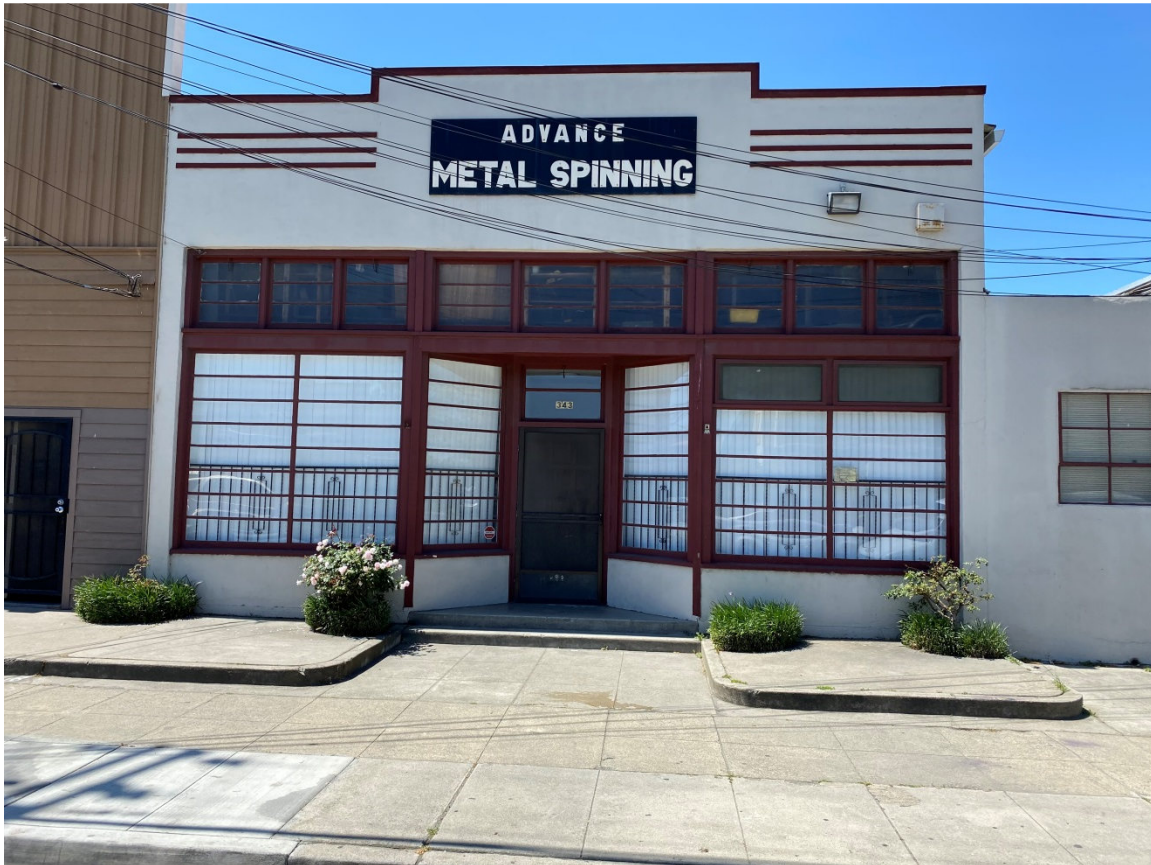
### 343 North Montgomery Figure 1

The 343 North Montgomery Street building is 31' Wide, 20'6" Tall and 206' in length. The structure is clad with tin siding and tin roofing. The façade is plaster as shown above. There is an interior office with a storage mezzanine on top of it. (See Figure 3) The building's Warehouse portion of the structure is constructed of wood posts and trusses on the eastern side then the framing switches to steel trusses with overhead crane rails attached on each end running the length of the building. (See Figures 3,4,6) There is a circa 1949 non-historic addition planted on the north side of the structure which should be removed as it does not fit architecturally and will complicate a move. The building is in fair condition although the tin on the roof is rusted (See Figure 2) however the façade and offices are in good condition. If one were to contemplate moving the structure the likely scenario would be to disconnect the office mezzanine area to the nearest truss and move that portion as a separate section and then brace all posts down to the concrete

**In Conclusion:** The front office portion of 343 North Montgomery could be disconnected from the Warehouse section and moved rather easily in one piece depending on the receiver site. The warehouse portion of the building could be moved by completely dismantling it and reconstructing it elsewhere. There will be a tremendous amount of labor for this endeavor given the myriad of pieces of tin siding, roofing, trusses, wall framing and so forth which will certainly result in damage as noted above. The tin is not practical for reuse as it will be full of holes and as noted is rusted. Please note in figure six that the window glass appears to have been replaced with green fiberglass panels and will be an expensive proposition to replace. The condition of the sash is unknown. The move of the warehouse portion of the building is potentially feasible but practically does not make sense particularly because the historic portion of the building appears to be the Streamlined façade attached to the office. The reconstruction is complicated by the factors noted in the paragraph above. Although the Office portion of the building could be a good candidate for a move depending on the receiver site, the Warehouse portion is not.

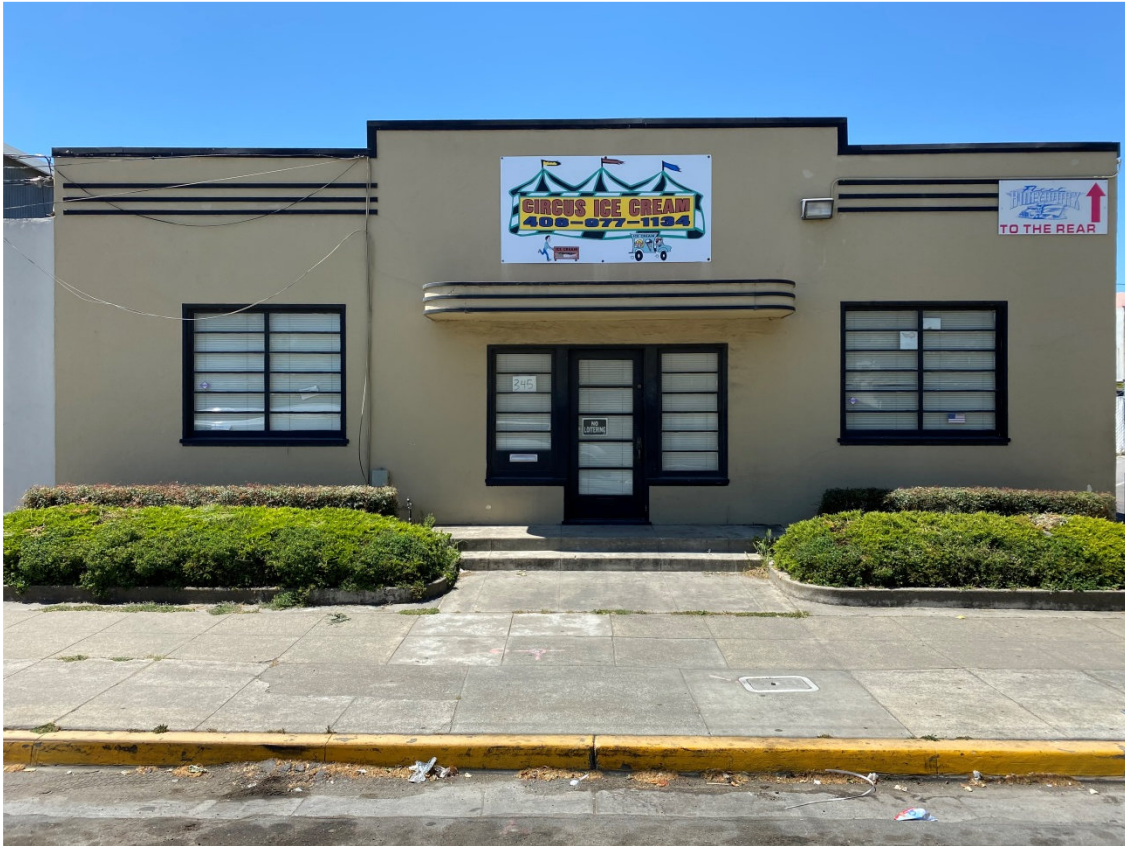
345 North Montgomery Figure 1

345 North Montgomery is a wood framed building with a flat roof which is 40' wide, 80' long, and 17' high. The majority of the building's interior is clad with lap siding. The façade is clad with plaster in good condition as are the windows shown above. The north, west, and partially on the south side of the building are clad with T-1-11 siding which is NOT original. The exterior of the building was originally clad with lap siding as you can see in Figure 3. In order to move the structure it is likely that it would be cut into two- 20'x40' pieces and moved with traditional moving equipment.

In Conclusion: 345 North Montgomery is only 17' tall and can be cut into manageable sections making a move feasible depending on the receiver site.
