Re: Arborist Report for 3315 Almaden Expressway, San Jose

This arborist report addresses the proposed project at 3315 Almaden Expressway. Per the City of San Jose's Tree Removal Ordinance Chapter 13.32, the scope of work includes:

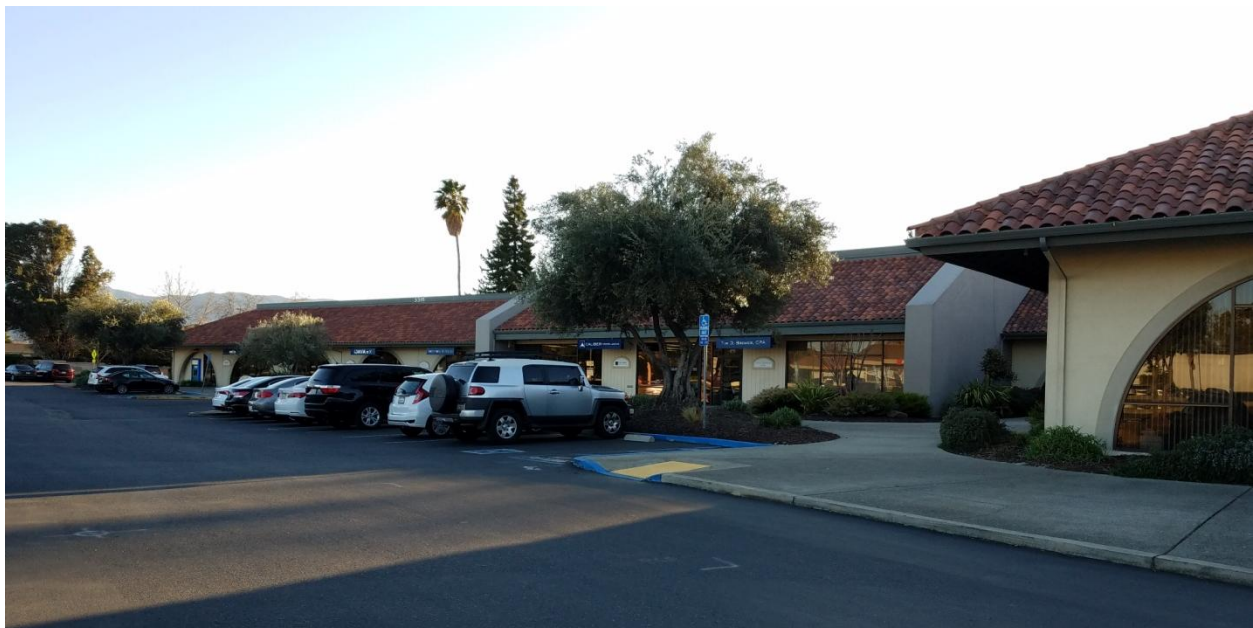
Figure 1. The property is developed with a commercial complex. Nearly all existing structures, landscaping, and hardscape will be demolished to construct a new assisted living facility.

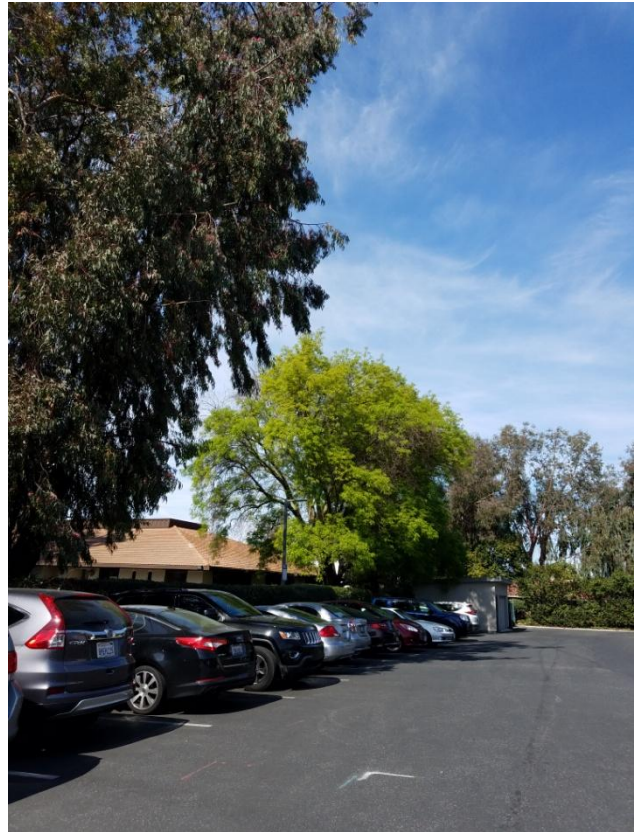
Figure 2. The new driveway will likely result in significant root loss for the eucalyptuses (#70 & 71, left) and the ash (#69, center). I recommend exploratory trenching by the ash to assess root encroachment & to inform design.

The off-site ash (#69, Figure 2) at the northwest corner of the property is worthy of preservation efforts. I recommend digging an exploratory trench to assess the potential root loss from the proposed driveway. It

is likely to be high, based on visible asphalt damage, and design changes will likely be required to reduce encroachment on the tree. The trenching will also determine the depth of the roots causing damage – if they are sufficiently deep, I would recommend reusing as much of the existing subgrade and subbase as possible to reduce root loss. Likewise, design adjustments will be necessary if other off-site trees must be saved (i.e. pending city or owner approval).

- Dig an exploratory trench along the property line by tree #69 to review root encroachment from the proposed driveway. Trenching may be completed with an arborist air spade or with hand tools down to the anticipated depth of excavation. If root loss will be excessive, the proposed driveway will need to be adjusted to preserve the tree. Tree protection recommendations will need to be updated if the tree is retained.
 - Alternatively, the tree may be removed if the owner approves of its removal.
- In general, to save off-site trees (e.g. 70 & 71) along the north and west property lines, maintain the same footprint for the proposed driveway and curb as the existing driveway and curb. The updated plans will need to be reviewed to update the recommended tree protection
- New irrigation lines shall be located as far from trees #65-67 as possible to reduce root disturbance.

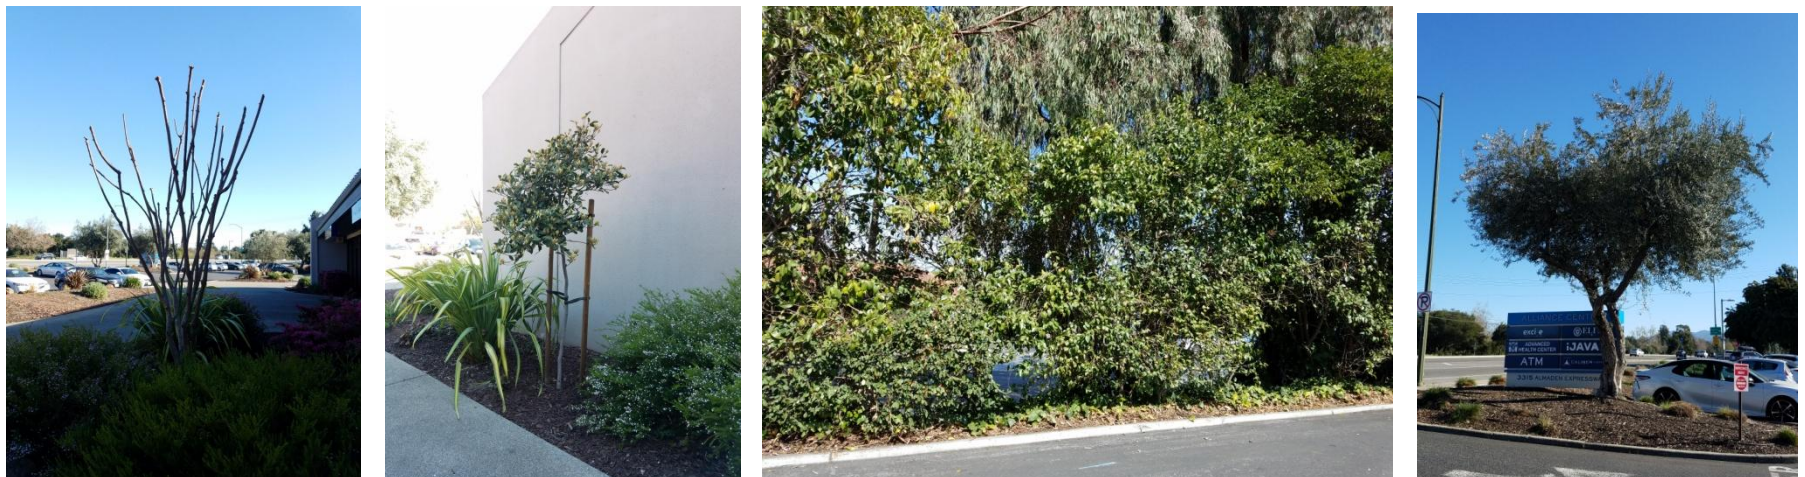
Figure 3. (L-R) The crape myrtles, Indian hawthorn, privets, and olives (except 2) will all need to be removed.

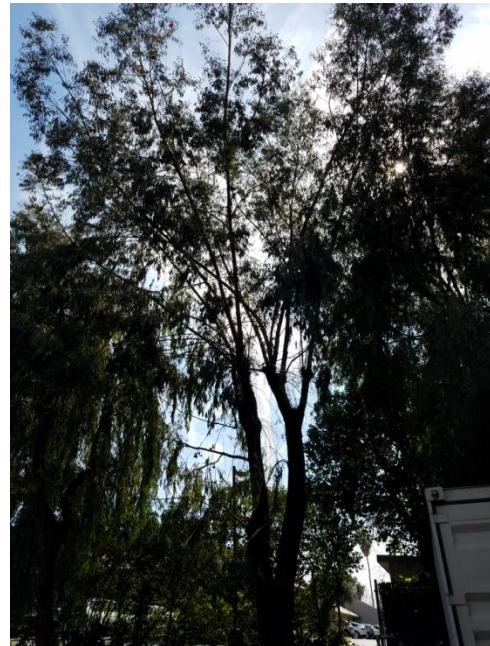
#	Species	DBH	Health	Structure	Dripline				Age	DE	Ci	OS	Comments	Action
					N	E	S	W						
64	Ironbark eucalyptus	27.5	F-P	VP	20	20	10	10	M	X	H	X	Off-site. Topped at 20' with very elongated shoots and obvious failures; canopy sparse. Co-dominant stems at 6' above grade. Obvious root shaped asphalt damage. 5' from proposed parking.	Remove. Owner approval required.
65	Ironbark eucalyptus	28	F	P	18	15	18	18	M		L	X	Off-site. Topped at 20'. ~23' from proposed parking.	Install temporary protection fencing. Keep proposed irrigation as far as possible to reduce root disturbance.
66	Oleander (<i>Nerium oleander</i>)	4, 2, 2.5, 2, 2, 1	F	F	3	3	8	8	M		L	X	Essentially a shrub. Clear of construction, in proposed landscape area. Not great specimen for preservation but may be retained for minor screening.	Install temporary protection fencing. Keep proposed irrigation as far as possible to reduce root disturbance.

Figure 4. The ironbark eucalyptuses (#64 above) were topped and have poor structure. I recommend their removal due to high root encroachment.
