Re: Revised Arborist Report for 3090 S. Bascom Ave., San Jose

Tree Assessment, 3090 S. Bascom Ave.

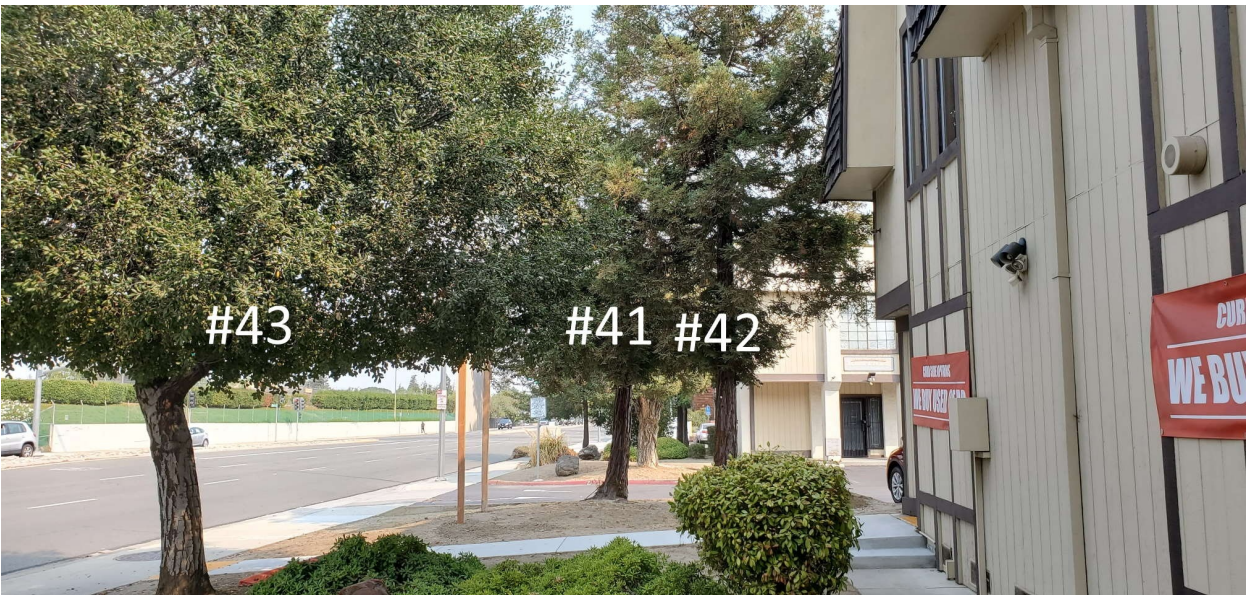
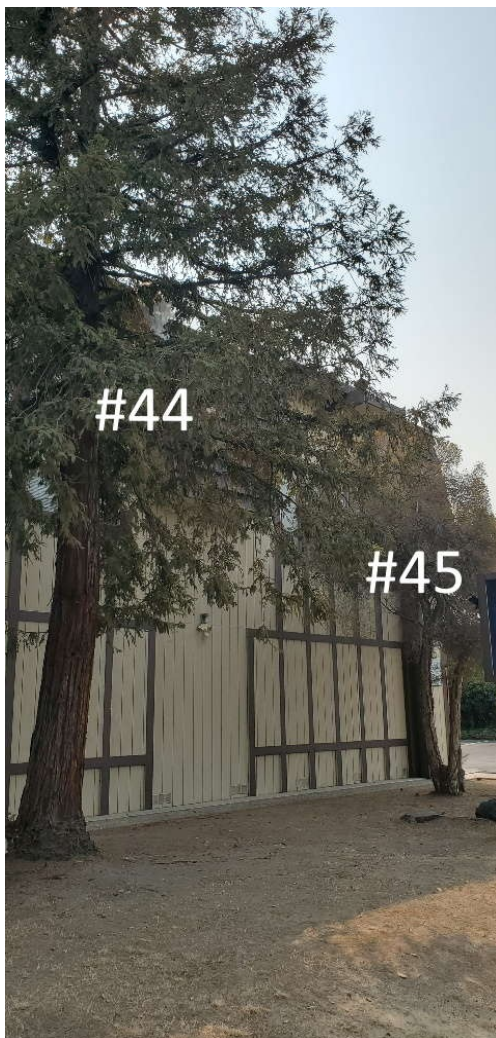
Tag #	Species	Trunk Circumference	Condition	Comments	Native	Mitigation Planting Required 15 gallon
41	<i>Sequoia sempervirens</i> "Coast Rwd"	40"	Fair	Drought stressed.	Yes	5
42	<i>Sequoia sempervirens</i> "Coast Rwd"	44"	Fair	Drought stressed.	Yes	5
43	<i>Quercus agrifolia</i> "Coast Live Oak"	39"	Fair-good	Co-dominant leaders that are included at the main crotch.	Yes	5
44	<i>Sequoia sempervirens</i> "Coast Rwd"	56"	Fair	Drought stressed.	Yes	5

Photos of on site trees Trees #41 & 42 (redwoods), & #43 coast live oak.

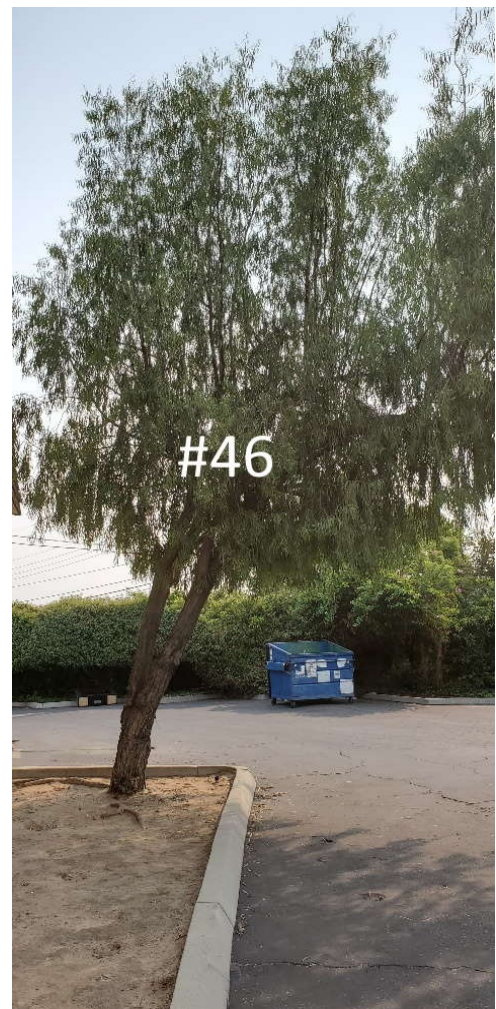
Tag #	Species	Trunk Circumference	Condition	Comments	Native	Mitigation Planting Required 15 gallon
45	<i>Malaleuca sp.</i> "Paper Bark Tree"	22" & 19" (41")	Poor	Drought stressed, declining canopy.	No	4
46	<i>Geijera parviflora</i> "Australian Willow"	28" & 25" (53")	Poor	Drought stressed, girdling root, included main crotch. One-sided canopy.	No	4
47	<i>Sequoia sempervirens</i> "Coast Rwd"	30"	Good	Proposed grading for understory garage within dripline.	Yes	3
48	<i>Pinus thunbergiana</i> "Japanese Black Pine"	47"	Fair	Stunted growth, compacted soil. Reconfigured hardscape will necessitate removal.	No	4
49	<i>Malaleuca sp.</i> "Paper Bark Tree"	25"	Fair-poor	Completely engulfed by ivy	No	2
50	<i>Photinia fraseri</i>	10, 10, 16, 6, & 4" (46")	Poor	Old, declining woody shrub.	No	4
51	<i>Quercus agrifolia</i> "Coast Live Oak"	16, 12.5, 9, & 6", (43.5")	Fair	Hedged into a tight ball.	Yes	5
52	<i>Prunus amygdalus</i> Almond	12, 12, 9, 6, & 5", (44")	Poor	Co-dominant poorly structured leaders, drought stressed.	No Orchard tree	3

Redwood and
paper bark tree
#44 & #45
