## Arborist Report

# Tree A of Initial Study Fig 15

Address: 484, 488 E Saint John Street and 93,95, 97 N. 11th Street  
San Jose, CA. 95112

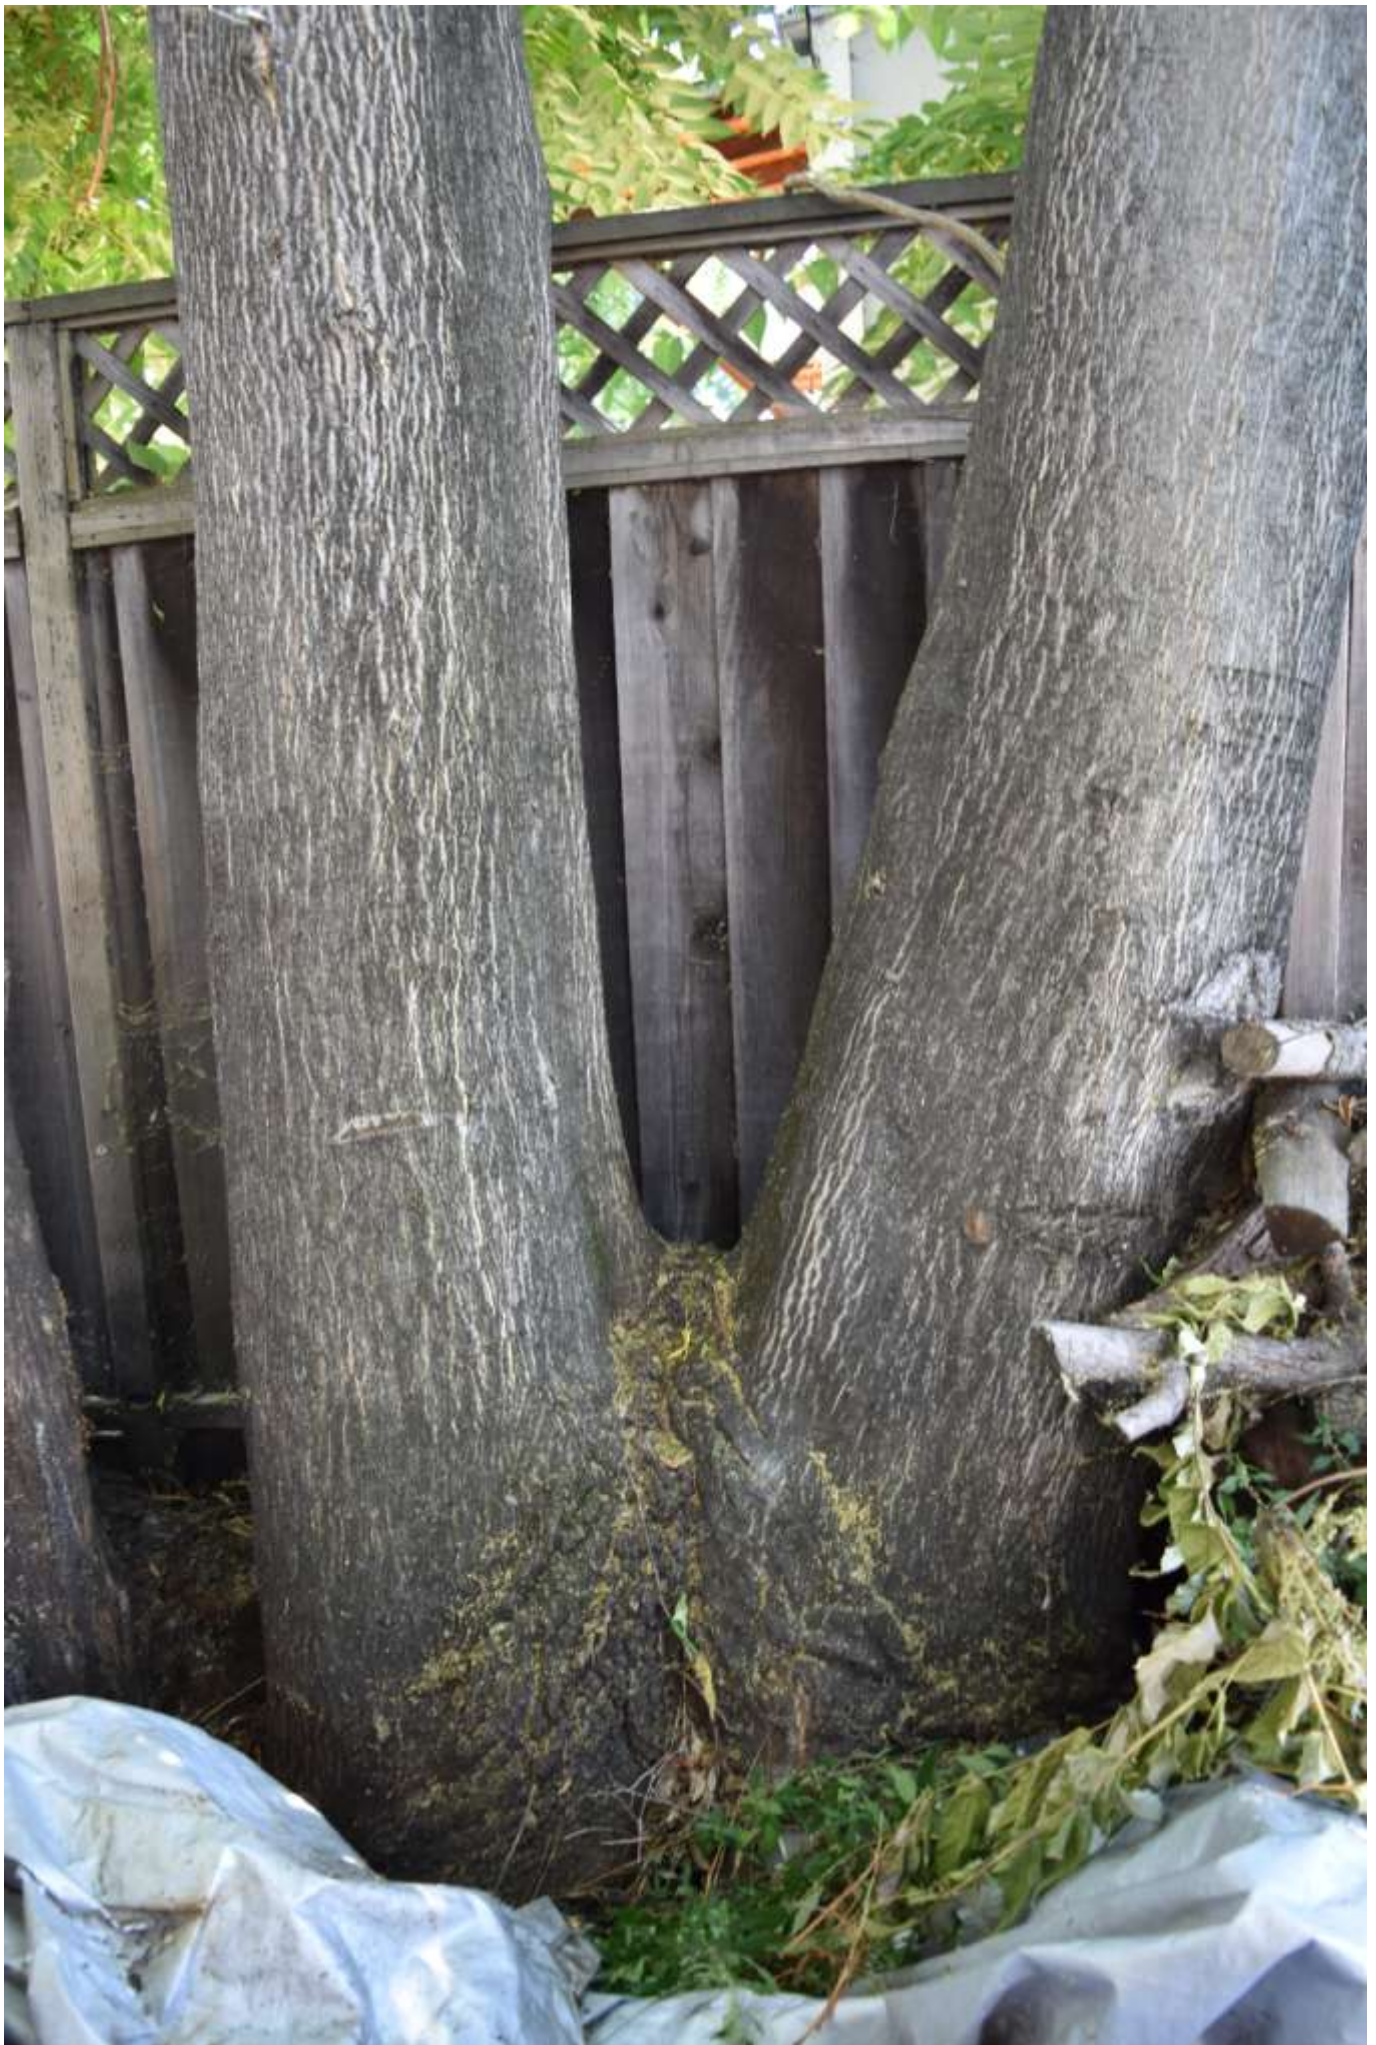
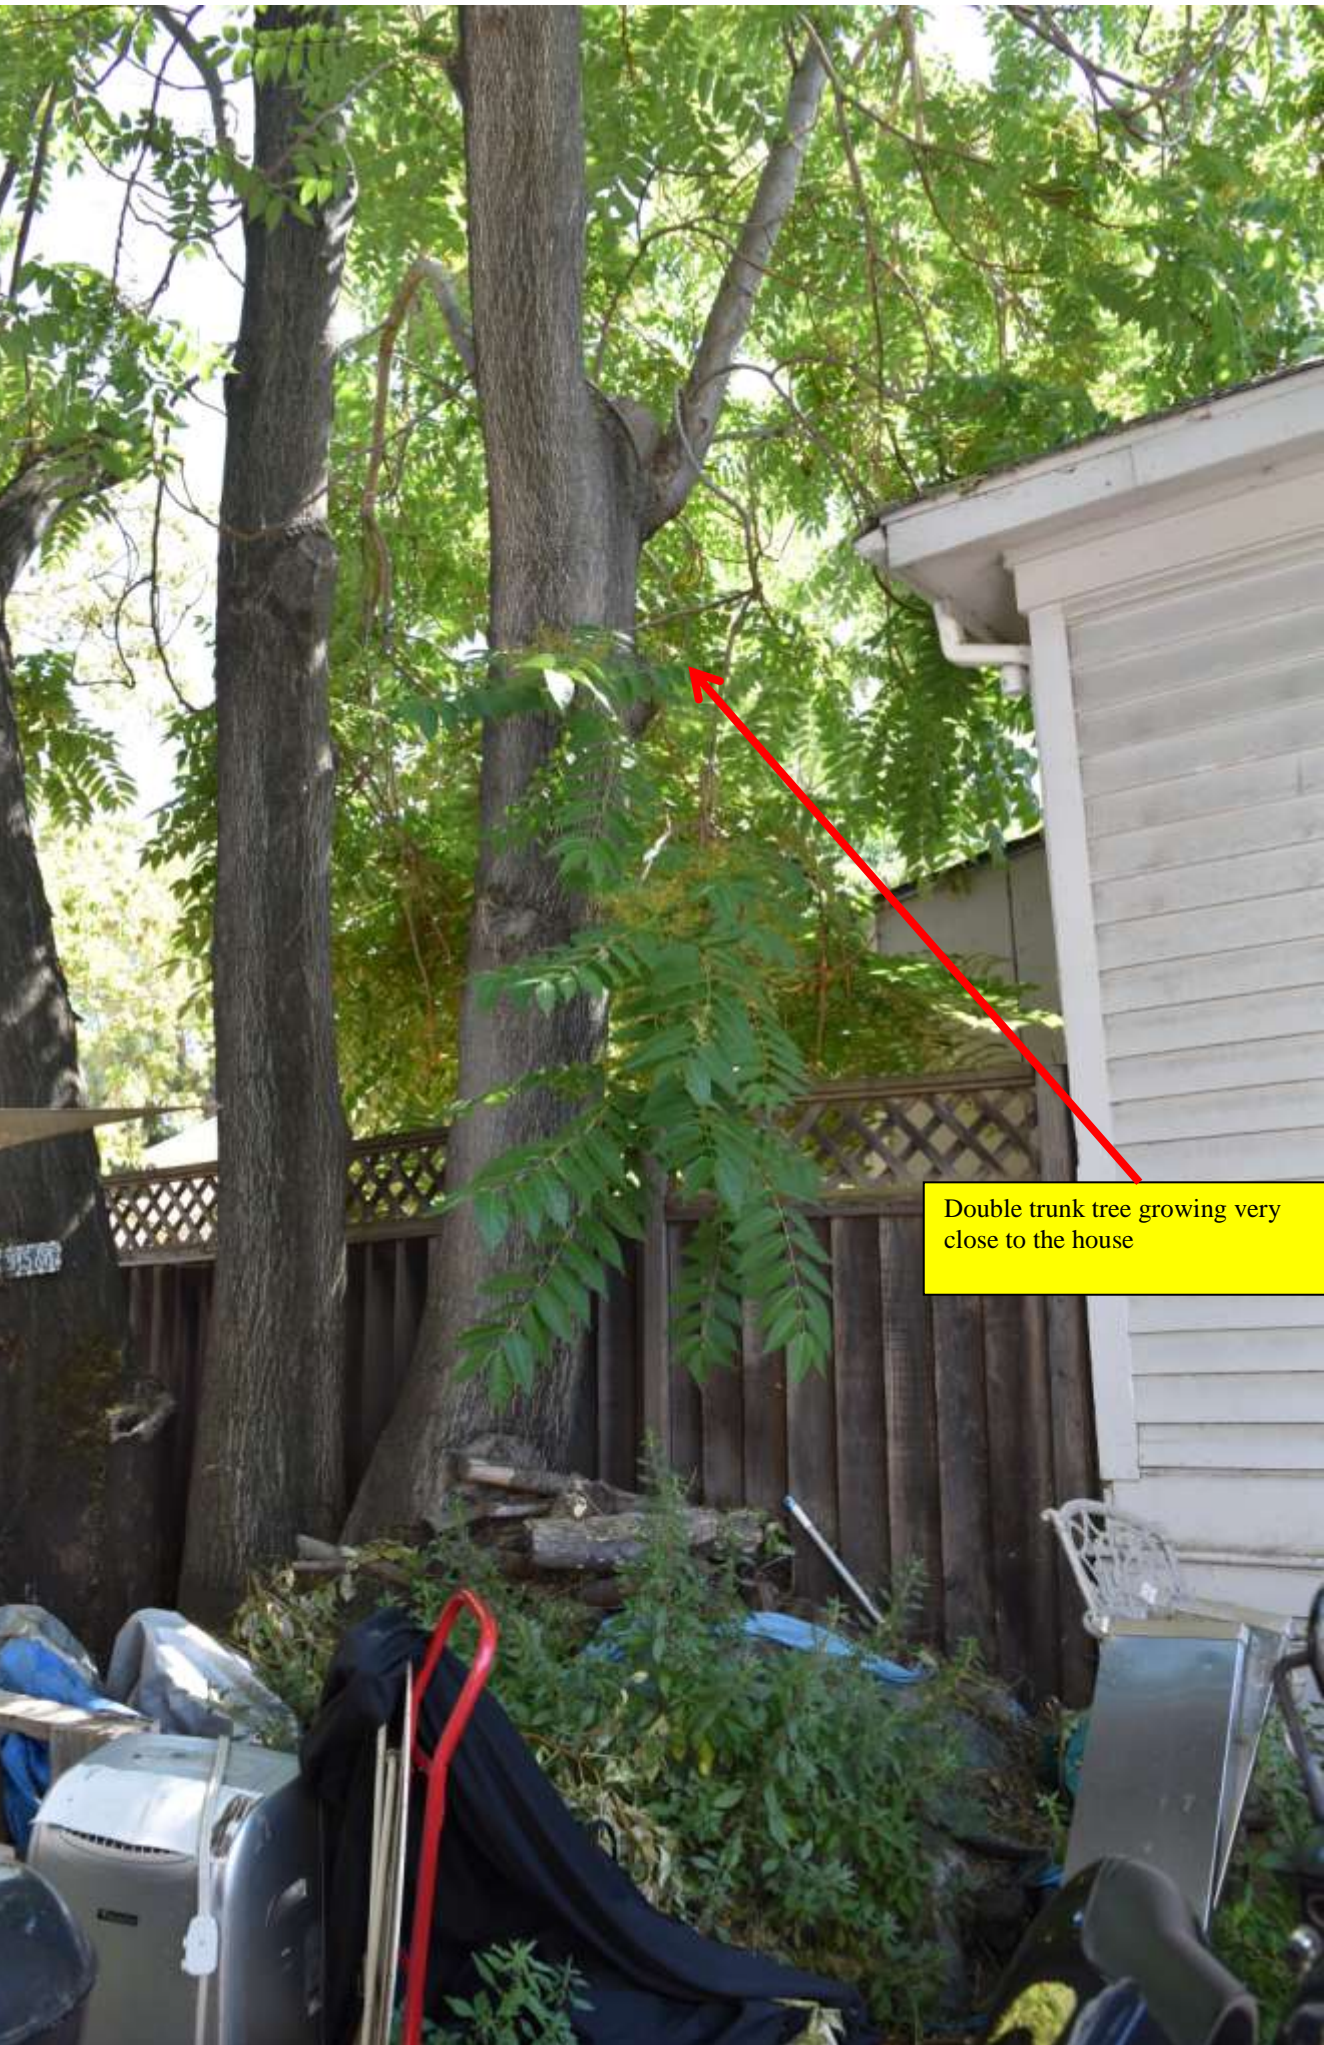
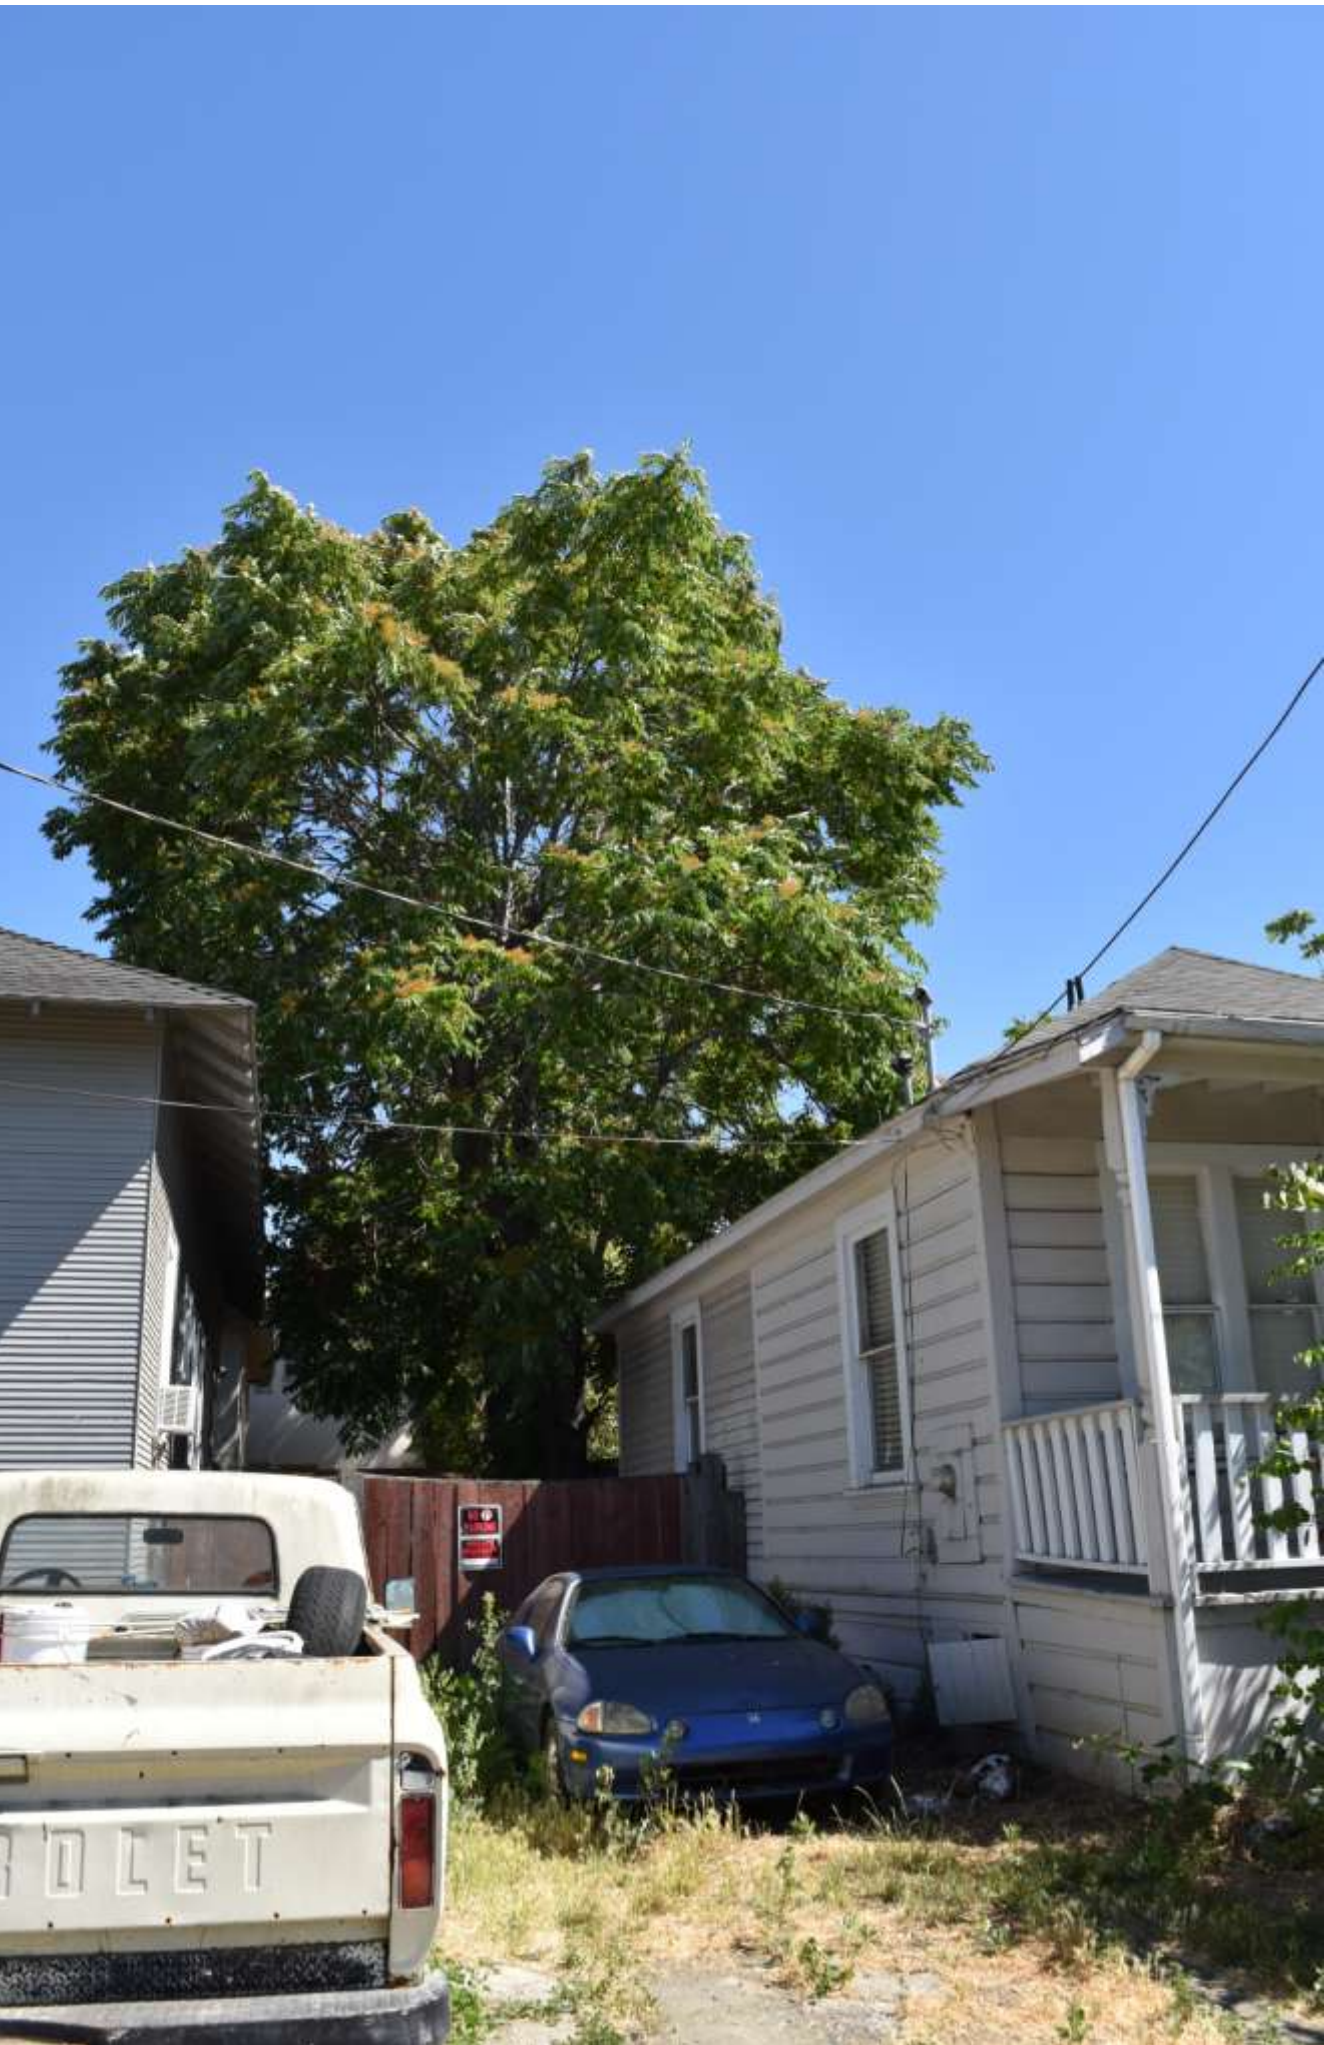
I found the tree with several natural defects and irreversible damage, severely topped, poor structure, unbalanced, poor branch taper and weak attachments. These conditions are less than ideal for a mature tree.

The current condition of the tree and the proximity from the tree to the house increases the risk for a potential failure, posing a very significant hazard to the existing structures and the public.

Double trunk tree growing very close to the house

Hazard abatement: remove tree, replace with one  
15 gallon European Hornbeam

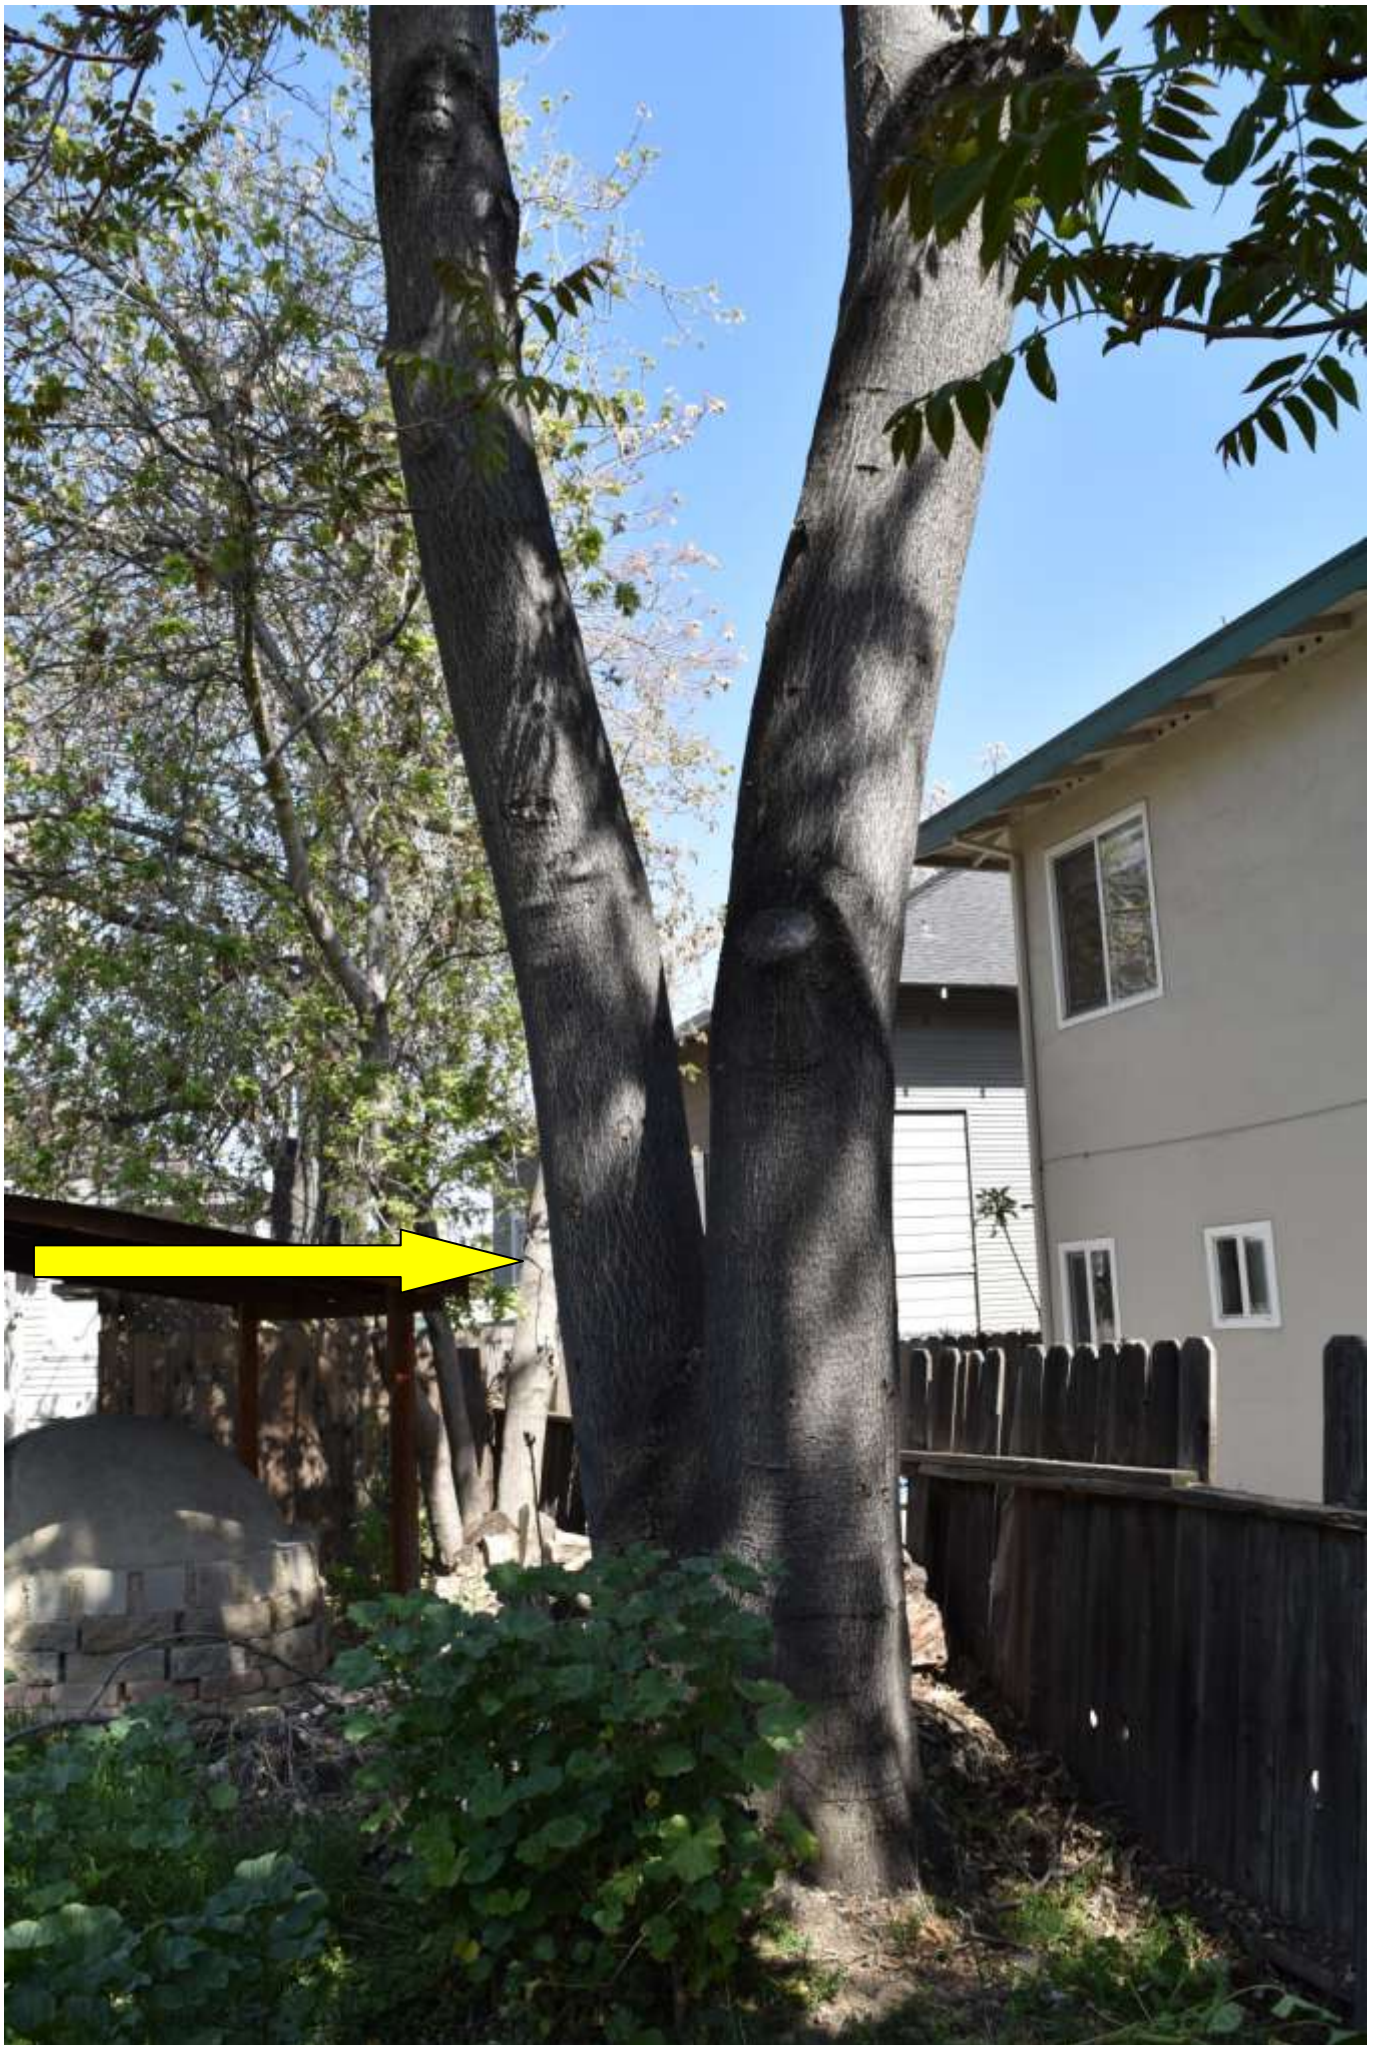
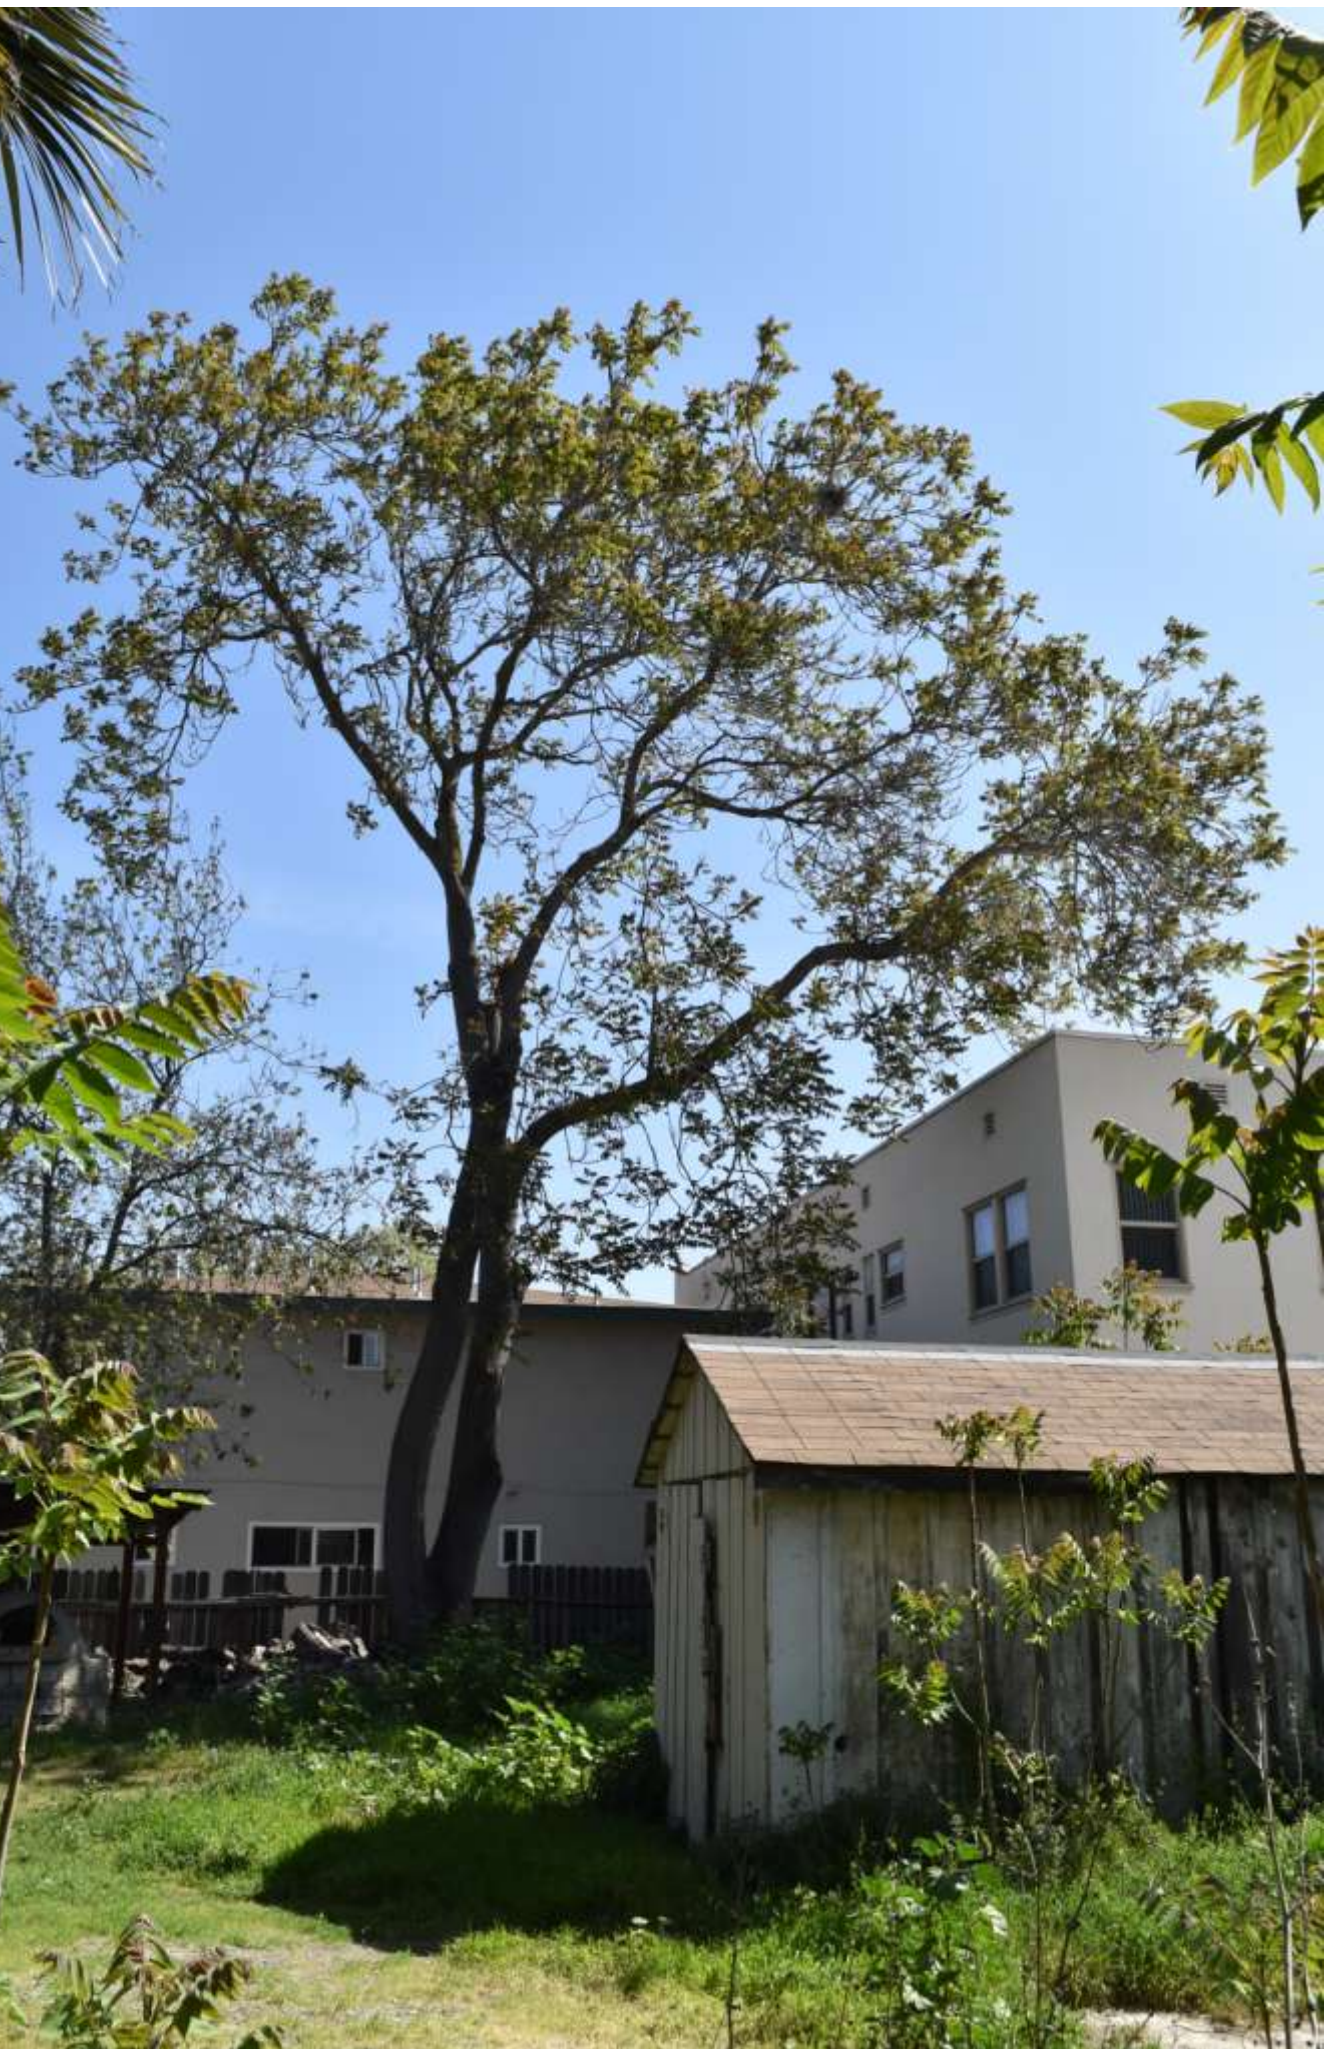
Non native tree, is very well known for spreading and becoming a common invasive plant in urban, agricultural and forested areas. This species is currently listed as an unsuitable tree by the city of San Jose.  
The location where the tree is growing strongly indicates that it was a seed carried by wild life or dispersed by the wind.  
I found the tree with several natural defects, poor structure, unbalanced, large branches over the roof areas, leaning towards the neighbors structures and weak attachments. These conditions are less than ideal for a mature tree.  
A better selection of new trees with an improved planting process will provide a better result in the future.  
The current condition of the tree and the proximity from the tree to the structures, increases the risk for a potential failure, posing a very significant hazard to the existing structures and the public.

Failure potential: low medium **high** severe  
Tree part most likely to fail: branches  
Hazard abatement: remove tree, replace with one 15 gallon Chitalpa tashkentensis
