## Arborist Report

# Tree A of Initial Study Fig 15

Address: 484, 488 E Saint John Street and 93,95, 97 N. 11th Street  
San Jose, CA. 95112

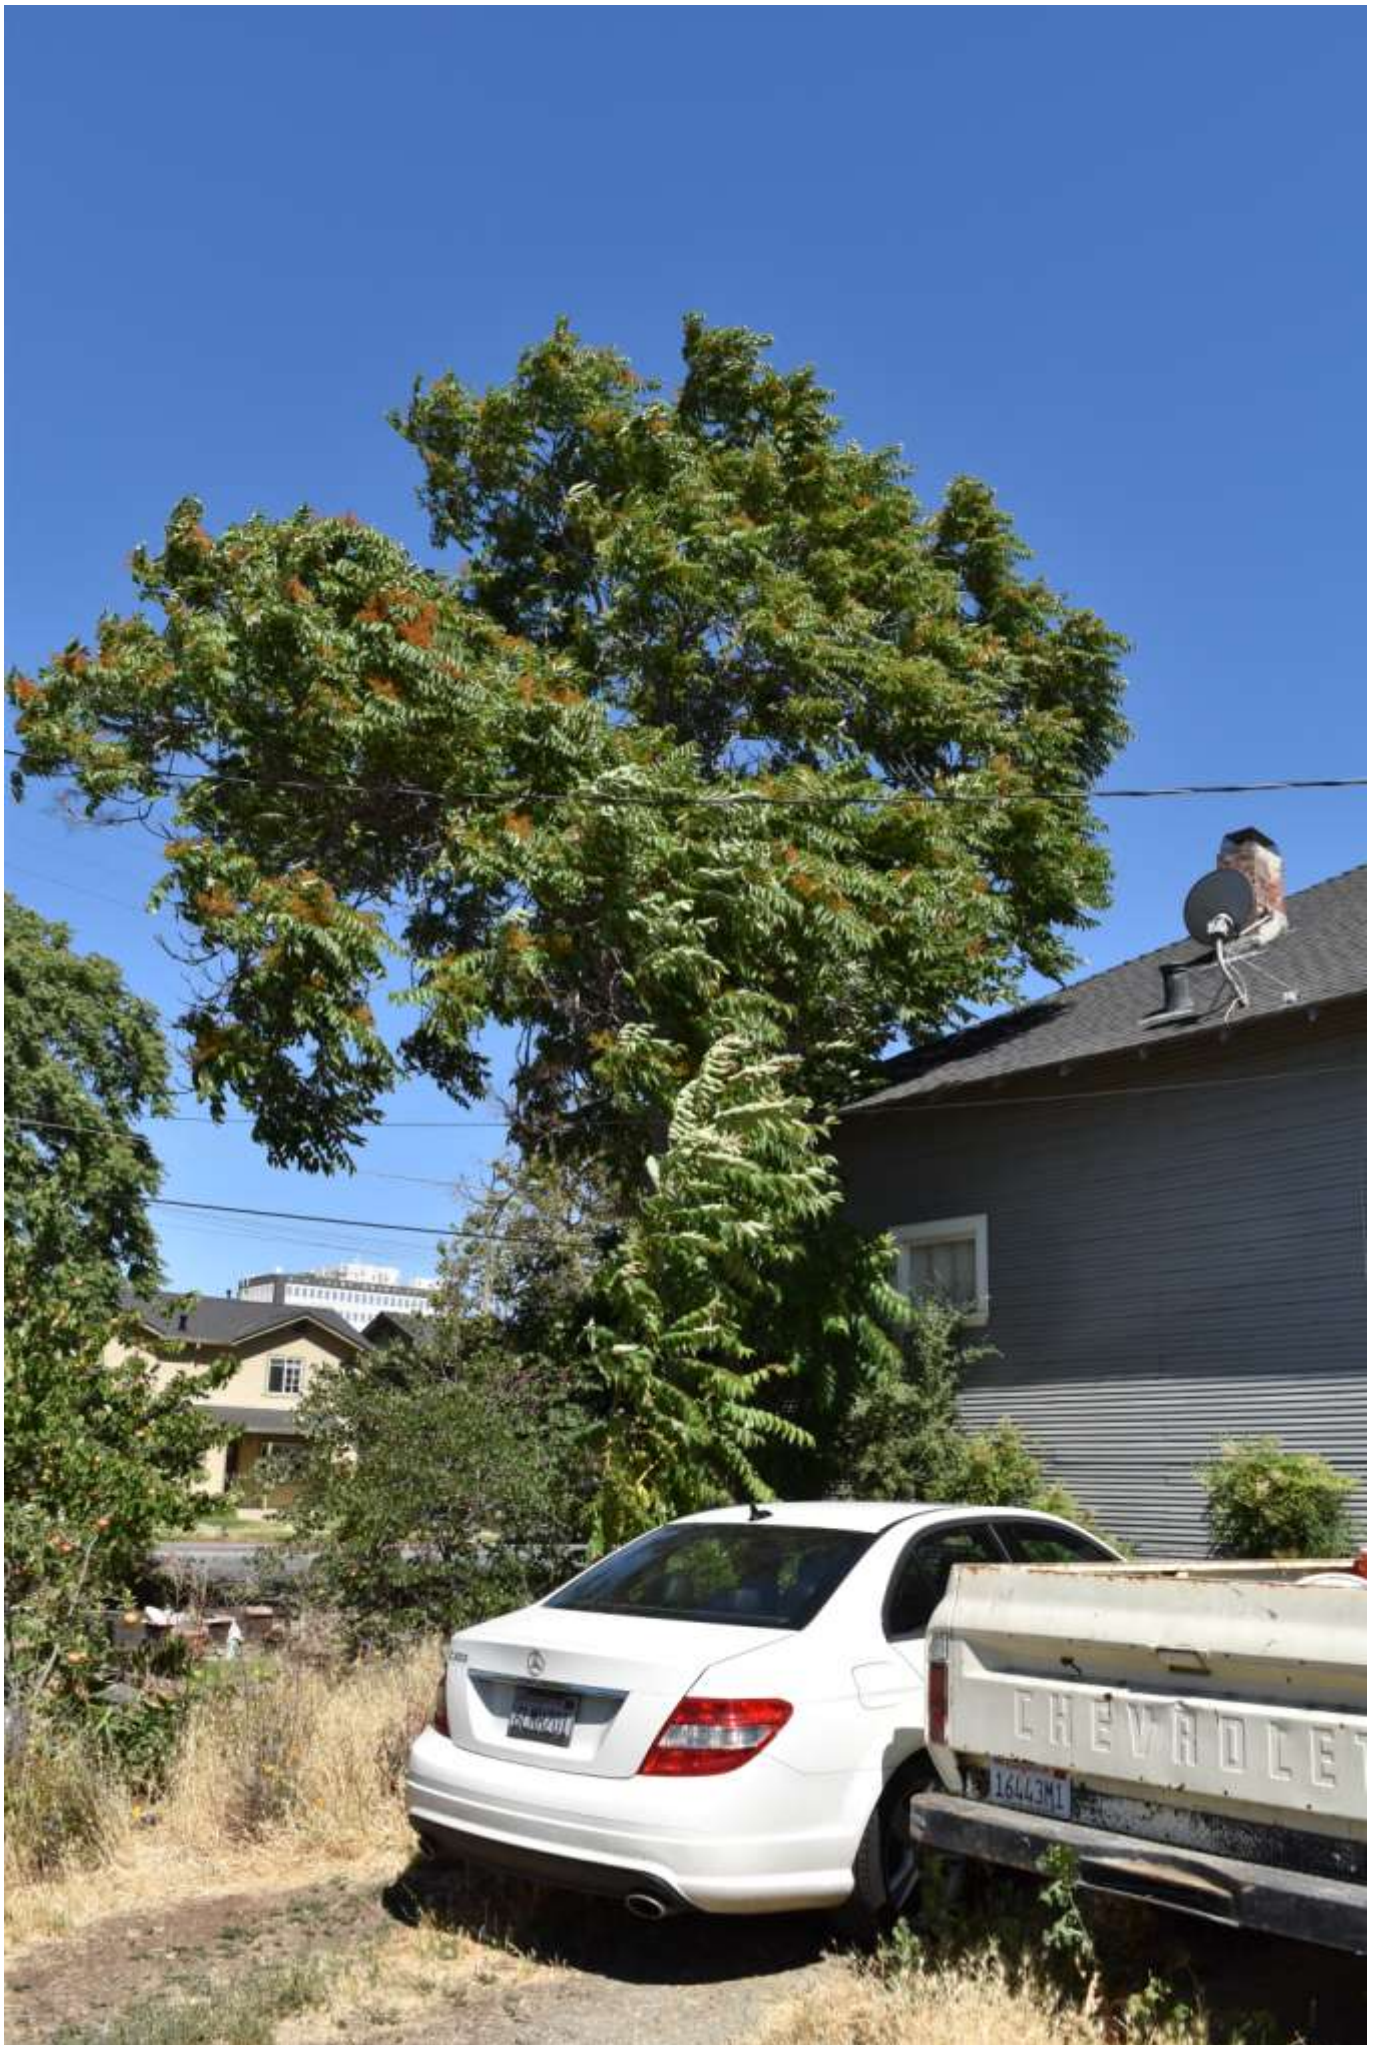
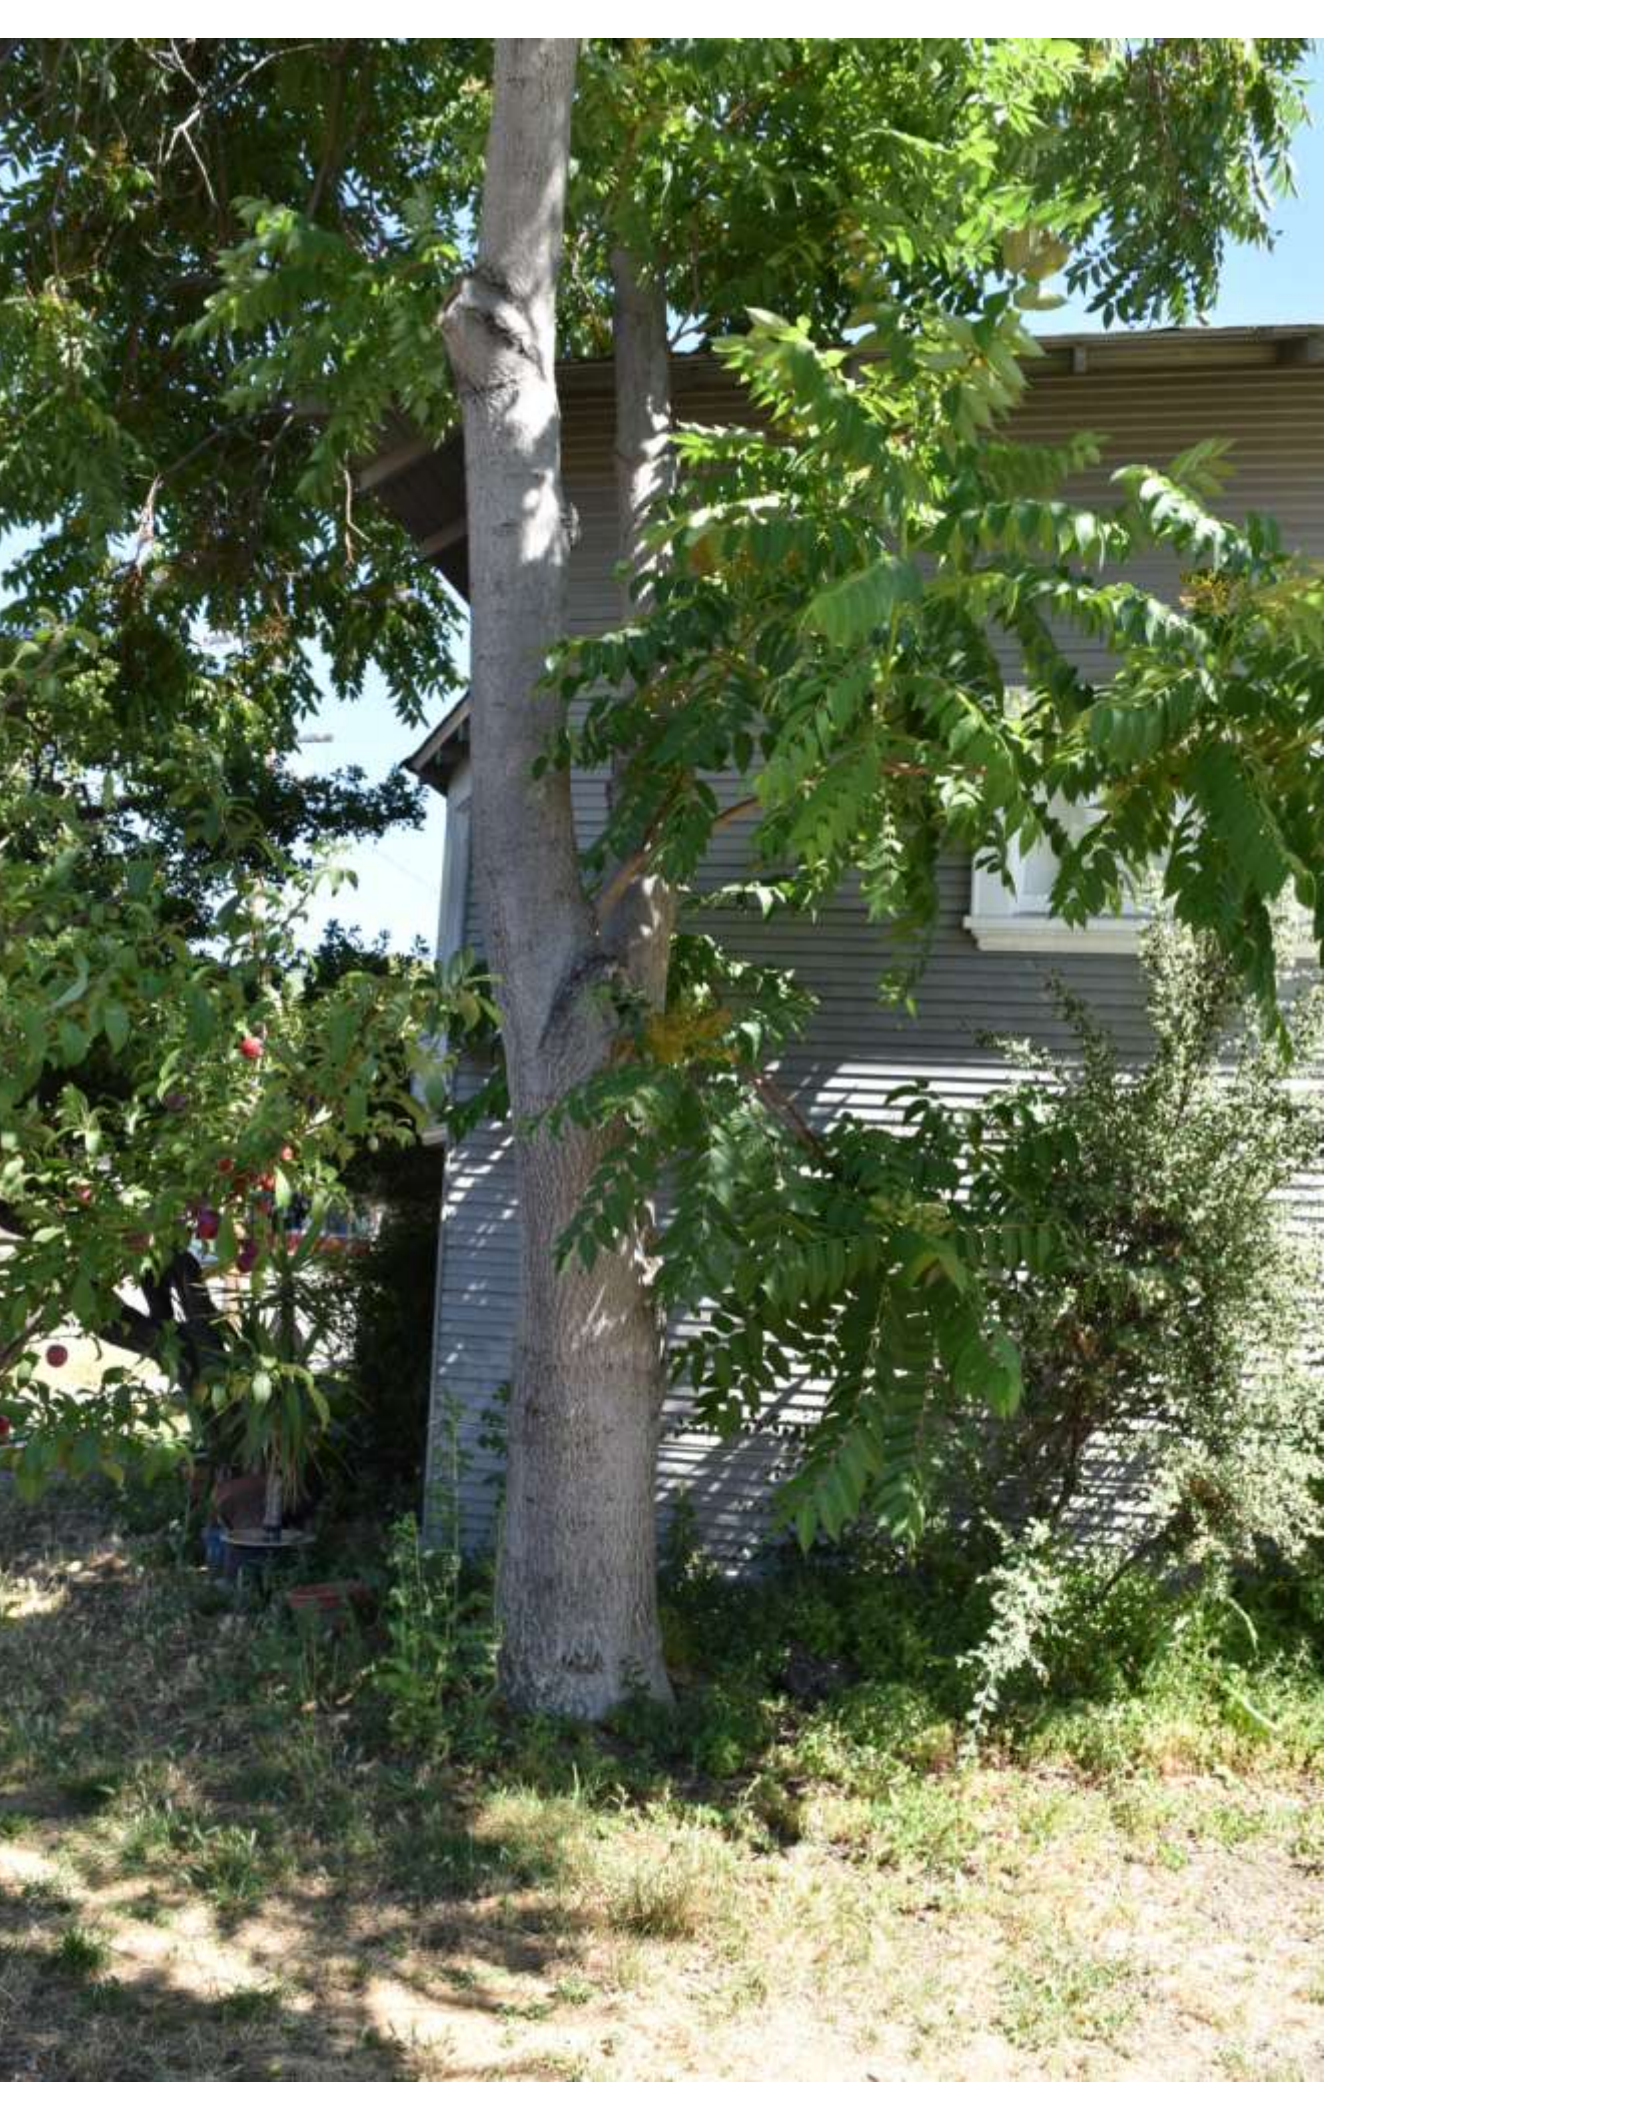
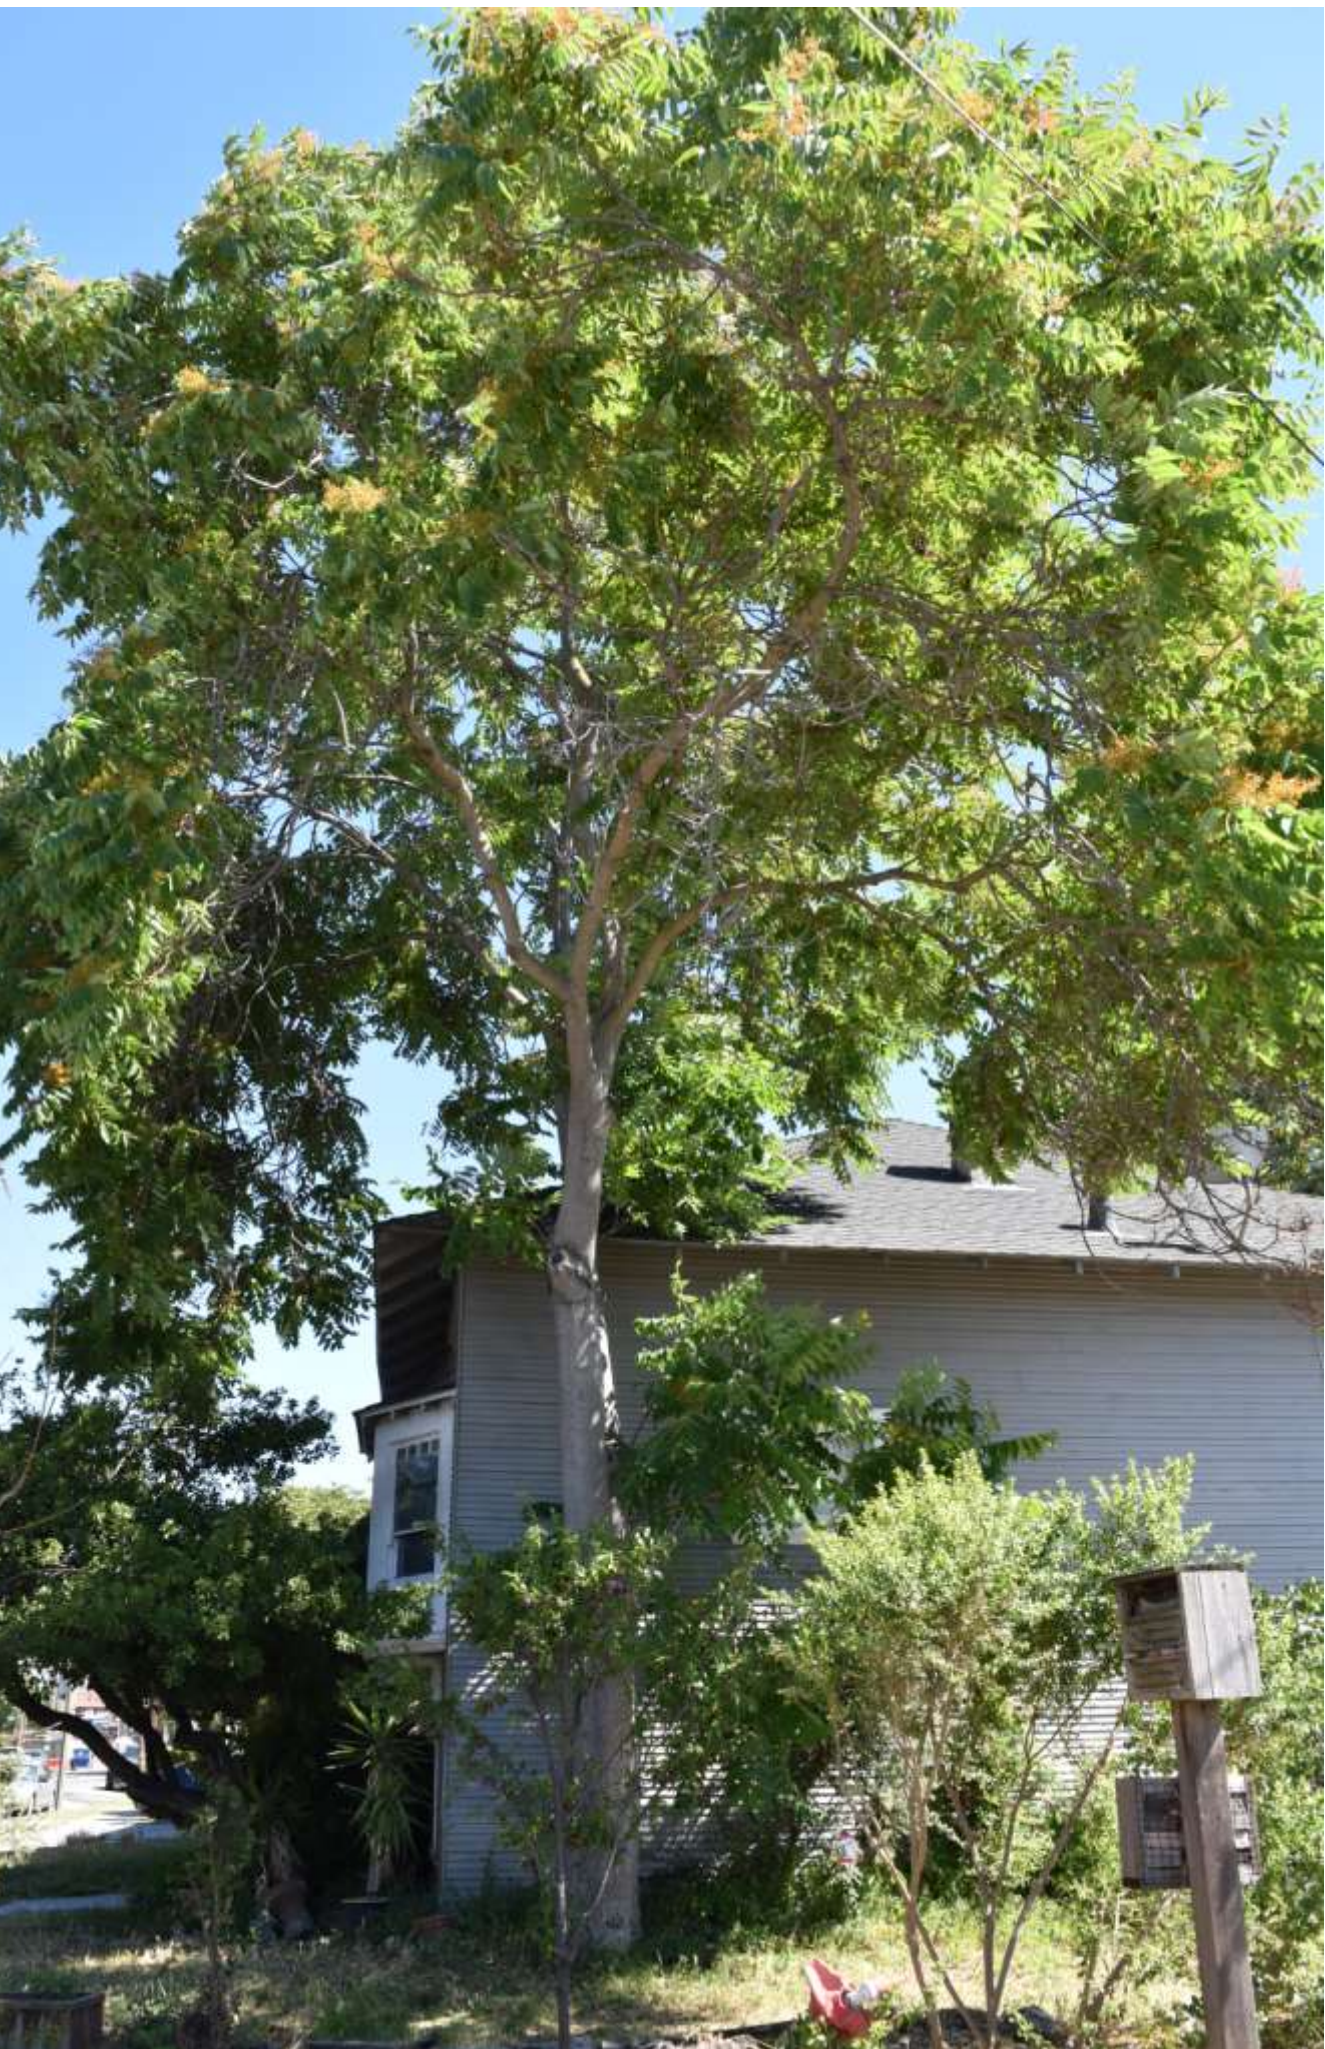
Non native tree, is very well known for spreading and becoming a common invasive plant in urban, agricultural and forested areas. This species is currently listed as an unsuitable tree by the city of San Jose.  
The location where the tree is growing strongly indicates that it was a seed carried by wild life or dispersed by the wind.  
I found the tree with several natural defects, poor structure, unbalance, poor branch taper, large branches over the roof area and weak attachments. These conditions are less than ideal for a mature tree.  
A better selection of new trees with an improved planting process will provide a better result in the future.  
The current condition of the tree and the proximity from the tree to the house increases the risk for a potential failure, posing a very significant hazard to the existing structures and the public.

Failure potential: low medium **high** severe  
Tree part most likely to fail: branches  
Hazard abatement: remove tree, replace with one 15 gallon European Hornbeam

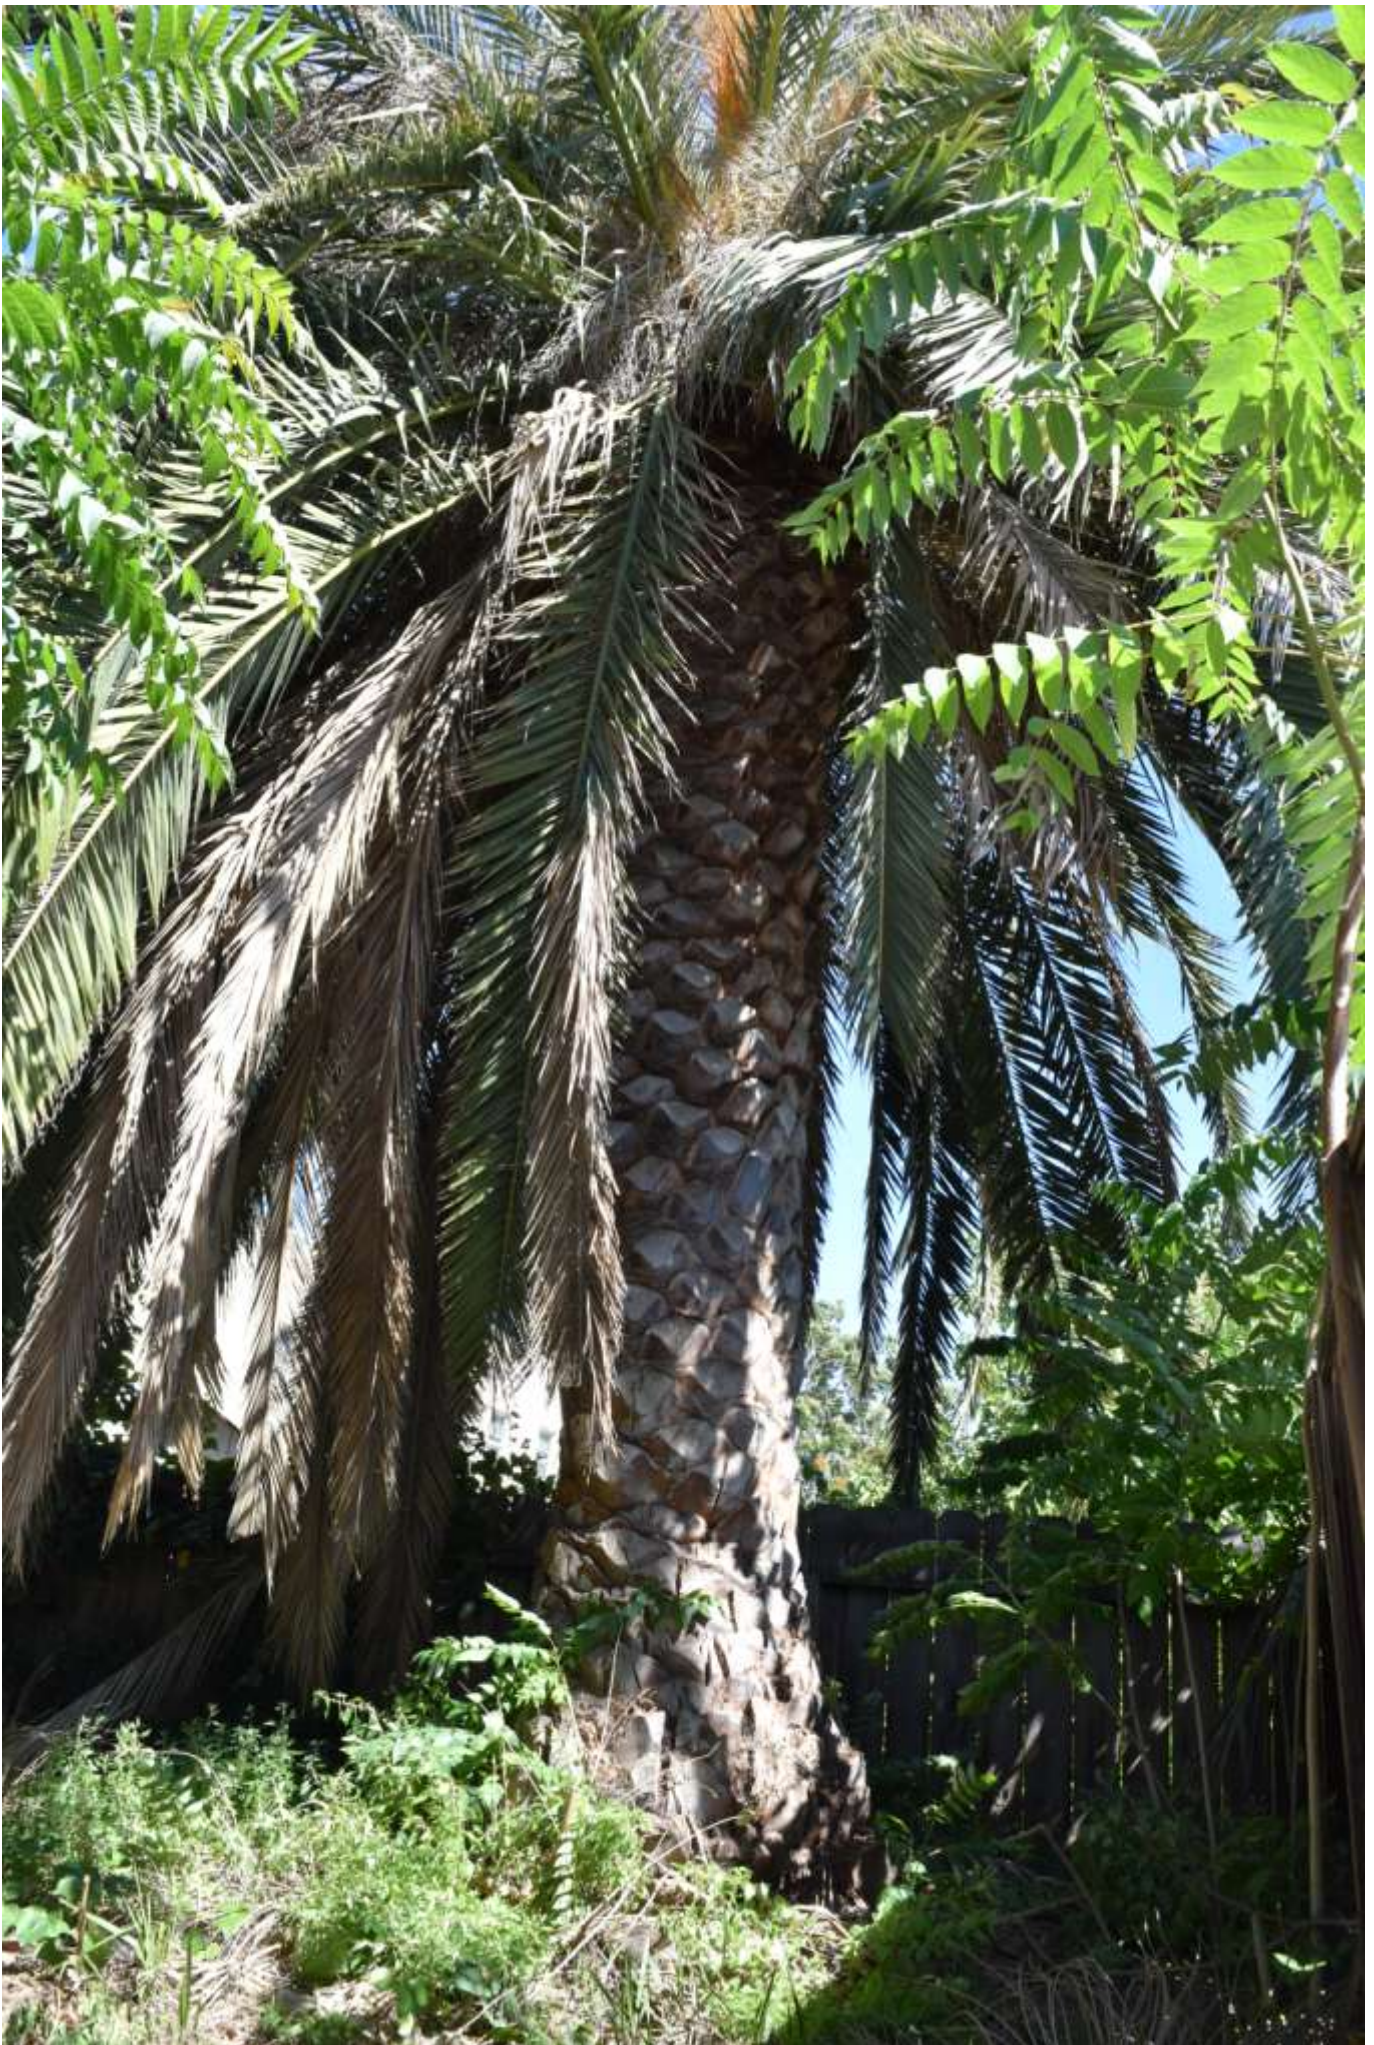
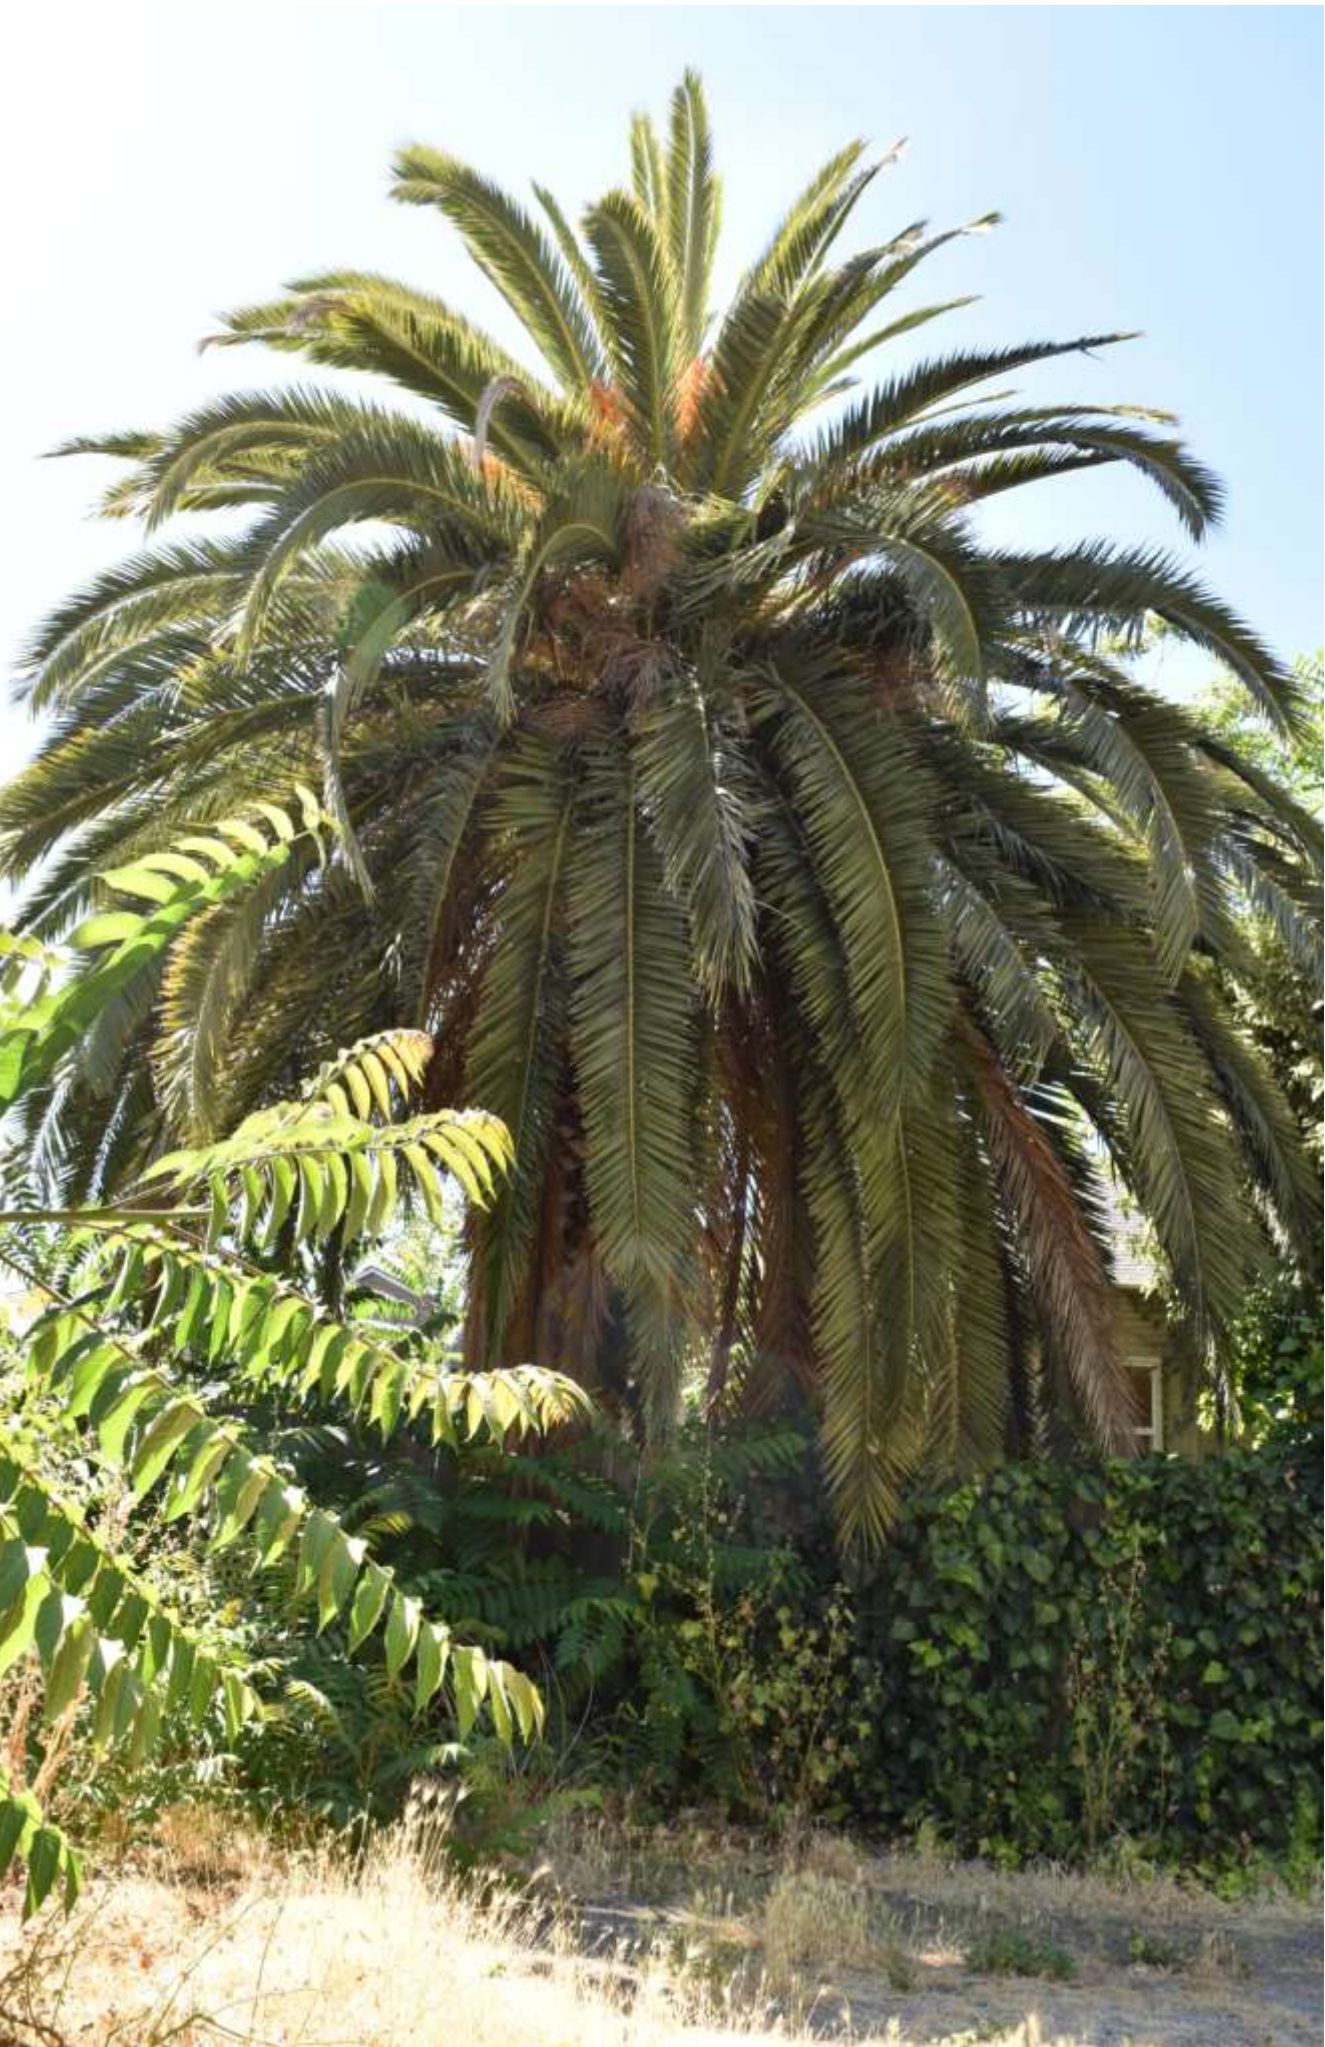
I found the tree under stress with very poor crown ratio and a excessive amount of dead and dying fronds.

The current condition of the tree and the proximity from the tree to the house increases the risk for a potential failure, posing a very significant hazard to the existing structures and the public.

Hazard abatement: remove tree, replace with one  
15 gallon European Hornbeam

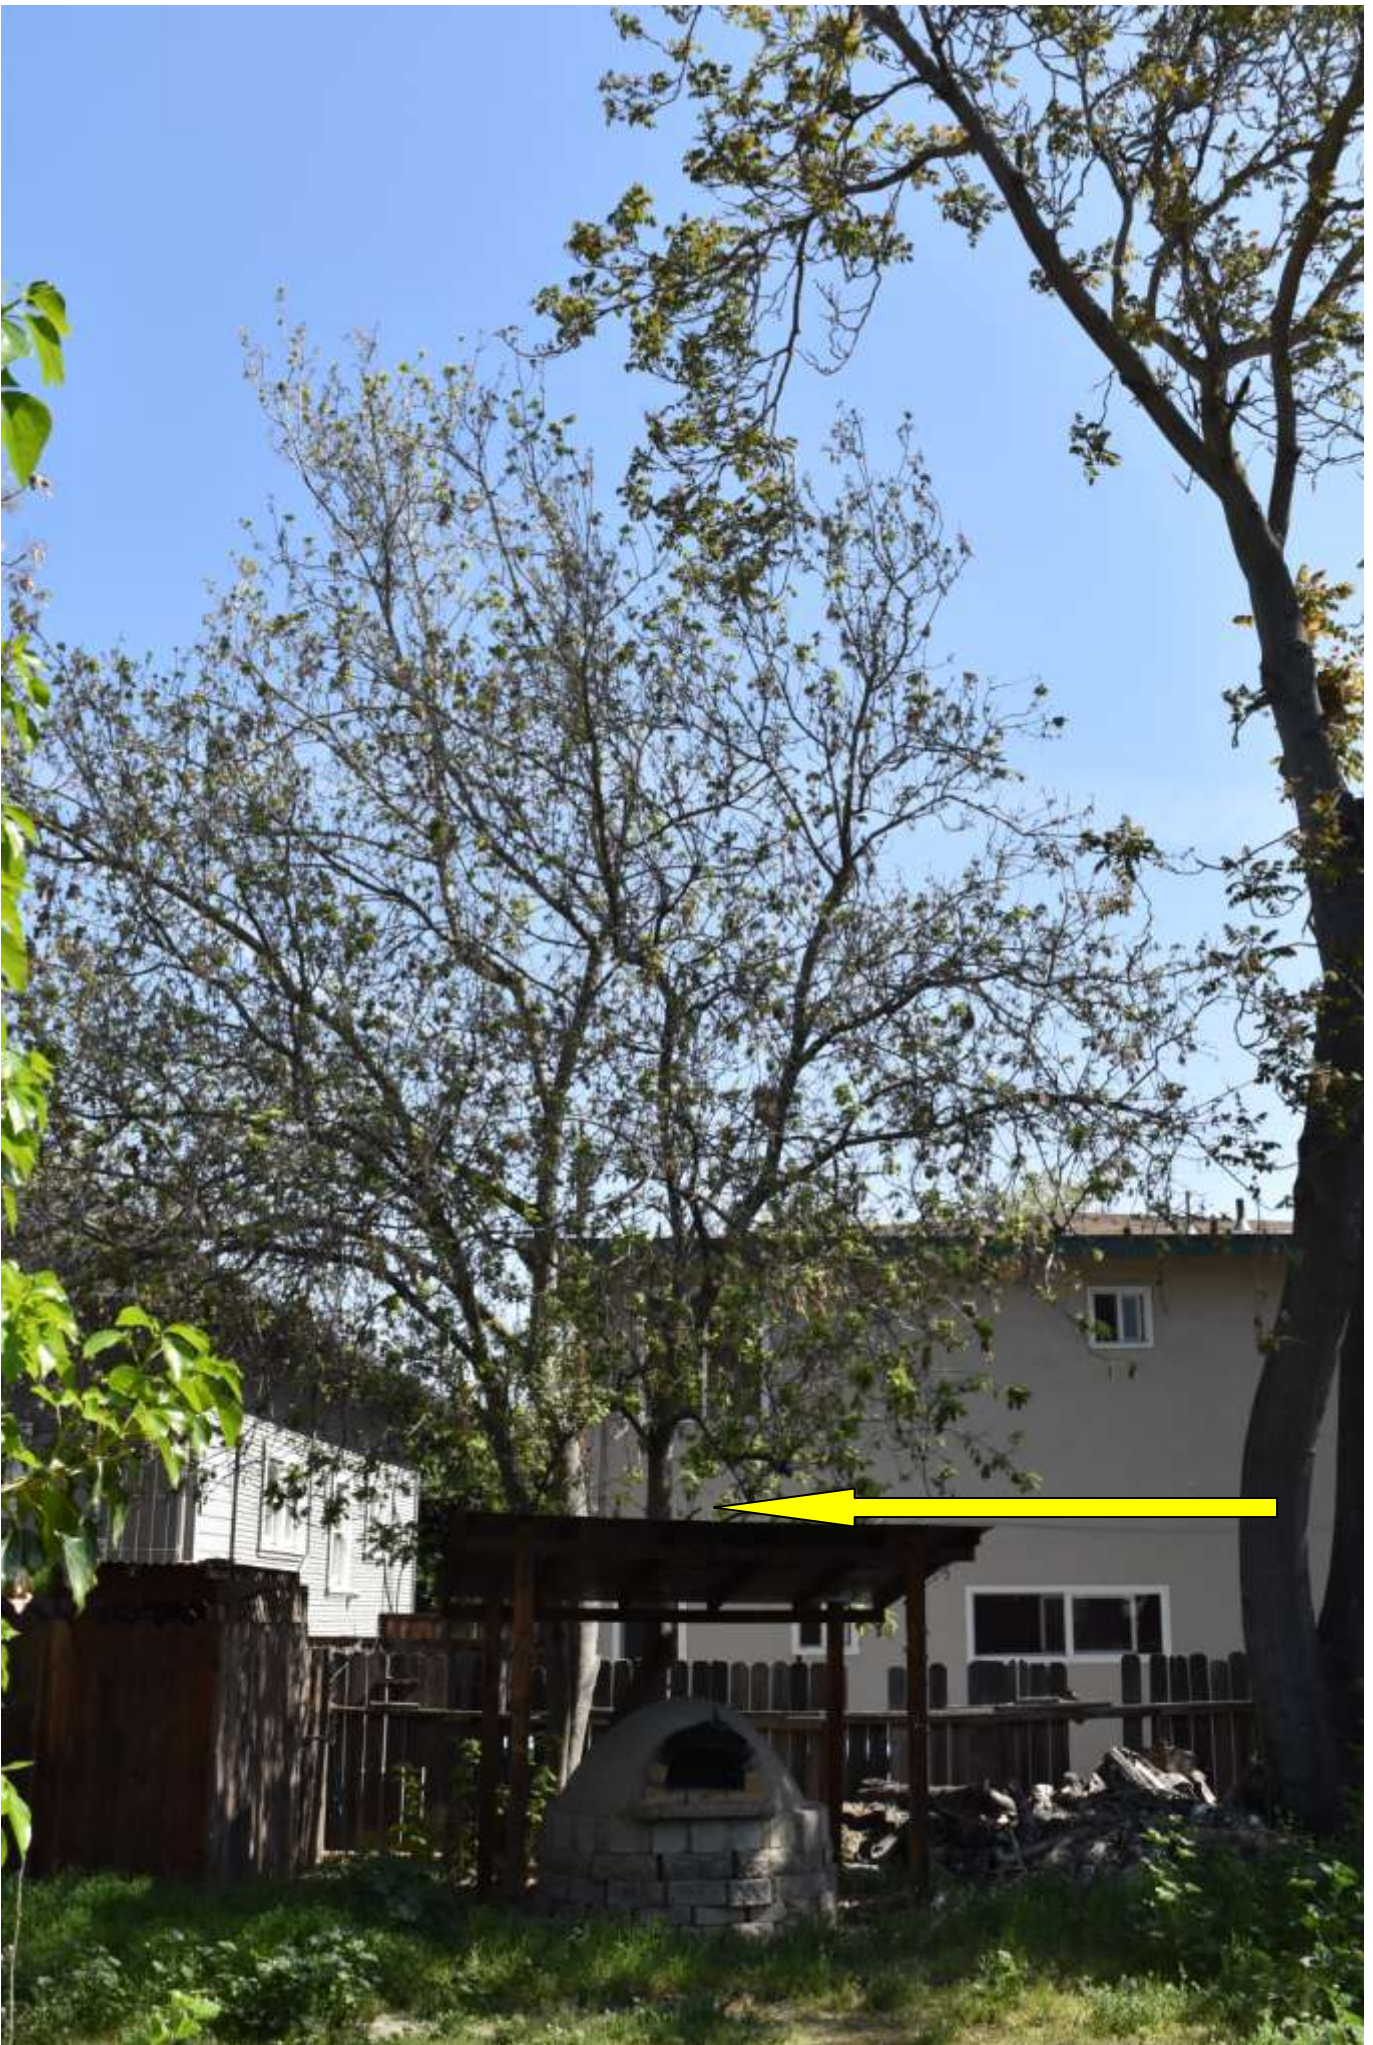
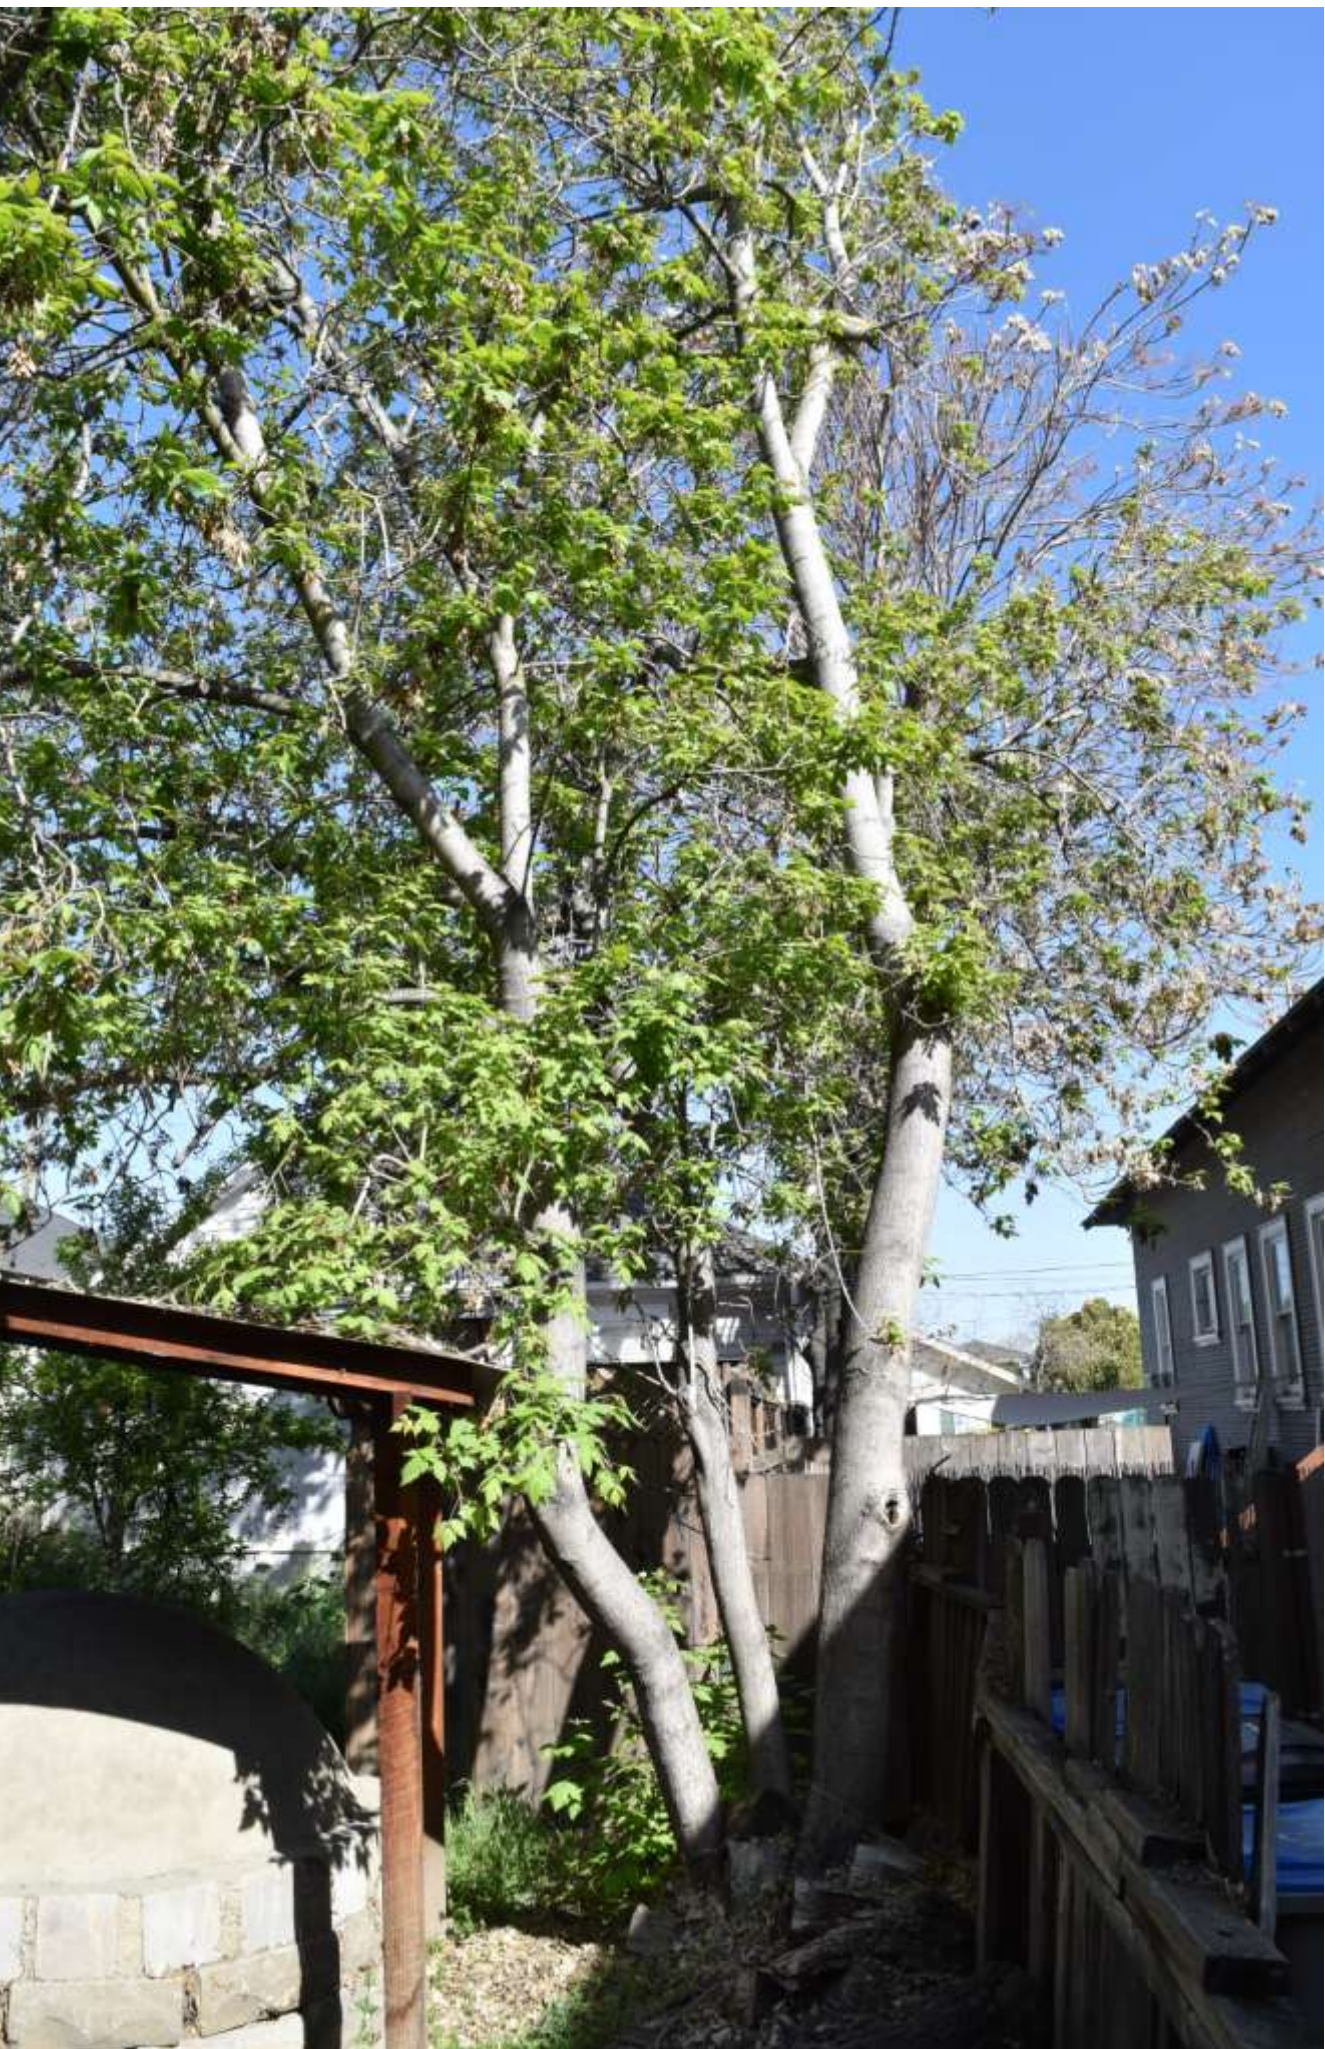
I found the tree with several natural defects, poor structure, unbalanced and weak attachments. These conditions are less than ideal for a mature tree.

The current condition of the tree and the proximity from the tree to the structure, increases the risk for a potential failure, posing a very significant hazard to the existing structures and the public.

Hazard abatement: remove tree, replace with one 15 gallon Chitalpa tashkentensis
