## Arborist Report

# Tree A of Initial Study Fig 15

Address: 484, 488 E Saint John Street and 93,95, 97 N. 11th Street  
San Jose, CA. 95112

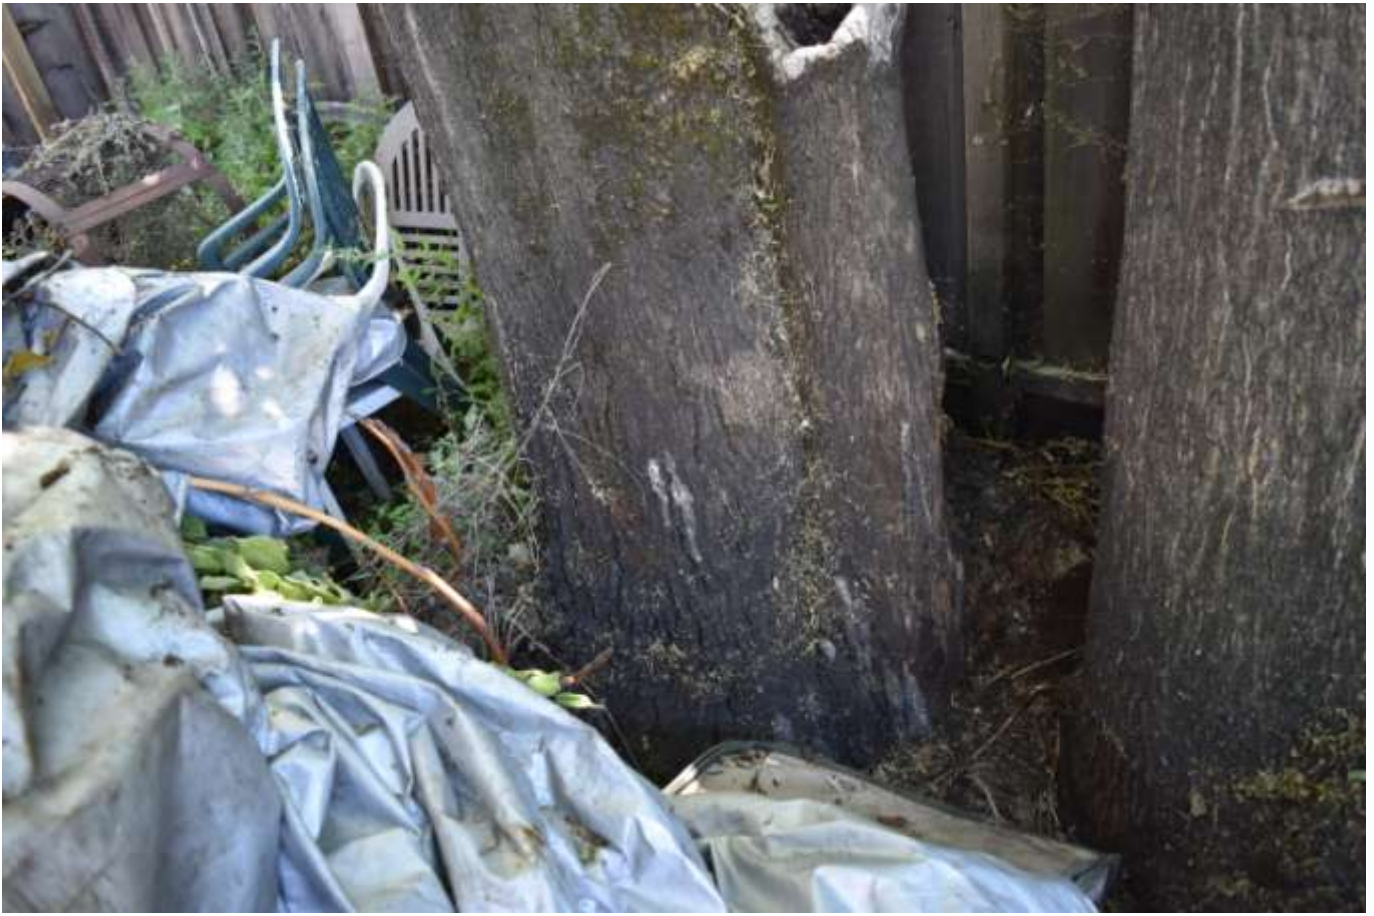
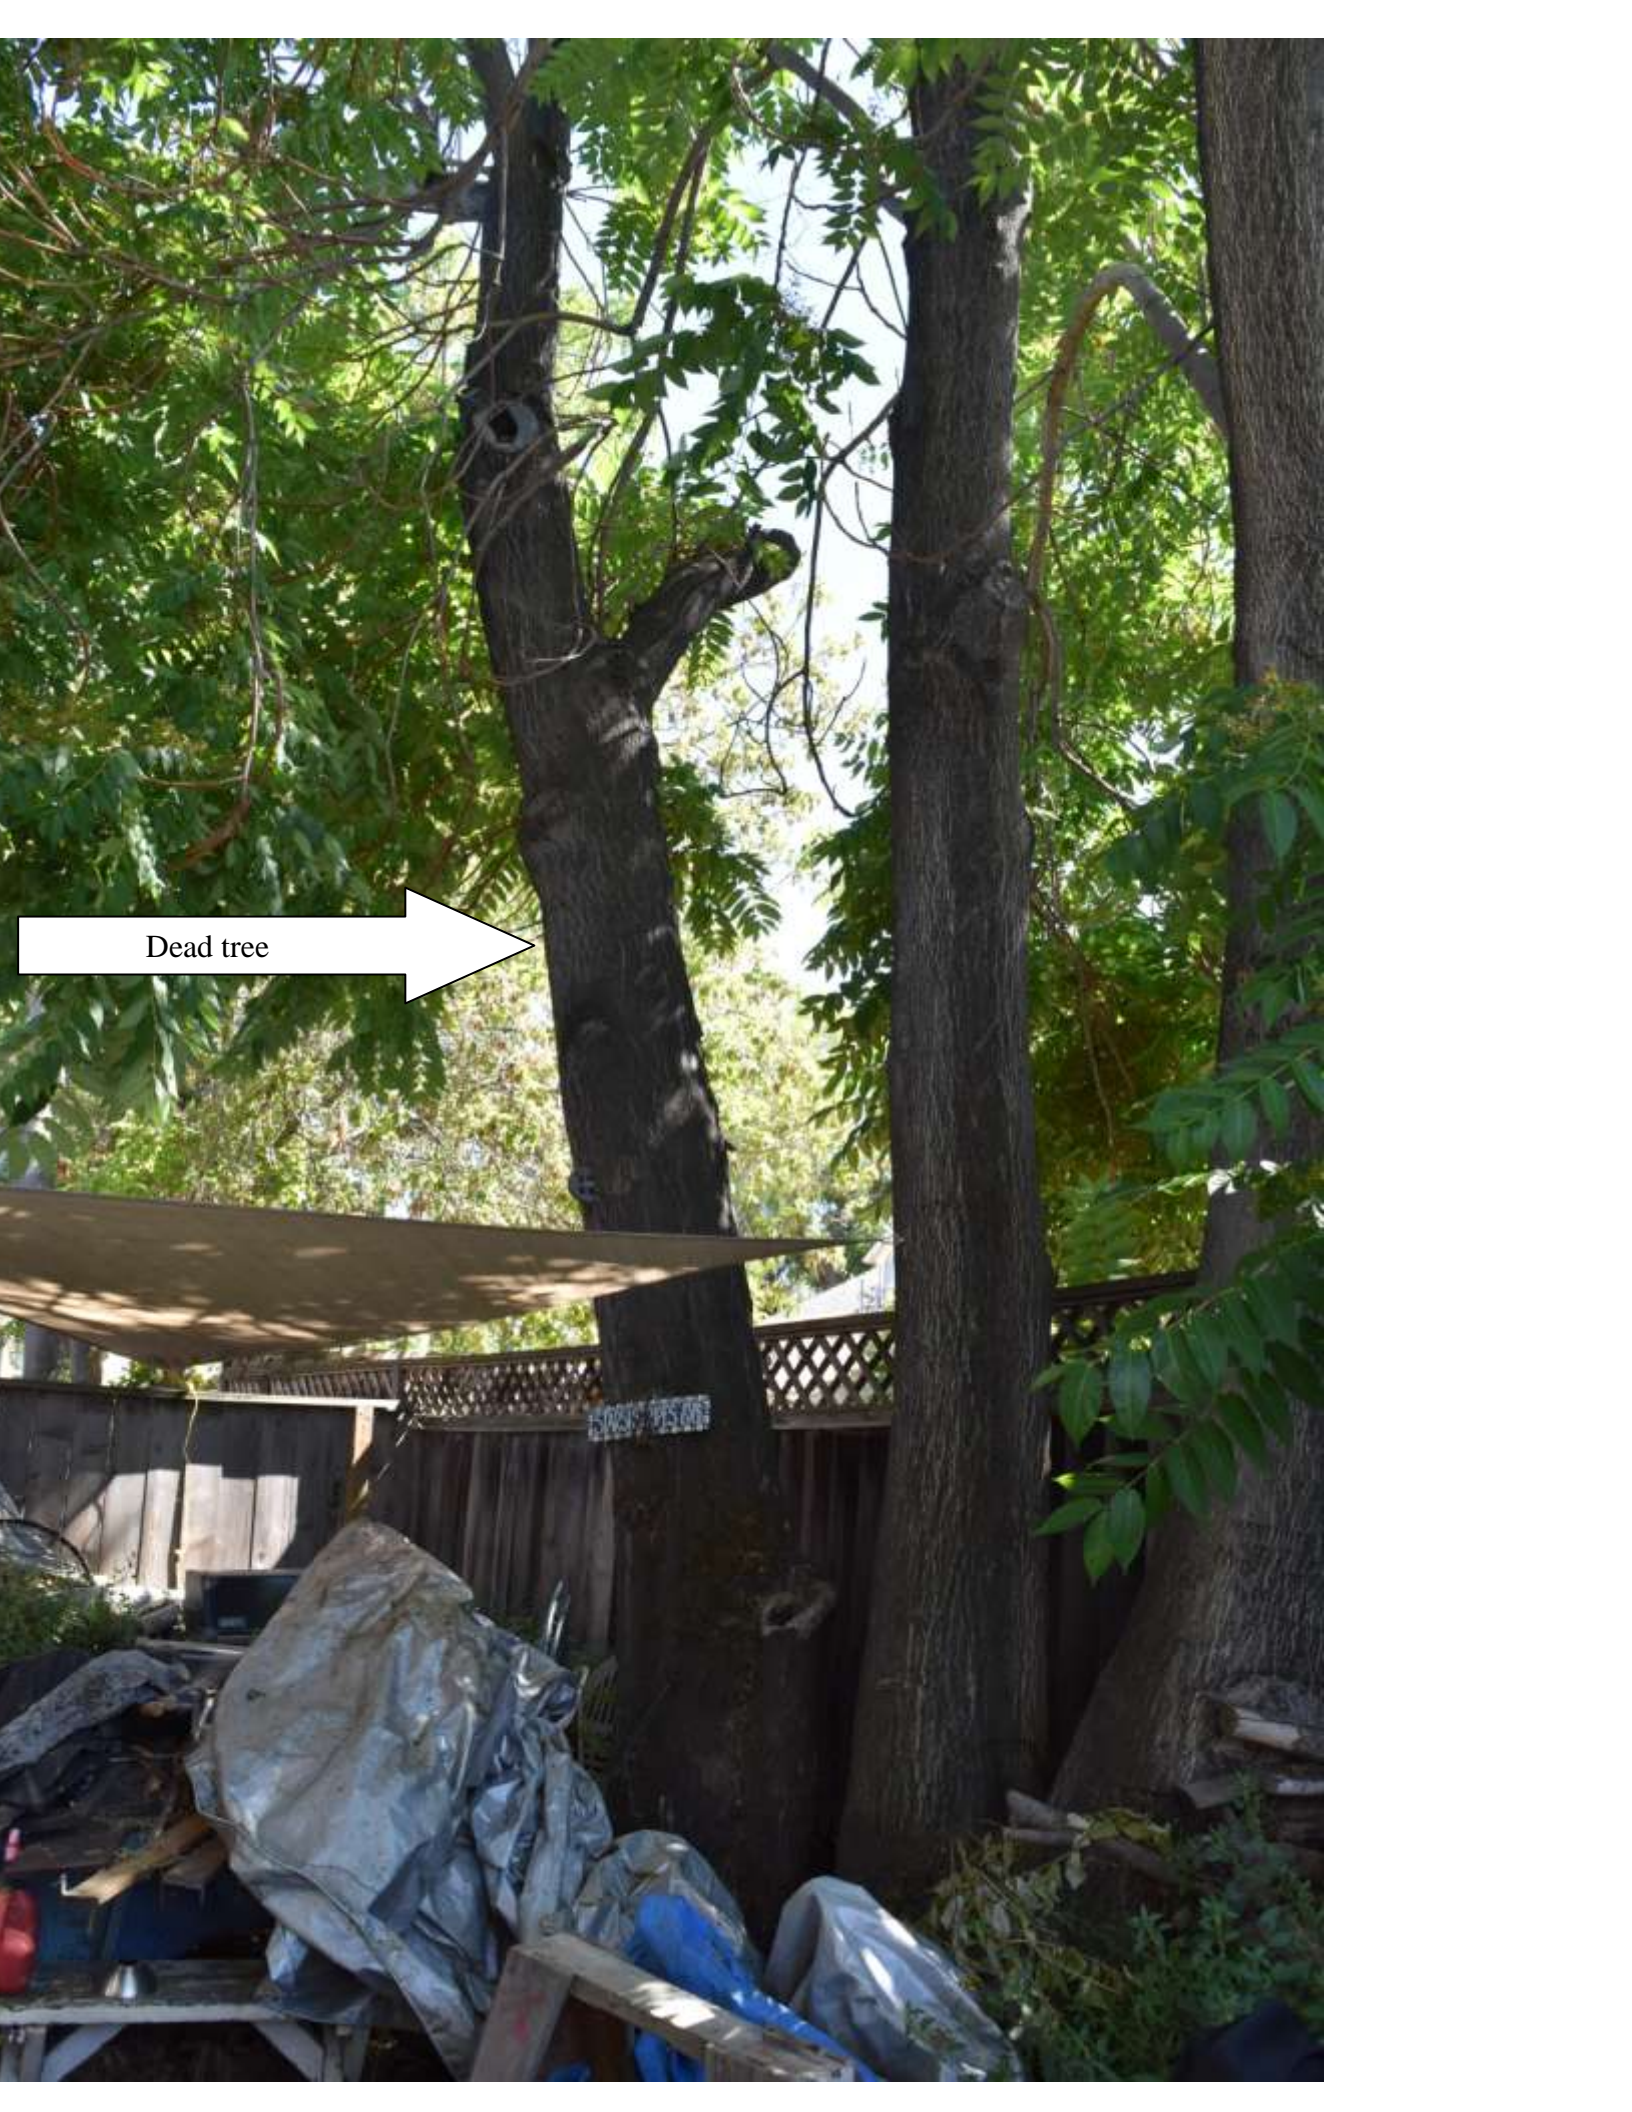
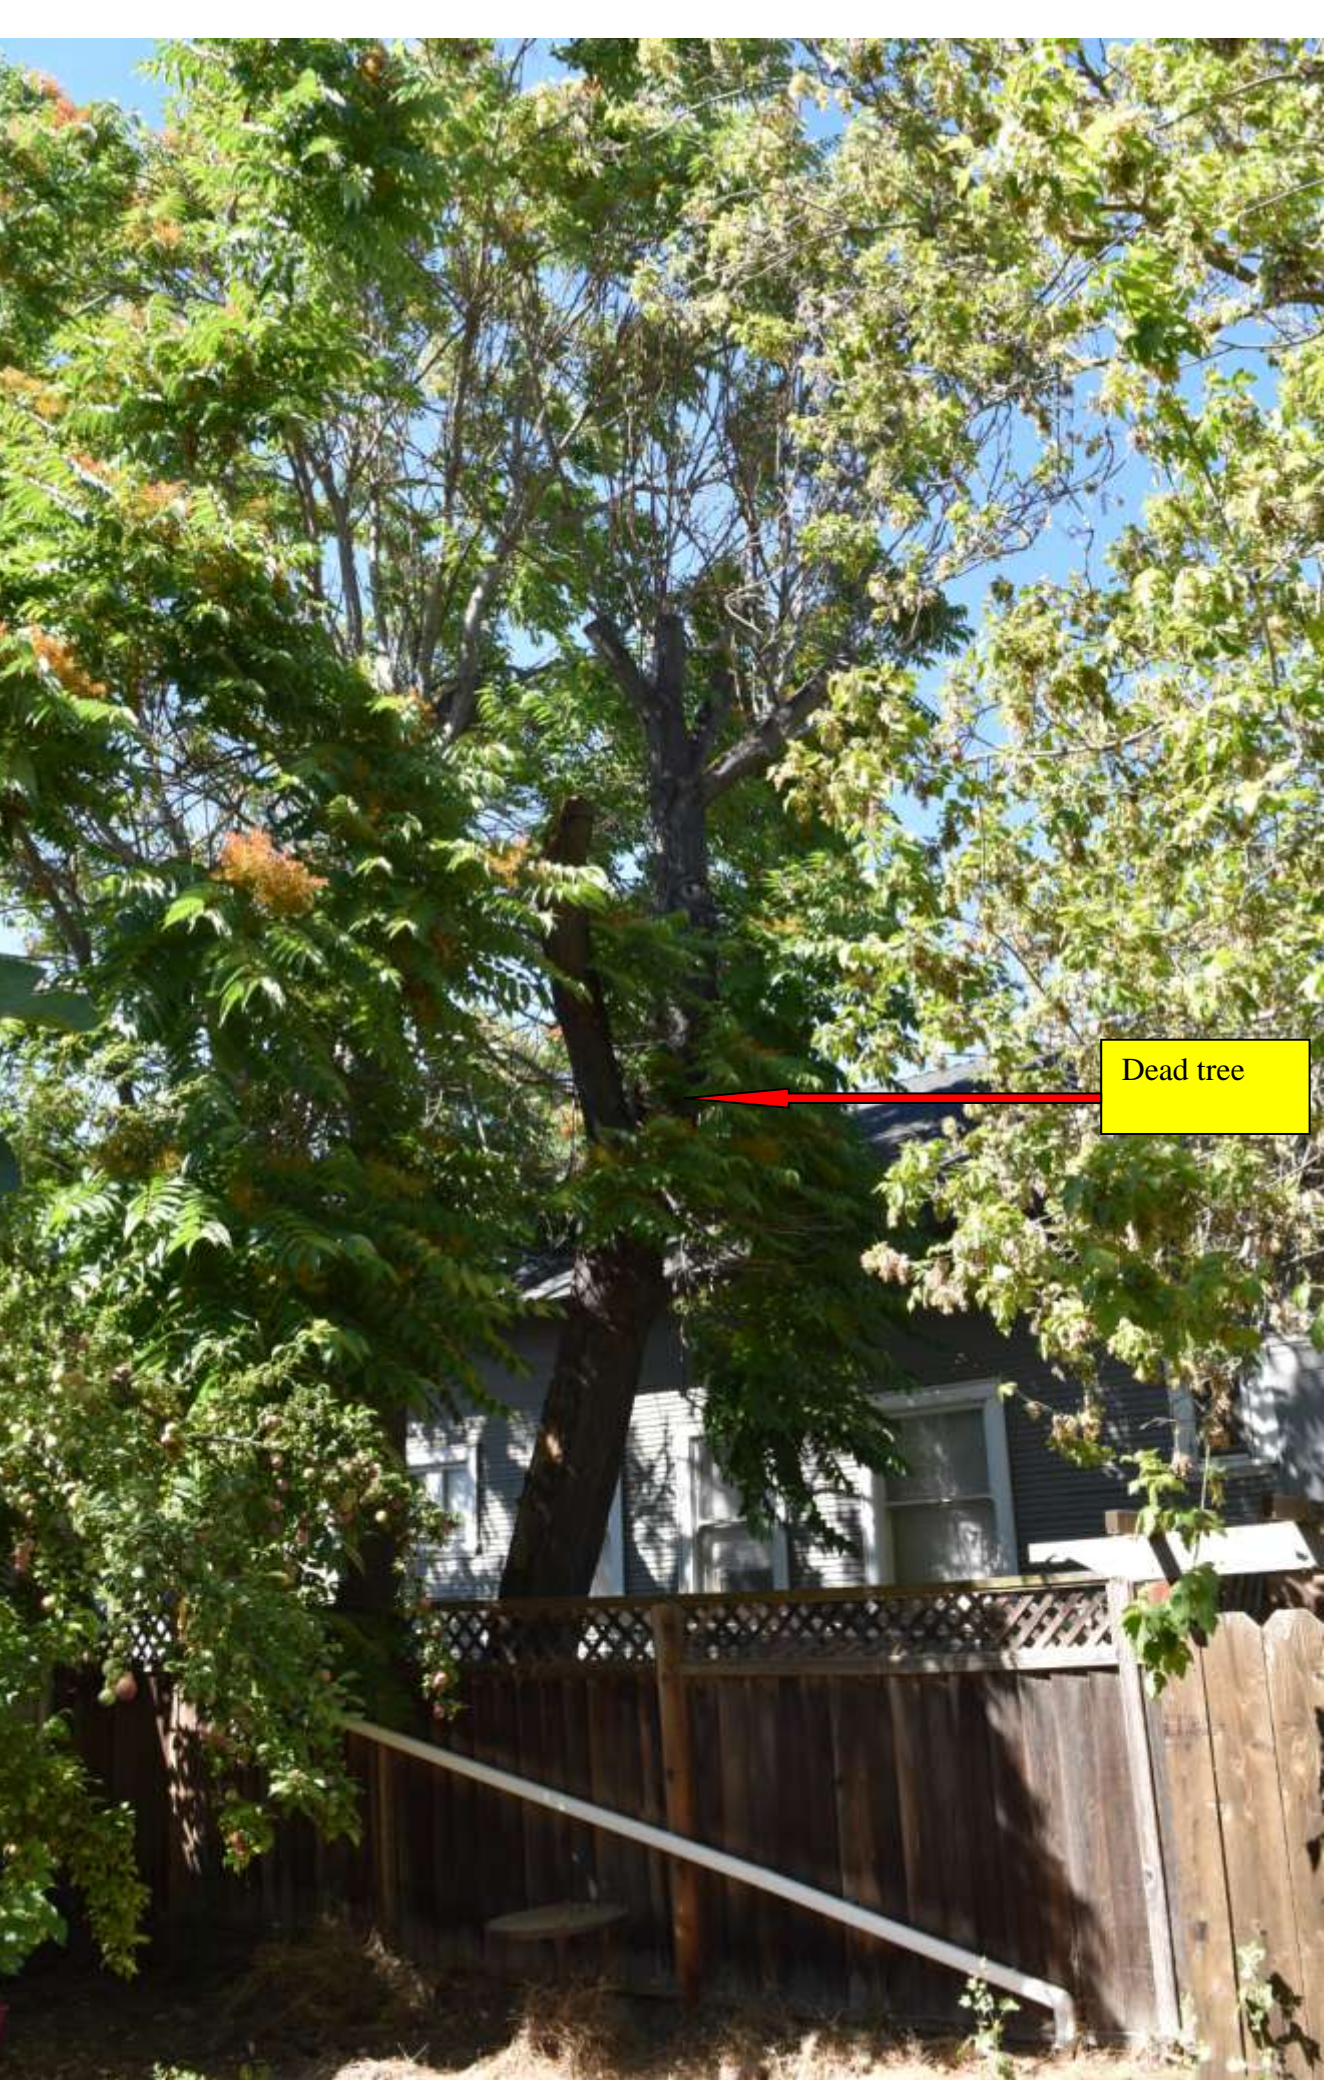
**The tree is 100% dead and it should be removed as soon as possible.**

Dead tree

Hazard abatement: remove tree, replace with one 15 gallon European Hornbeam

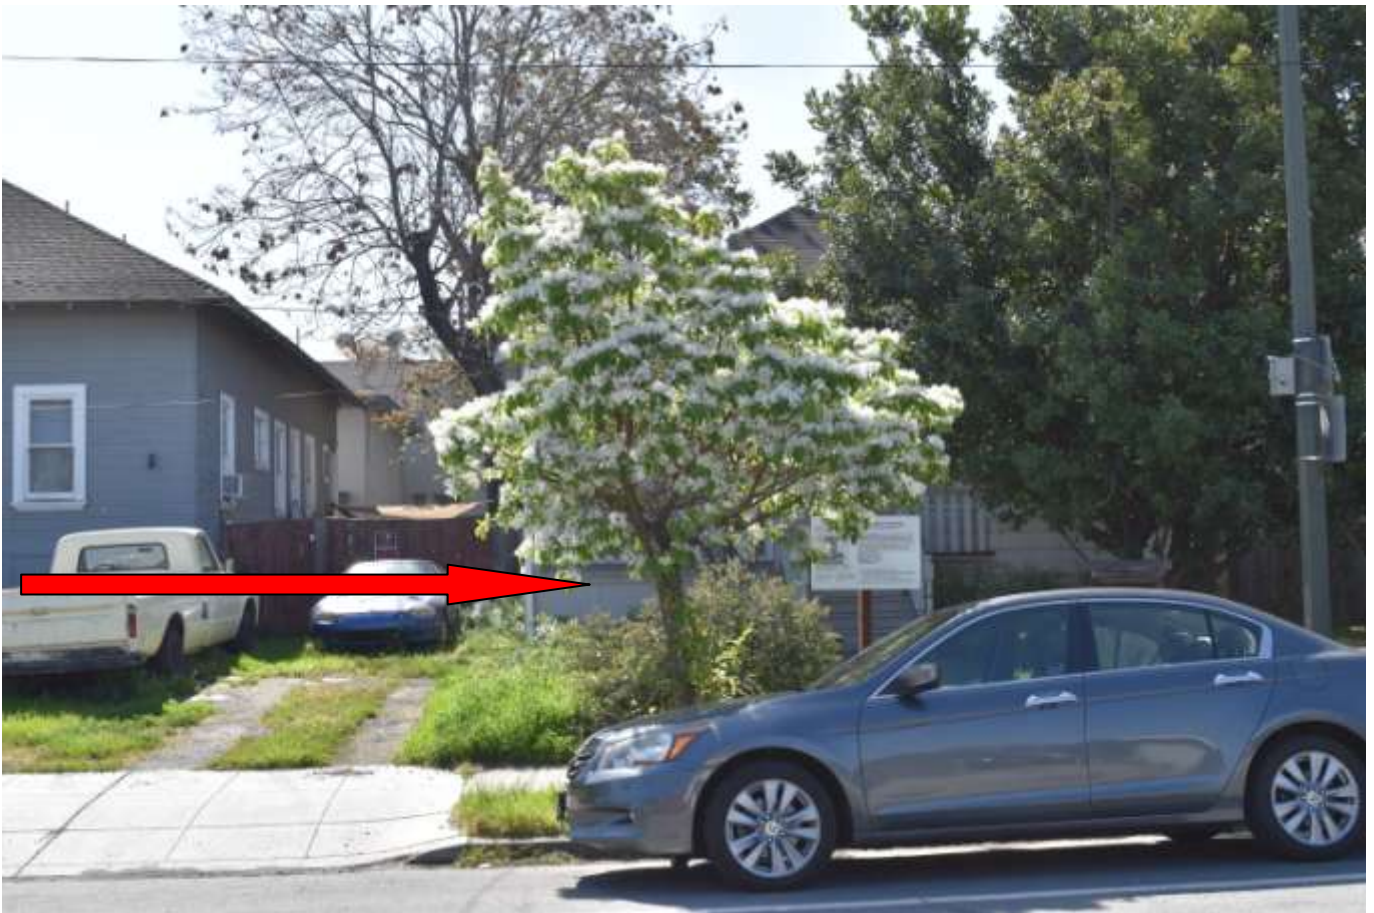
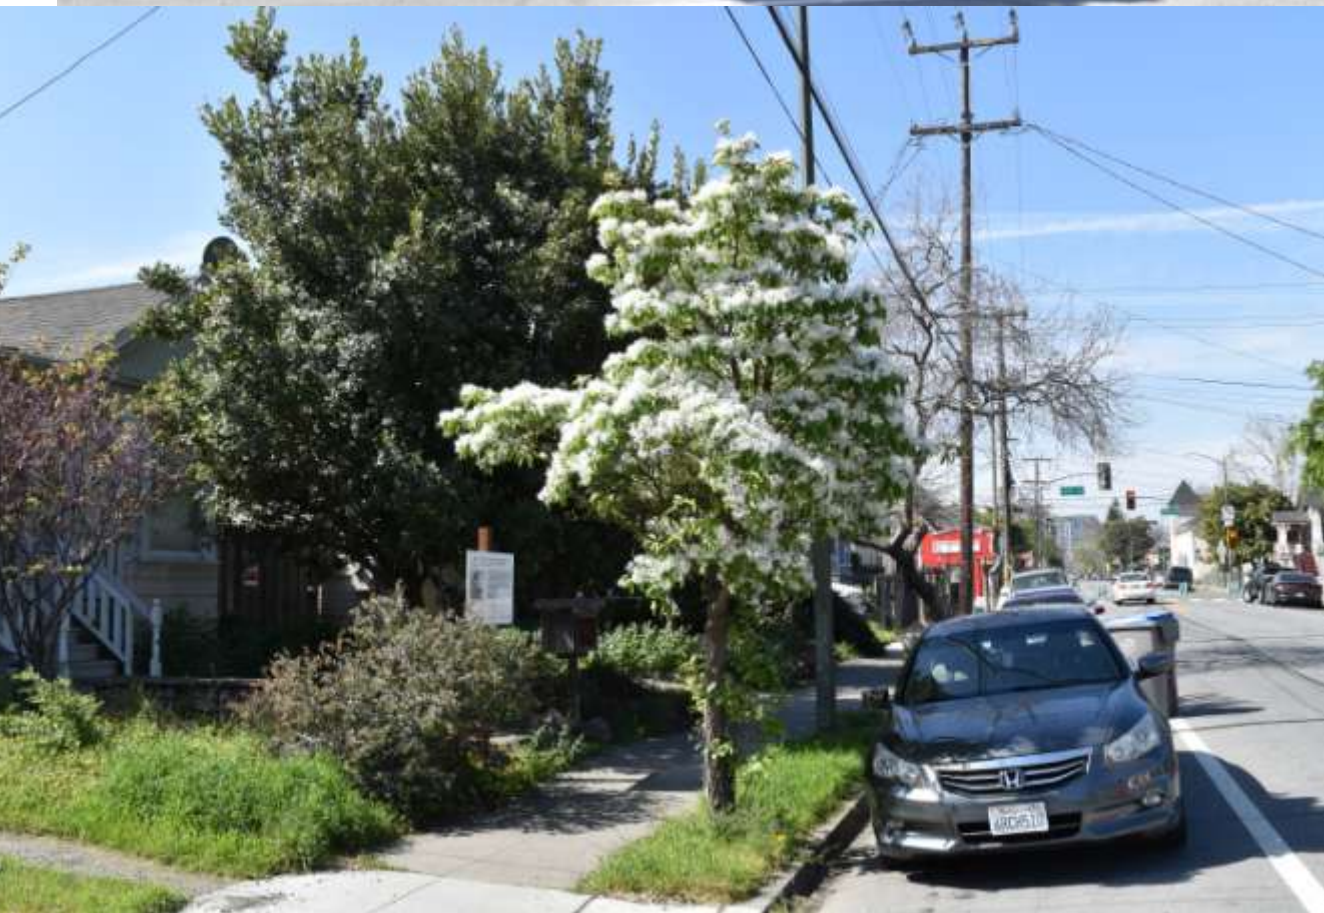
The overall condition of the tree is good, the foliage looks normal, healthy trunk taper and excellent crown ratio.

Hazard Abatement: Thin the crown by selective removal of branches to increase light and air penetration, raise low branches, remove dead and dying branches.

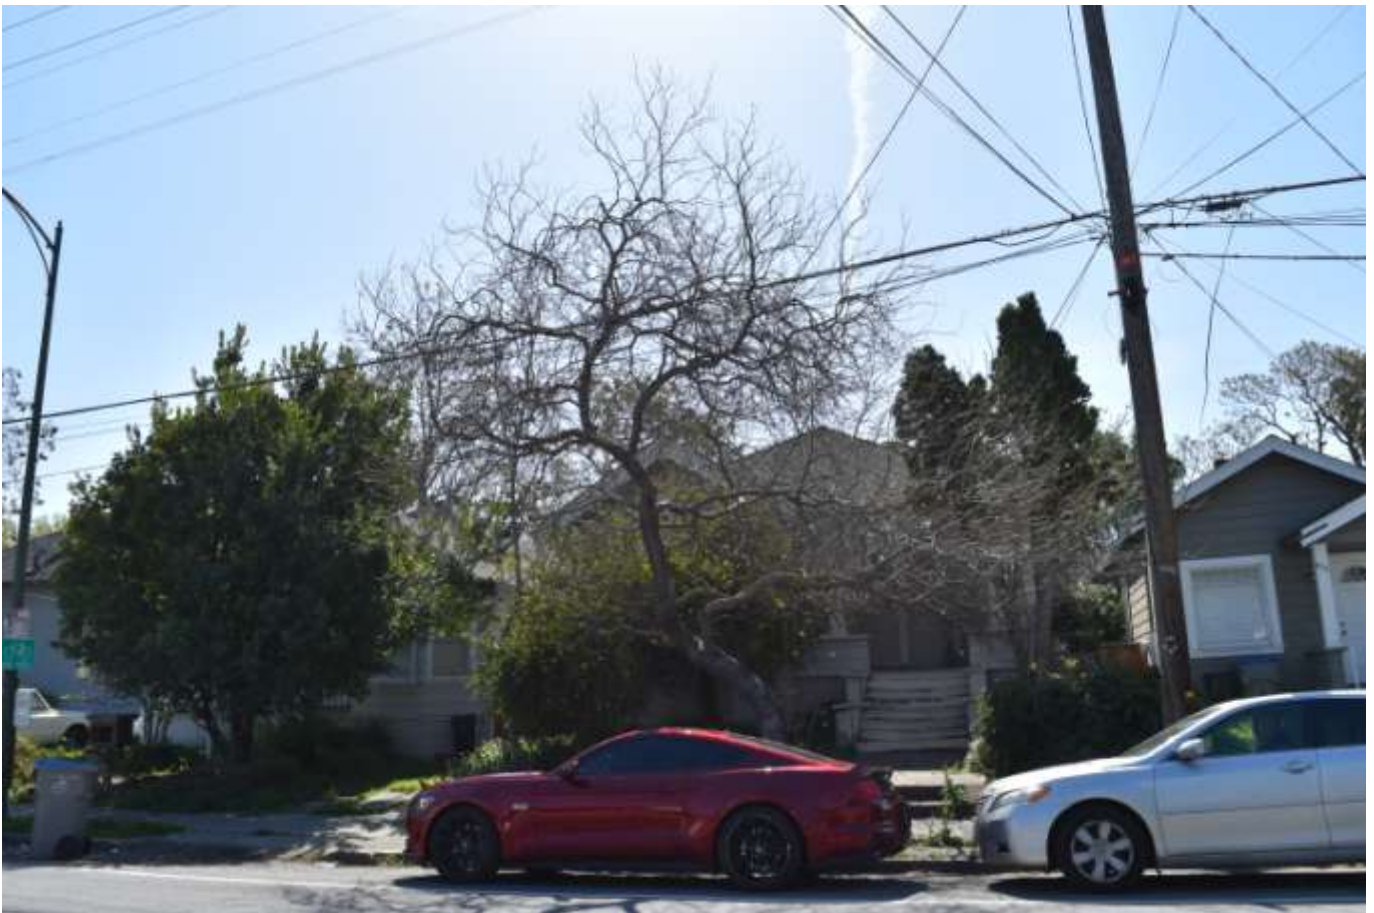
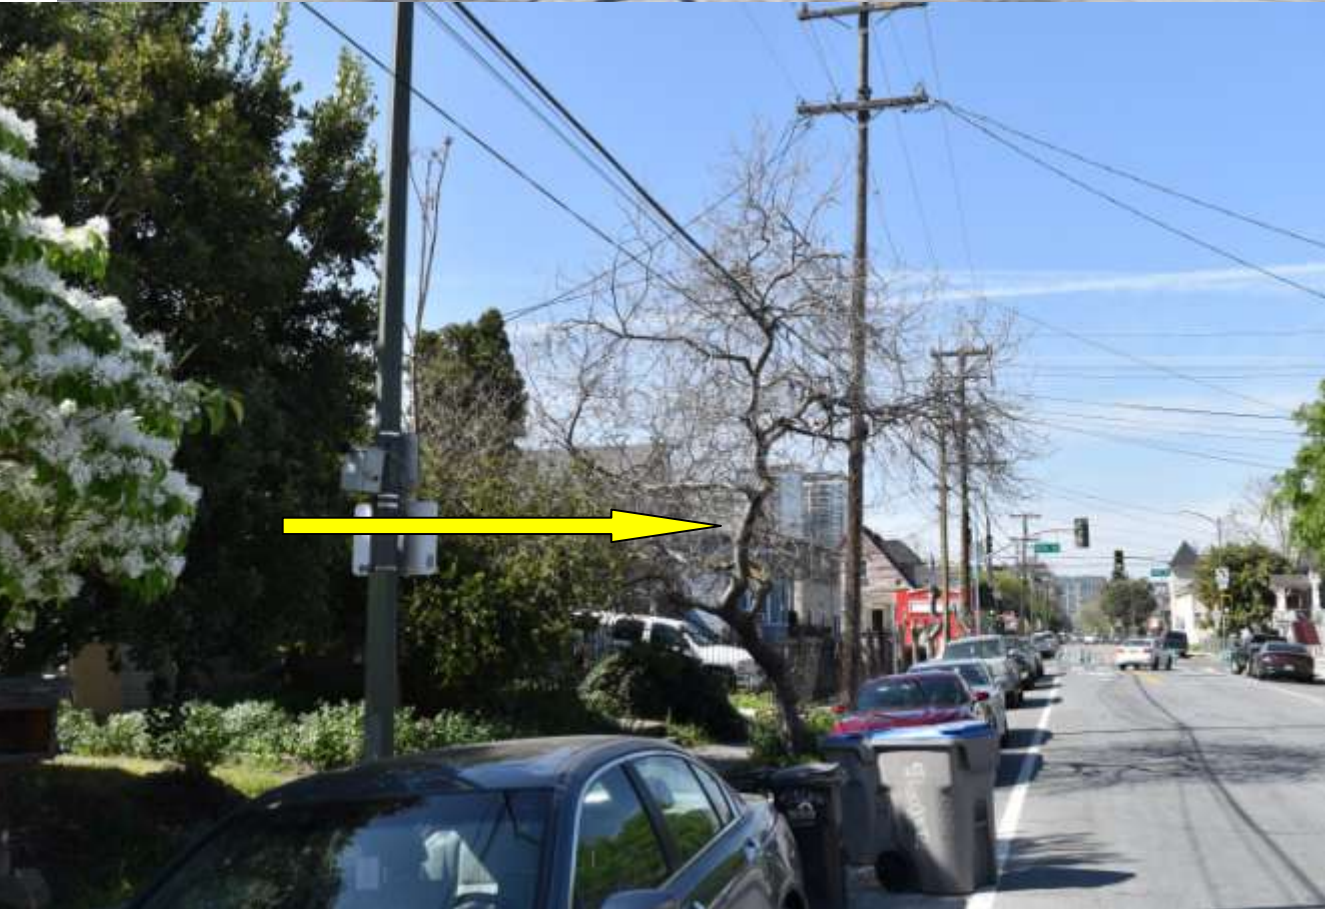
Flowering tree drought tolerant , its native habitat are the desert lands of Texas, California and Mexico.  
 The tree is growing next to a utility pole in the parking strip.  
 The overall condition of the tree is normal, but the tree should be trimmed to correct some natural defects.  
 The selection for the species in this location is appropriate, the compact shape and general appearance makes this tree a good selection for a street tree in specific areas.

Tree part most likely to fail:  
Hazard abatement: Thin the crown of the tree by selective removal of branches to increase light and air penetration, raise low branches, remove dead and dying branches.

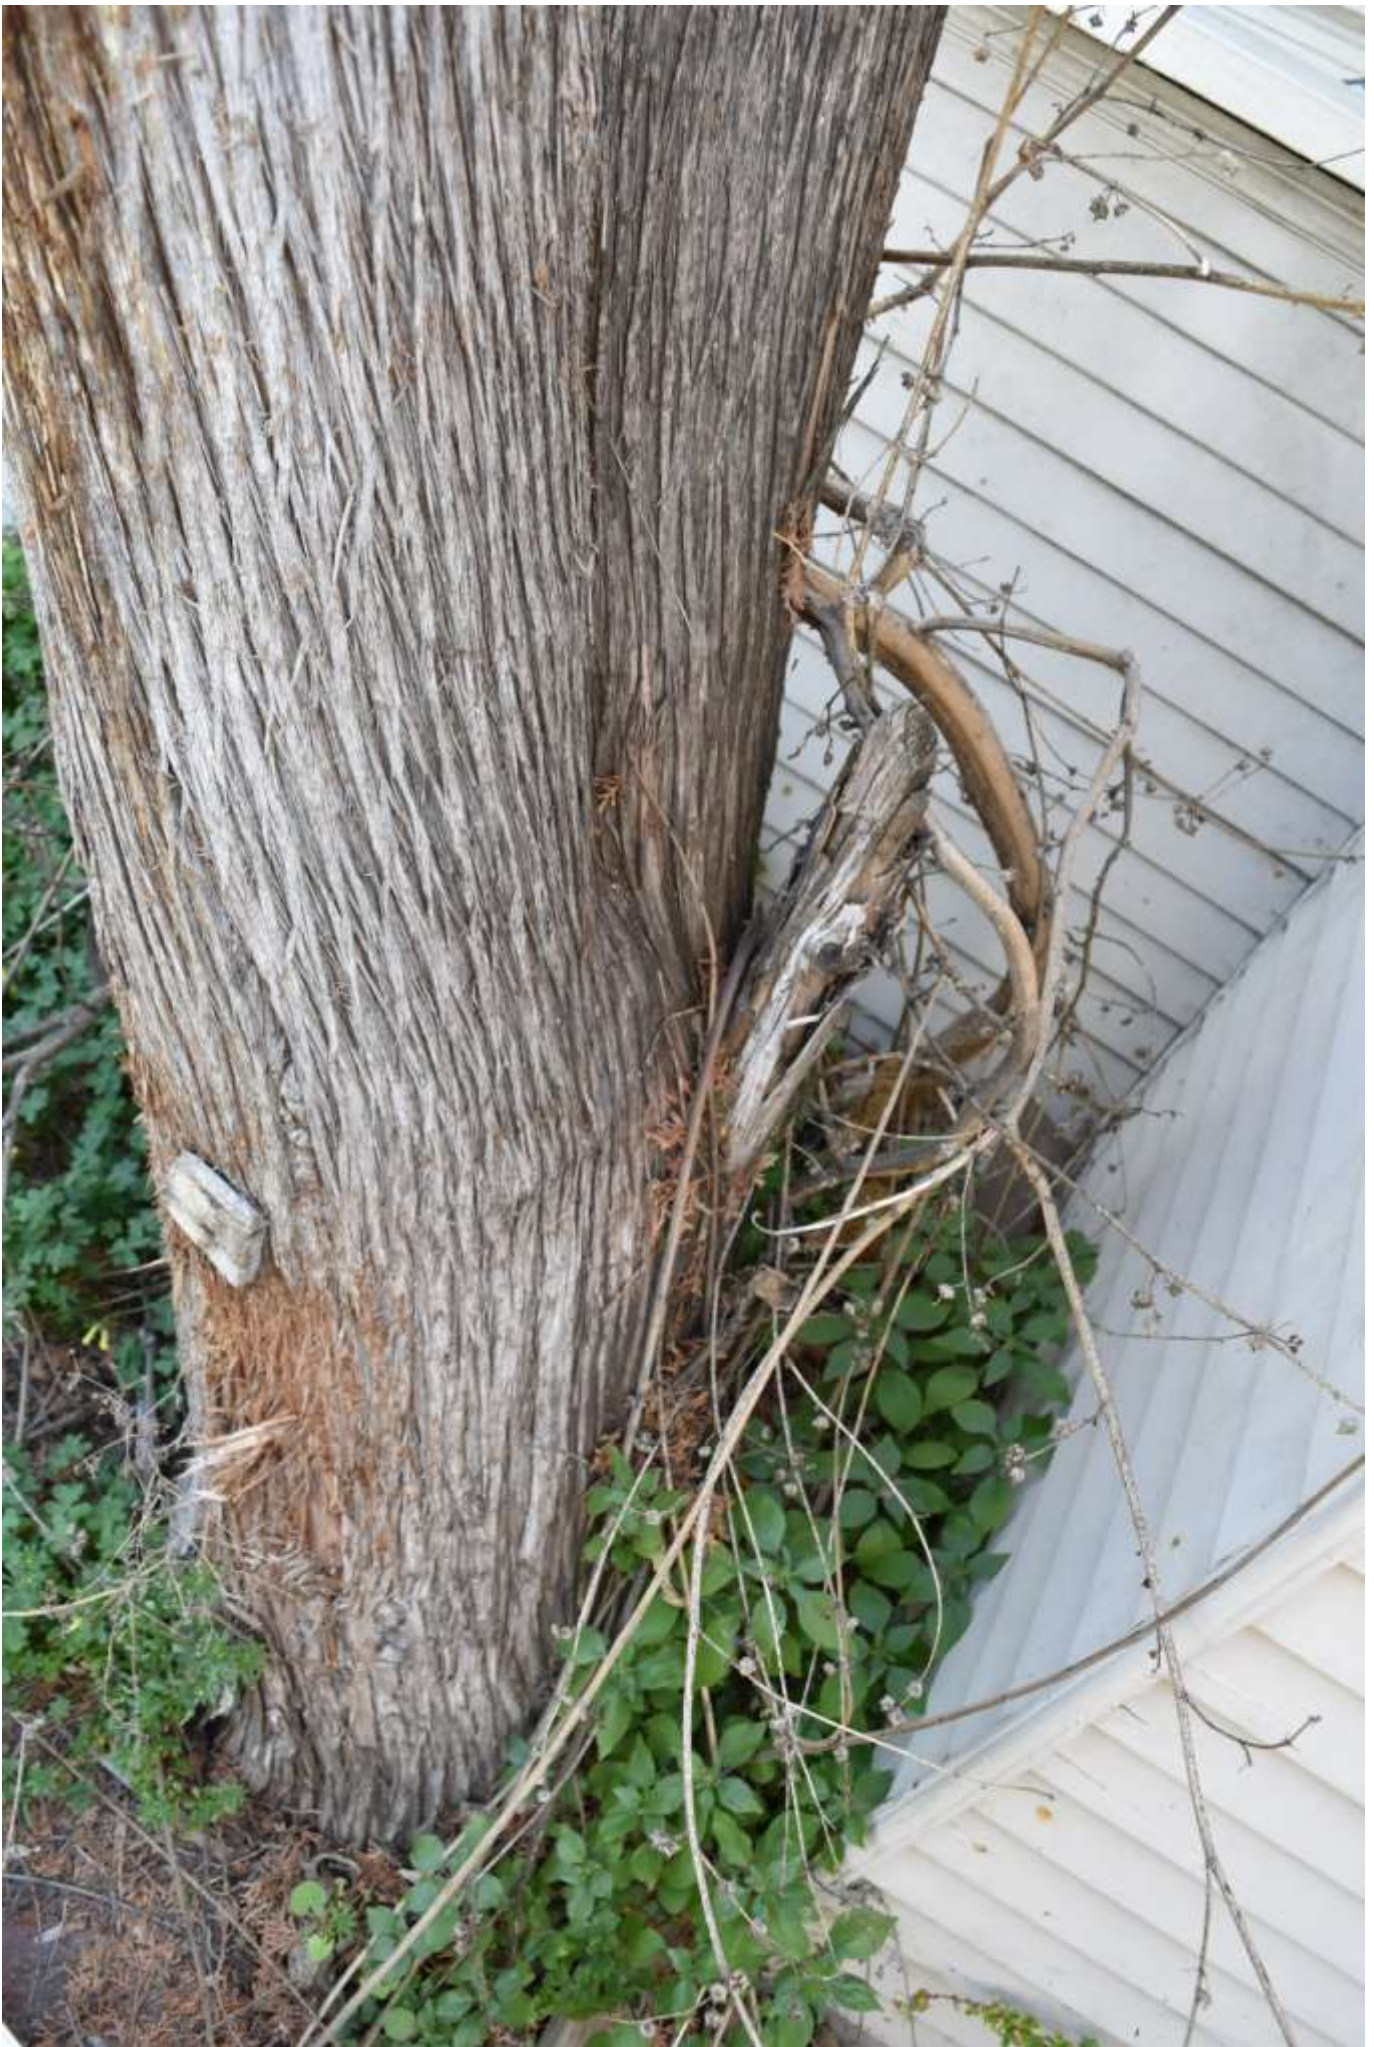
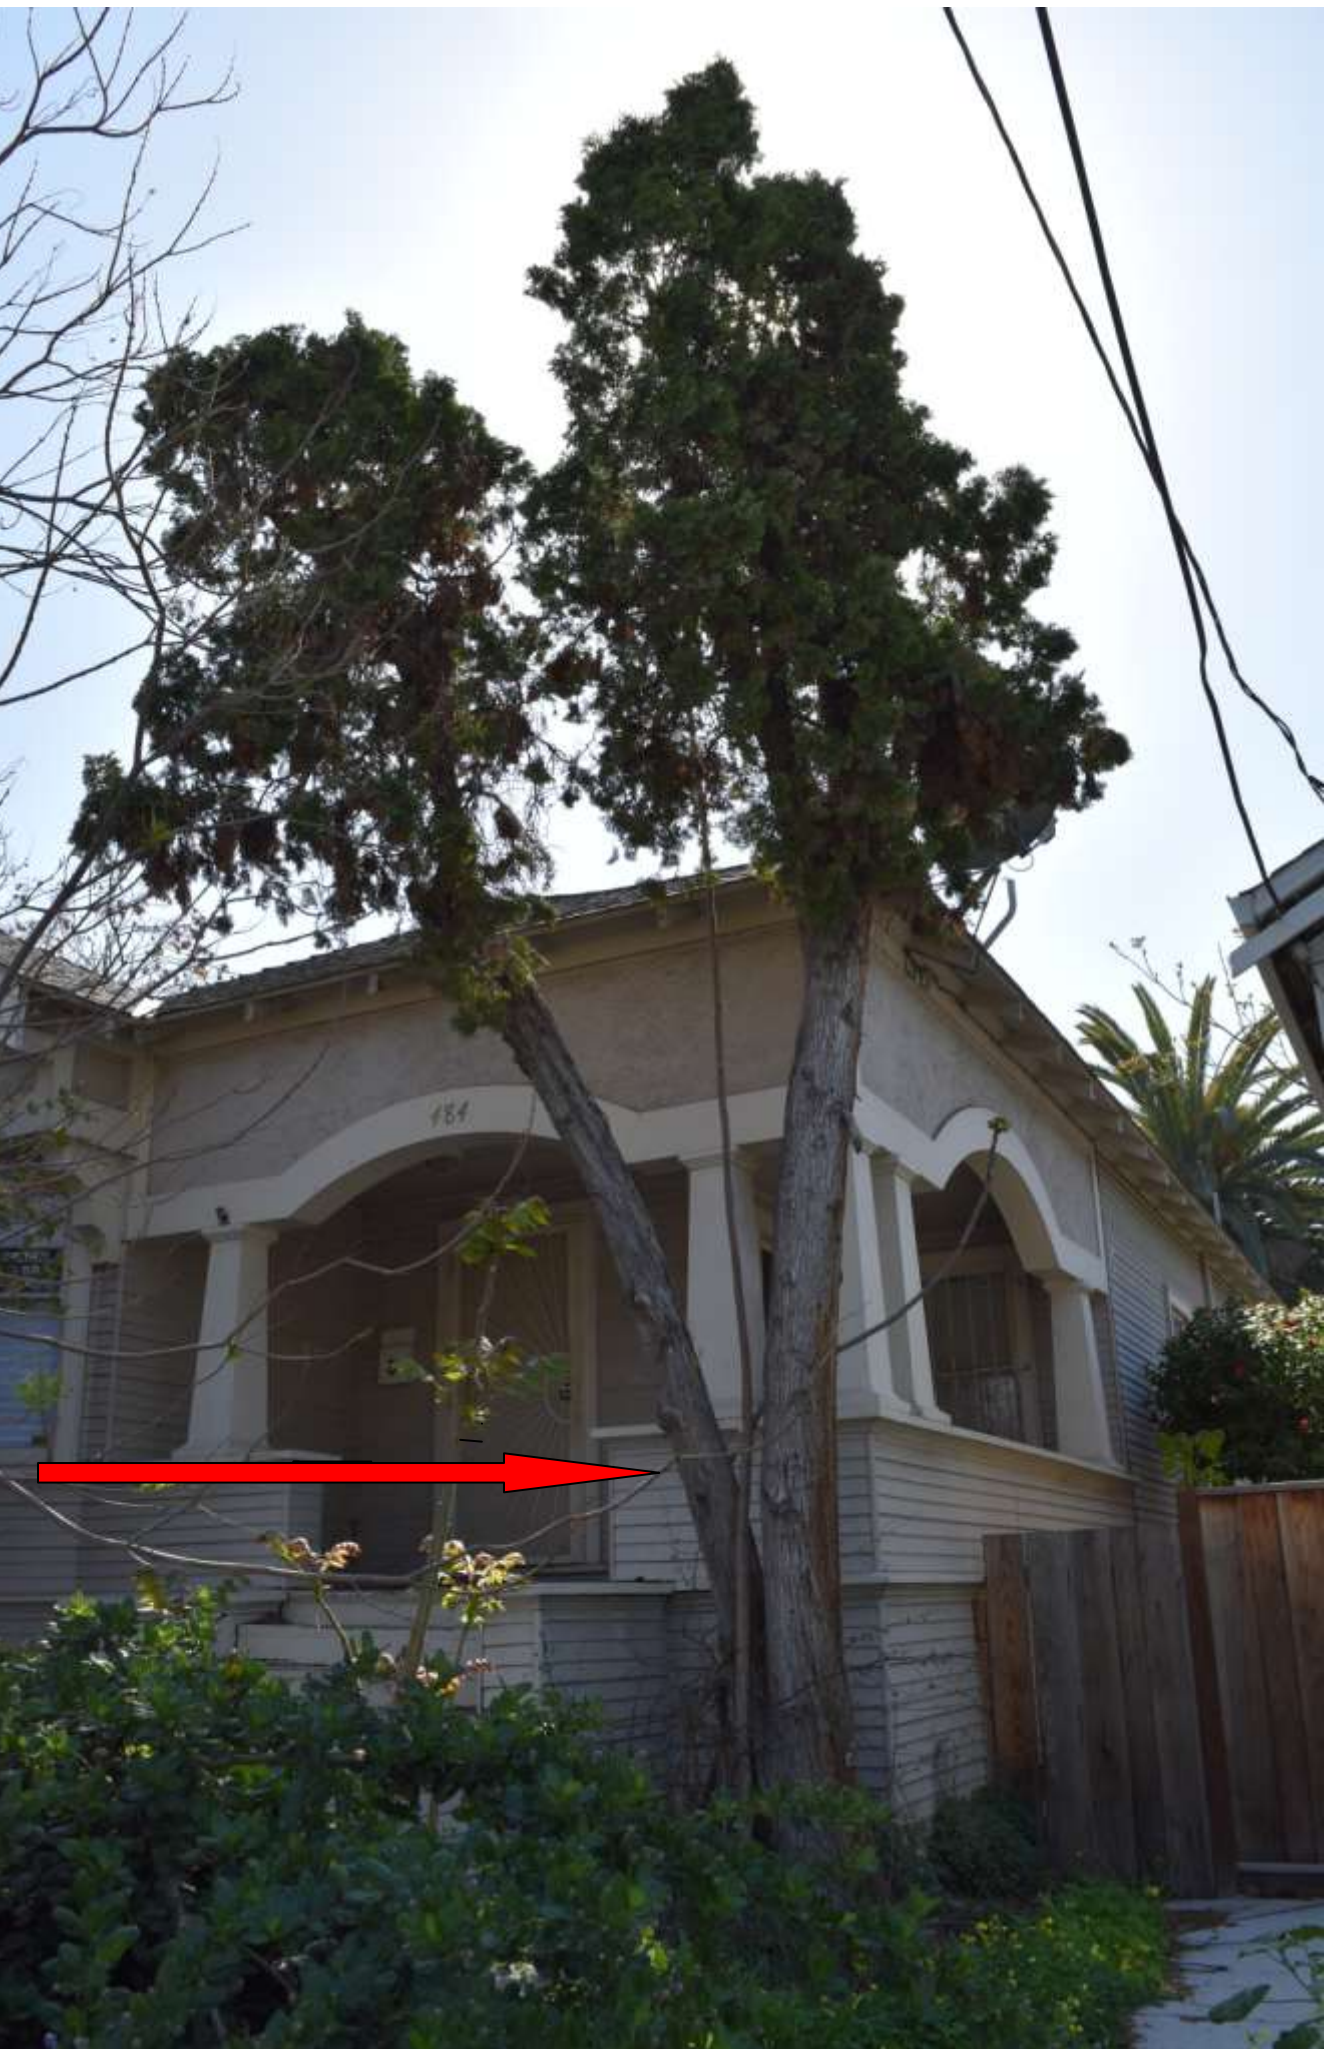
The tree is currently very unhealthy and dying, I found the tree with very poor structure, low crown ratio, topped, trunk decay and with a deformed shape.

The current condition of the tree and the proximity from the tree to the house increases the risk for a potential failure, posing a very significant hazard to the existing structures and the public.

Hazard abatement: remove tree, replace with one 15 gallon Magnolia grandiflora 'Little Gem'

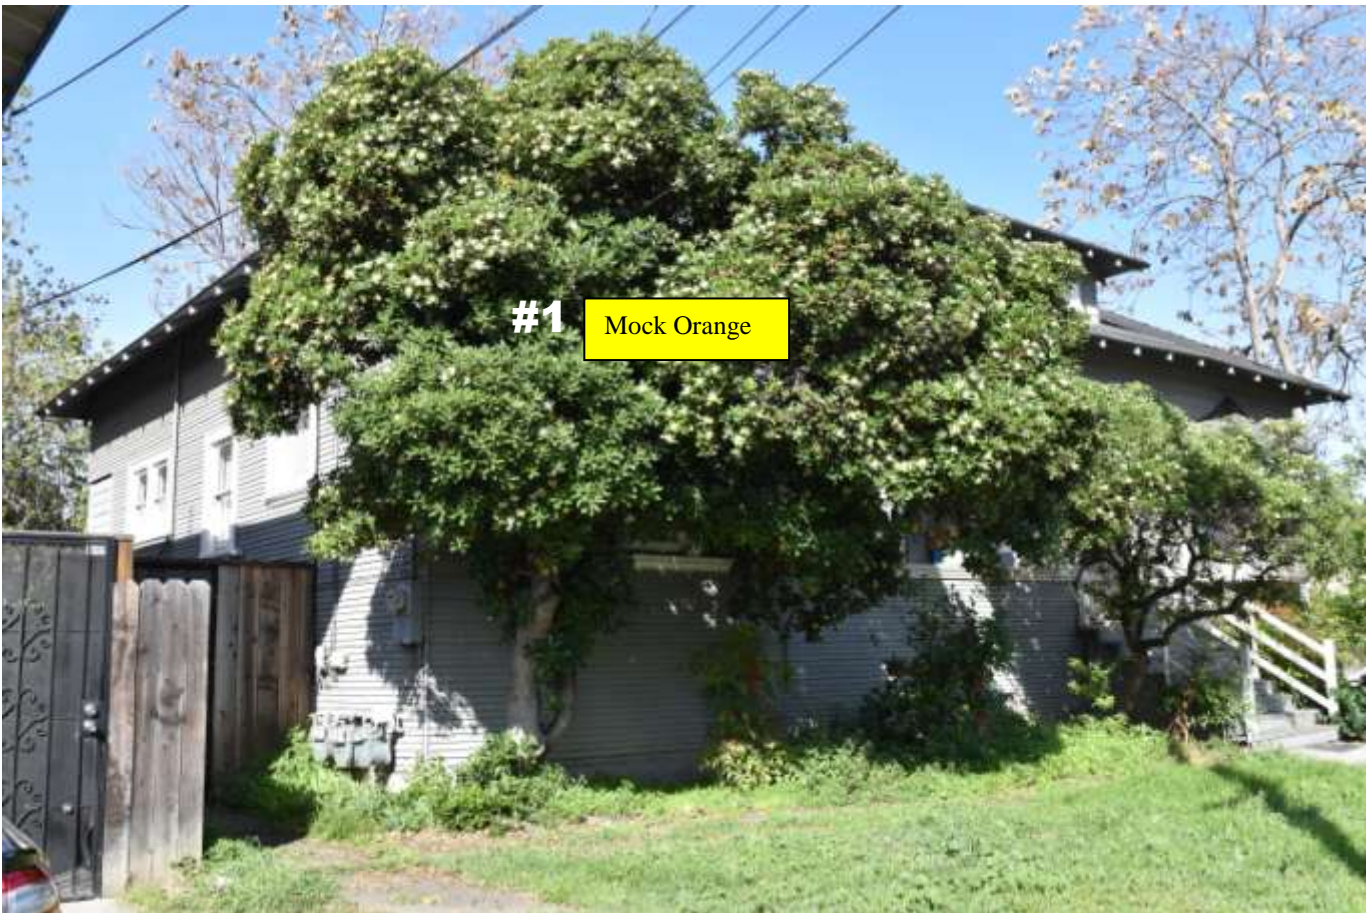
#1

Evergreen plant native to Japan.  
The color of the foliage looks normal and the overall condition is good.

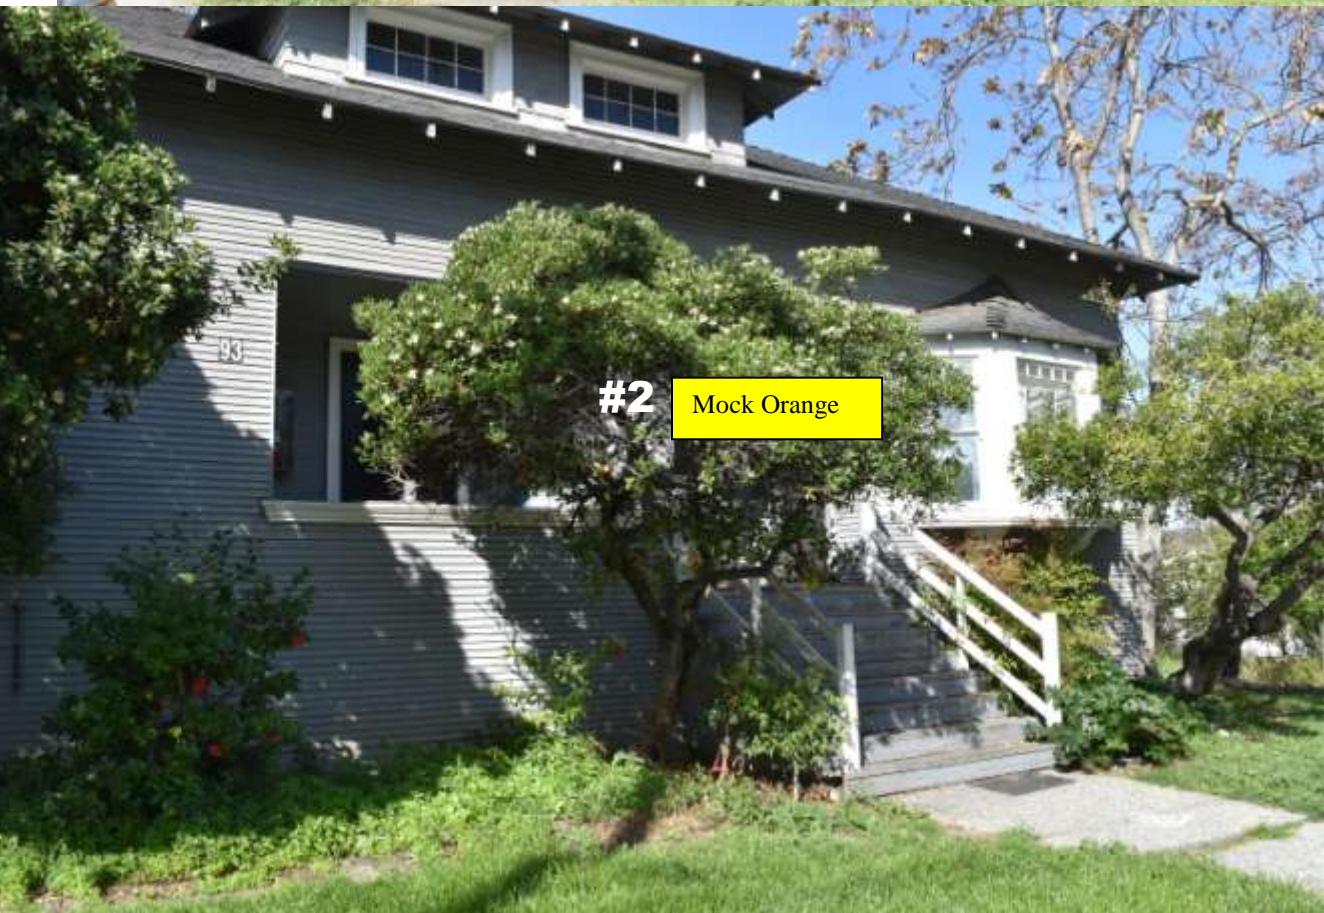
#2

Evergreen plant native to Japan.  
The color of the foliage looks normal and overall condition is good.

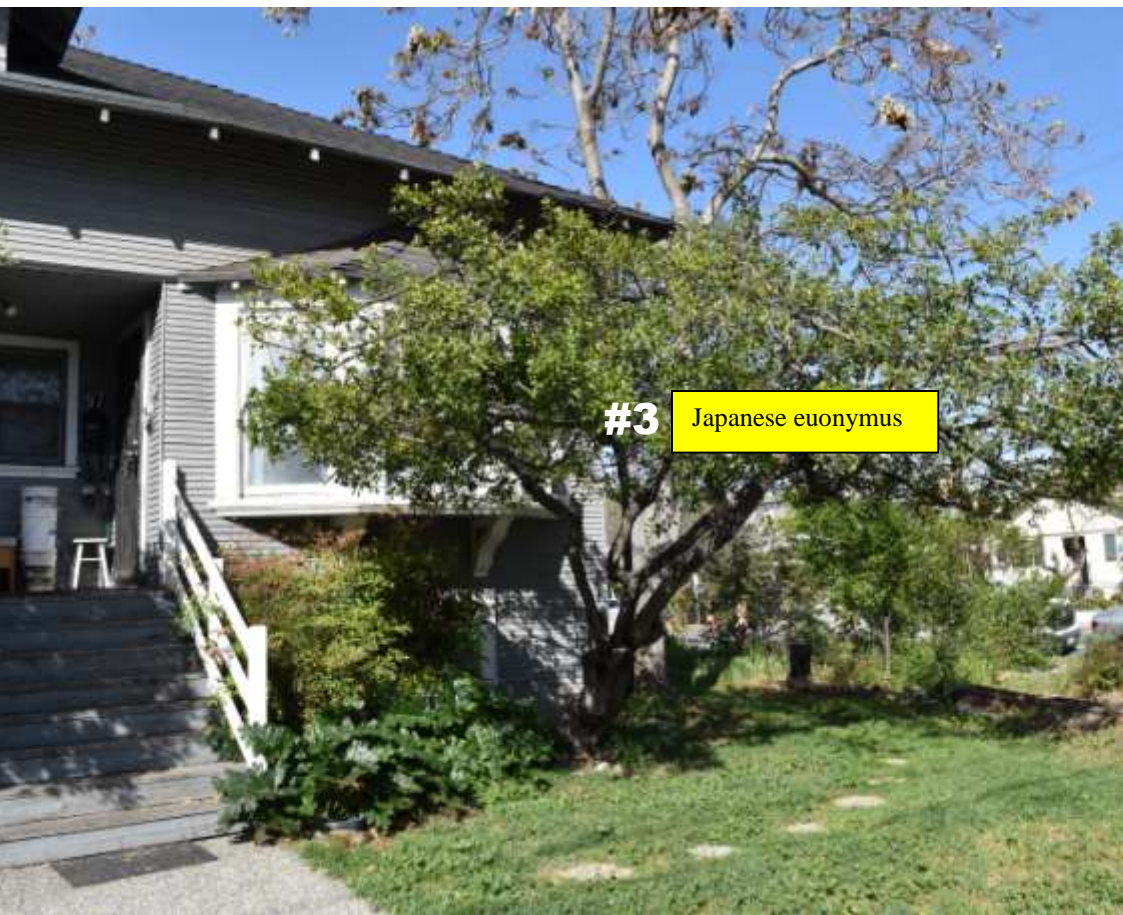
#3 Japanese euonymus

Evergreen plant native to Japan, Korea and China.  
Subject plant is dying, poor crown ratio, dead bark and poor structure.
