## Arborist Report

# Tree A of Initial Study Fig 15

Address: 484, 488 E Saint John Street and 93,95, 97 N. 11th Street  
San Jose, CA. 95112

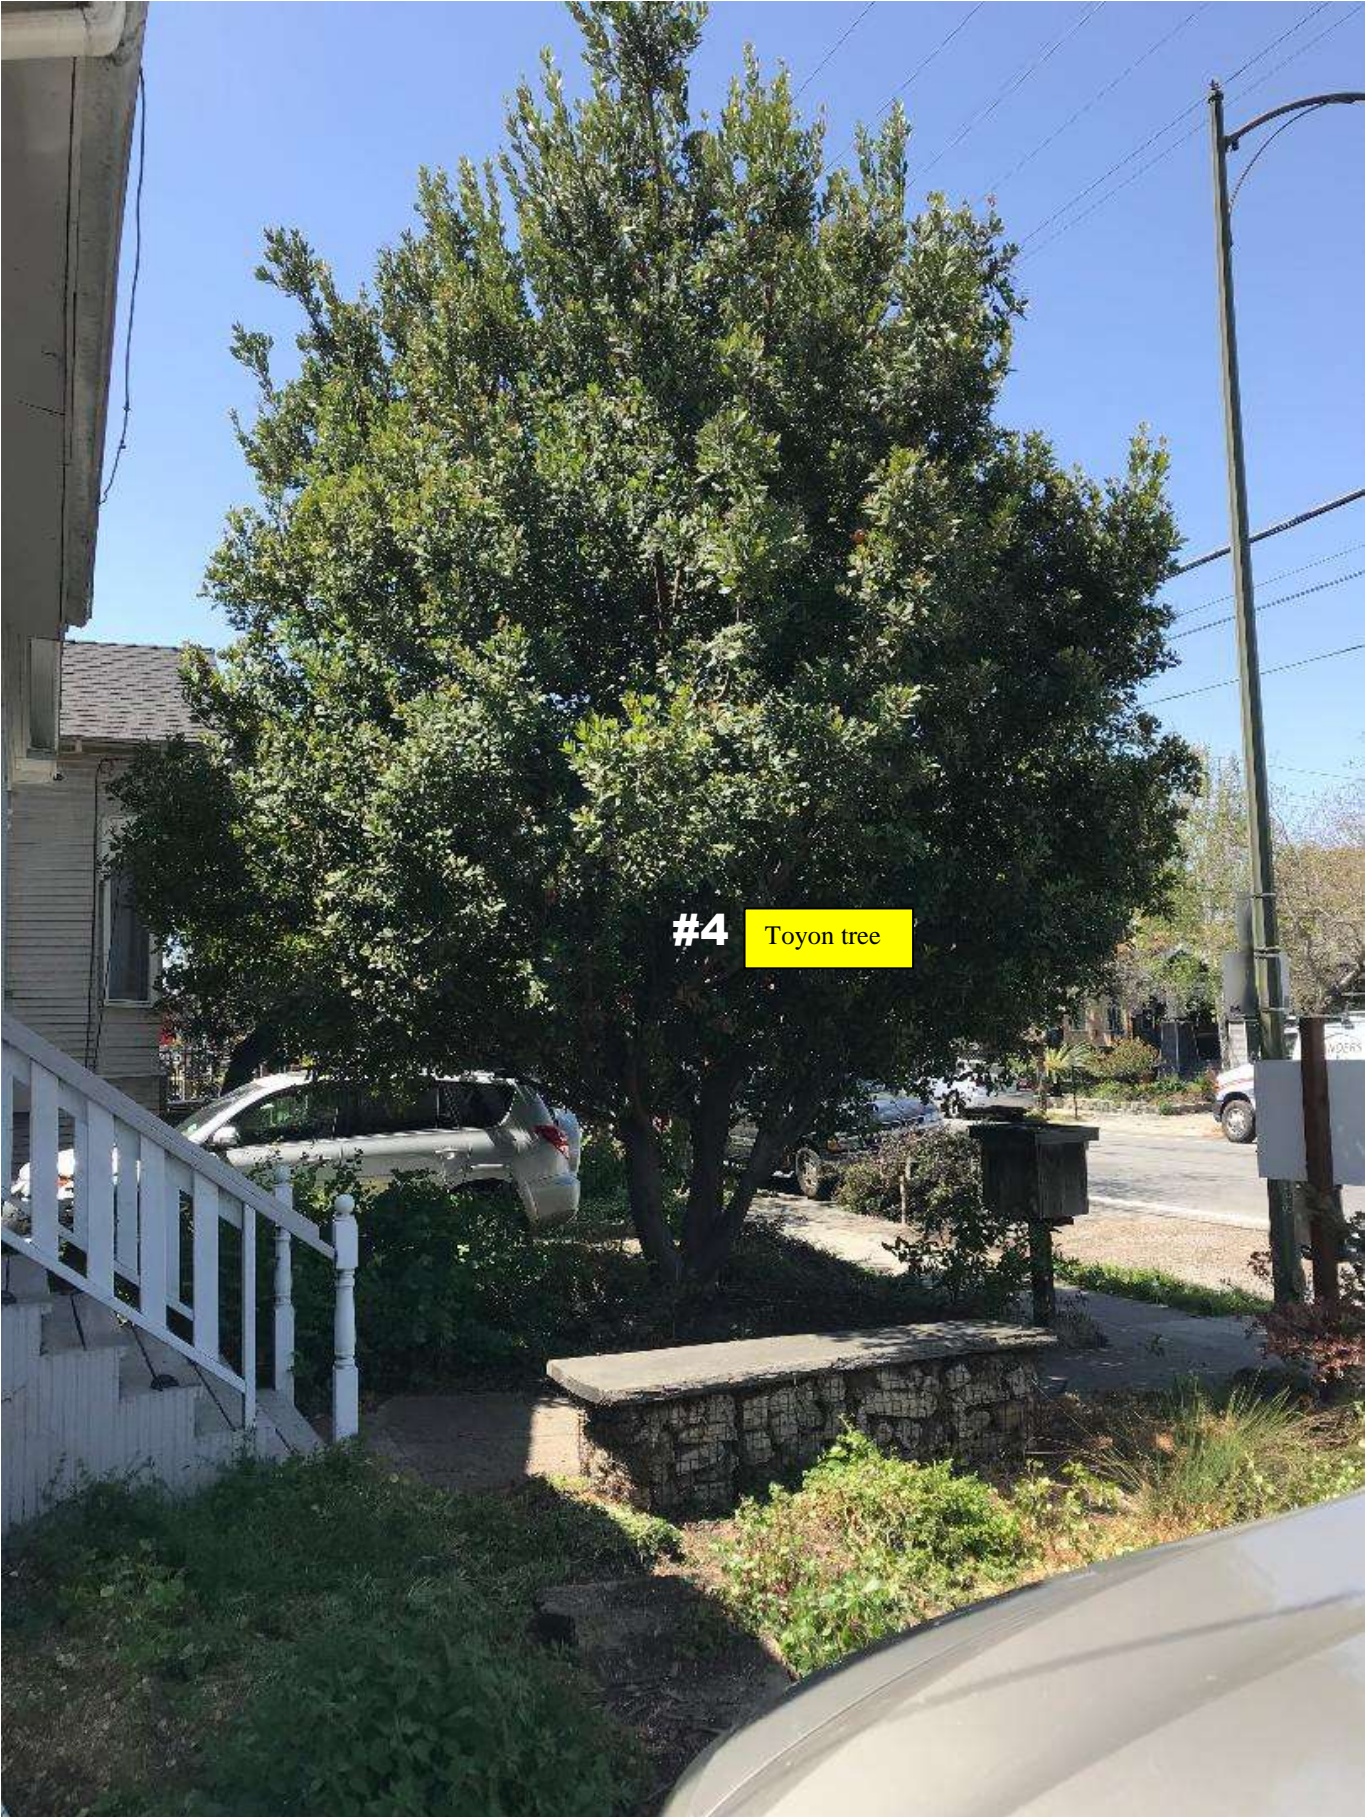
#4 Toyon tree

Evergreen tree native to Oregon, California, Baja California and British Columbia.  
The foliage looks normal, healthy structure and few natural defects.

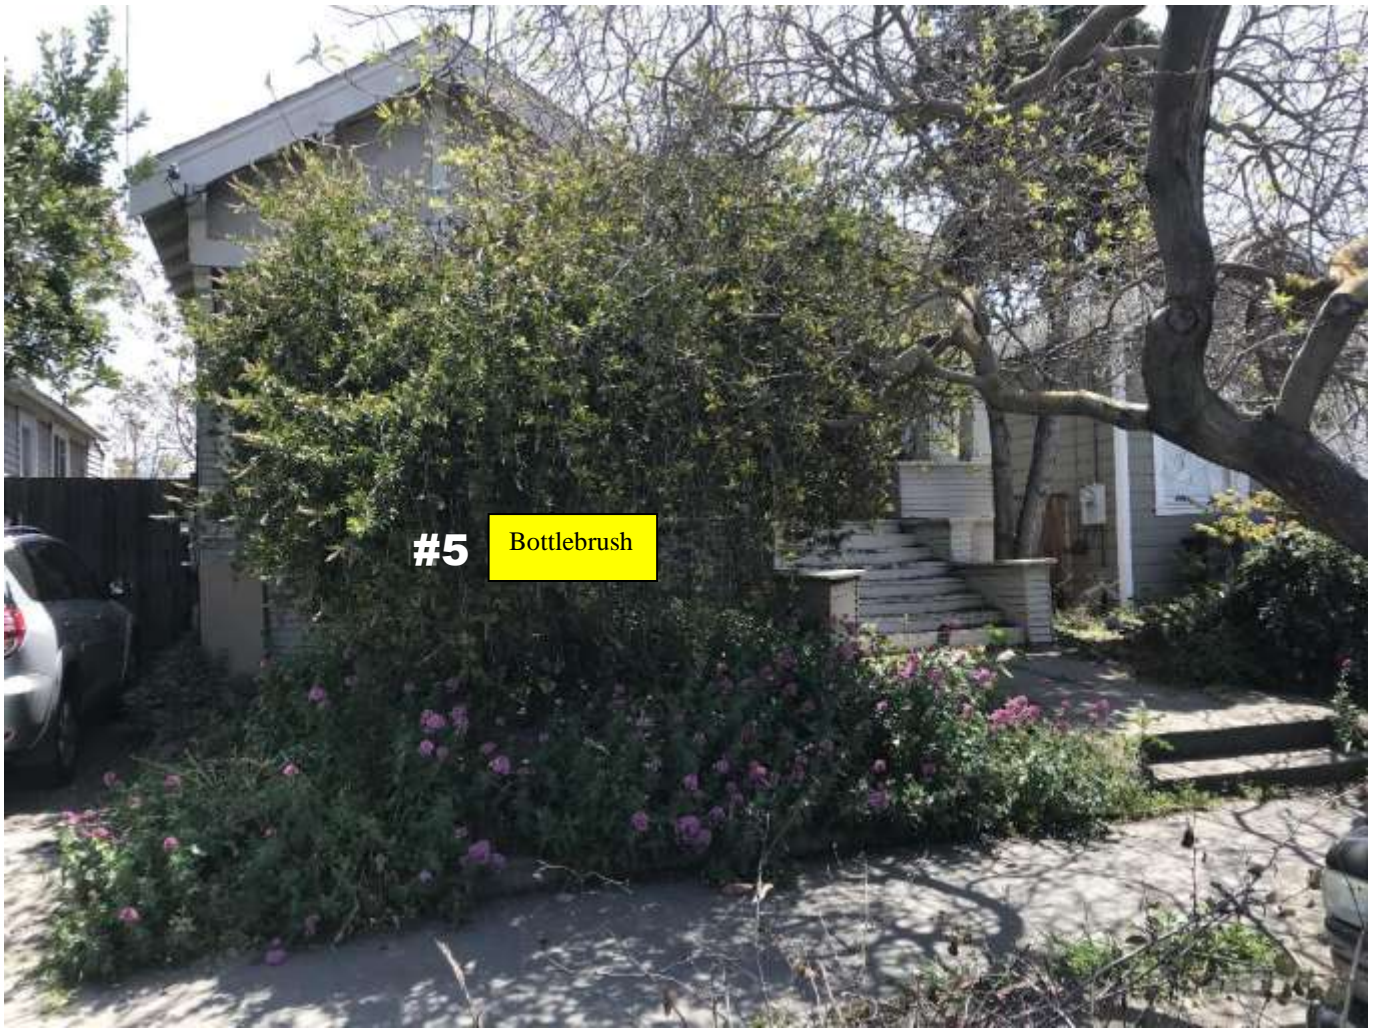
**#5**

Evergreen tree native to Australia.  
The foliage looks normal, tree is leaning towards the sidewalk and with a healthy crown ratio.

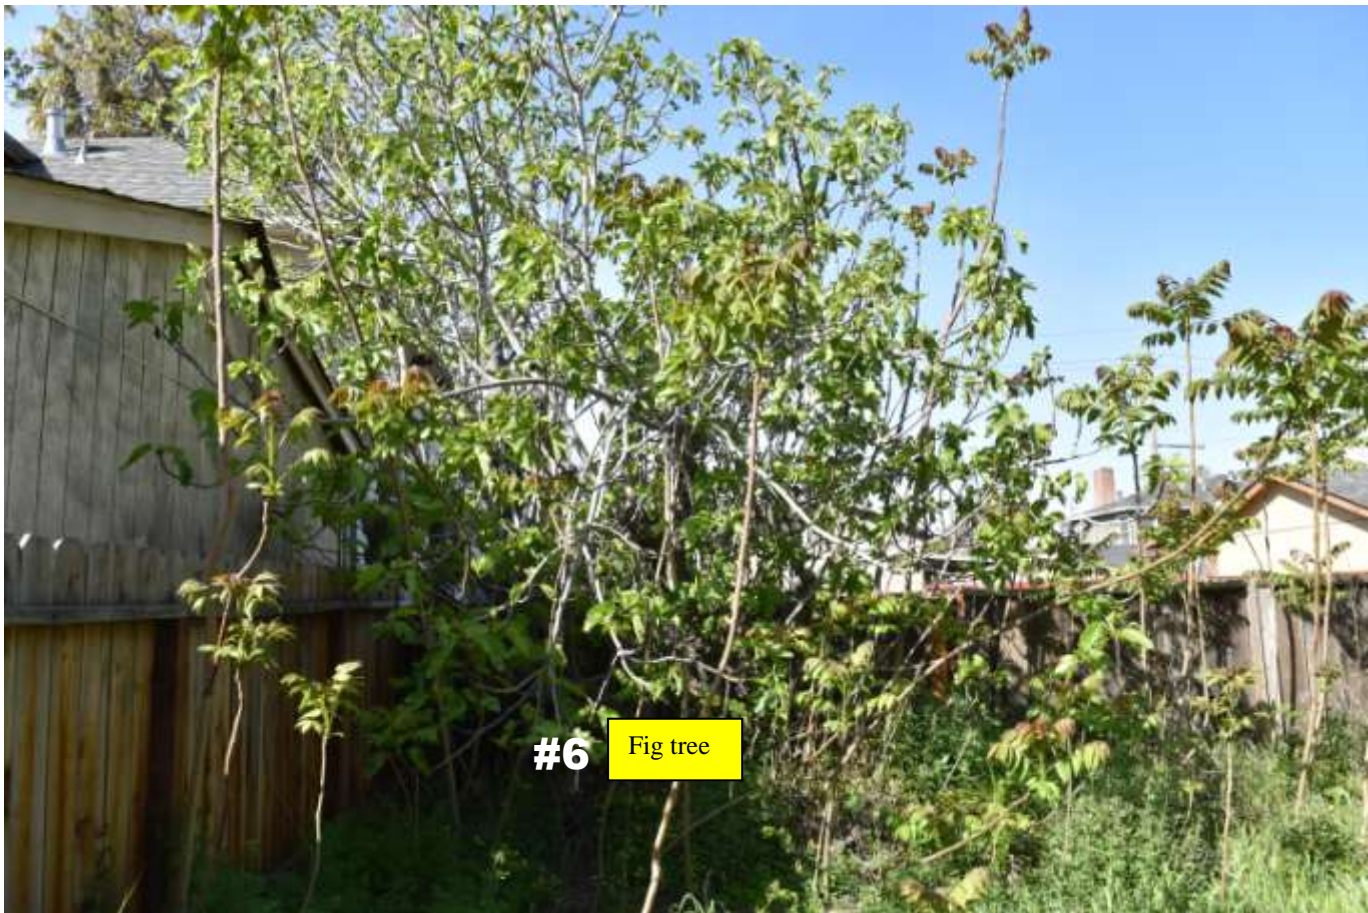
#6 Fig tree

Fruit tree native to Asia.  
The tree is very overgrown with several suckers growing from the root system and lack of maintenance.

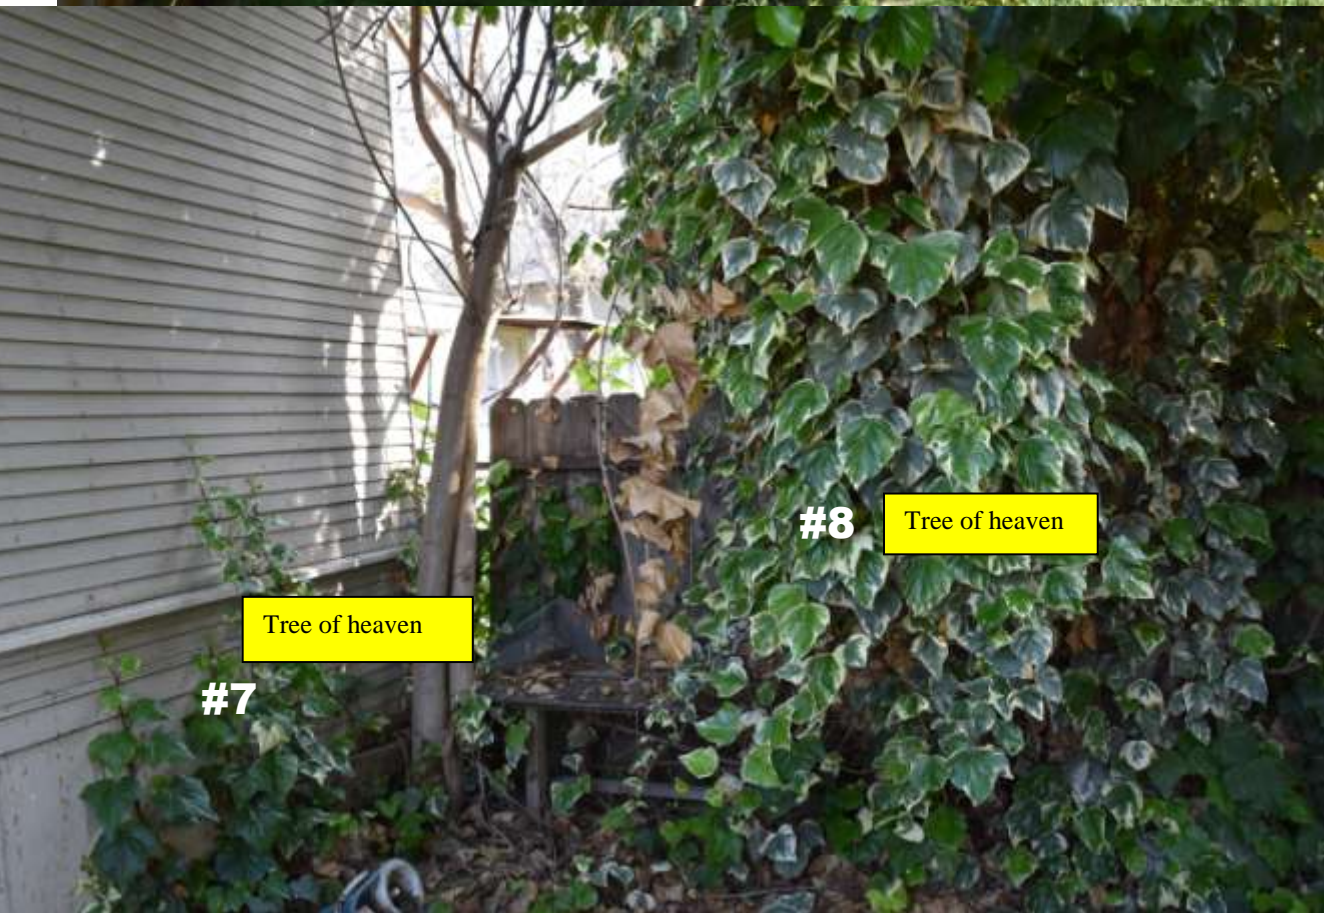
#7

The tree is covered with Ivy and is in very poor condition.

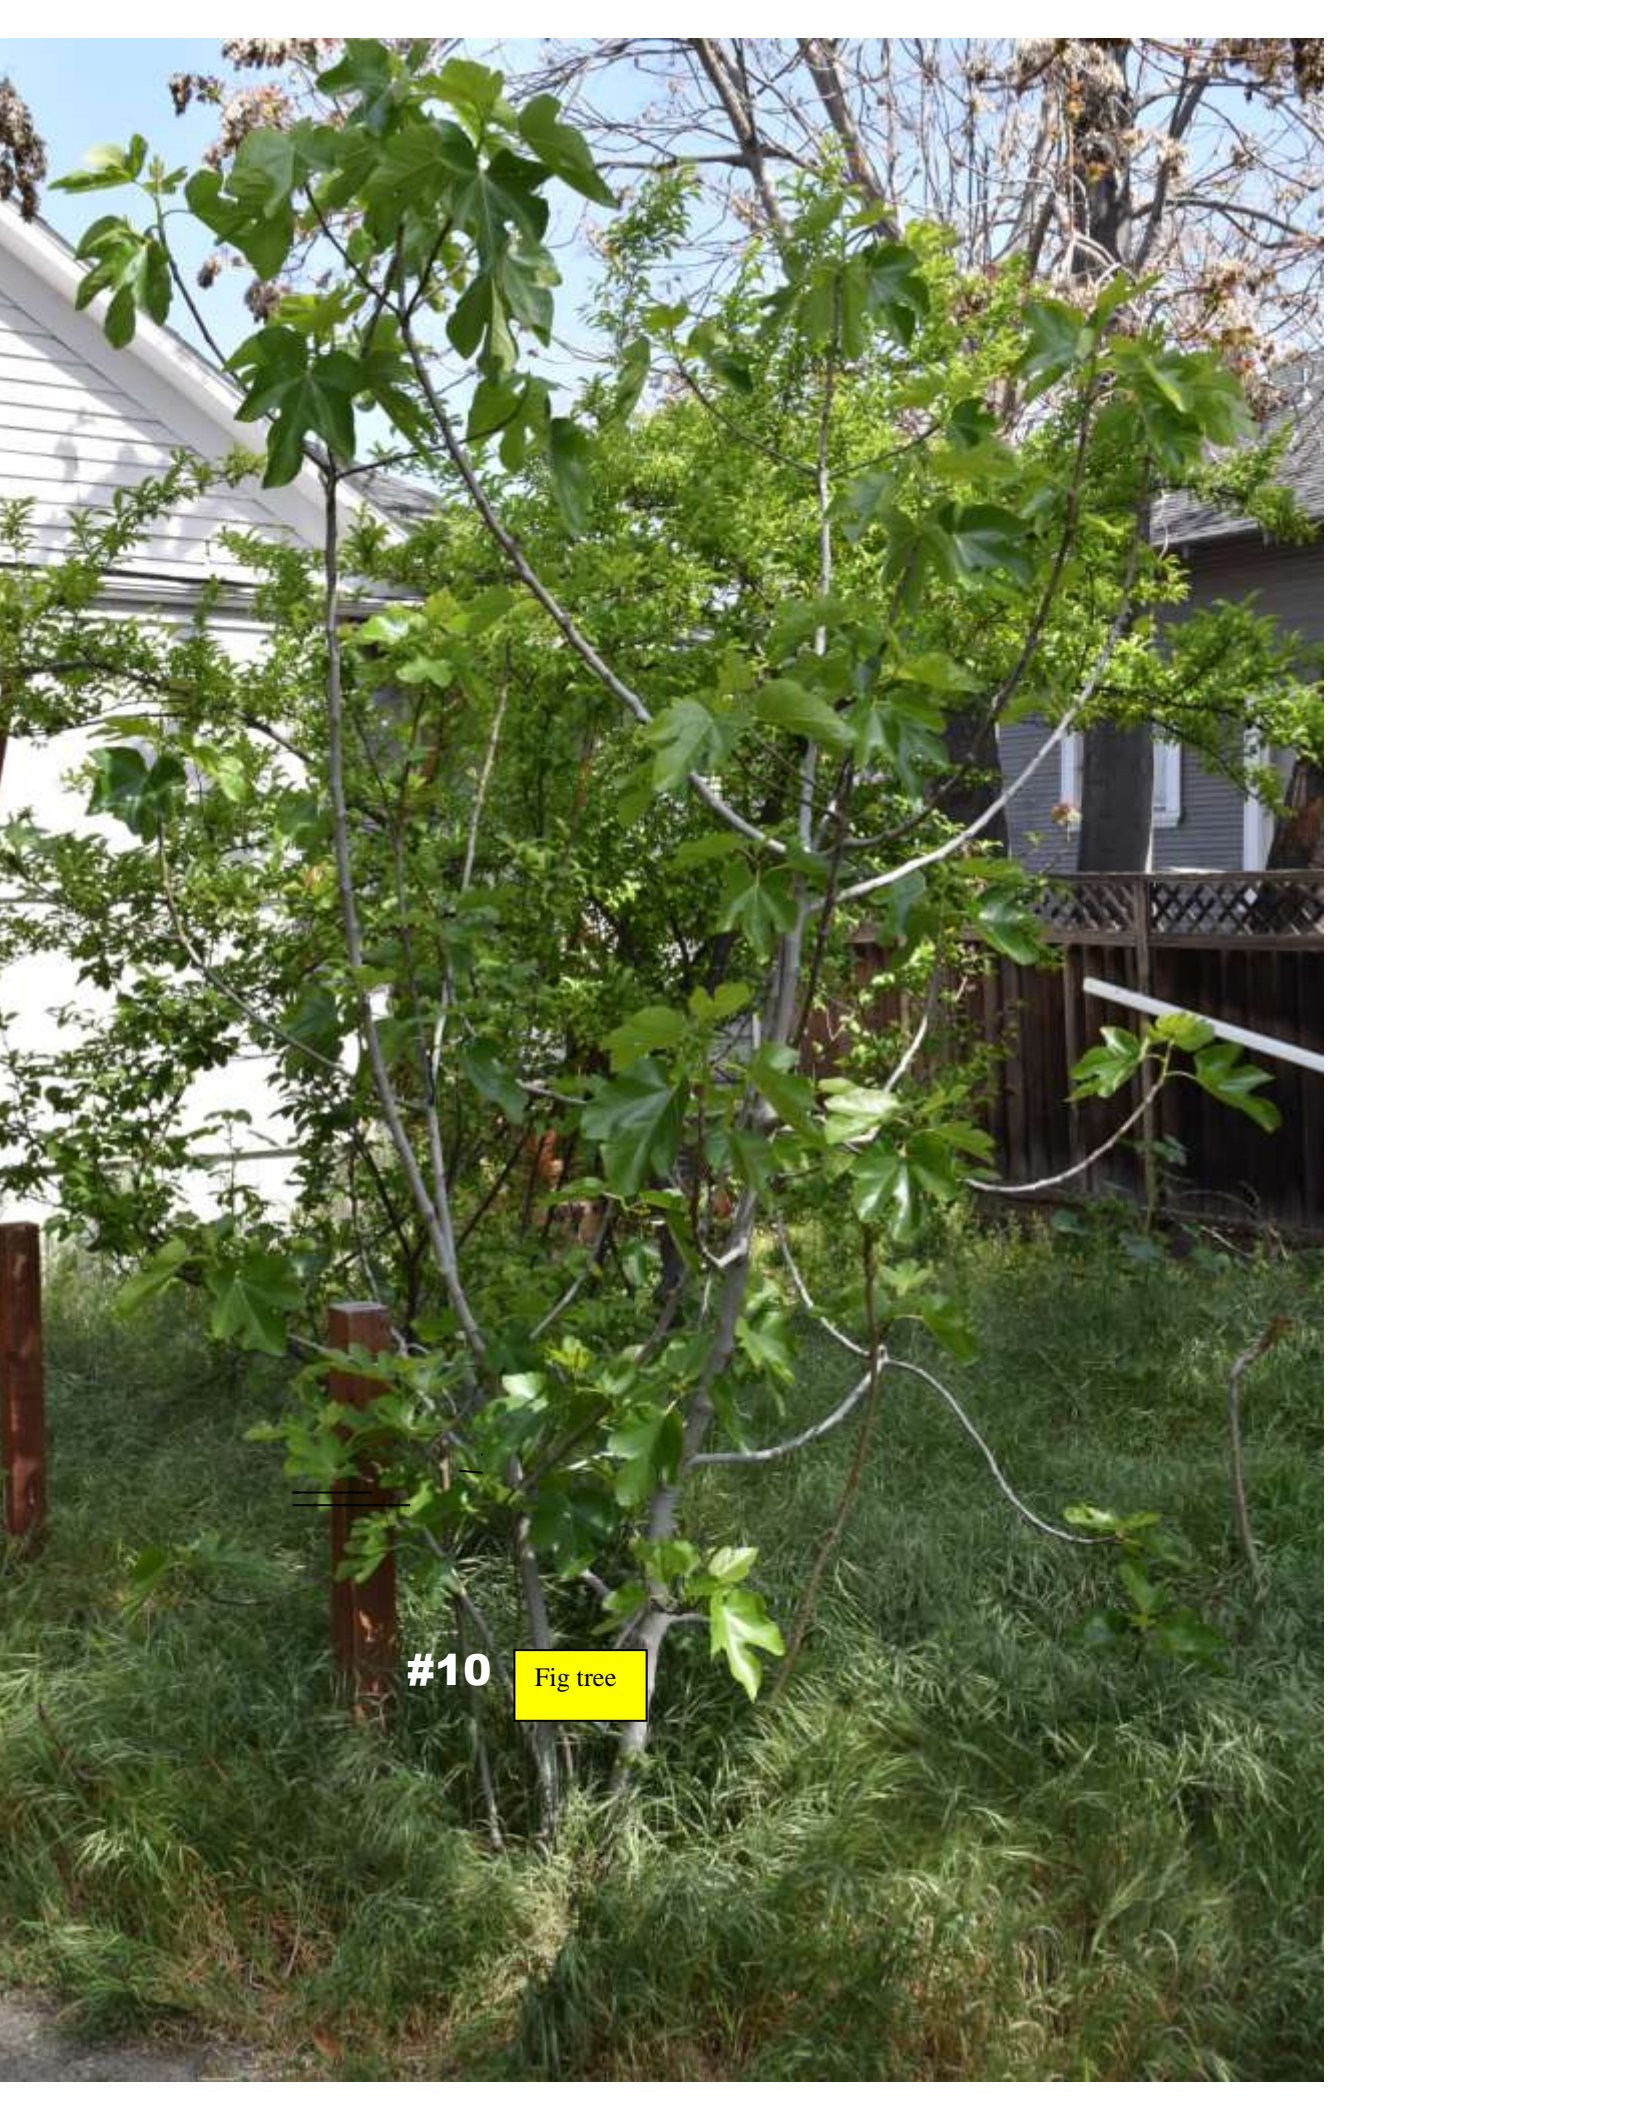
#10

Very young non-native fruit tree.
