**Tree Inventory, Assessment
and
Protection**

**1728 & 1750 Rogers Avenue
San Jose, CA**

December 2, 2020

Monarch Consulting Arborists

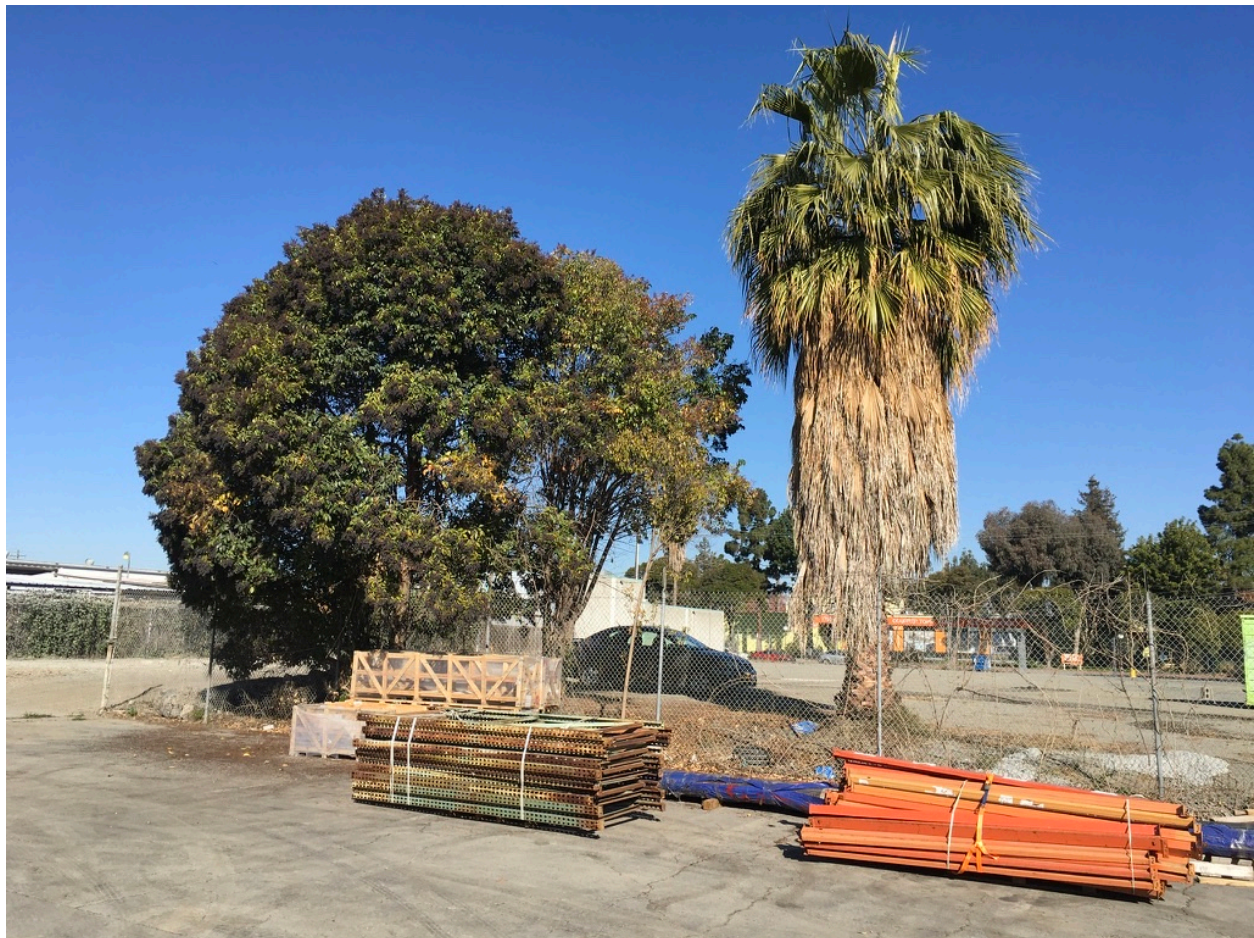
FAN PALM AND PRIVETS IN BACK TO BE REMOVED

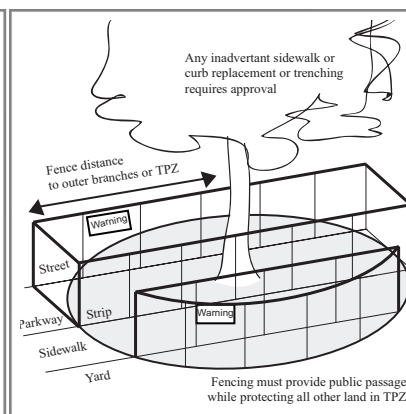
Figure 2: Type II Tree protection with fence placed along the sidewalk and curb to enclose the tree. Image City of Palo Alto 2006.

Tree protection for this project will require a Type II scheme (Figure 2 below) because the only trees to remain are “Street trees”. Fence will need to be placed at the sidewalk to enclose the exposed soil space to the perimeter security fence. Each planting bed should be fenced to prevent damage.

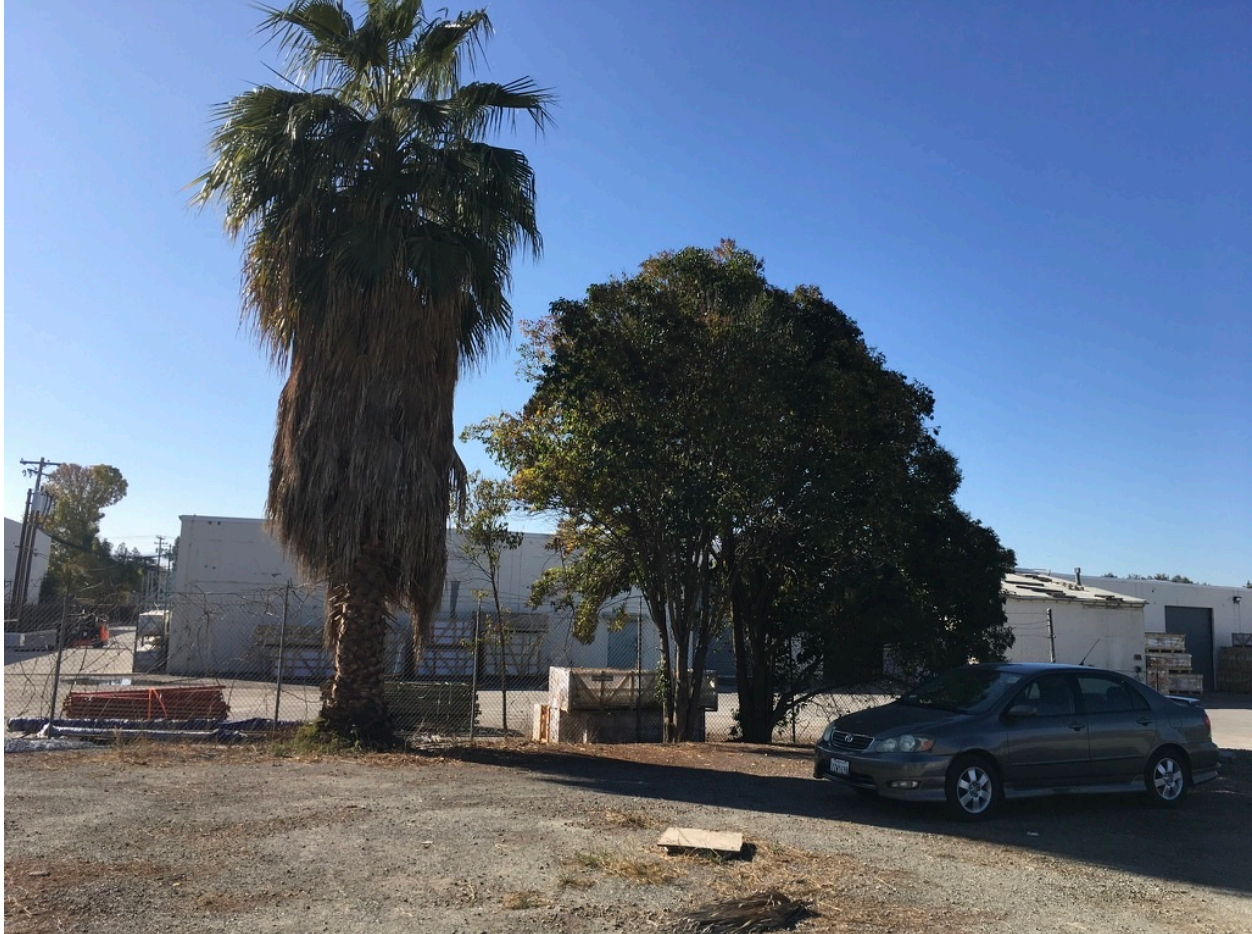
C1: Fan palm #1 and privets #2 and #3

Three trees are “Ordinance” size and include the Mexican fan palm #1 and privets #2 and #3 in the center rear of the site. The remaining trees are “Street Trees” and include zelkovas #4 - #8, Raywood ash #9 and #10, and fir #11. All of the street trees are located under the high voltage lines along Rogers Avenue. The inventory contains three “Ordinance” and eight “Street Trees.”

All the "Street Trees" are in "poor" or "very poor" condition while the volunteer privets and Mexican fan palm are in "good" or "fair" shape.

All the trees indicated for removal, Mexican fan palm #1 and privets #2 and #3, would meet the following finding as stated in Chapter 12.32.100 section A subsections “(2) *That the location of the tree with respect to a proposed improvement unreasonably restricts the economic development of the parcel in question;*” and (3) *That the condition of the tree with respect to disease, danger of falling, proximity to an existing or proposed structure, and/or interference with utility services, is such that preservation of the public health or safety requires its removal;*”

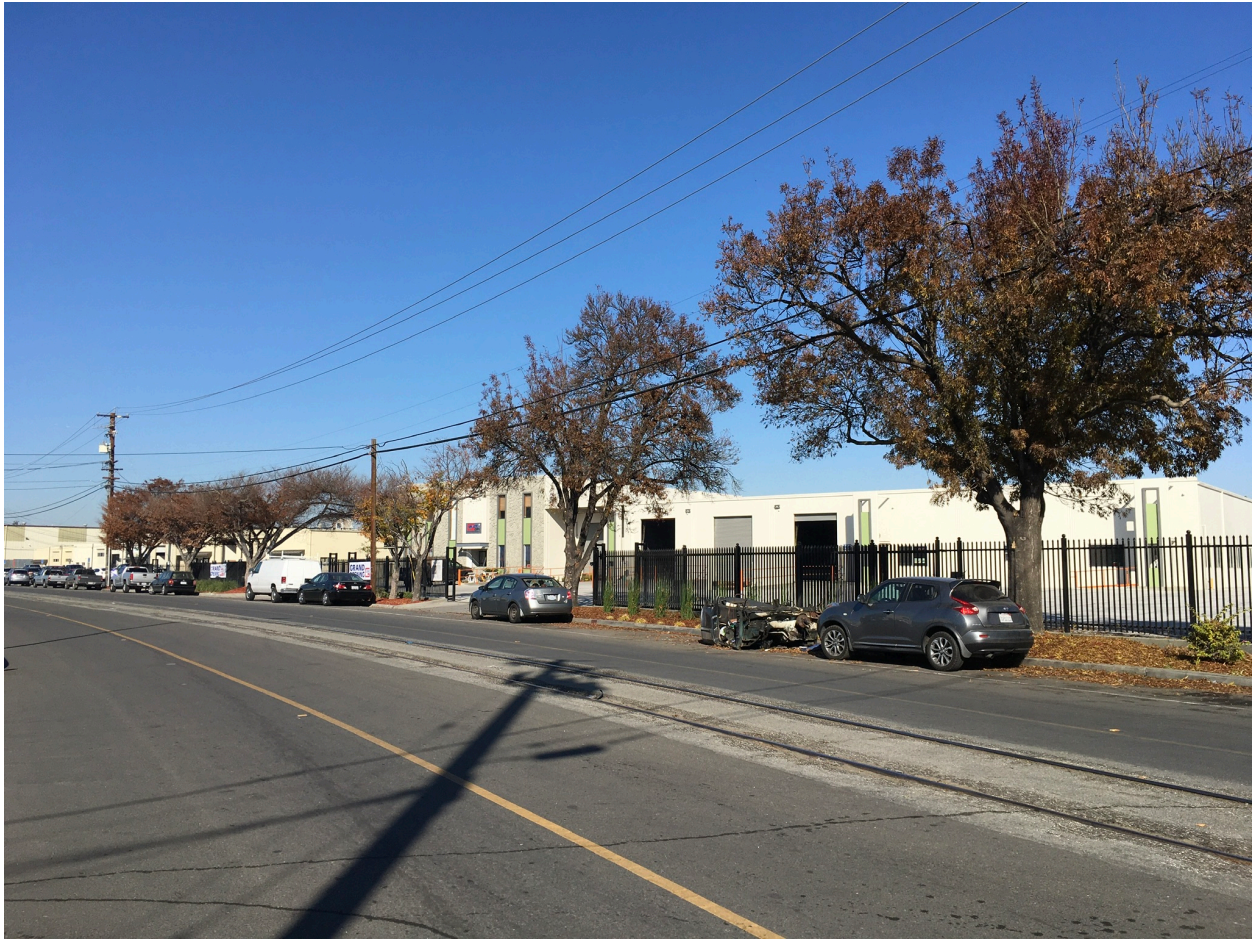
C2: Street trees #4 through #10

The remaining “Street Trees” #4 through #11 are not expected to be impacted by the proposed project and are to remain.

1. Place tree numbers and any protection schemes on all the plans.
2. Place tree protection fence around the street trees to be retained at the edge of sidewalk and to enclose them in a Type II scheme to the security fence.

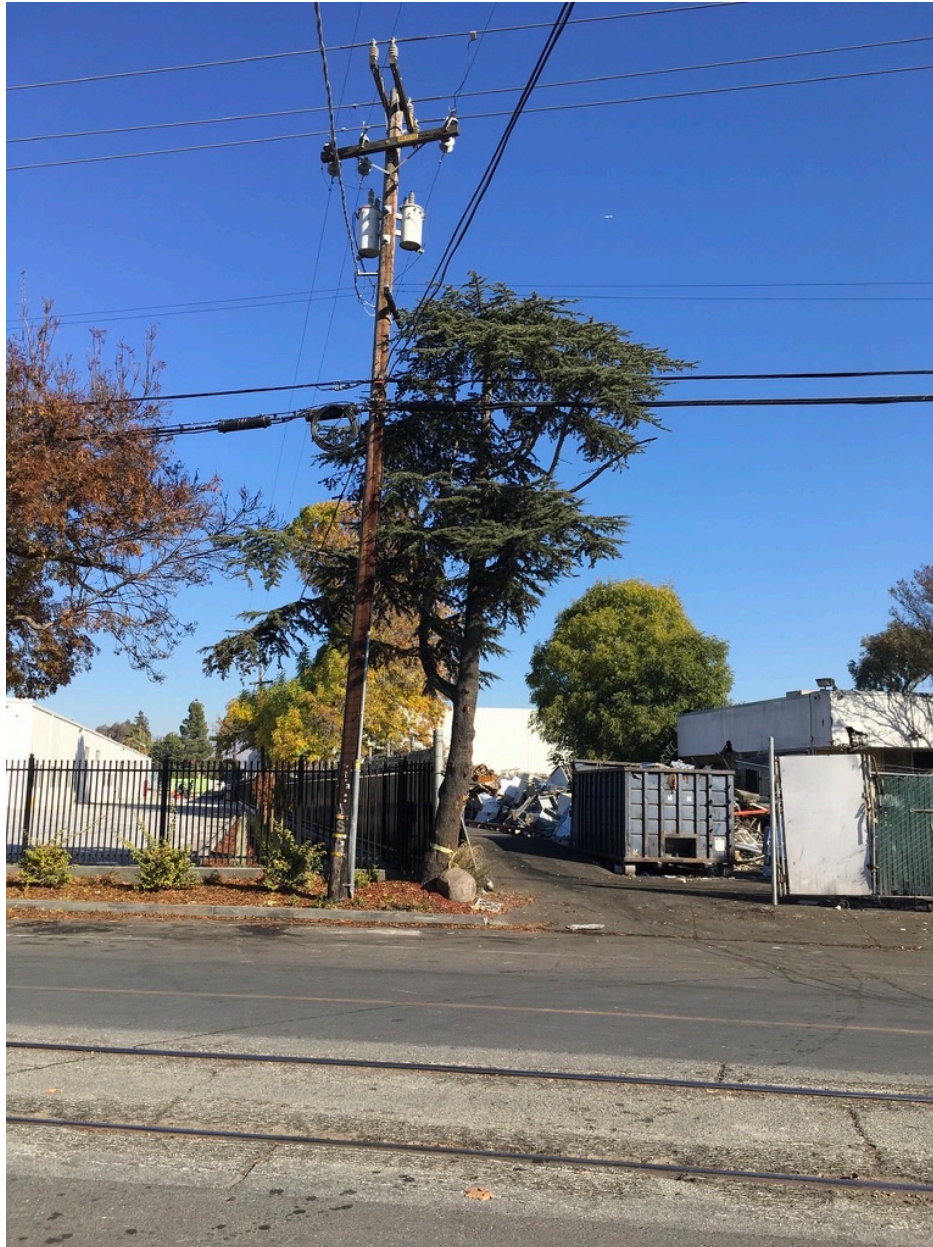
C3: Fir #11

Fir (<i>Abies concolor</i>)	11	Very poor	Poor - Condition and inappropriate species under utility lines
