ARBORIST REPORT

Re: 972 Elm Street, San Jose CA

Tree Chart
972 Elm Street, San Jose, CA
(revised May 19, 2021)

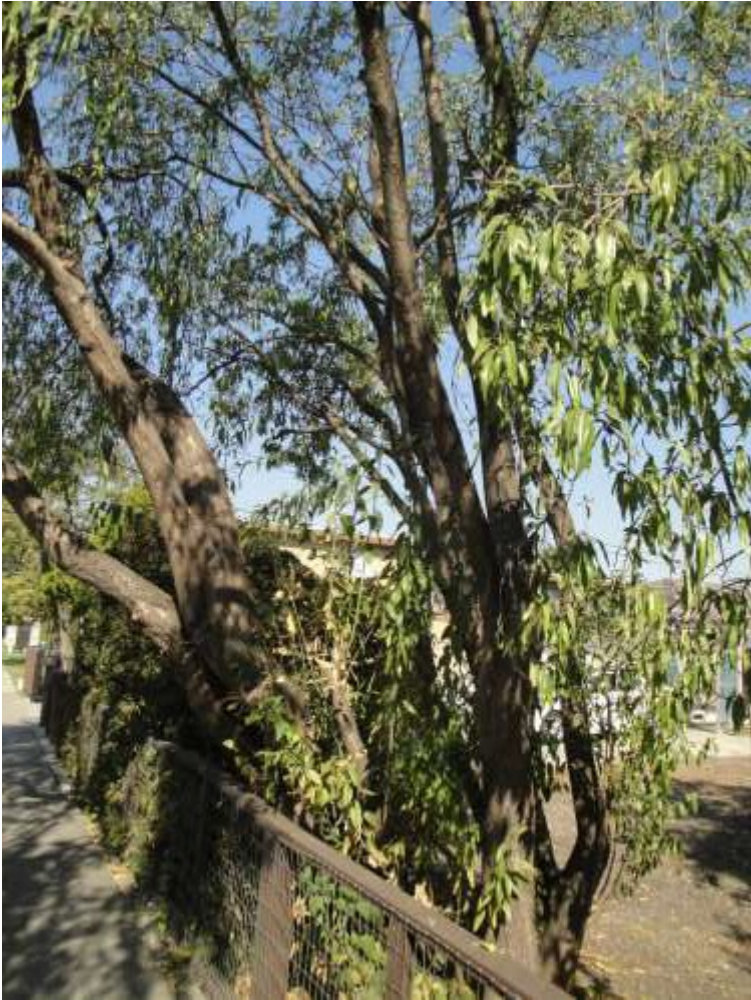
Tree #2

Tree # 2, Almond tree species: appx. 38" DBH combined, multiple main stem trunk, a 119.4" circumference, and an 18' canopy. Tree is in decline and struggling to survive due to drought stress and neglect. Tree is leaning a bit to the east, and appears to have had no maintenance for a long time. Some dead twigs and branches are present. Tree has no preservation value, and should be removed.

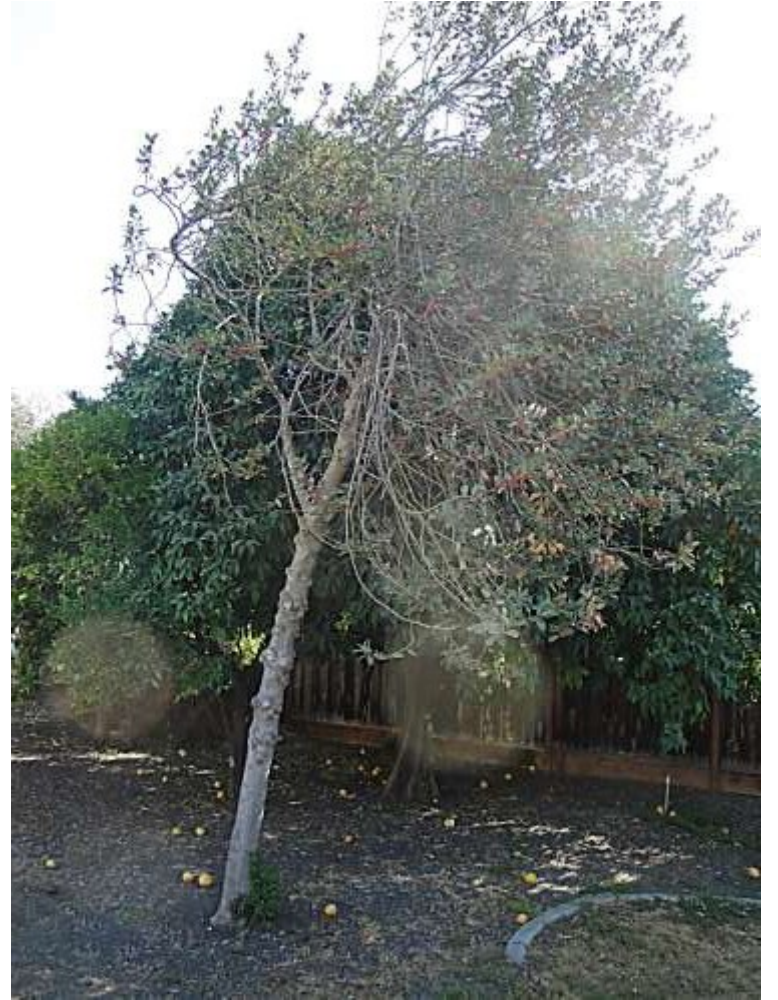
Tree #1

Tree #1, Holly Tree, Ilex specie: 6" DBH, an 18.8" circumference, and an 8' canopy. The tree is in poor condition and is in need of extensive pruning and shaping. There are areas of included bark; however, no decay is present. Tree foliage is sparse, has been neglected, is drought stressed, and has no preservation rating.

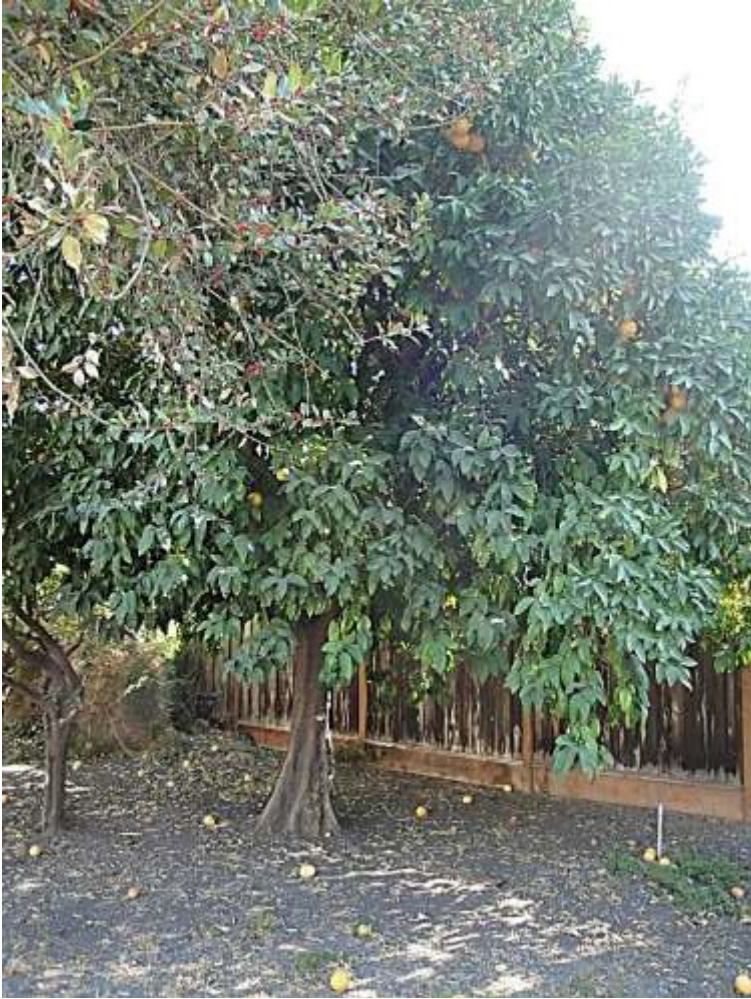
Tree #3

Tree # 3, Citrus species, Grapefruit tree: 15" DBH, a 47.1" circumference, and a 26' drip canopy. This tree is a mature fruit bearing which is in fair to good condition. Foliage is lush, dark-green, and full, with plenty of fruit within the canopy. Tree has a moderate preservation value.

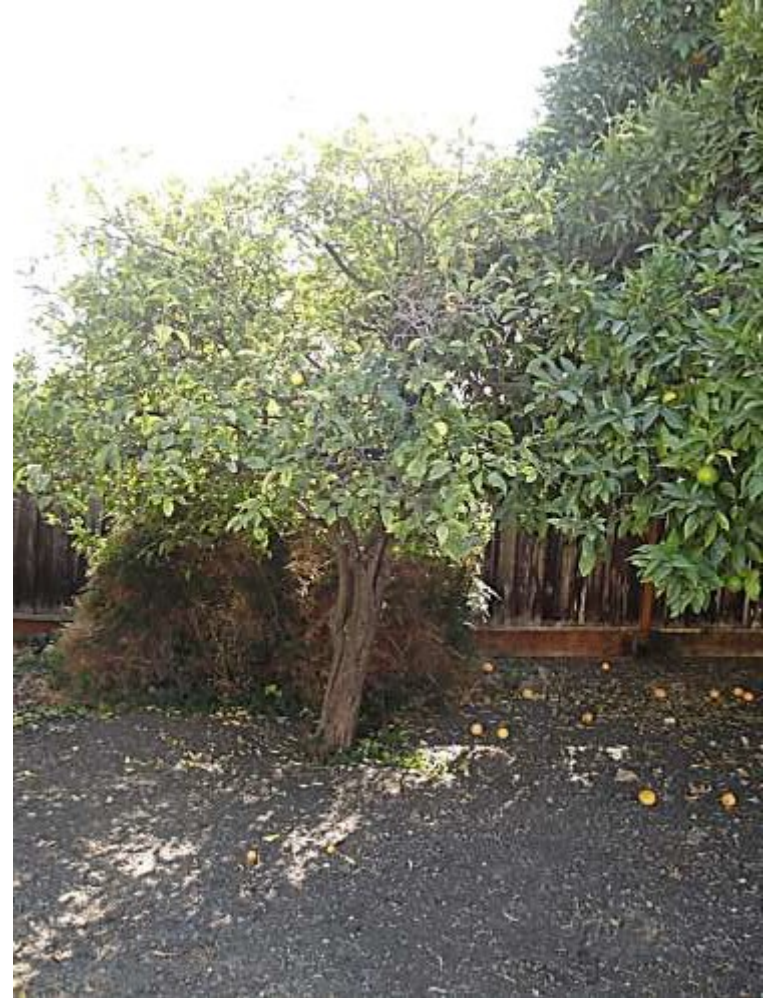
Tree #4

Tree # 4, Citrus species, Orange tree: 6" DBH, an 18.8" circumference, and a 6' drip canopy. Tree is neglected, drought stressed, and in poor condition. Tree has no preservation value.

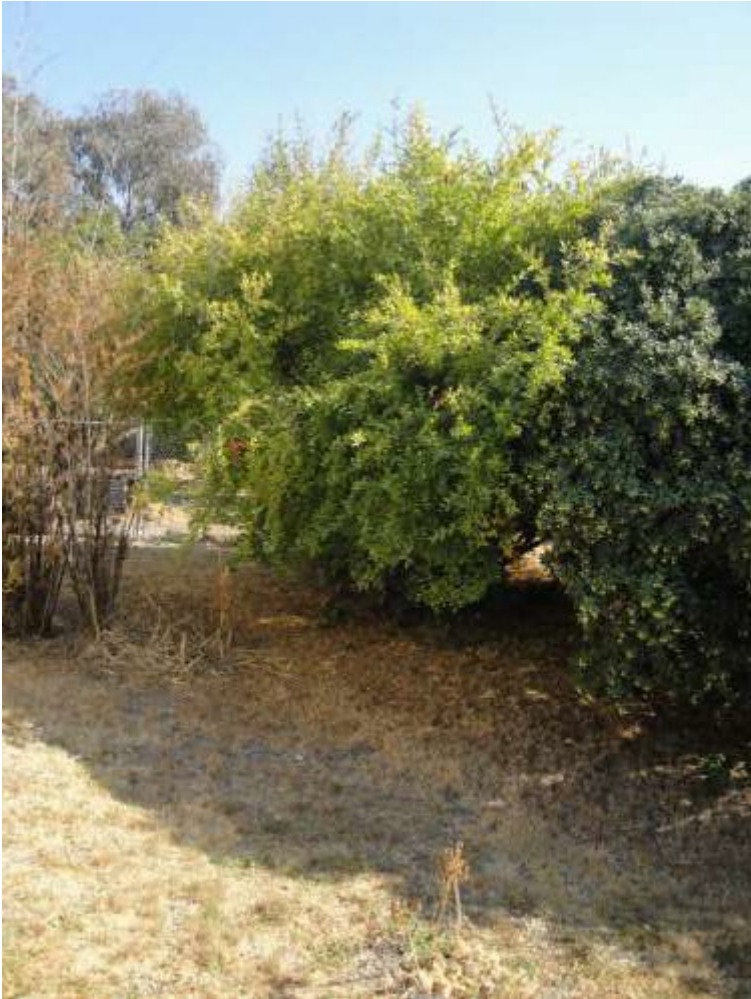
Tree #5

Tree # 5, Pomegranate species: Tree has many multiple stems growing from a common point in the ground, app. 36" DBH, a 113.1" circumference, and a 25' canopy. The tree has plenty of fruit growing within the canopy and is going dormant at the time of the inspections. Tree has no preservation value.

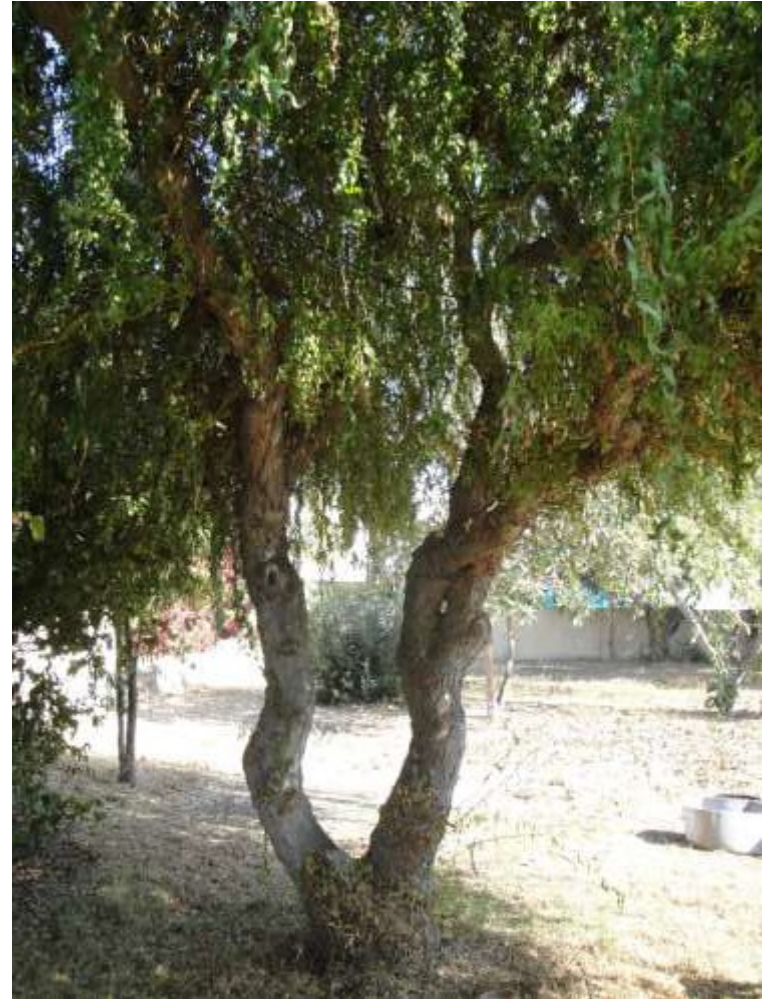
Tree #6

Tree # 6, Willow species, Salix species: 18" DBH combined with appx., a 56.5" circumference, and a 24' canopy. Overall tree structure is poor due to the wide apex ratio within the crotch. The tree is in fair to poor condition and has no preservation value.

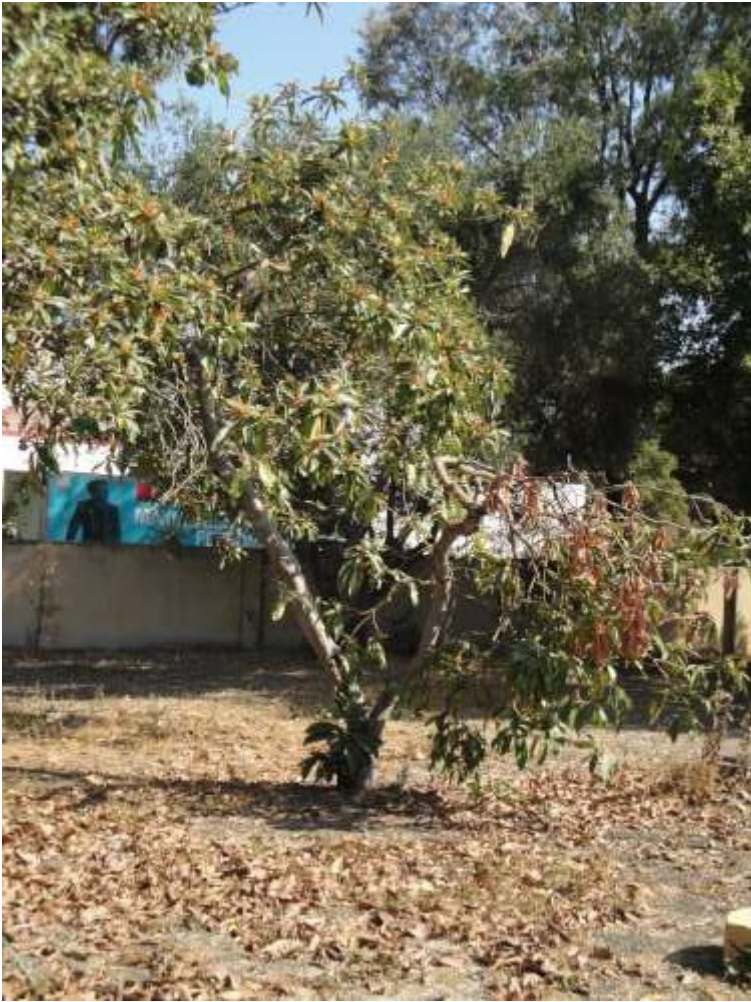
Tree #7

Tree # 7, Eriobotrya japonica, Loquat tree: 7" DBH, a 22" circumference, and an appx. 8' canopy. Foliage is sparse, and the structure is poor and chaotic. Some dead twigs and branches are present and the tree appears to have been neglected for a long time. This tree is in poor condition and has no preservation value.

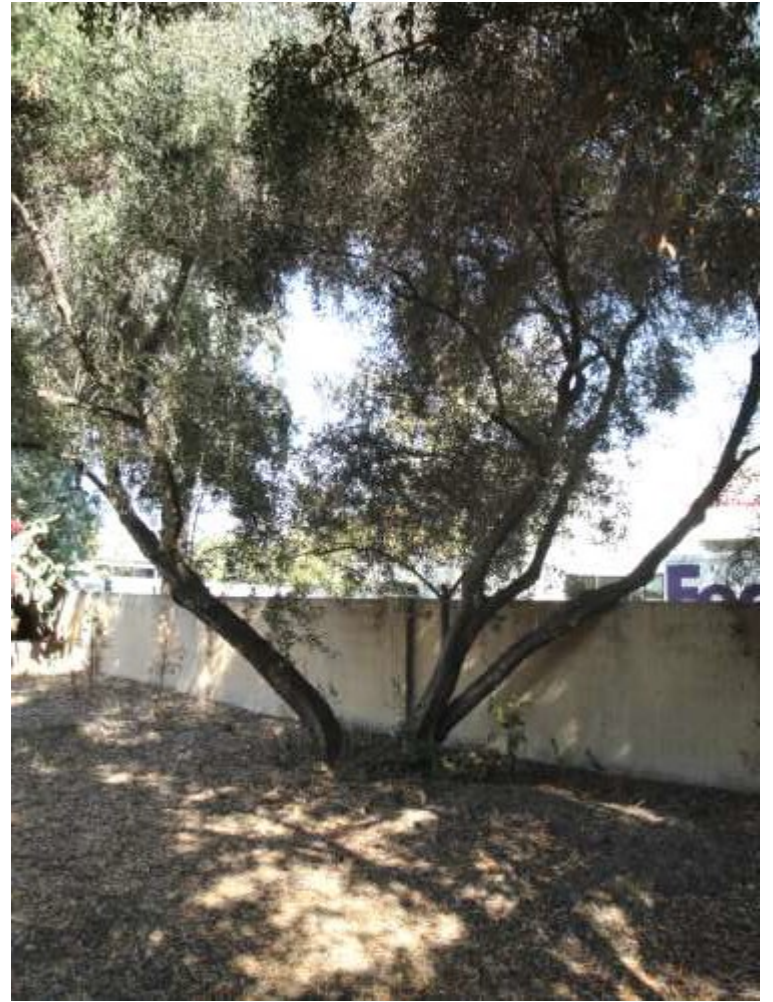
Tree #8

Tree # 8, Olea species, Olive species: 30" DBH combined, a 94.2" circumference, and a 41' drip canopy. Overall foliage is lush, medium-green, and full; however, the tree appears somewhat drought stressed. There are a few broken branches present within the canopy at the time of the inspections. This tree is in fair to poor condition due to its overall structure, with wide apex ratio at the ground level crotch, with reaching branches. Tree and has a low preservation value.

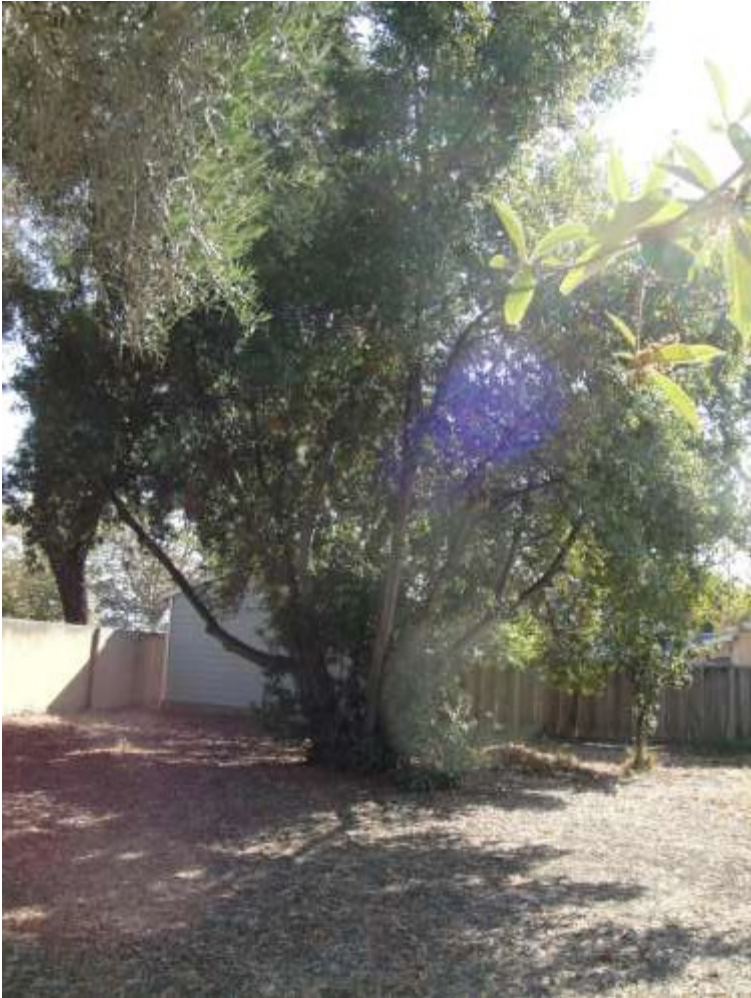
Tree #9

Tree # 9, Umbellularia californica, Calif. Bay tree: Tree has multiple main stems coming from a common point with a total of 38" DBH, a 119.4" circumference, and a 41' drip canopy. Overall structure is fair. The foliage is medium-green, full, lush, and thriving, with no signs of any diseases, infestations, or nutrient deficiencies at this time. There is no decay present at this time.

Tree has a low preservation value.

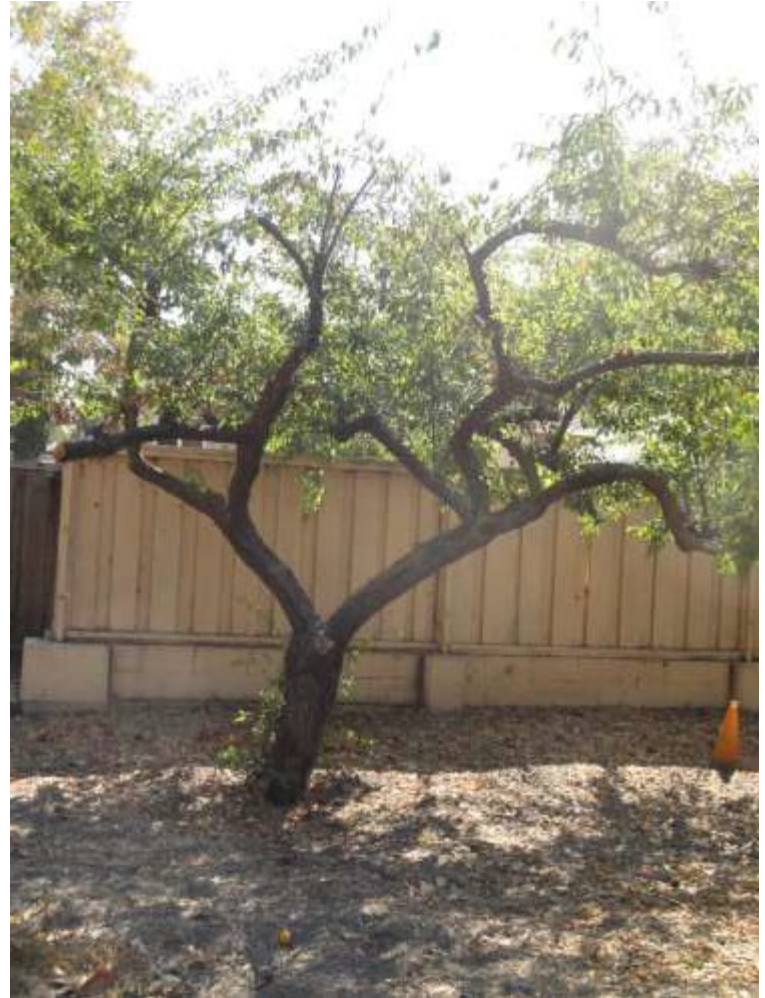
Tree #10

Tree # 10, Plum species, fruit tree: 12" DBH, with a 37.7" circumference. Tree is in poor overall condition with evidence of boring insects throughout the canopy on major branches, and the trunk. Decay is present in many areas of the large branches. Tree has no preservation value and should be removed.

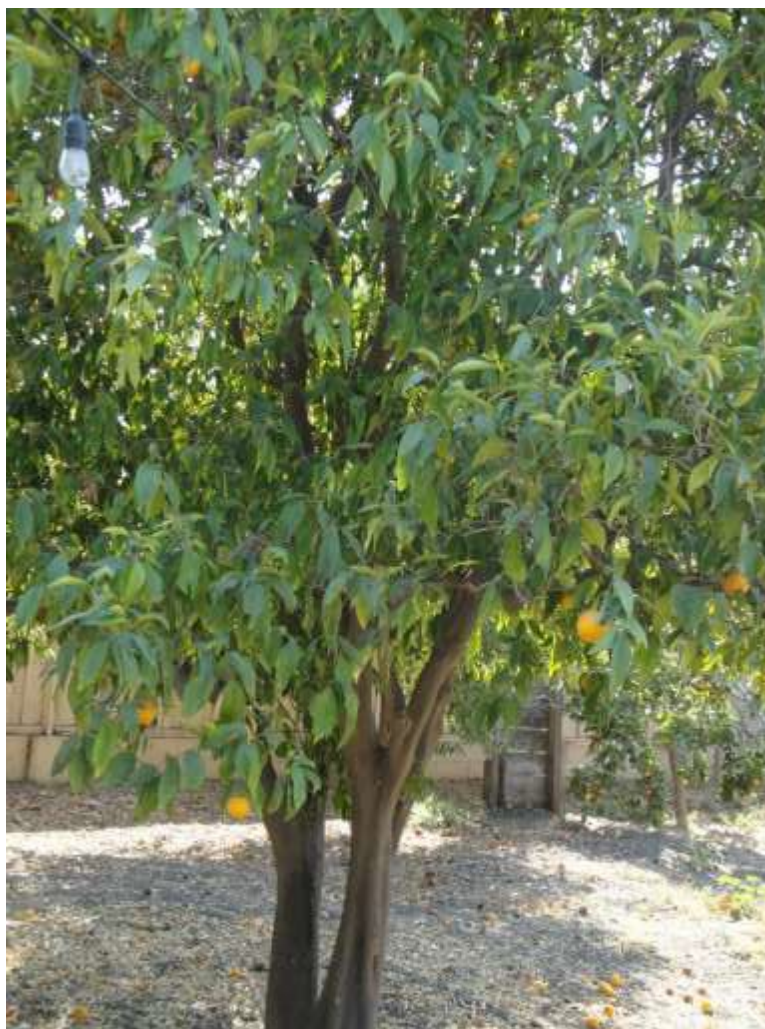
Tree #11

Tree # 11, Citrus species, Orange species: 10" DBH combined, with a 31.4" circumference. Tree is in poor condition due to neglect and drought stress. Leaves are yellowing, and are deficient in nutrients and moisture. Tree has no preservation value and should be removed.
