Arborist Report

Kielty Arborist Services LLC

April 5, 2018

Site: Cambrian Park Plaza, San Jose

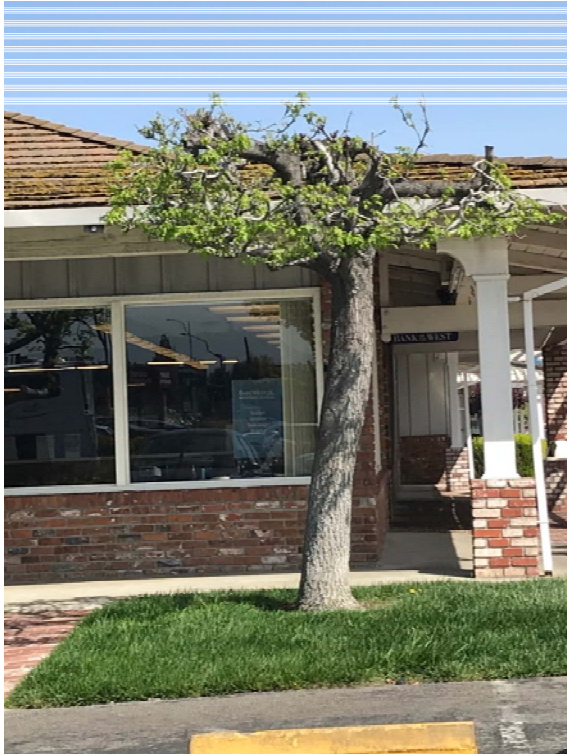
The trees on site are a mix of imported trees, there are no trees native to San Jose on site. All of the trees are proposed for removal to facilitate the proposed construction. All of the trees are in poor condition due to being topped in the past, with the exception of the Mexican fan palm trees and the Italian cypress trees that are in fair condition. Topping trees is never recommended as it promotes decay and leads to future branch failure. All trees that have been topped would need to be kept at their existing height in order to not become a hazard.

Showing topped liquidambar tree

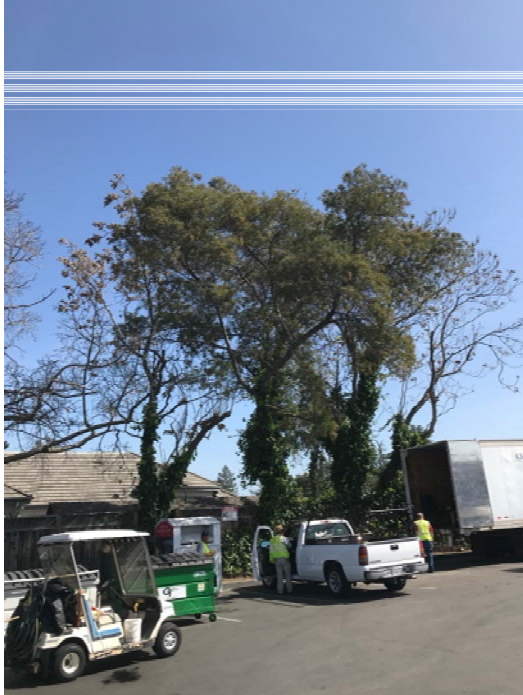
On the east side of the property are many neighboring trees in close proximity to the property line. These are trees #32 -42. Many of the neighboring trees are tree of heaven trees (*Ailanthus altissima*). This species along with neighbor's acacia tree #33 are extremely invasive trees. These trees are on the cities Unsuitable Trees list for this area. If possible these trees should be removed.

Showing neighboring trees with ivy growth up to 20 feet

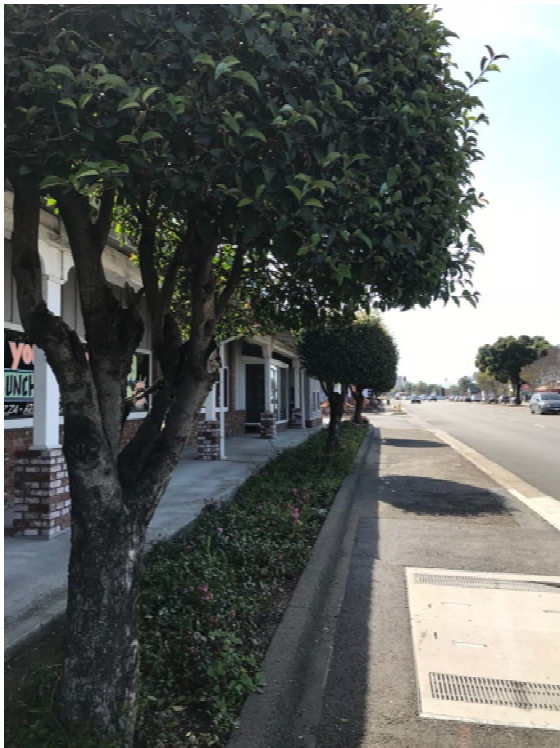
Privet trees #44-51 are all located in close proximity to the street on Camden Avenue. These trees are all in poor condition due to being topped repeatedly. These trees may be considered street trees.

Showing topped privet trees
