July 6, 2021

Robson Homes, LLC
2185 The Alameda
San Jose, CA 95126

Monarch Consulting Arborists

Summary

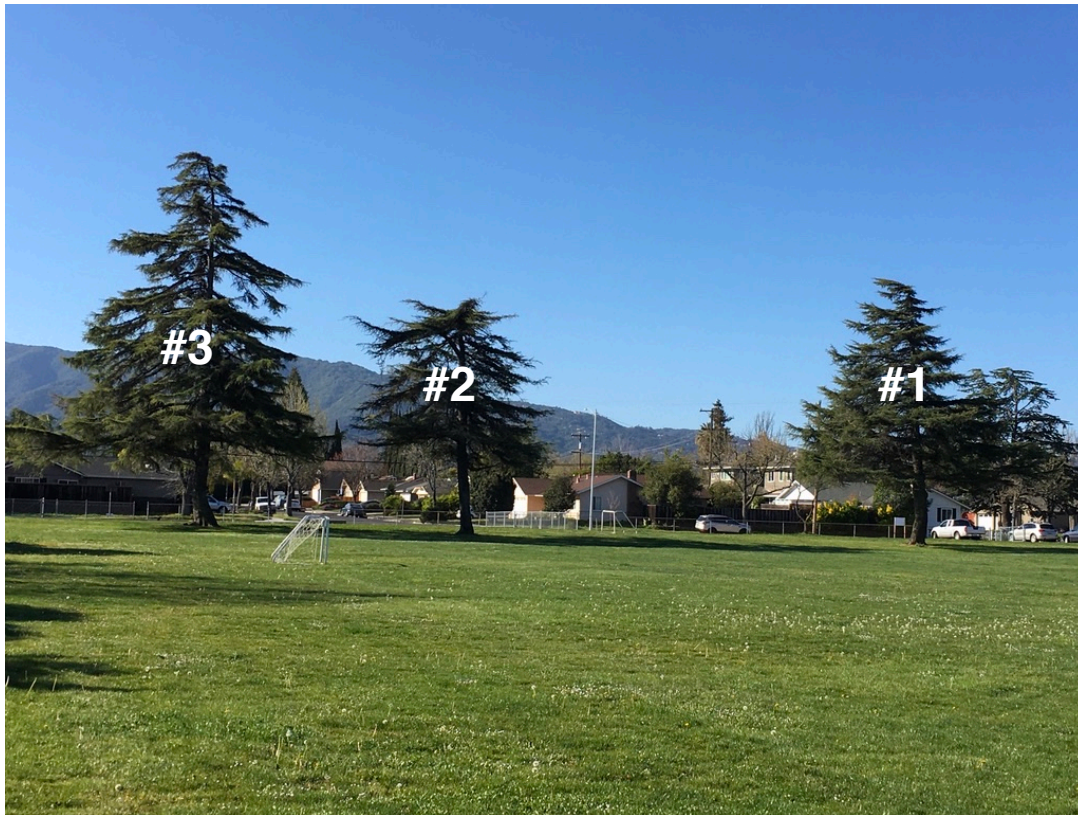
The images below are of the three trees and the proposed site plan.

All three deodar cedars are in good condition with slightly deformed form from being windswept. Foliar color and density were normal and all have a single central stem.

All three trees are within the footprint of the proposed plans and will be highly impacted and required to be removed.

Communicate with the planning department to identify the appropriate mitigation for the loss of the trees or redesign the project to accommodate them.
