Appendix B
Arborist Reports

ARBORIST REPORT

TREE IMPACT ASSESSMENT

565 LORRAINE AVE., SAN JOSE, CA 95110

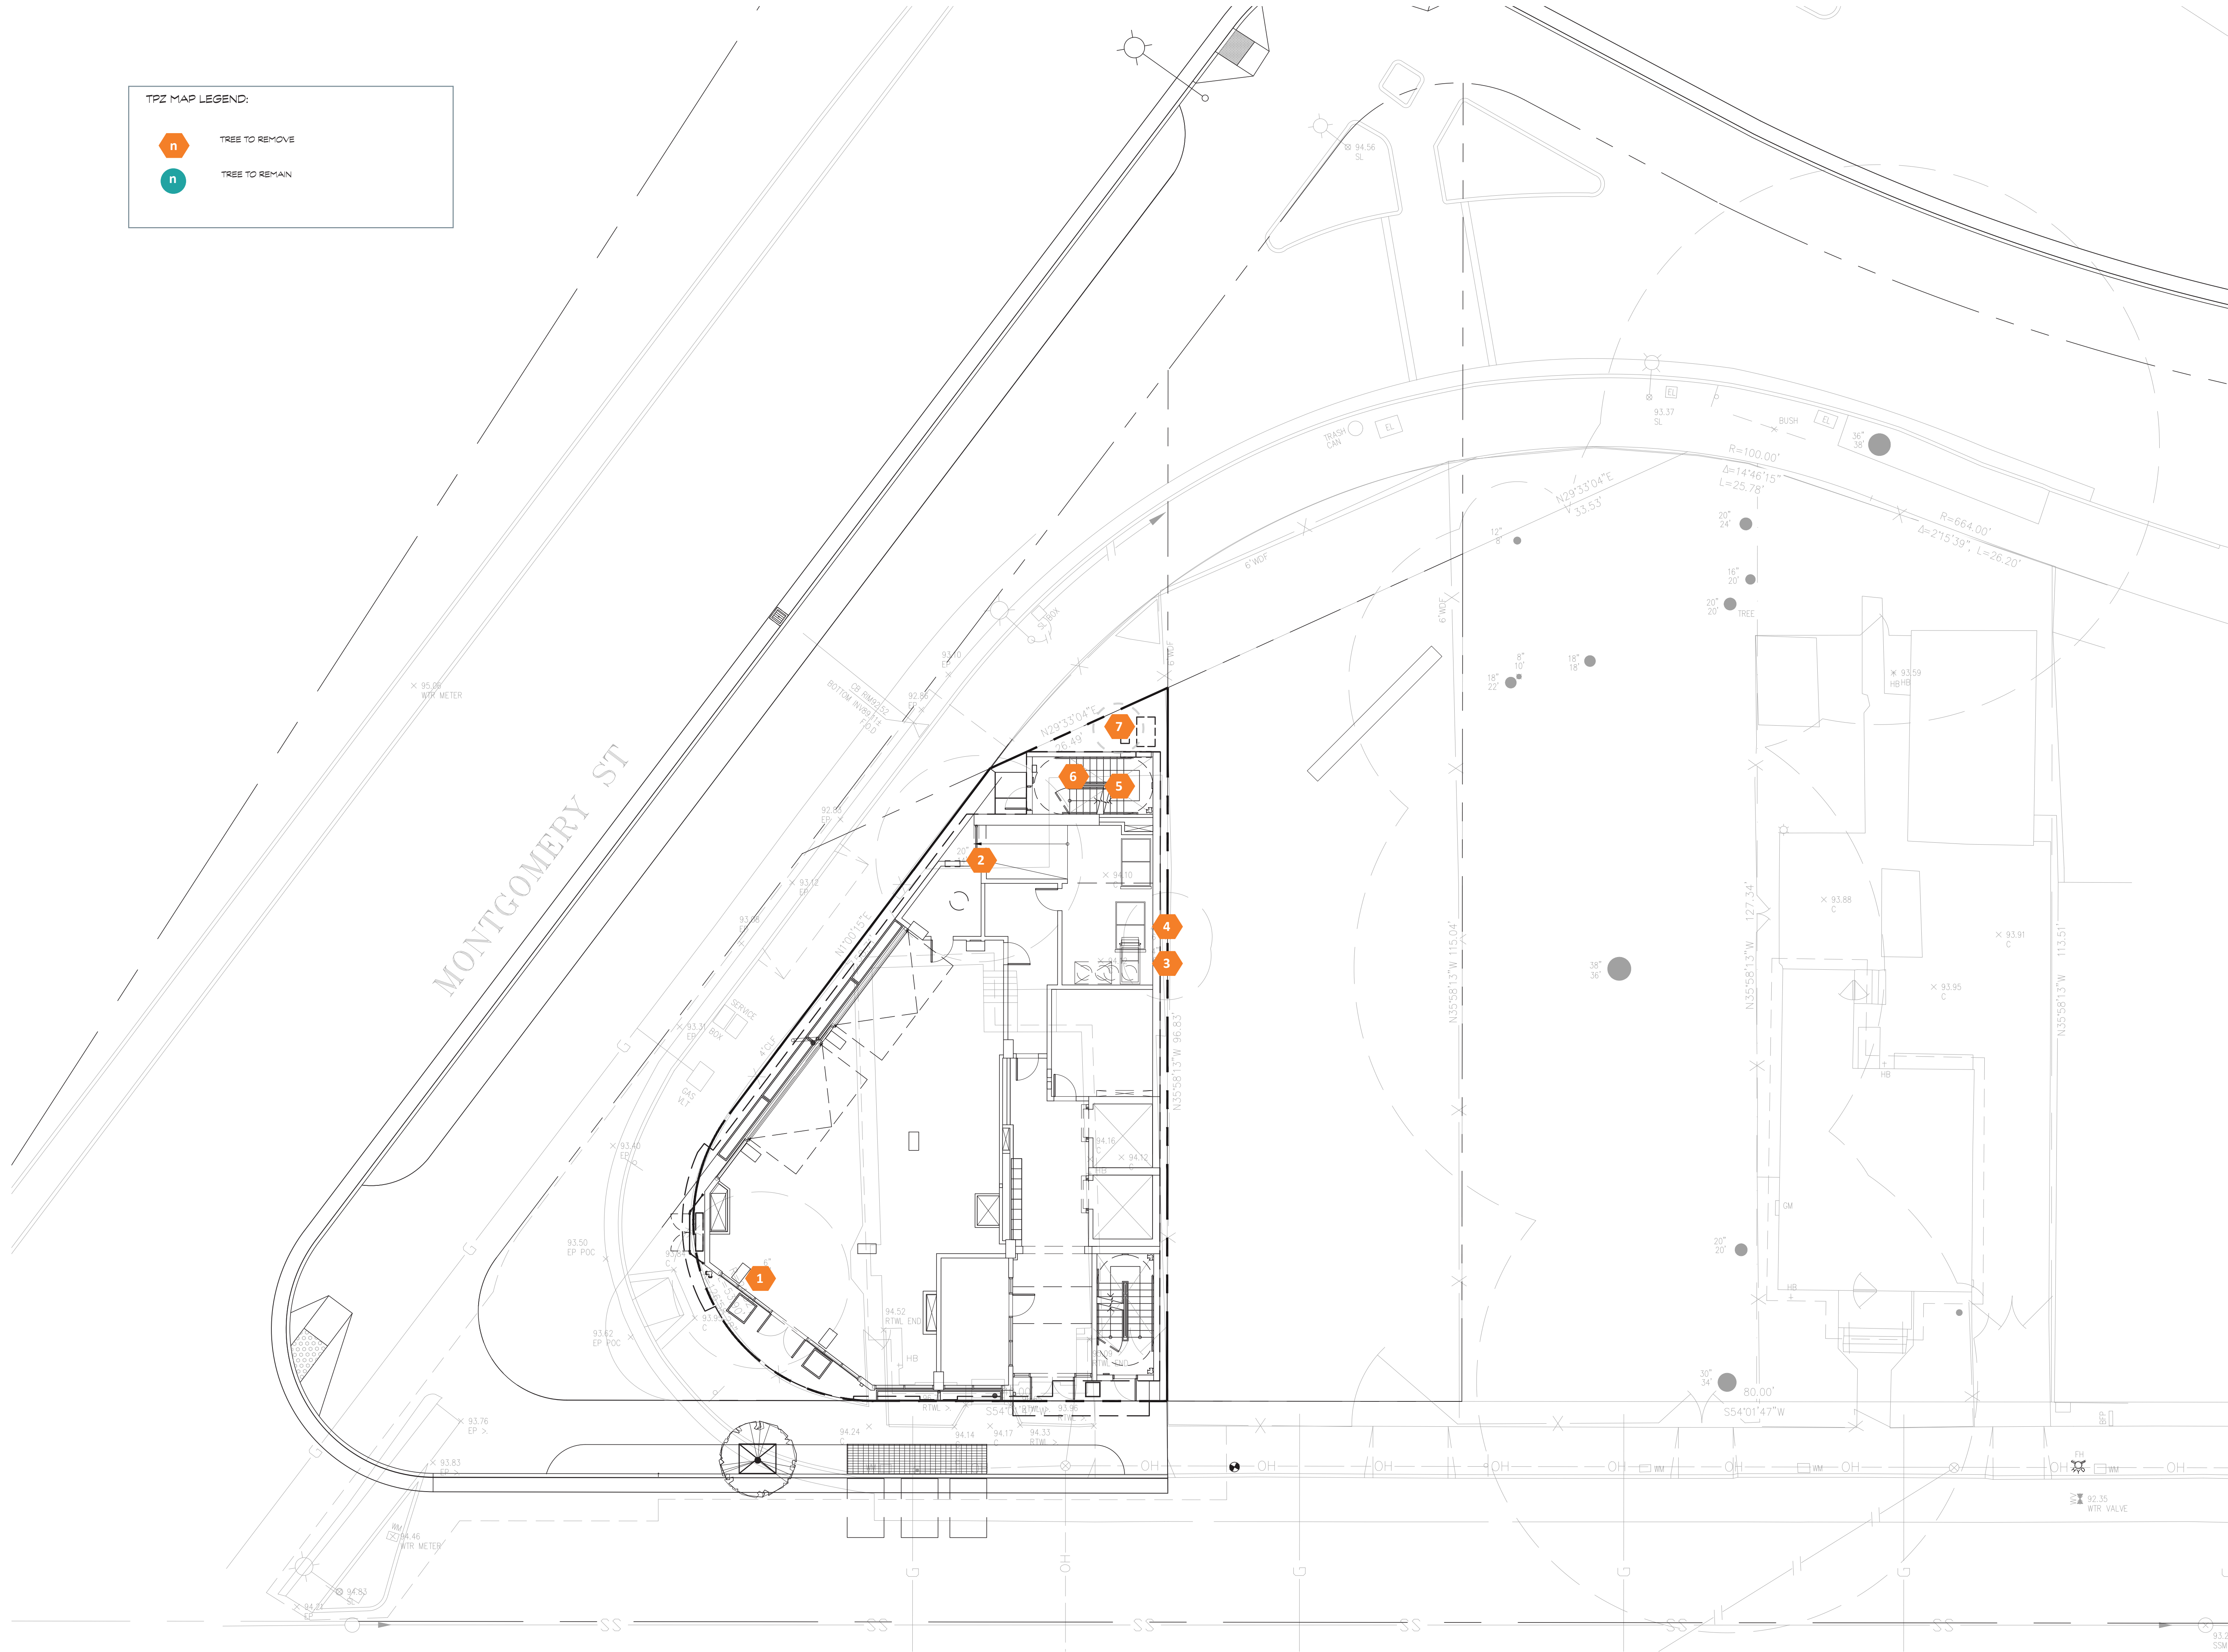
I identified seven (7) trees which would be impacted by the proposed project (all on the property to be developed). Trees have been labeled #1 - #7 on the Tree Map and Inventory table included in this report. All neighboring trees were sufficiently distant from the proposed areas of disturbance. All (7) trees were requested for removal.

Most trees were low-value species. The exception was Tree #2, a mature avocado tree. This tree would be within the footprint of the proposed development and could not survive the development. Nor could the new building be constructed if the tree were to remain.

The proposed multi-family building project appeared to be a valuable upgrade to the property and neighborhood. After review of the plan set, I determined that retainment of trees #1 - #7 would not be possible if the project were to move forward as planned. Therefore, I assigned a "severe" impact rating to these trees, with "low" suitability for retainment. Tree #2, an avocado fruit tree, was the only tree with any significant value. **Removal of Trees #1 - #7 would be justified for the economic development of the parcel.**

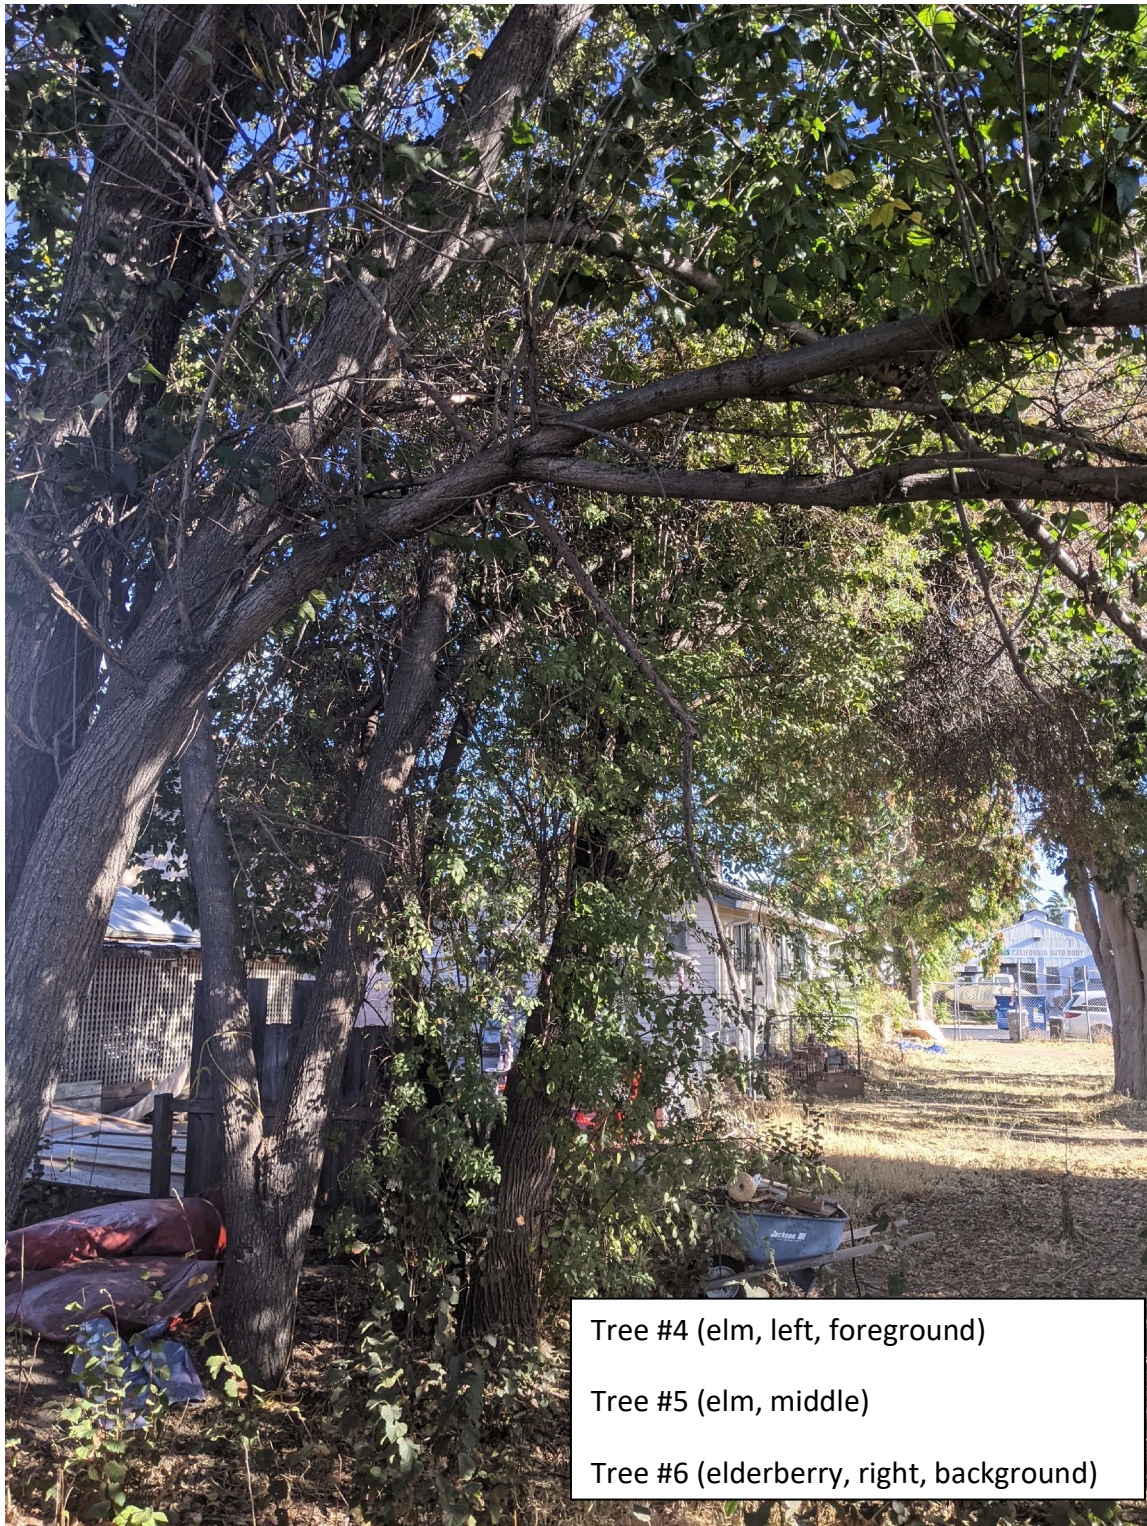
Tree #4 (elm, left, foreground)

Tree #5 (elm, middle)

Tree #6 (elderberry, right, background)

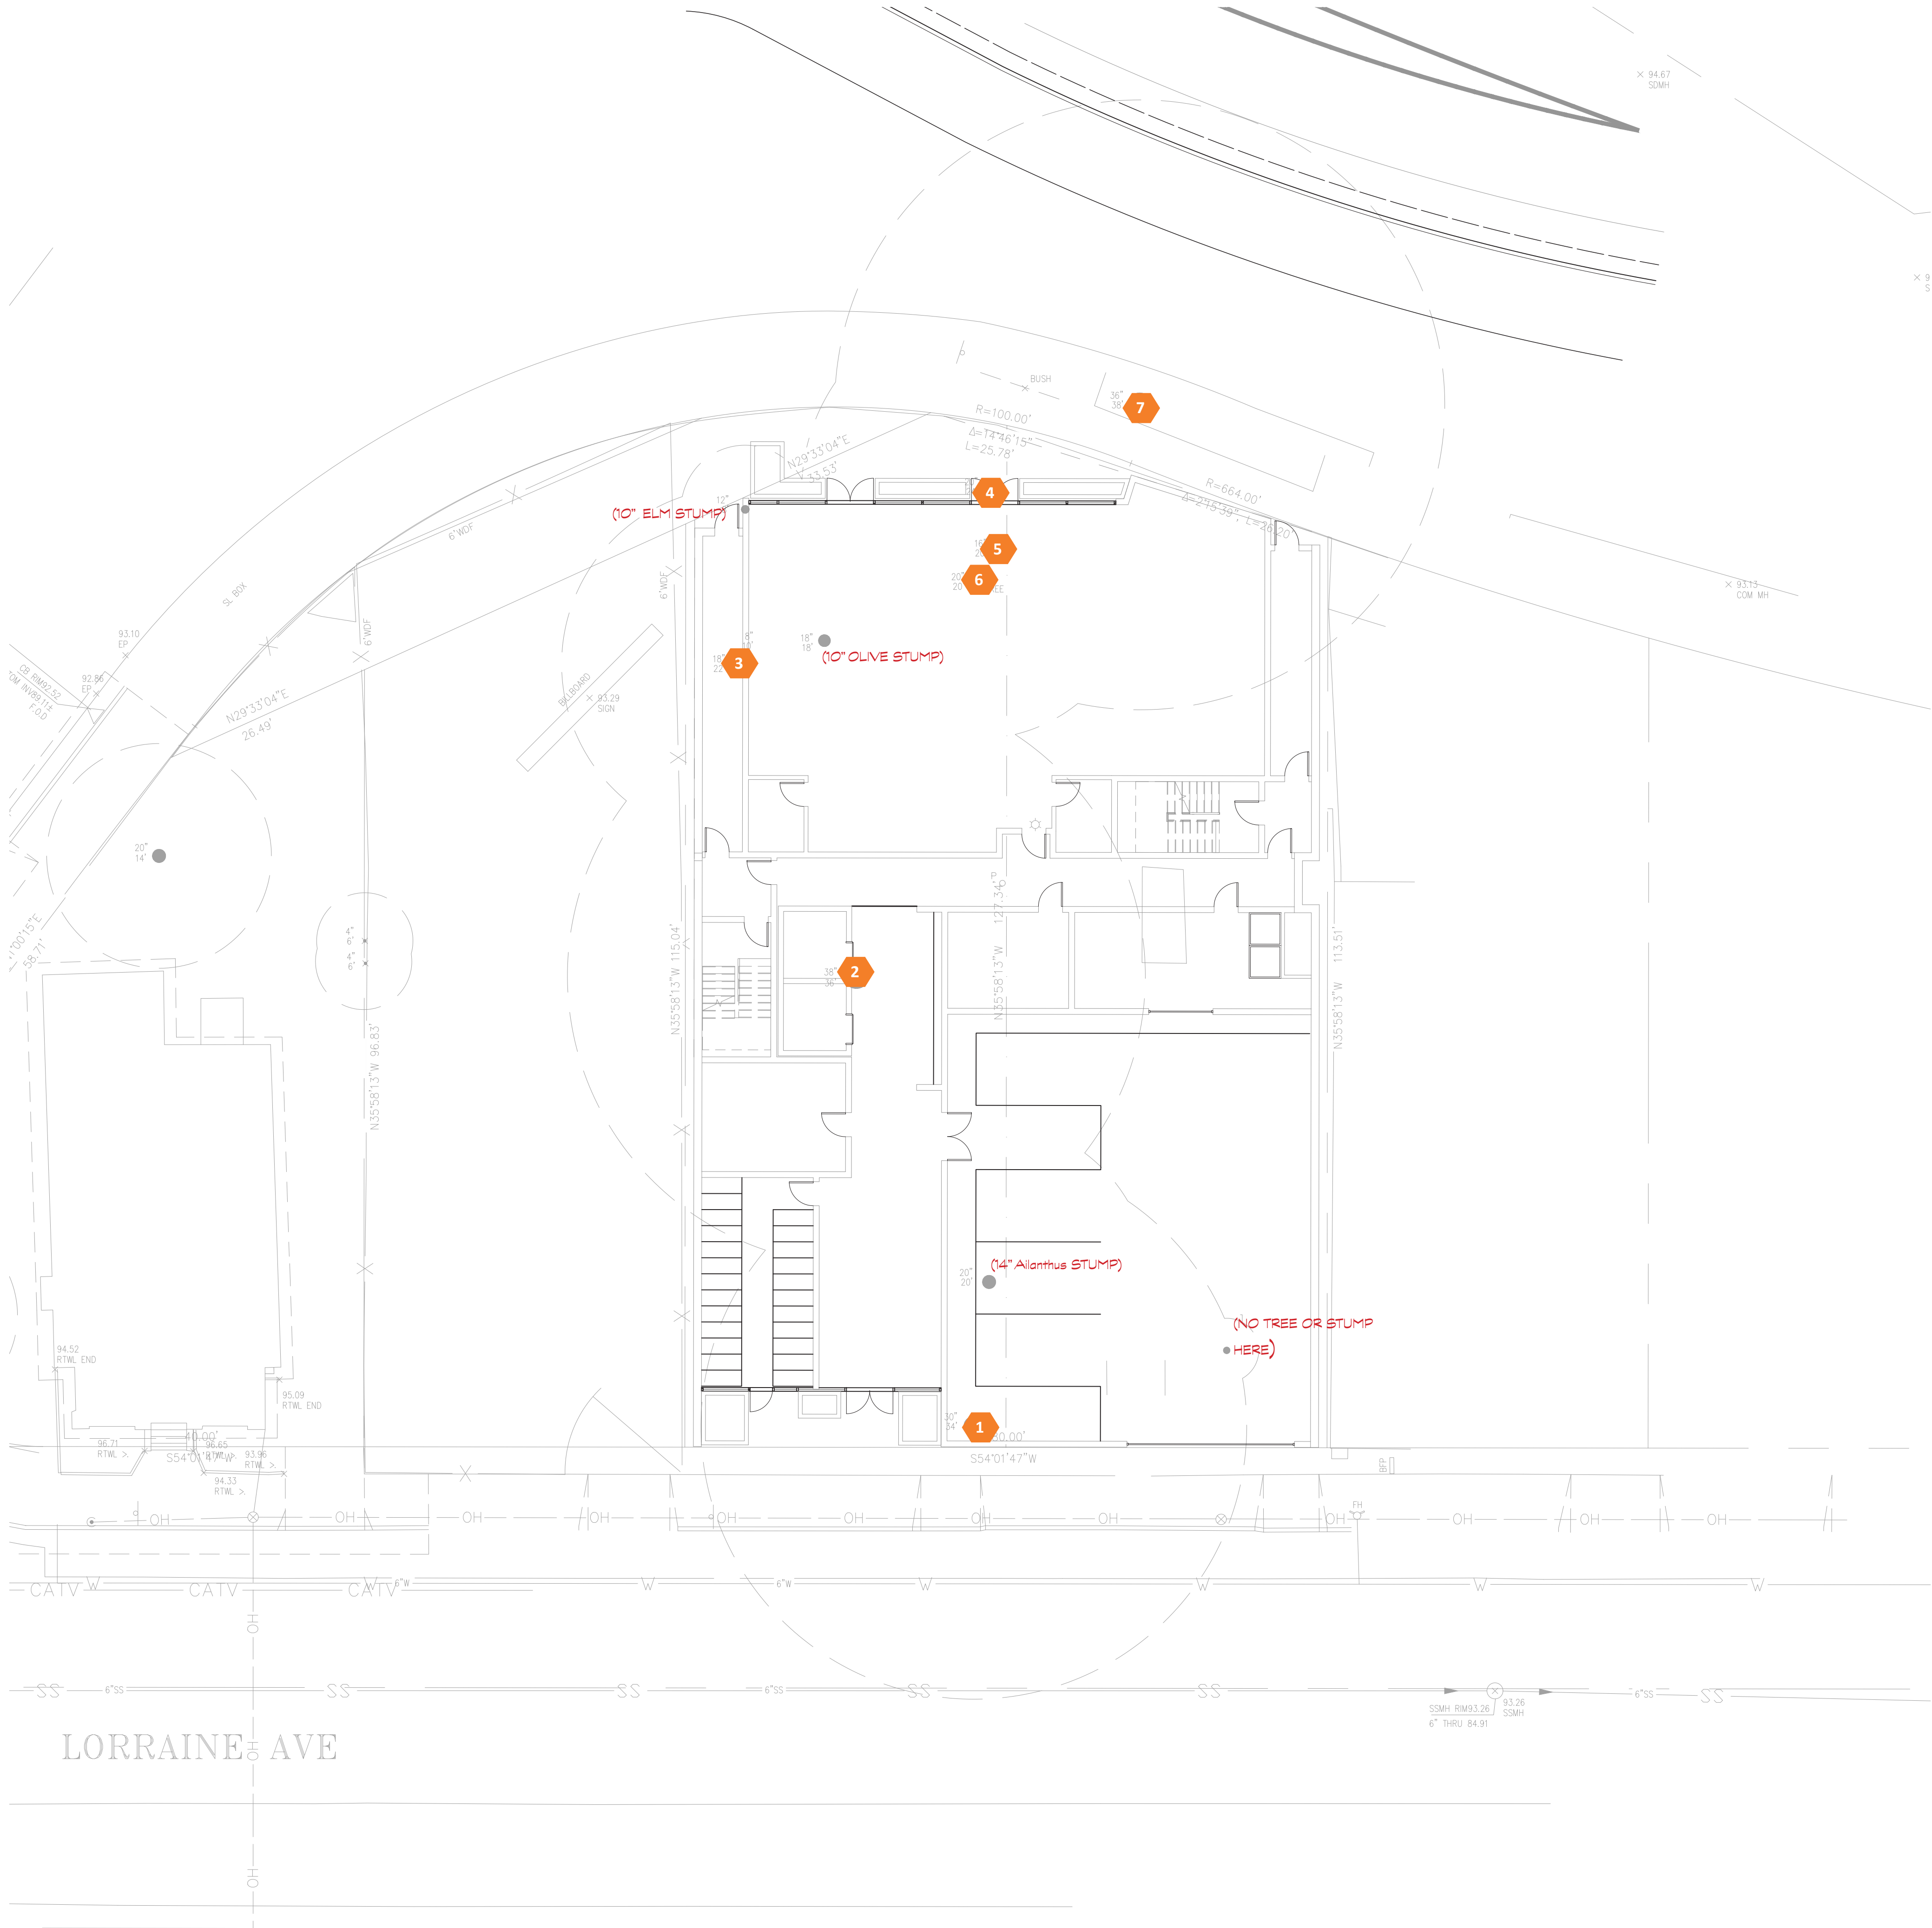
TREE PROTECTION ZONE MAP

I identified seven (7) trees which would be impacted by the proposed project (all on the property to be developed). Trees have been labeled #1 - #7 on the Tree Map and Inventory table included in this report. All neighboring trees were sufficiently distant from the proposed areas of disturbance. All (7) trees were requested for removal.

The proposed multi-family building project appeared to be a valuable upgrade to the property and neighborhood. After review of the plan set, I determined that retainment of trees #1 - #7 would not be possible if the project were to move forward as planned. Therefore, I assigned a "severe" impact rating to these trees, with "low" suitability for retainment. **Removal of Trees #1 - #7 would be justified for the economic development of the parcel.**
