Preliminary Arborist Report

**420 S. 2nd Street
San Jose, CA 95113**

May 26, 2021

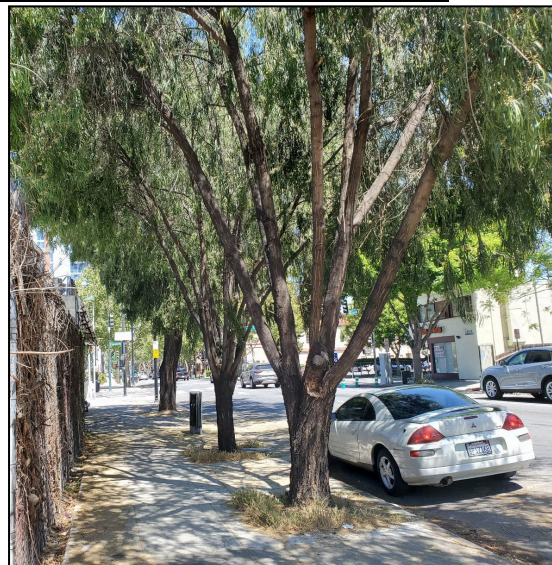
Three Australian willows were street trees along S. 3rd Street. Trees #186 and 187 were semi-mature, with trunks ranging in diameter from 11” to 14”. Tree #185 was mature, with a trunk diameter of 25”. All of the Australian willows were in poor condition with multiple stems arising from one and poor attachments between stems (Photo 1). They had very thin upper canopies with healthier and denser growth in their lower canopies.

Photo 1 (above): Australian willows 185 – 187 (left to right) were street trees with poor structure.

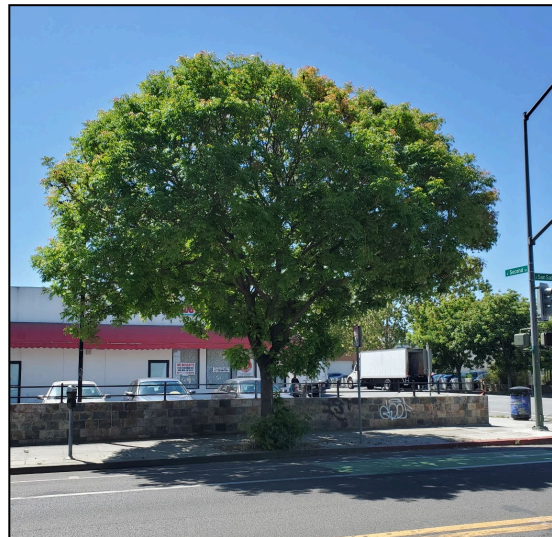
Chinese pistache #183 was a street tree planted in a concrete cutout along San Salvador Ave (Photo 2). It was in fair condition and was 11” in diameter. It had numerous basal sprouts and minor mechanical damage, but a dense, healthy crown.

Photo 2 (below): Chinese pistache #183 was a street tree planted along San Salvador Ave.

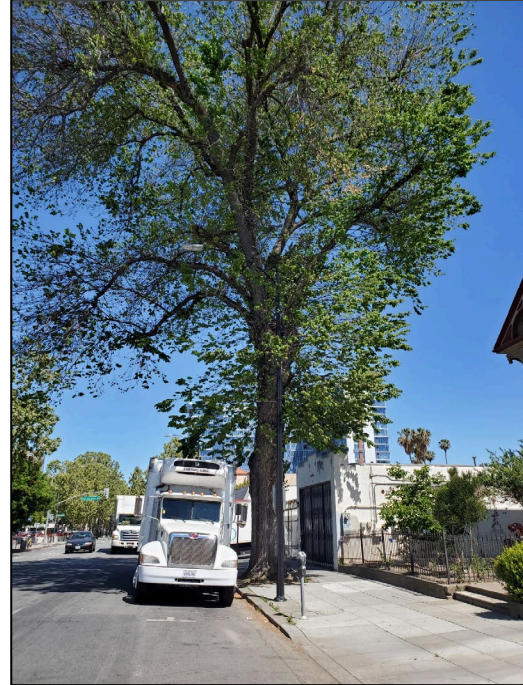
Chinese flame tree #184 was also planted as street tree along San Salvador Ave (Photo 3). It was in fair condition and had a trunk diameter of 7". It had a healthy, dense crown with a rounded form.

Photo 3 (left): Chinese flame tree #184 was planted as a street tree along San Salvador Ave.

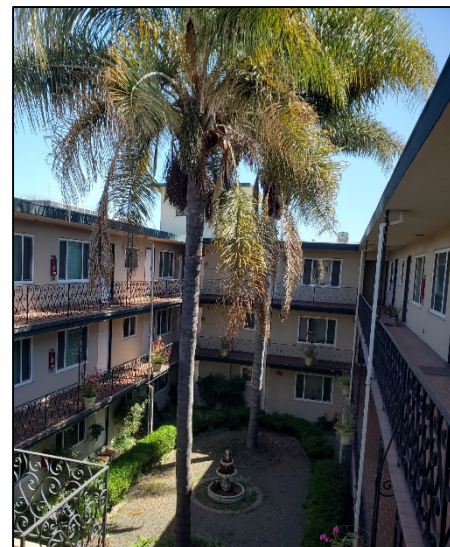
Two Canary Island date palms were located in the interior courtyard (Photo 1). Tree #180 was in good condition while tree #179 was fair. Trunk diameters were 15” and 14”. Both trunks had mechanical damage from climbing spikes, from base to crown.

Photo 1 (above): Canary Island date palms #179 and 180 were located in the main courtyard.

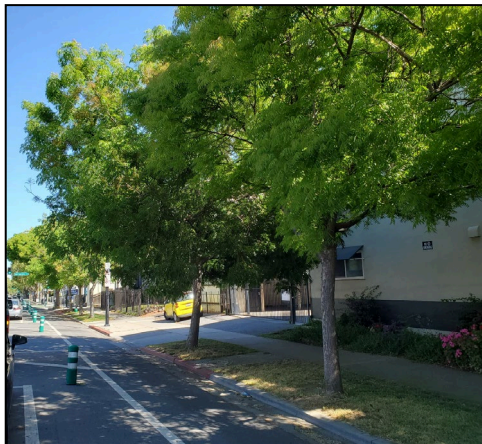
Two Chinese pistaches were street trees in 6.5'-wide planting strips along S. 3rd Street (Photo 2). Tree #175 had an 8” trunk and tree #176 was 11”. Both trees were in fair condition with rounded canopies and dense, green growth. Minor twig dieback in the lower crown was present on both trees.

Photo 2 (left): Chinese pistaches #175 and 176 were street trees planted along S. 3rd Street.

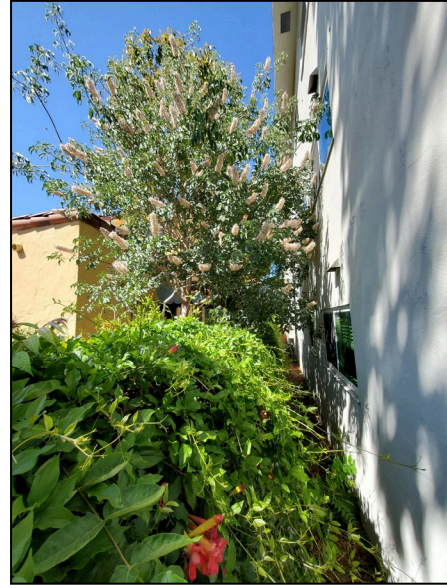
California buckeye #170 was located off-site. It was in good condition with an estimated 7" diameter. The base was approximately 6" from avocado #171 and 6' from the property line. Its crown overhung the subject property by approximately 4' and had minor branches rubbing against the existing apartment building (Photo 3).

Photo 3 (top): California buckeye #170 had a 4' overhang with branches rubbing against the building.

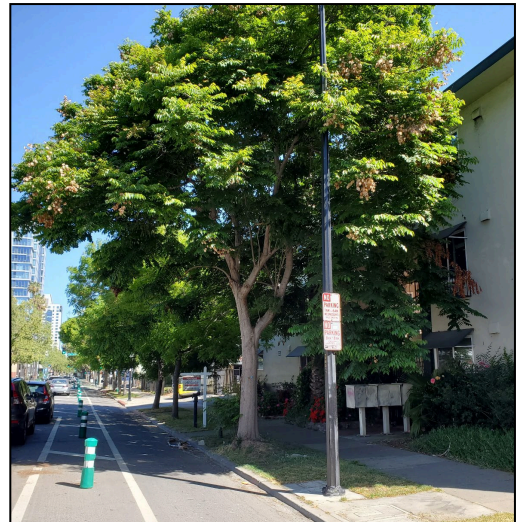
Chinese flame tree #174 was a street tree in a 6.5'-wide planting strip along S. 3rd street (Photo 4). It had a 15" trunk diameter and was in fair condition. Though it had some epicormic growth, the tree crown was dense and green.

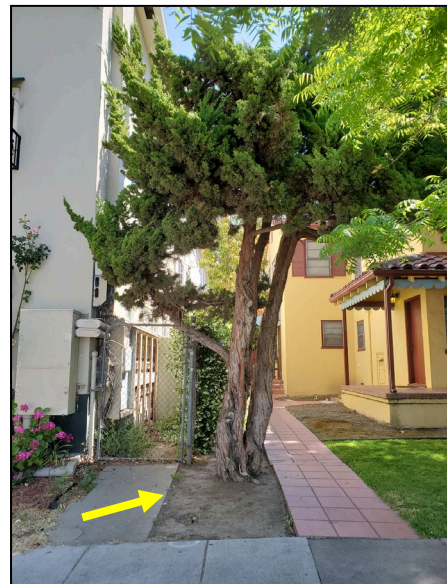
Hollywood juniper #173 was located off-site, approximately 1' from the property line with a 5' overhang (Photo 5). It was in good condition and had multiple trunks, with diameters ranging from 4" – 9". The crown was dense and had a semi-rounded shape.
