Appendix D
Updated Arborist Report

ARBORIST REPORT FOR SAN JOSE INDUSTRIAL PARK 2150, 2222, 2350 Qume Drive, San Jose

September 10, 2021 (updated 1/27/23)

By: Jennifer Tso
Traverso Tree Service, Inc.
4080 Cabrilho Drive
Martinez, CA 94553
Board Certified Master Arborist #WE-10270B
Tree Risk Assessor Qualified

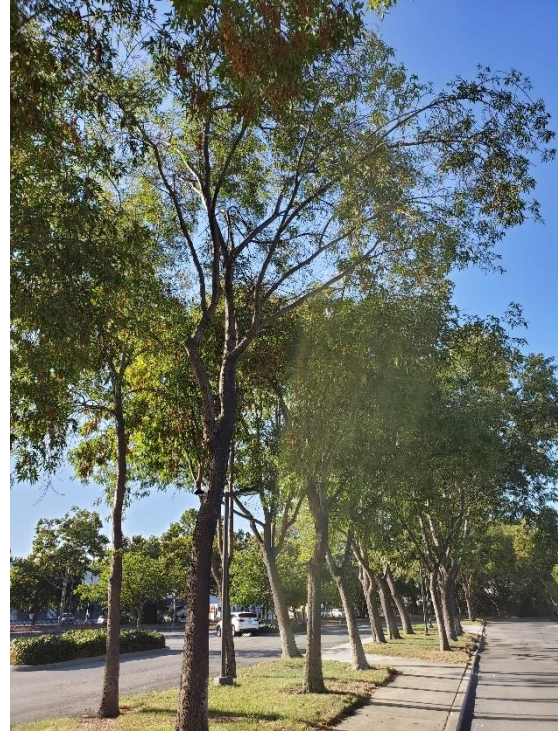
Figure 2. The ashes are packed together in landscape strips surrounded by hardscape (tree #142 in foreground). Repair of adjacent walkways has damaged the roots of many trees, resulting in sparse canopies and declining branches.

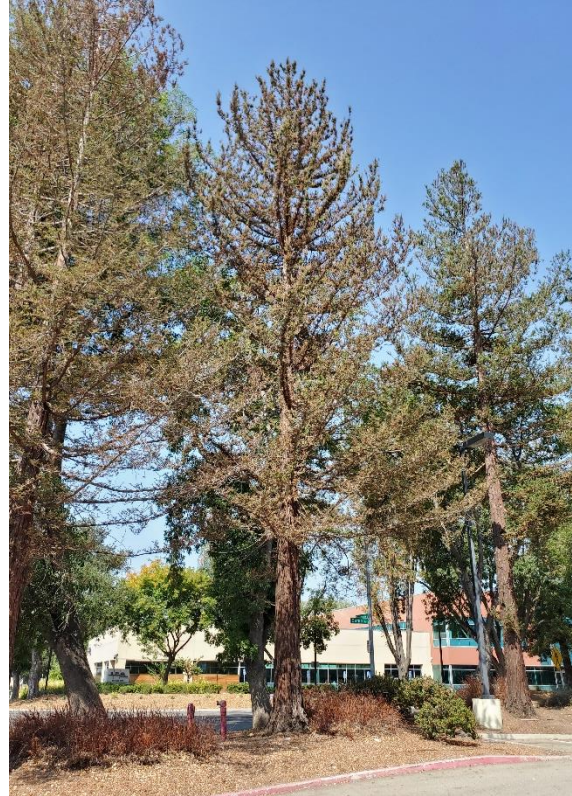
Figure 3. The redwoods (#648 at center) are highly sensitive to salinity and are suffering from recycled water damage. Unless there is a switch back to potable water, the trees would likely not recover.

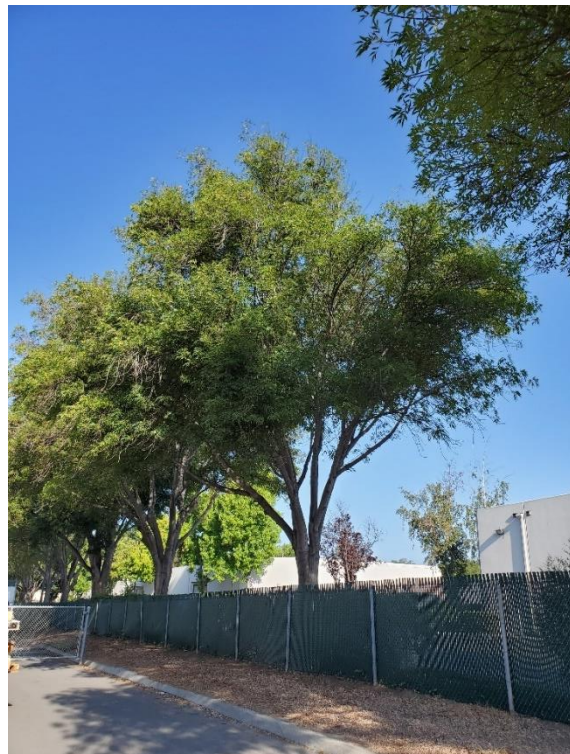
Figure 4. Proposed bio-retention basins were shifted further from the neighbor's trees (#12 above) along the north property line, and the new parking lot will be kept in a similar location to the existing lot.

An example of the changes includes the proposed parking lot and bio-retention basins along the north property line. Originally, the basins would encroach right up to the property line, which required the removal of the neighbor's trees (#1-30, Figure 4). The new design keeps the parking lot in a similar location to the existing parking lot. Instead of a continuous treatment basin along the entire property line, smaller separate basins alternate with the trees to reduce root encroachment. The contractors will still need to be cautious while excavating the basins, since they will likely run into large roots. I recommend having an arborist on site at the start of the excavation to discuss expectations and monitor a few basins. This is particularly crucial when working around trees that belong to other property owners.

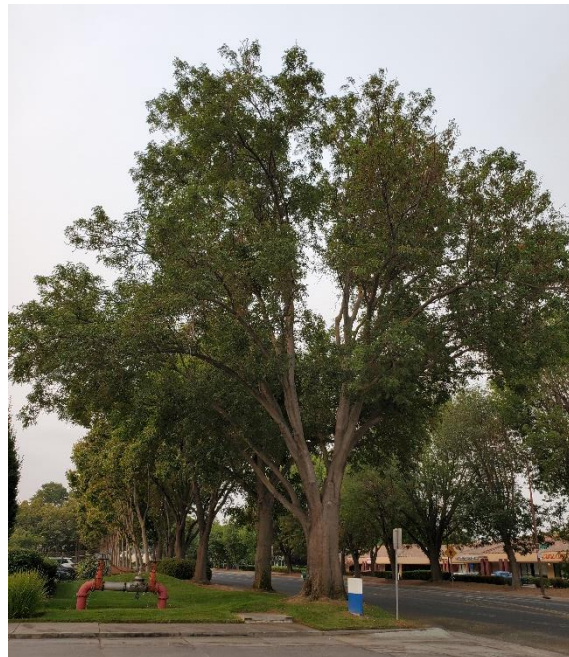
Figure 5. Several mature trees, including ash #440 above, were located in the proposed City-mandated sidewalk. The sidewalk is now moved halfway into the street, with the other half made of decomposed granite. Removal of the berm to the left of the trees will also impact their roots.

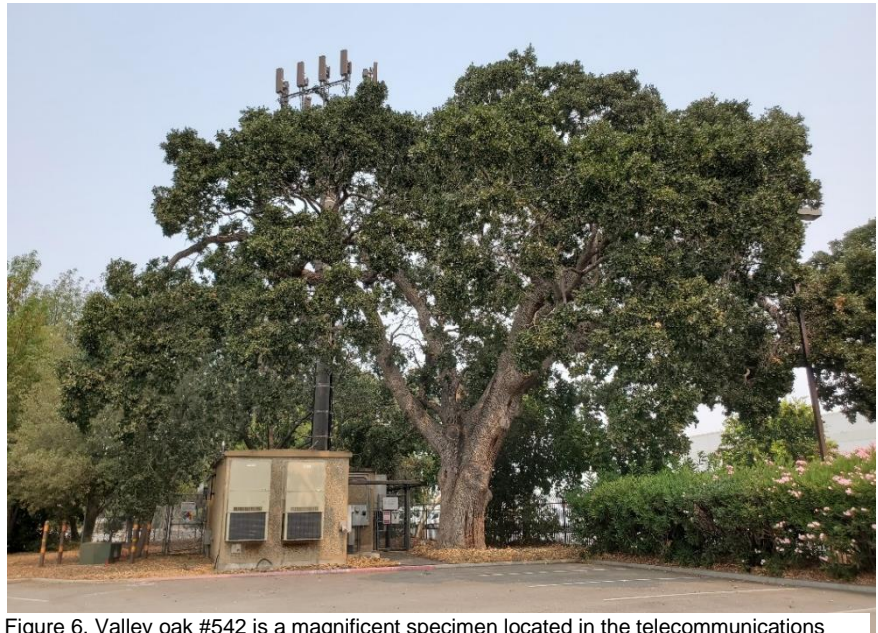
The elevation of the parking lot appears to be higher than the original elevation of the tree. A tree growing in its natural environment has a pronounced flare at the base where the trunk transitions into the roots (i.e. "root crown"). If the trunk remains the same diameter as it enters the ground, soil was likely added around the tree when the property was developed. Trunk wood differs from root wood; it is not accustomed to being belowground. When trunks are buried in this manner, the added soil holds moisture against the trunk and creates a favorable environment for wood decay organisms. Over time, the trunk becomes decayed and loses strength, even if the overall tree still appears healthy. I recommend performing a root crown excavation on this oak to restore the original grade and to evaluate whether its trunk has been compromised by decay. The excavated area around the trunk should not be filled back in. Instead, the grade around the tree should be gently tapered up to the surrounding landscape area.

This oak is irreplaceable. Because of its veteran status, every effort must be made to respect its surroundings and reduce impact. Accidentally damaging a tree of this age can trigger a slow descent into death, since it may not be growing actively enough to repair damage or replace lost foliage. As a blanket recommendation, every detail and change shall be passed through a consulting arborist, and a consulting arborist must be on-site for any ground-disturbing activities that occur within 60' of its trunk. The design shows minor changes around the tree, except for the conversion of the parking lot to landscaping. Even demolition of the existing hardscape can be detrimental if roots have grown underneath the parking lot. Chain-link fencing shall be installed around the planter area at the limit of grading, and additional fencing should be left on-site to expand the protected area after demolition. Pruning of the tree should not be done unless absolutely necessary for hazard reduction.

Figure 6. Valley oak #542 is a magnificent specimen located in the telecommunications area. Every effort shall be made to reduce encroachment on this tree, even when demolishing the existing parking lot. Changes must be reviewed by the project arborist, who will also monitor all construction activities around the tree.

- Perform a root crown excavation to expose the original grade of the trunk and to evaluate the condition of the trunk. Do not backfill the excavated area. The grade shall be tapered to meet the surrounding landscape. (This can be done with the air/water-assisted methods during the landscaping phase.)

- Perform a root crown excavation on tree #542 to expose the original grade of the trunk and to evaluate the condition of the trunk. Do not backfill the excavated area. The grade shall be tapered to meet the surrounding landscape. (This can be done with the air/water-assisted methods during the landscaping phase.)
