ARBORIST REPORT-
Tree Survey & Preliminary Construction Impact Assessment

70-80 North 27th Street

San Jose, CA

7/20/2022

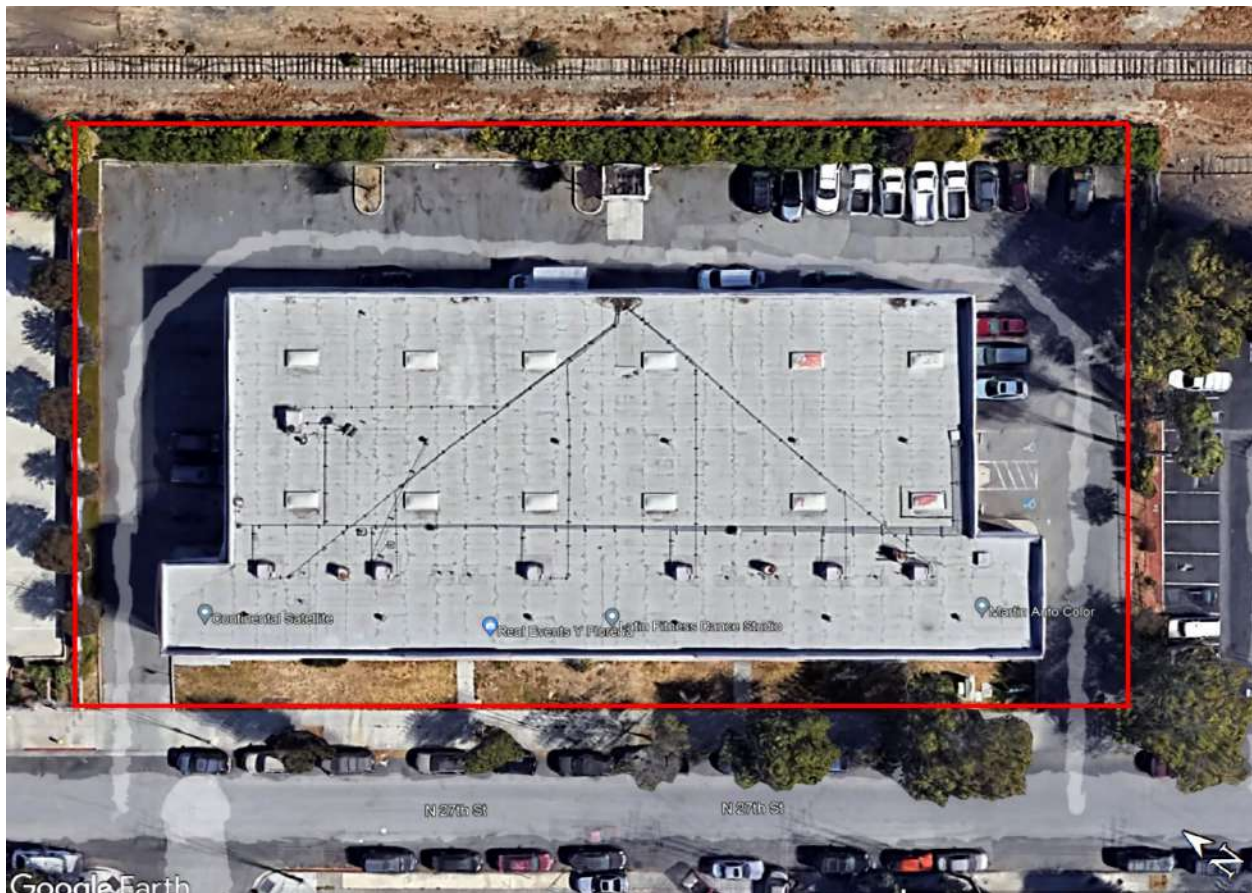
The one-acre parcel is on a flat grade and contains a multi-tenant commercial building, parking lot, and trees planted around the lot perimeter, (Image #1). Commercial buildings are adjacent to the north and south. A railroad right-of way is located to the east, with North 27th Street to the west.

Image #1- Parcel boundary in red with existing building, adjacent to North 27th Street. On-site trees are planted around the property perimeter. Street trees are between North 27th street and the property boundary.

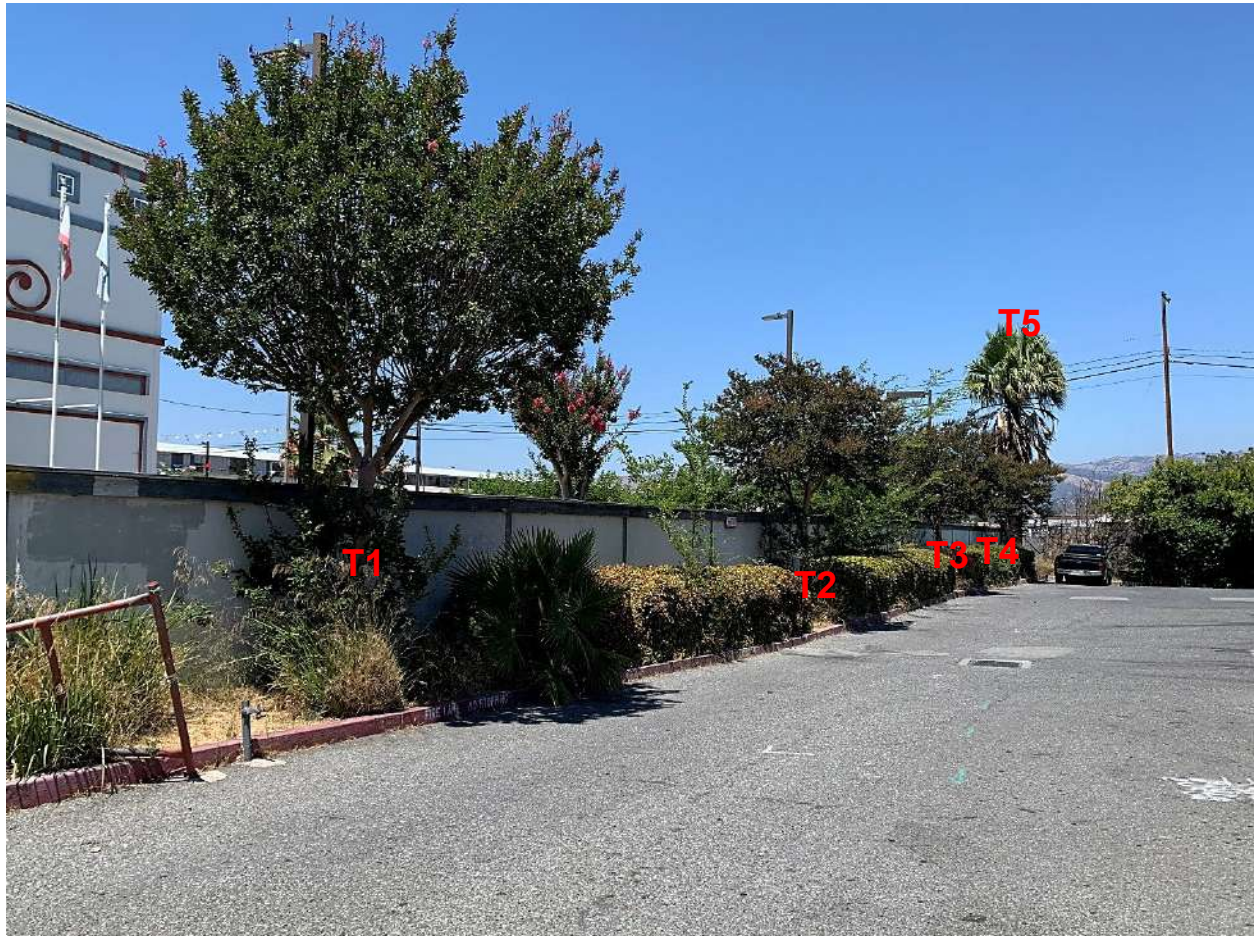
Four crape myrtle grow in a planter along the north fence line, (Image #2). A fan palm grows in the northeast property corner, (Image #2),

Image #2- Trees T1 – T4, crape myrtle and T5, fan palm.

The young myrtles, T1-T4, have well developed structure and are in good condition.

The trunk and lower fronds of fan palm, T5, are blackened. Apparently a fire burned adjacent to the palm but does not appear to have significantly affected the tree. The palm is in fair condition.

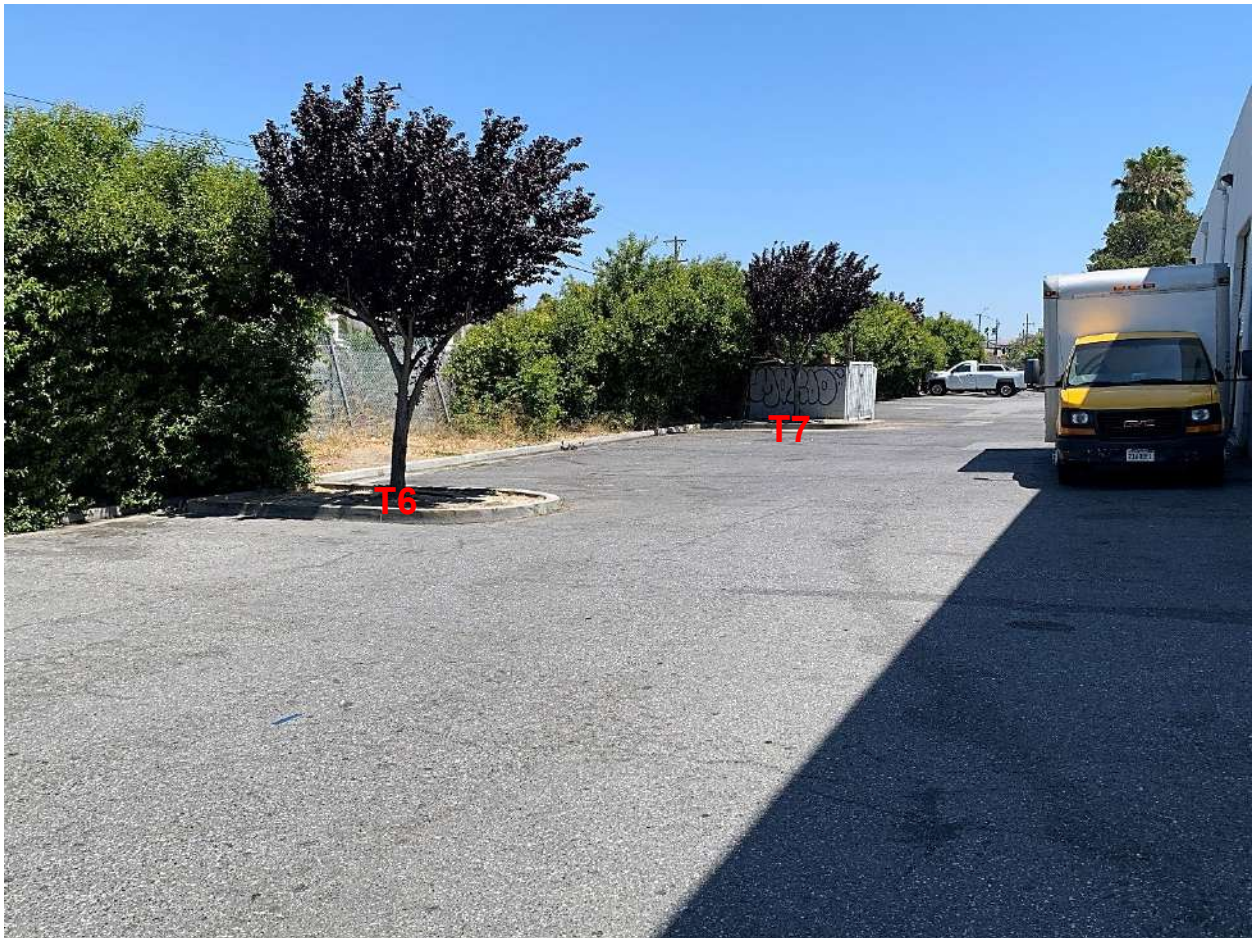
A hedgerow of xylosma has been planted along the east property line as a screening shrub from the railroad right-of-way, (Image #3).

Three purple-leaf cherry plums are planted at evenly spaced intervals between the xylosma hedge, (Image #3).

Image #3- Trees T6 and T7 purple-leaf plum, growing between hedgerow of xylosma shrubs. Tree T8, purple-leaf plum not visible, grows near top of image.

The purple-leaf plums are in good condition.

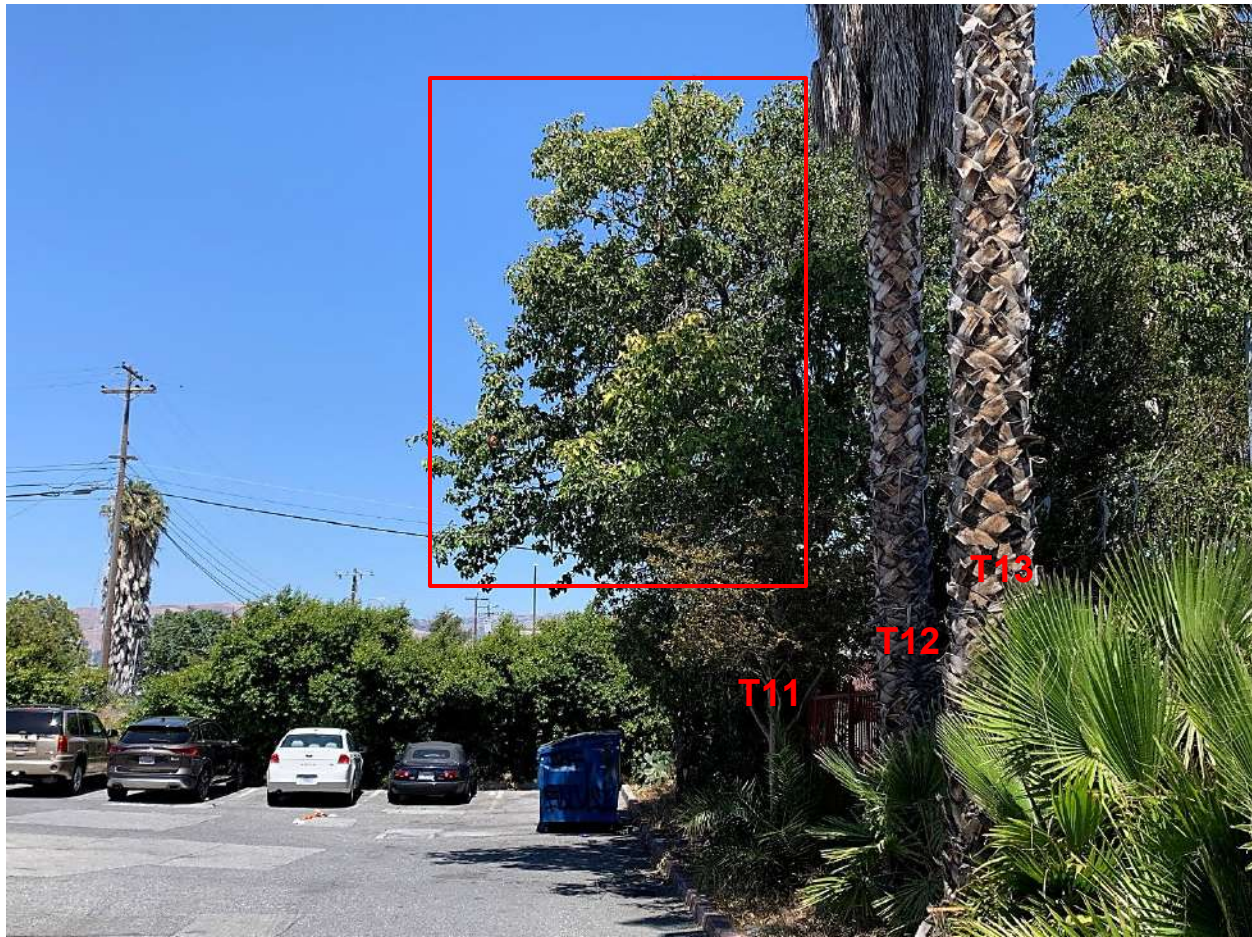
Four crape myrtle, trees T9, T11, T14, T15, a glossy privet, T10 and two fan palms, T12 and T13, grow in a planter along the south fence line, (Image #4).

Image #4 – Trees T11, crape myrtle and T12 and T13, fan palm, grow in landscape planter along south fence line. Also note overhanging canopy of trees T2-A & T3A, (red outline), ornamental pear, which grow on the MacDonaldis property.

The four crape myrtle growing along the south fence line are in fair or good condition. The glossy privet is in fair condition, and the two fan palms are in good condition.

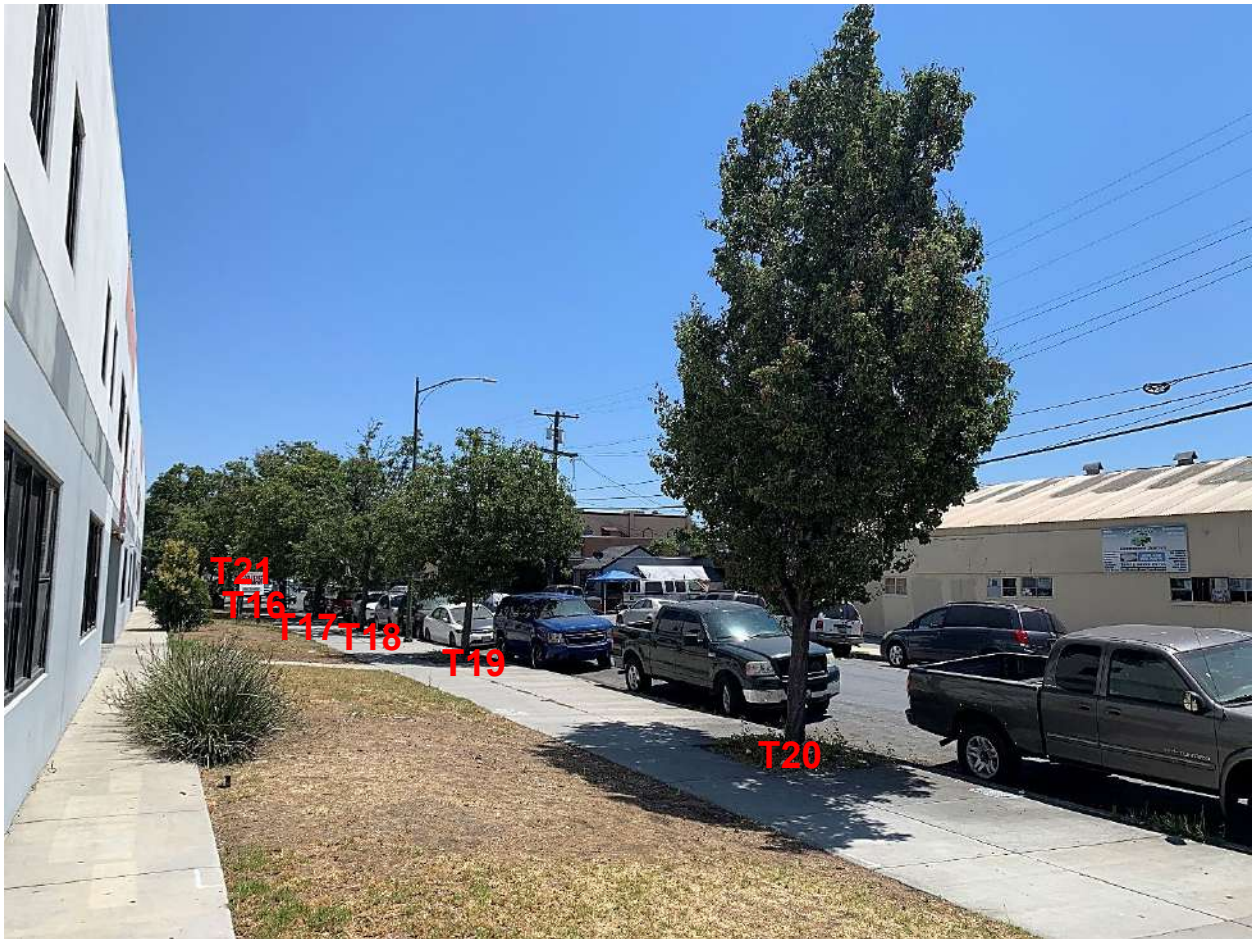
Six ornamental pear street trees grow in sidewalk cutouts along North 27th Street, (Image #5).

Image #5 – Street trees T16-T21, ornamental pear.

Most of the street trees are in fair condition. Some show signs of water deficit as evidenced by tip dieback. All have minor to moderate fire blight infection as evidenced by groups of dead leaves at branch tips. Fire blight is a common bacterial infection on ornamental pear.

One street tree, T18, has significant dieback throughout the canopy and is in fair to poor condition. The trees health should be monitored. It may be desirable to remove and replace this tree with a healthy specimen, if it continues to decline.

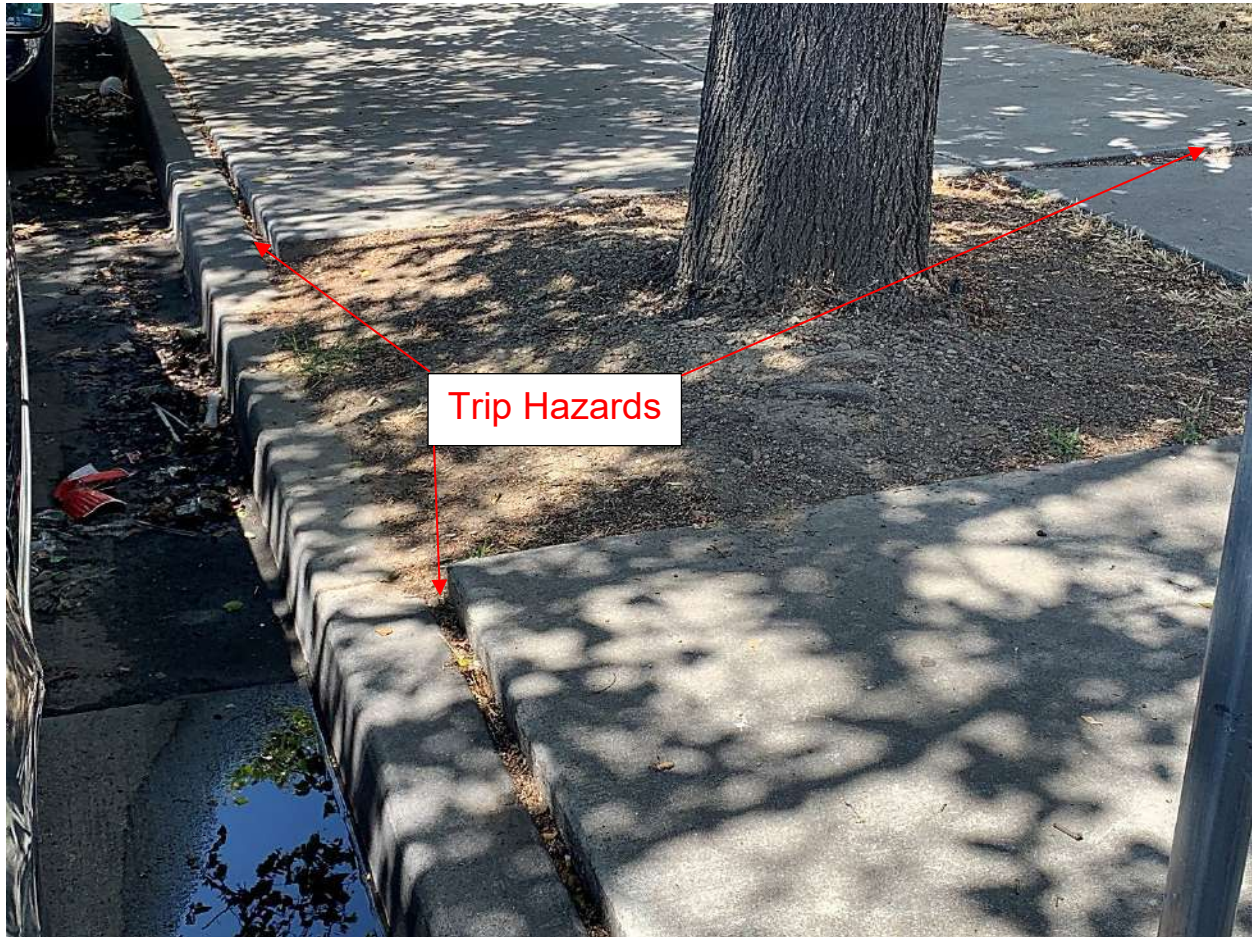
Three street trees T16, T17 & T18 are lifting the sidewalk. Trip hazards are occurring in multiple locations at tree T16, (Image #6).

Image #6 – Tree T16, ornamental pear. The lifted sidewalk is creating significant trip hazards in three locations.

The trees rooting area is restricted, shallow rooting has developed, and the sidewalk is lifted by root diameter expansion.

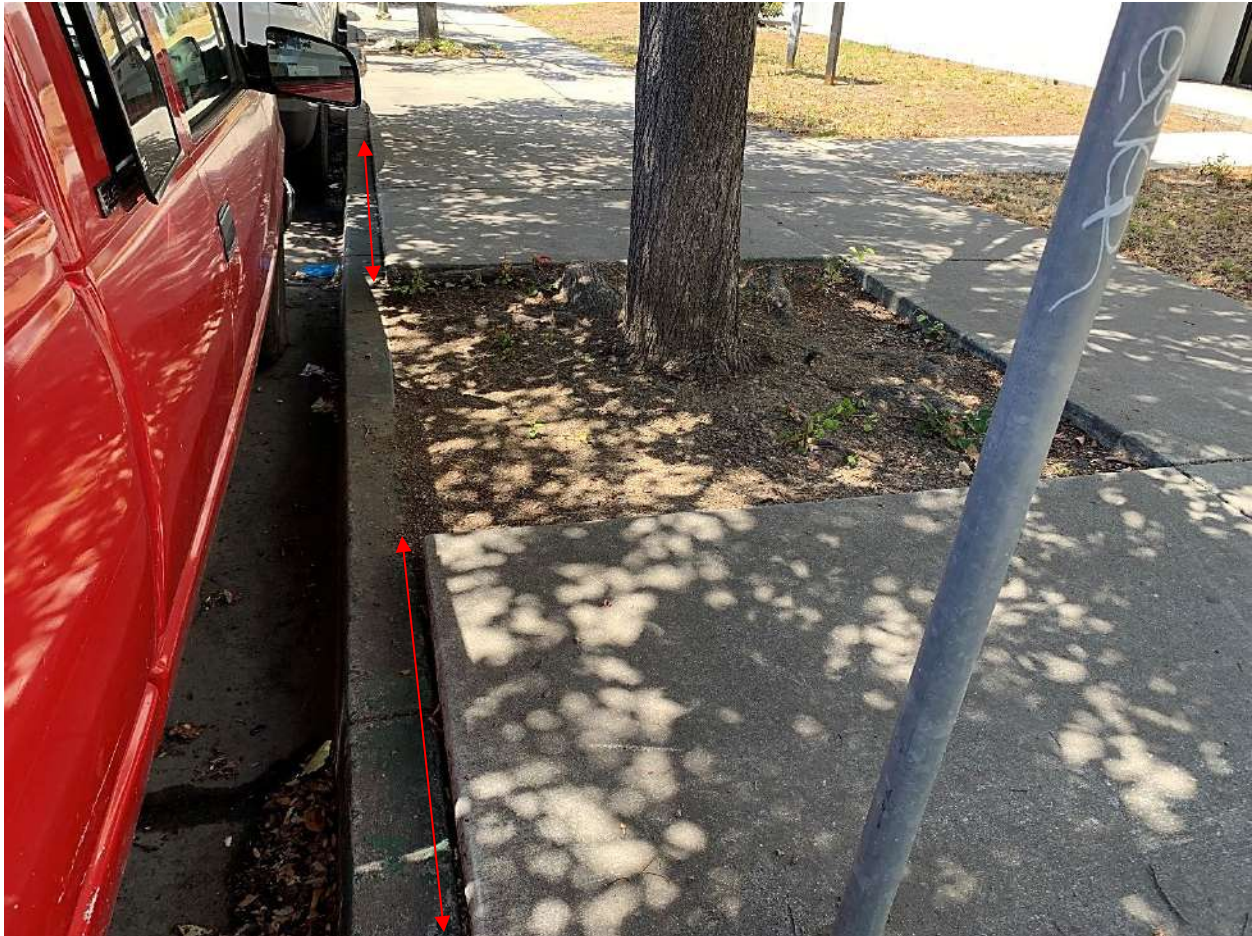
Shallow roots and a restricted rooting area also causing significant sidewalk lifting adjacent to tree T17, (Image #7).

Image #7 – Tree T17, ornamental pear. Note sidewalk lifting.

The sidewalk lifting above the curb from tree T17, is a significant trip hazard for people getting in and out of their vehicles.

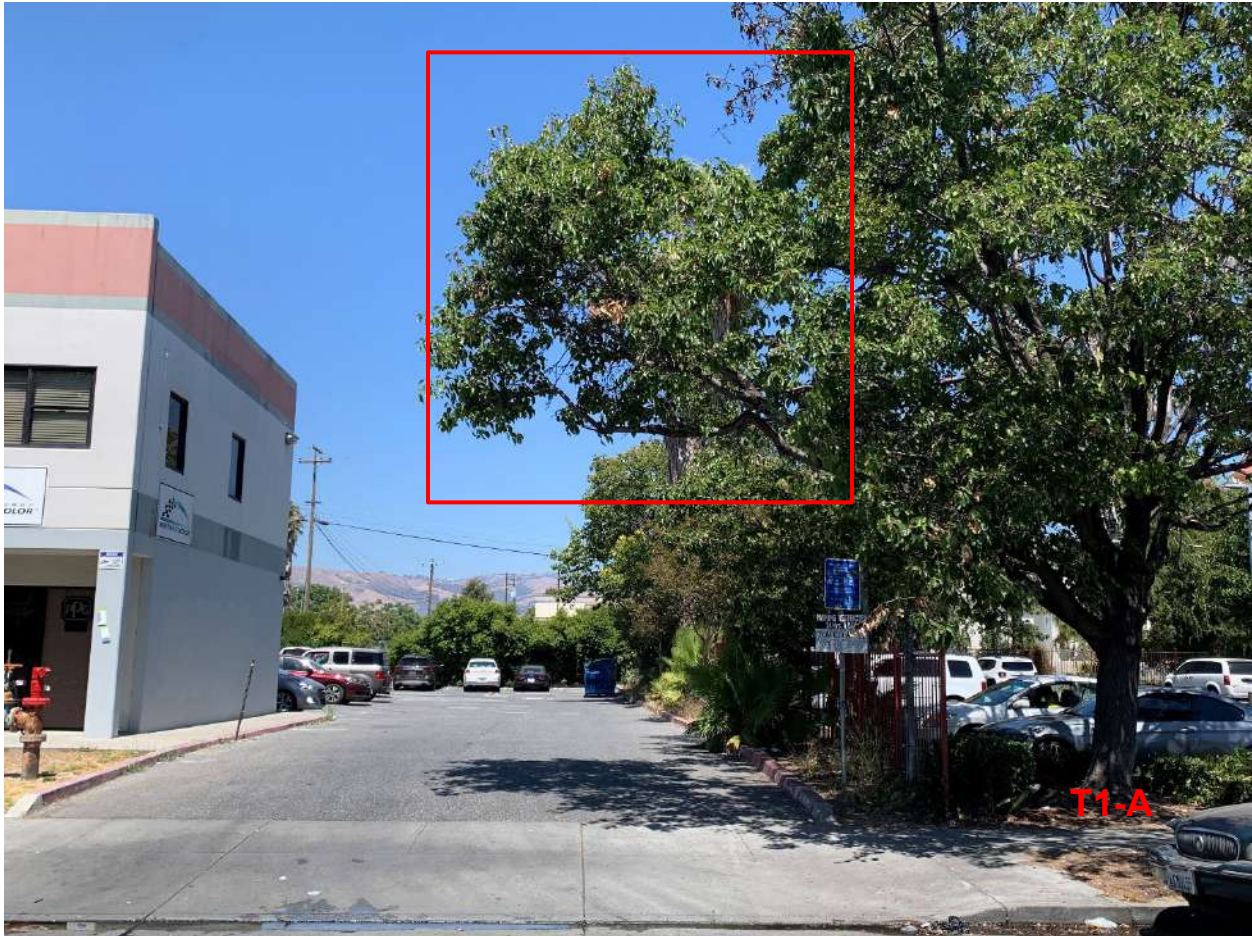
There are three “ordinance size” trees on the adjacent MacDonalds property to the south, with canopies that overhang the subject property. Tree T1-A grows near the entrance driveway to 70-80 North 27th Street, (Image #8).

Image #8 – Tree T1-A, ornamental pear. Note overhanging canopy, (in red).

The ornamental pear is in fair condition. Its canopy overhangs the subject property by about 10-feet.

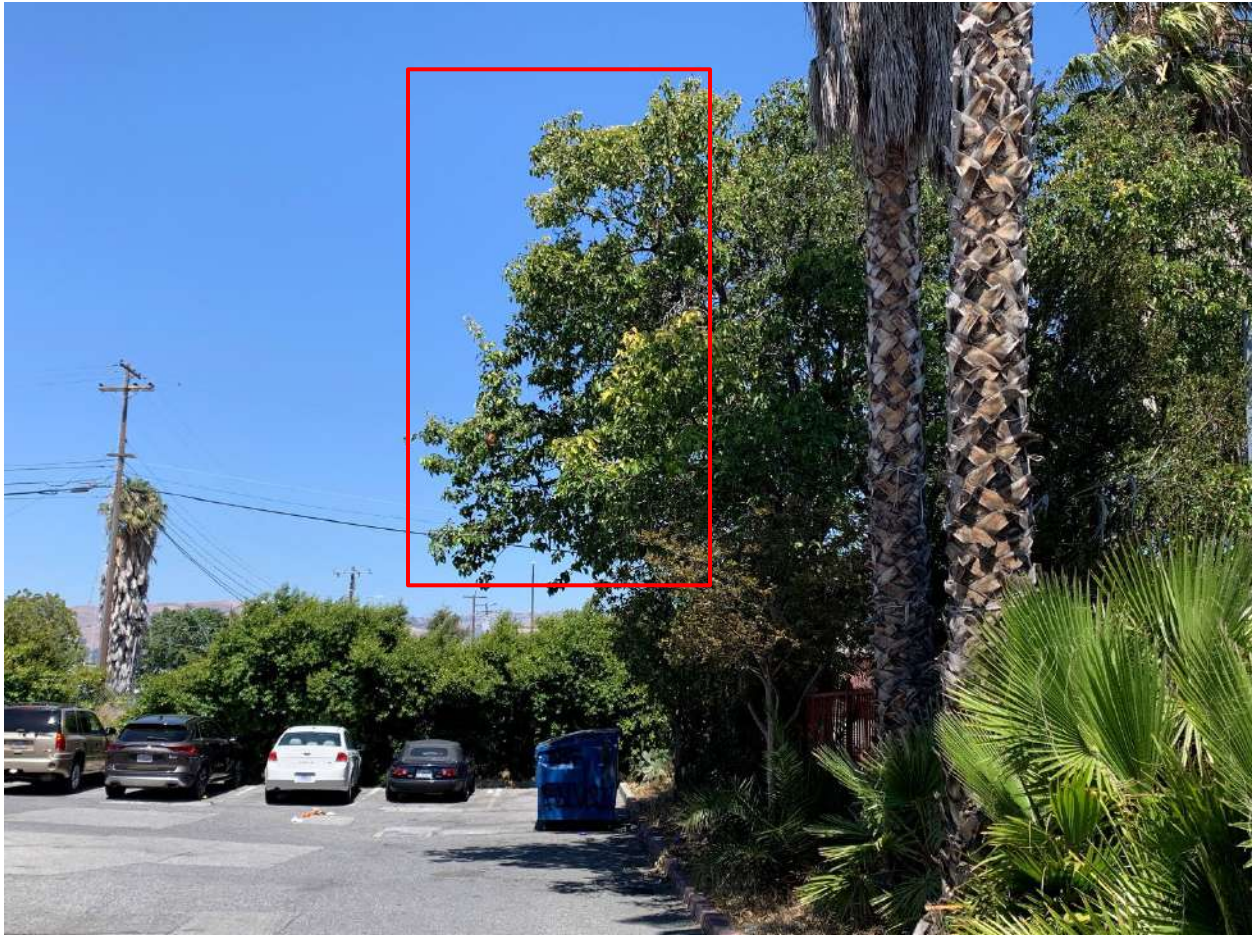
Trees T2-A and T3-A grow near the southeast corner of the subject property. Their canopies overhang the subject property, (Image #9).

Image #9 – Trees T2-A and T3-A, ornamental pear. Grow on adjacent property and have overhanging canopies, (in red).

The two ornamental pears are in fair condition.

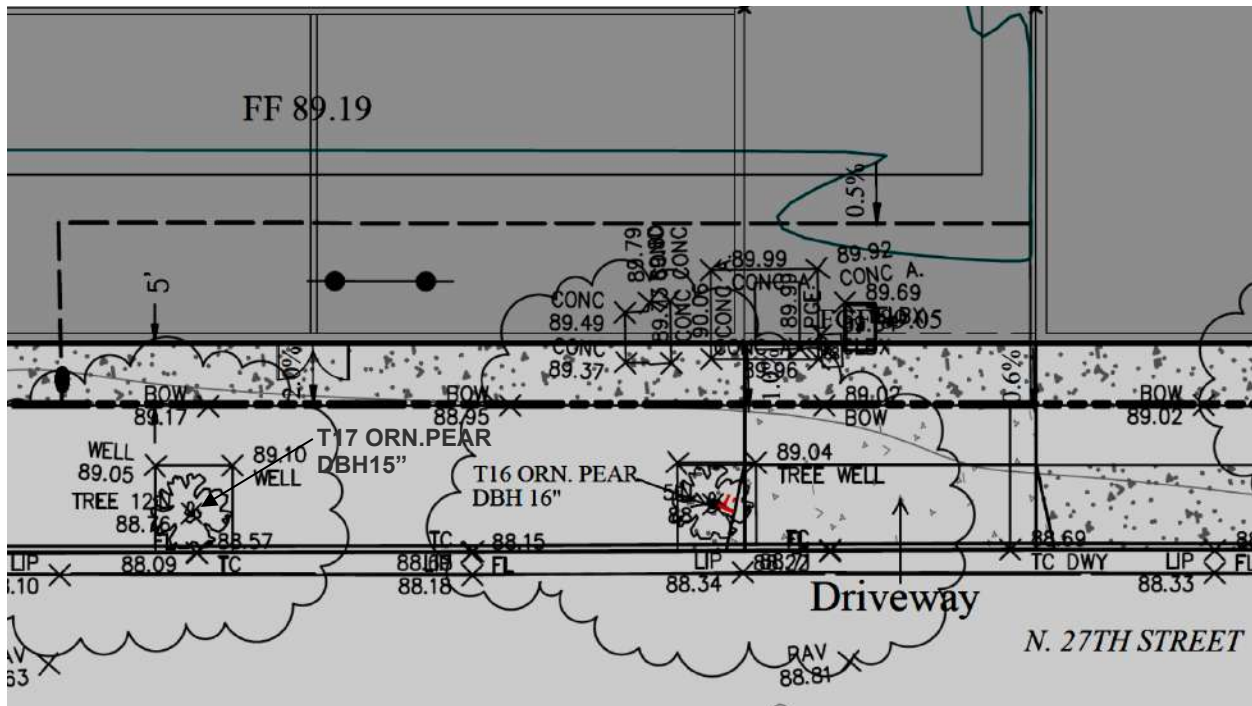
Street Tree T16, ornamental pear, will be less than one foot from the proposed driveway, will suffer extensive root loss beyond what it can tolerate, and its removal will be necessary, (Image #10).

Image #10 – Screen shot from Preliminary grading and drainage, Sheet C3. Tree T16, ornamental pear. Tree is located at edge of proposed driveway. The trunk will be within the footprint of over- excavation and forming. The canopy of tree T17, ornamental pear will need minor clearance pruning to allow construction of new building.

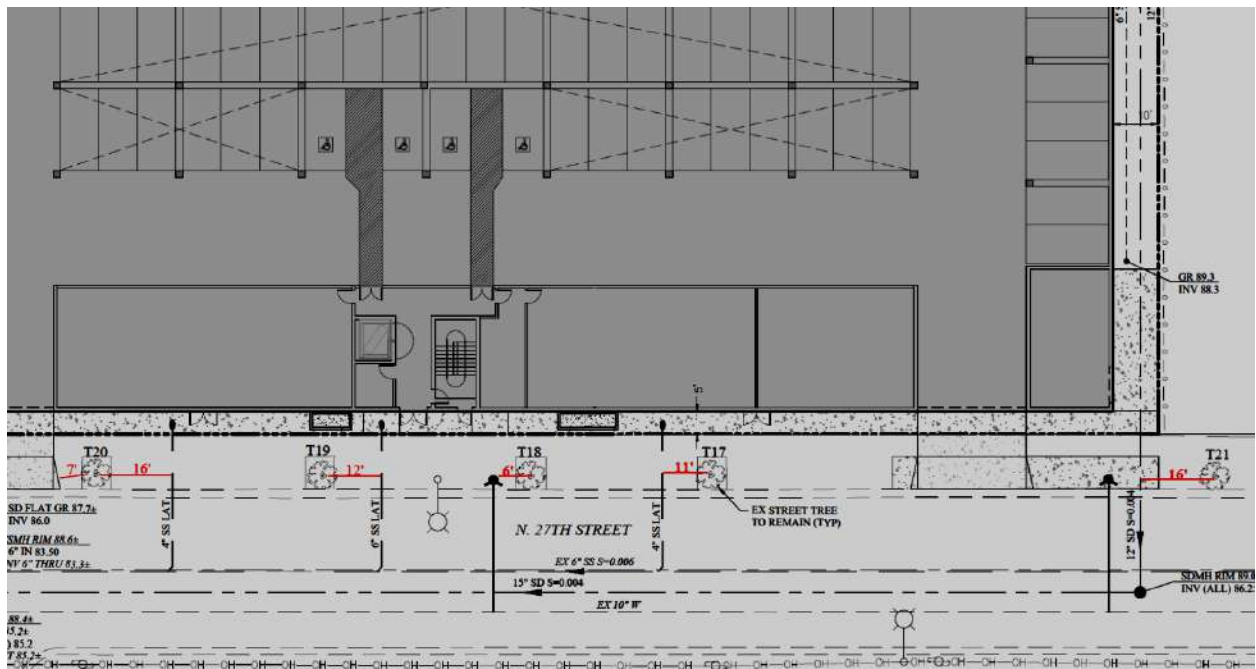
Excavation for utilities (fire service line, sanitary sewer lateral, storm drain line), (Image #11).

Image #11 – Screenshot from Preliminary Utility Plan, Sheet C4. Trees T17 -T21 ornamental pear, and distance to utility laterals.

Some root loss will occur from the construction elements, the ornamental pears can tolerate the loss, and will need tree protection measures, to reduce root loss impacts.
