Appendix E: Phase I Environmental Site Assessment

Type of Services	Phase I Environmental Site Assessment and Preliminary Soil Quality Evaluation
Location	2323, 2369, 2389, and 2391 Moorpark Avenue and Assessor's Parcel Numbers 282-01-014, 282-01-015, and 282-01-016 San Jose, California
Client	TTL Management
Client Address	12647 Alcosta Blvd., Suite 470 San Ramon, California 94583
Project Number	648-20-1
Date	December 5, 2019

Prepared by **Christopher J. Heiny, P.G.**
Principal Geologist

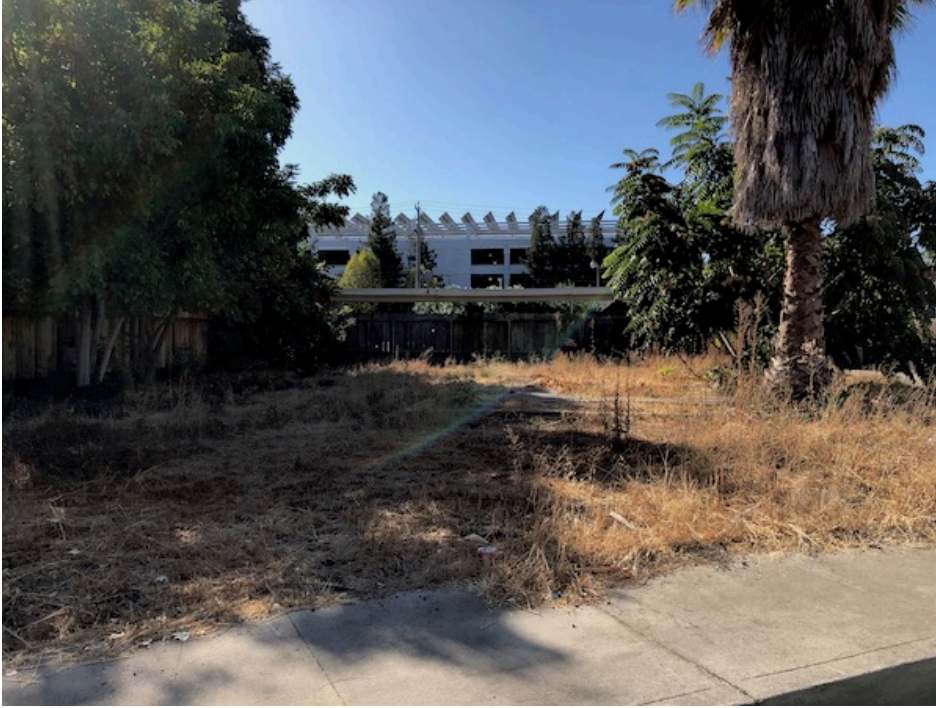
In the northeast corner of the Site, Cornerstone observed concrete walkways with a tree and other vegetation growing between some of the walkways. . Cornerstone assumed that this area is possibly an abandoned garden.

Photograph 2. View looking south across vacant lot (possible former garden) from northeast corner of Site.

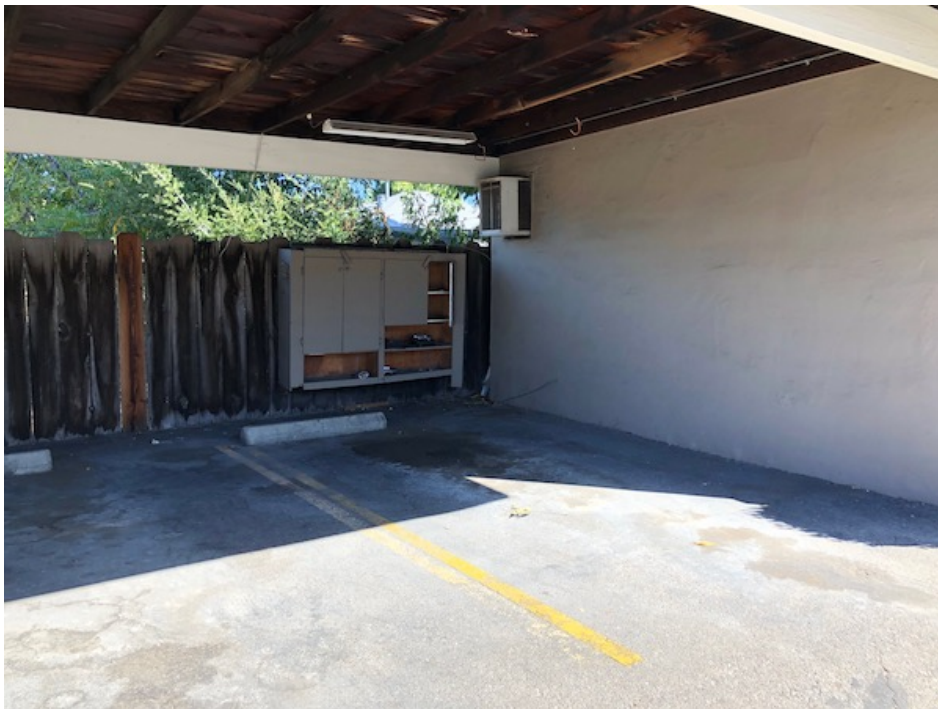
Photograph 7. Tenant storage cabinet within carport.

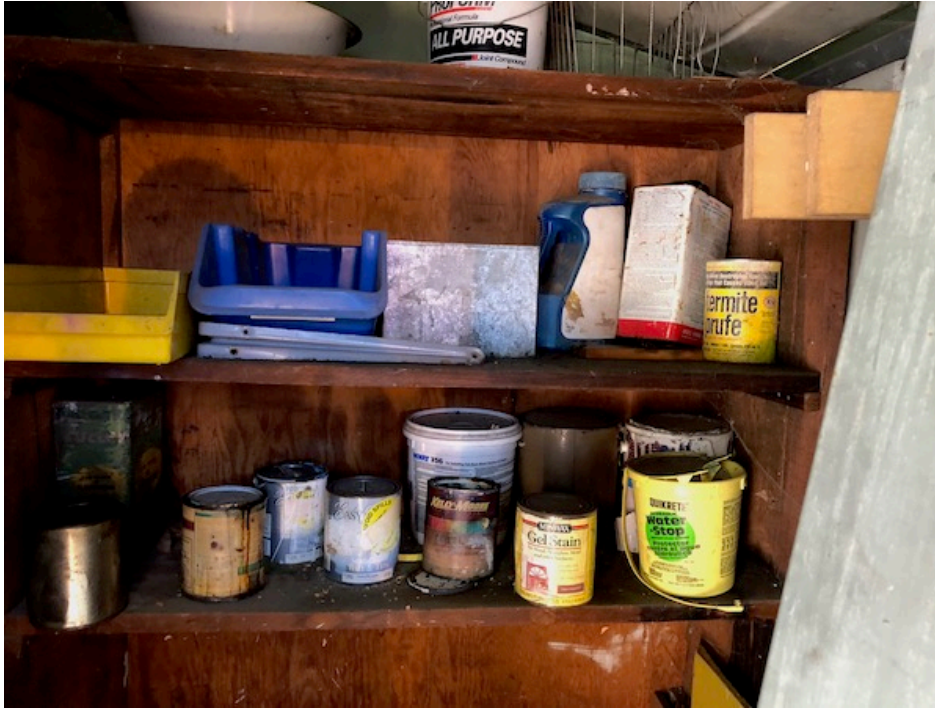
A maintenance shed containing multiple gallon size and spray can containers of paints was observed on the north side of the eastern apartment complex.

Photograph 10. Typical storage shed interior, note paints and coatings.

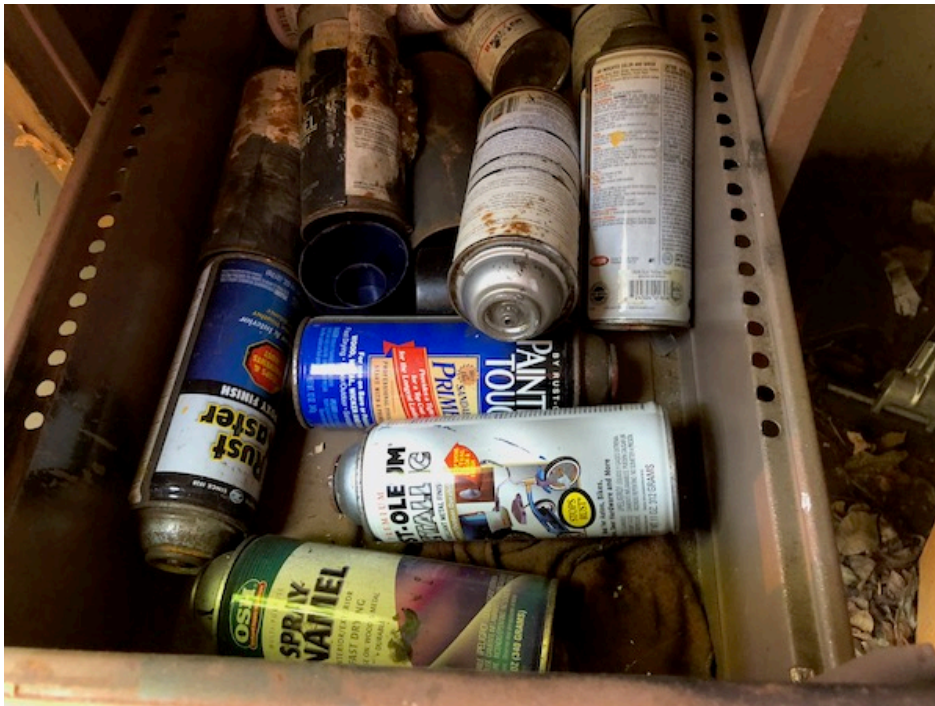
Photograph 11. Typical interior of file cabinet within storage shed. Note multiple spray paint cans.

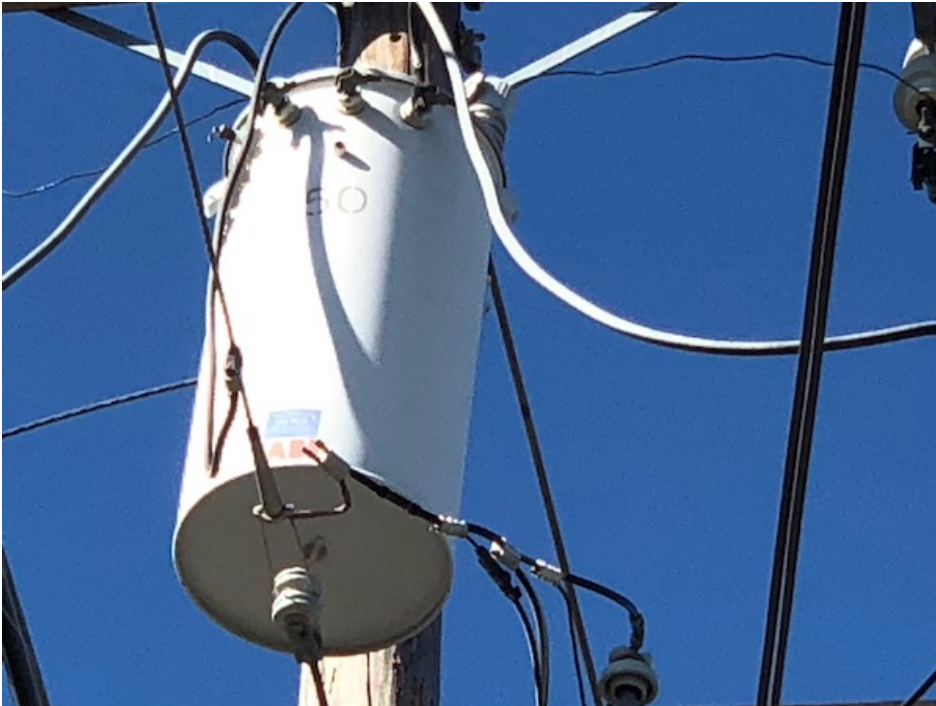
Two pole-mounted transformers were observed along Moorpark Avenue, both appeared to be labeled with “no PCB” blue stickers.

Photograph 13. Pole-mounted transformer labeled non-PCB.

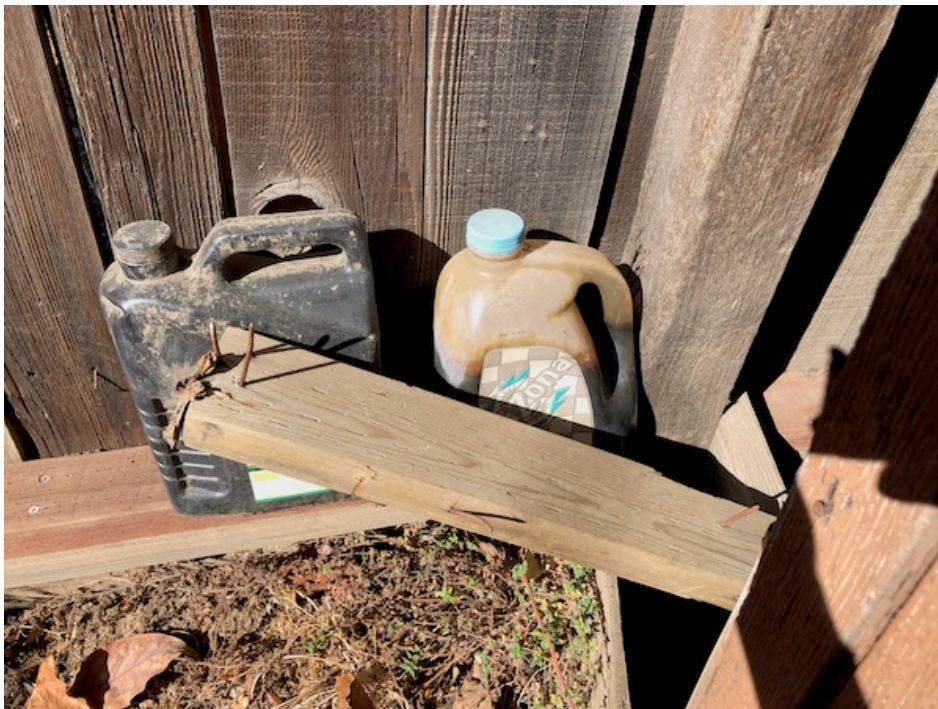
Photograph 21. Two containers of presumed waste oil near carport in northwestern portion of Site.

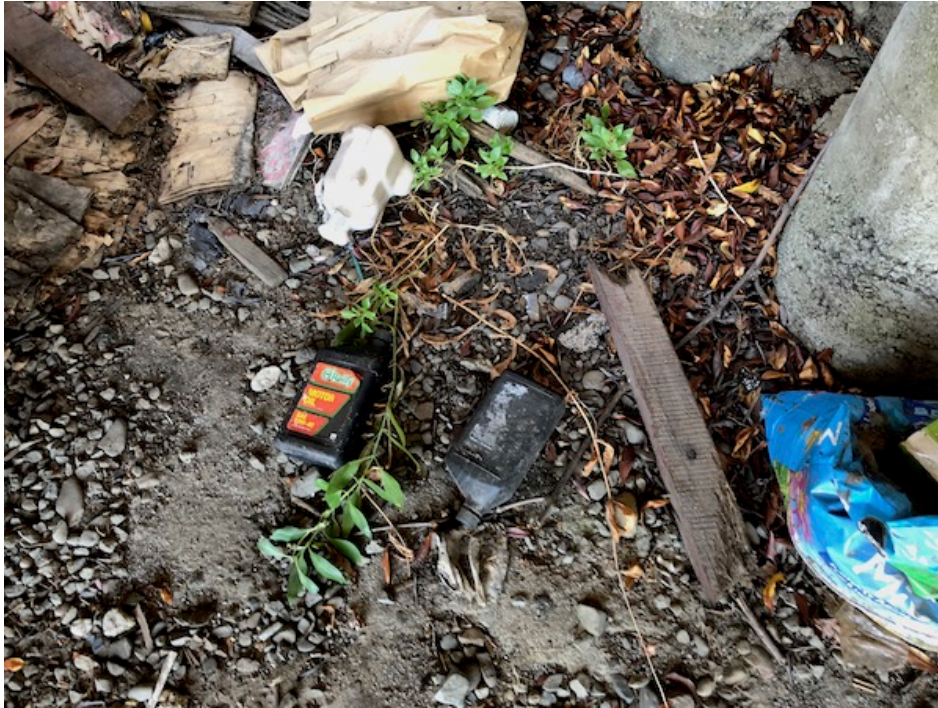
Photograph 24. Motor oil containers observed on ground surface within carport.

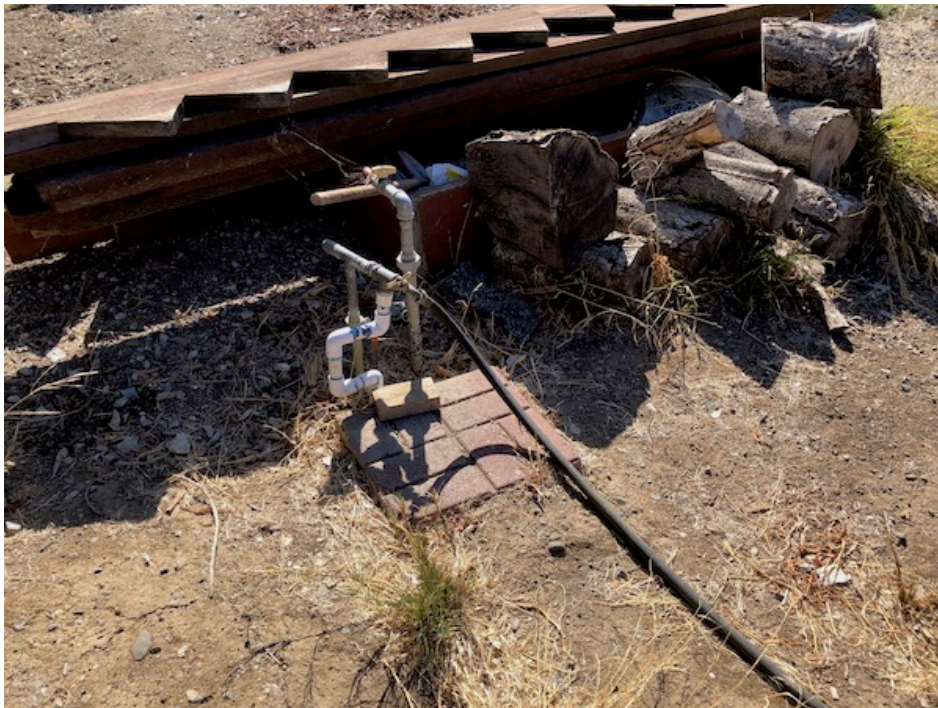
In the northwest corner of the Site, Cornerstone observed several garden sheds, a vegetable garden, and two shipping containers (locked and presumably used for storage). The interiors of several carports contained small containers of motor vehicle maintenance fluids including used motor oil. A possible irrigation well was observed in the garden area, identified by a water

spigot from the ground. No water tanks commonly associated with domestic wells were observed.

Photograph 27. Possible well or remote water spigot located within a garden area in northwest corner of Site.

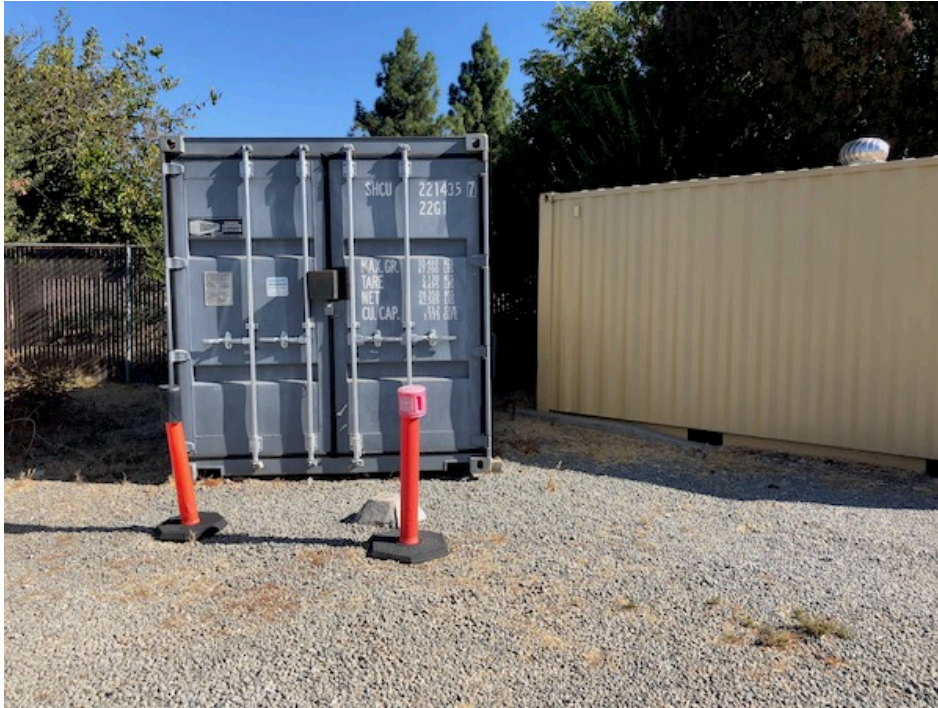
Cornerstone observed the exteriors of two locked storage sheds and two locked steel shipping containers in the northwestern portion of the Site; however, these structures were locked and not accessible during our Site visit.

Photograph 28. Shipping containers in northwest portion of Site.

- Cornerstone was unable to view the interior of the residences on-Site or interiors of locked storage sheds and shipping containers. Additional storage of potentially hazardous materials may be present within these structures. Improper storage of potentially hazardous materials within these locked storage areas increases localized risk of potential surface spills. We recommend requiring that all materials within these structures be removed and properly disposed of off Site prior to acquiring the property.

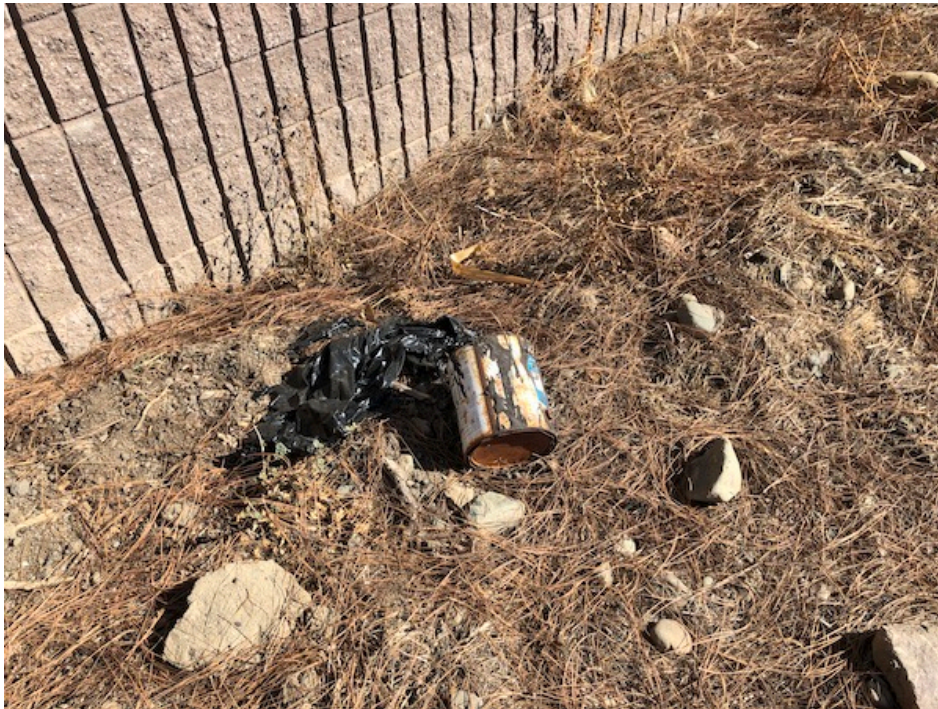
Photograph 47. Paint can and plastic debris within field on northern boundary of Site.

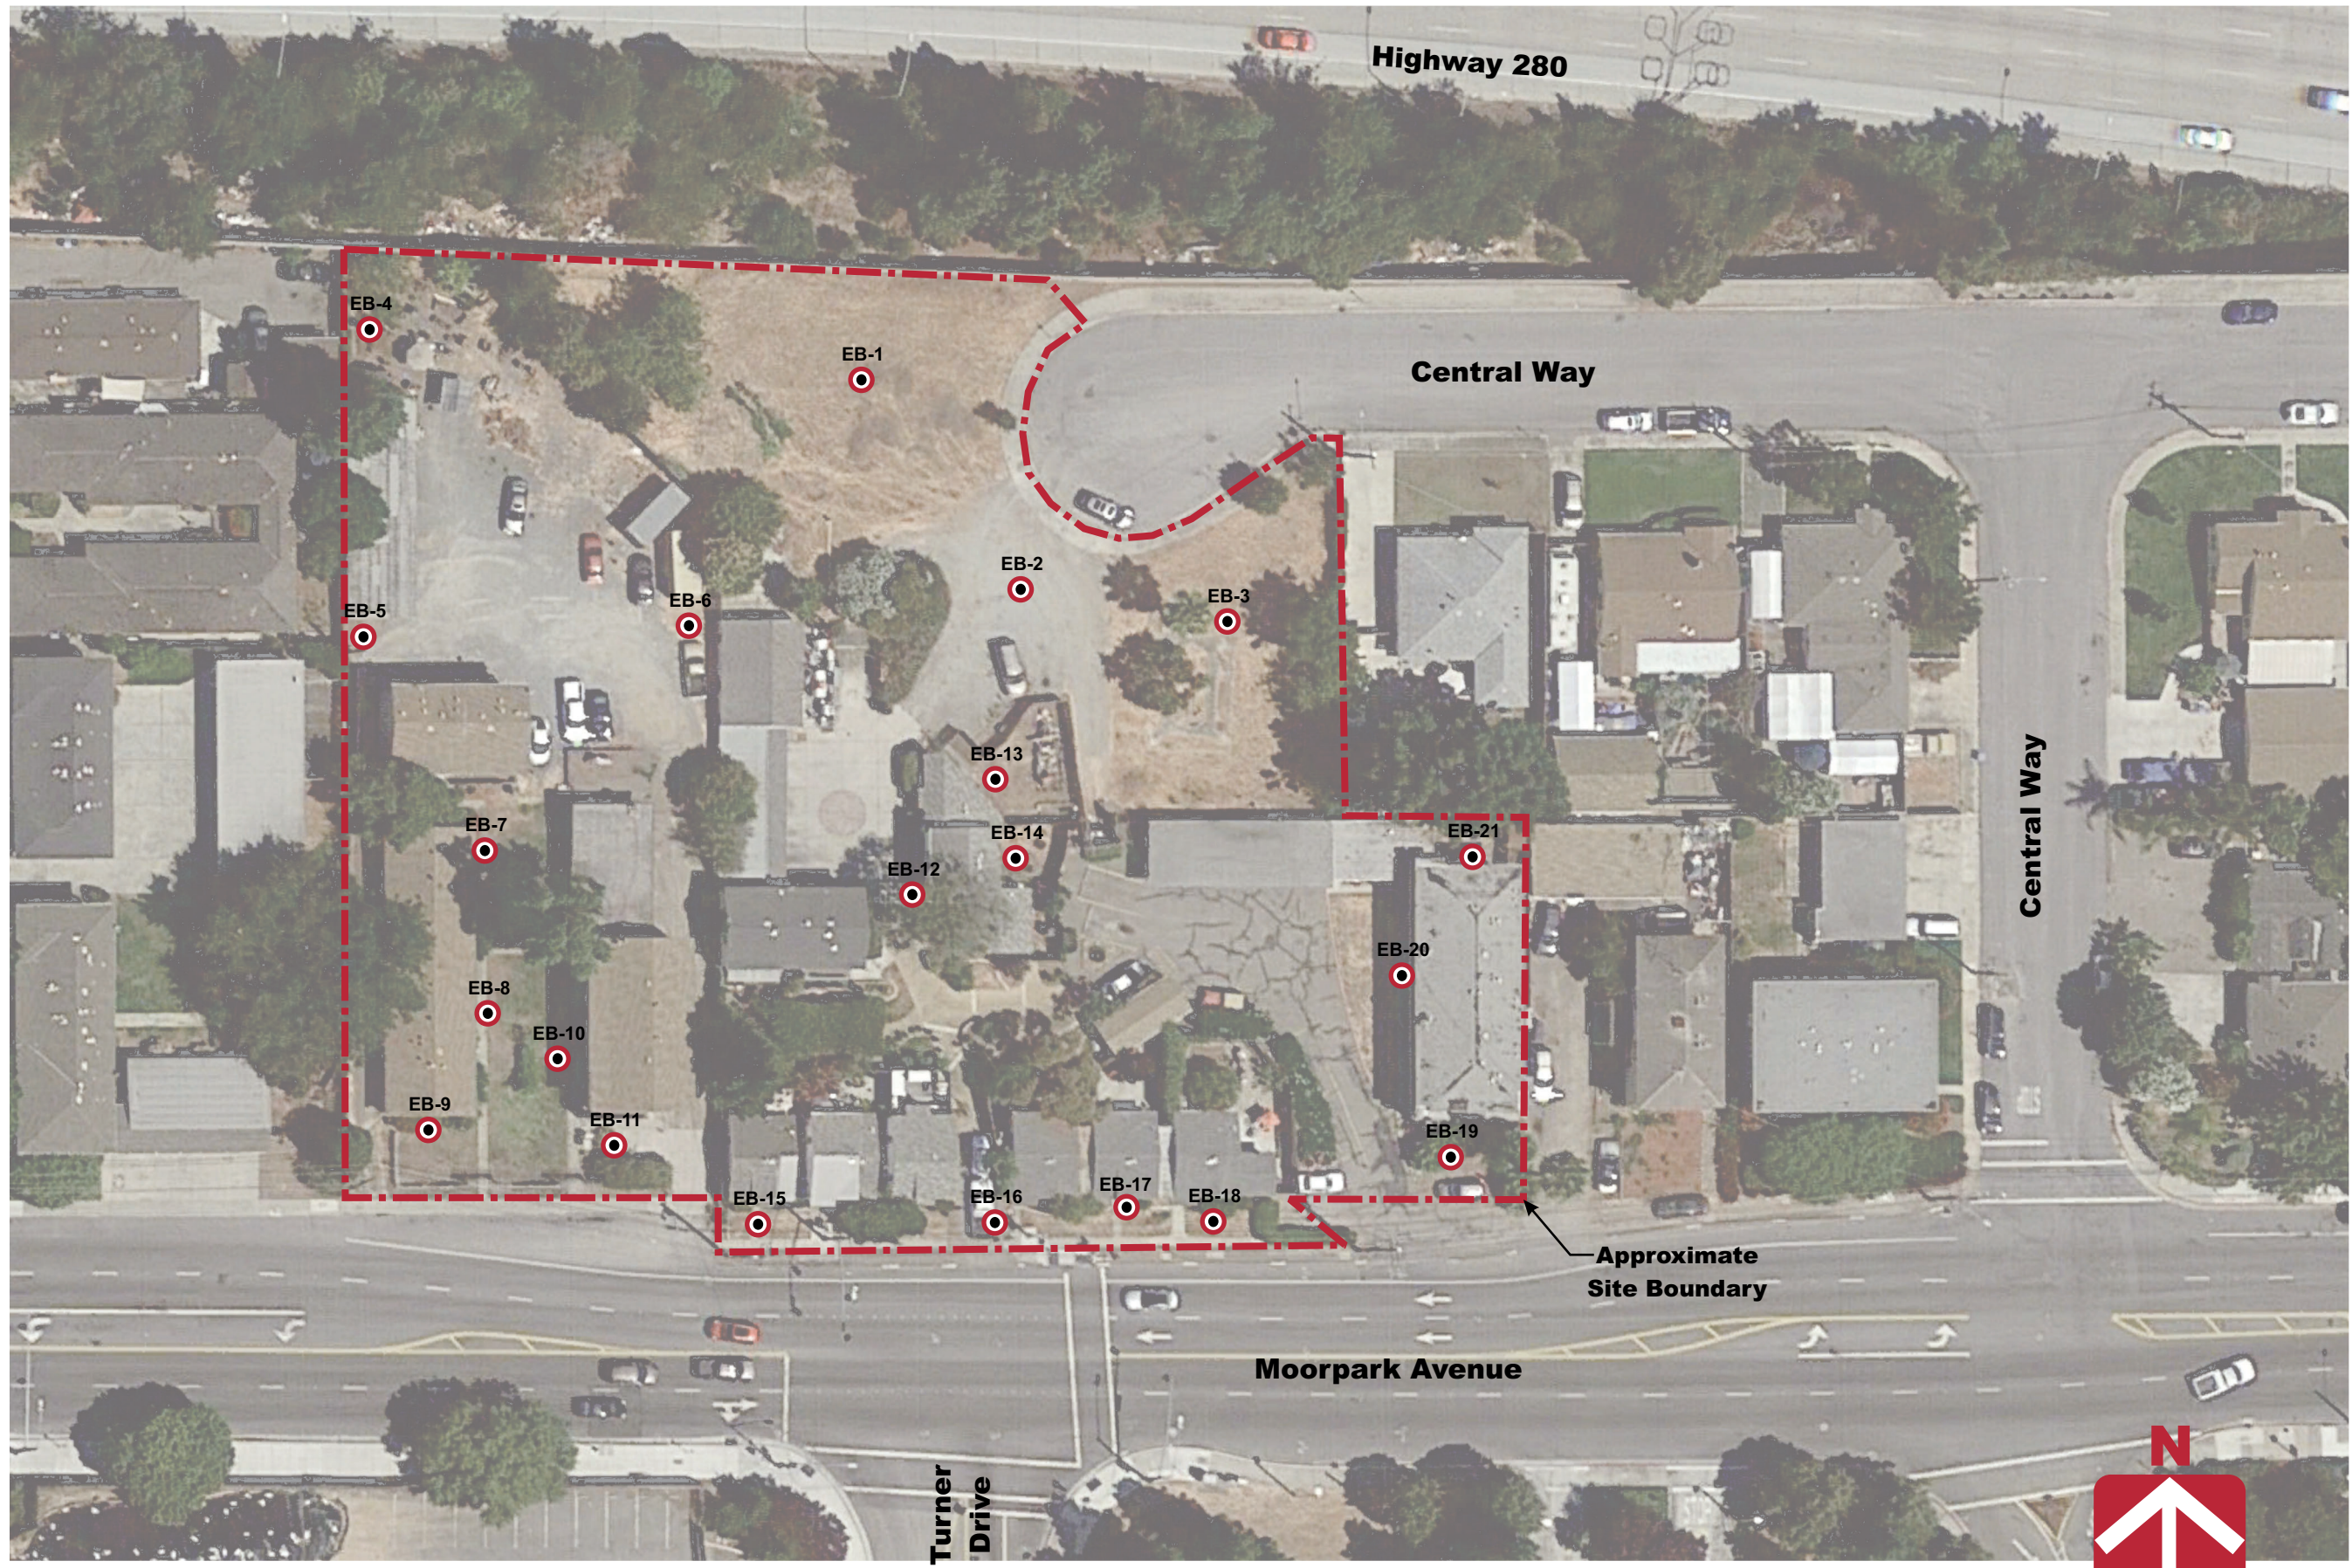
Elevated concentrations of lead were detected in eight samples collected adjacent to existing structures, and likely resulted from weathering/flaking of lead-based paints. Four of these samples (EB-15 through EB-18) were collected from soil adjacent to the six cottages located along Moorpark Avenue and constructed by 1939. The soil adjacent to the foundations of the cottages appears to have been impacted from lead-based paint weathering. The remaining elevated lead concentrations were detected around newer structures and appear to be more sporadic. Soil with total lead exceeding ten times the soluble threshold limit concentration (STLC) of 5 milligrams per liter (mg/L) (i.e. soil with total lead exceeding 50 mg/kg) may fail the STLC California hazardous waste limit. Soluble/STLC lead analyses will be required prior to removal of this soil for off-Site disposal. In our experience, soil with total lead exceeding 100 mg/kg has a high likelihood of exceeding the STLC limit.

Elevated detected concentrations of mercury (one sample), arsenic (four samples), chlordane (two samples), and dieldrin (two samples) likely resulted from past applications of pesticides/termiticides. The two elevated chlordane concentrations were detected two of the four sampling locations adjacent to the cottages, indicating that termiticides may have been used around these structures but in varying amounts and/or frequencies. The detected chlordane concentration in one of these samples exceeded the California hazardous waste (TTLC) threshold, indicating that some of the soil may be considered a hazardous waste if transferred off-Site for disposal. One of the elevated dieldrin concentrations was detected in a sample collected adjacent to one of the storage sheds and the other was detected from an open area of the Site. Based on these data, the chlordane and dieldrin concentrations appear to be laterally limited in lateral extent. Deeper samples were not analyzed for OCPs.

We recommend removal of soil exceeding residential screening criteria prior to Site development. Cornerstone recommends collecting/analyzing additional soil samples to evaluate the lateral and vertical extent of soil with elevated metals and OCPs detected. We additionally recommend preparation of a Soil Management Plan, Site-Specific Health and Safety plan, and Dust Control Plan to establish protocols for managing soil during grading activities.
