Arborist Report

210 Baypointe Parkway
San Jose, CA

July 2022
Rev. September 2022

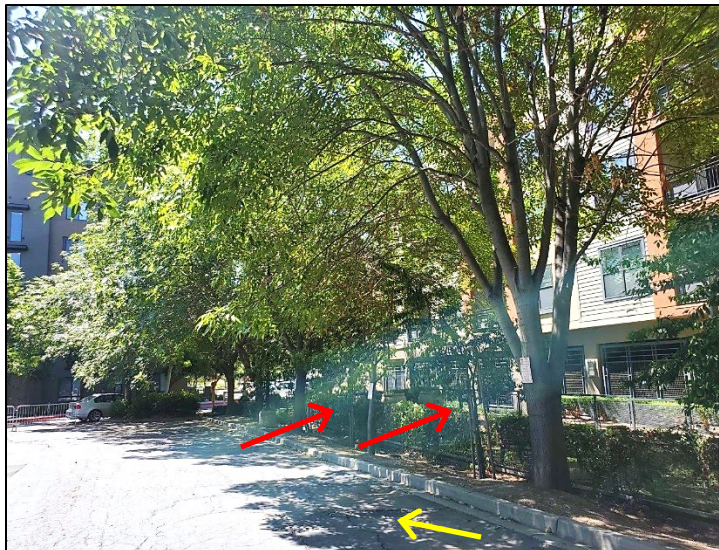
Evergreen ash was the most common species assessed, with 49 trees (43% of the population). Trees were growing in parking lot planters and along the western edge of the site (Photo 1). Most ash were in fair condition (26 trees), and 12 trees were poor. Several were growing in a row on or near the west property line.

Photo 1. Several evergreen ash were growing at the west edge of the site and had young Carolina cherry laurels planted between them (red arrows). Tree roots had displaced paving (yellow arrow).

Ash #118 was a vigorous tree in good condition and was the largest tree assessed with a diameter of 21 inches. Other ashes ranged from 5 to 18 in. Many of the trees had outgrown the available rooting space in 3x3-ft. planters and were displacing curbs and paving.

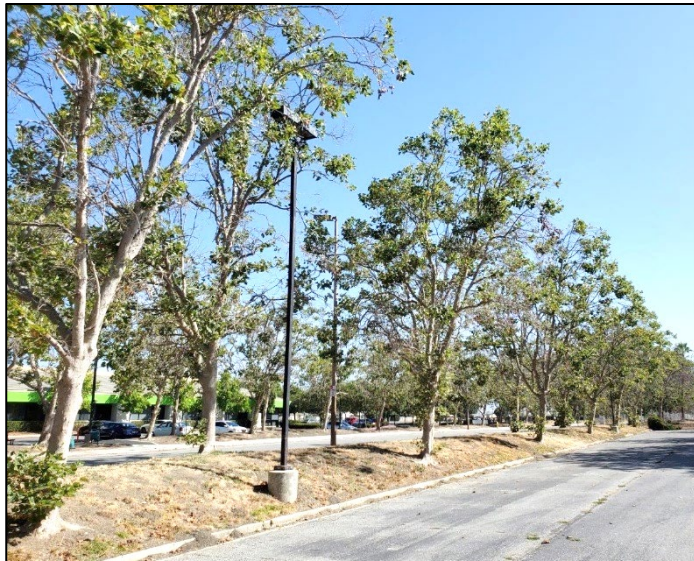
Twenty-eight (28) London planes were growing on a dry berm along Baypointe Parkway (24% of the population, Photo 2). Almost all (26) trees were in fair condition with codominant stems or multiple attachments. Plane #116 was in poor condition and crowded by a nearby ash; #120 was dead. Crowns were sparse and trees appeared drought stressed. Trunk diameters ranged from 9 to 14 in.

Photo 2. London planes grew in two alternating rows along Baypointe Avenue (in background). View is from the south.

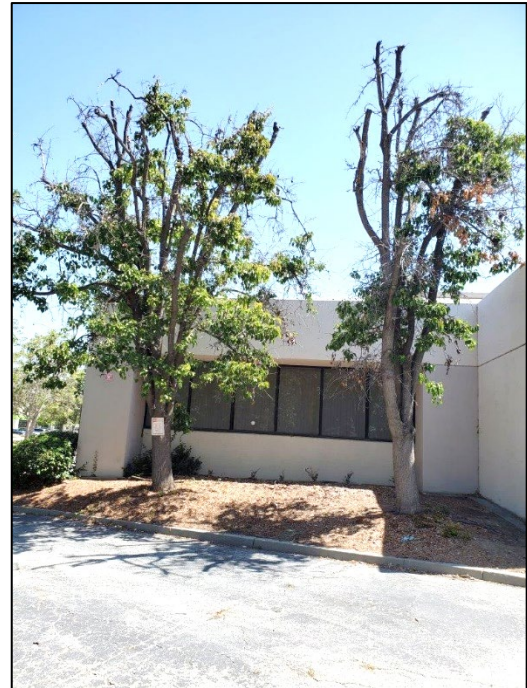
Photo 3. Callery pears #177 and 178 were in poor condition with extensive branch dieback and fireblight.
