Tree Assessment

Santana Row West
Winchester Blvd.
San Jose CA

Prepared by:
HortScience, Inc.
325 Ray Street
Pleasanton CA 94566

January 2016

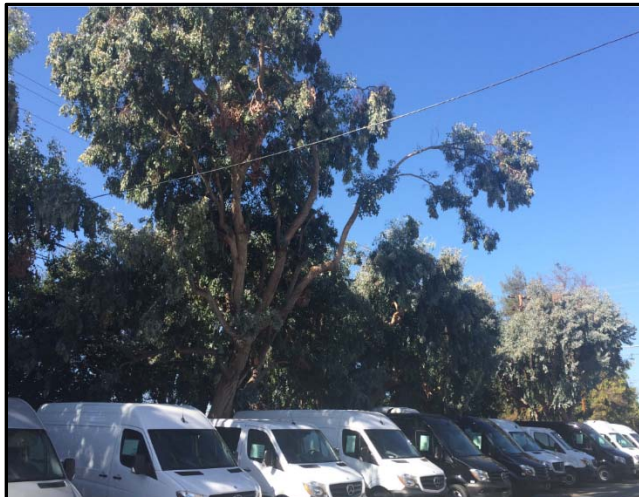
Twenty-five (25) silver dollar gums were located behind the buildings along the property line. They had all been topped to clear overhead utility lines (Photo 1). Trees were mature in development. Trunk diameters ranged from 16" to 37". The largest silver dollar gum, #44, was in poor condition. Over 50% of the trees were 24" or larger. Overall condition was fair (21 trees). Silver dollar gum #134 was in good condition. Gums #10, 18 and 44 were in poor condition.

Photo 1. Silver dollar gum were located behind buildings on the south and west sides of the property under utility lines.

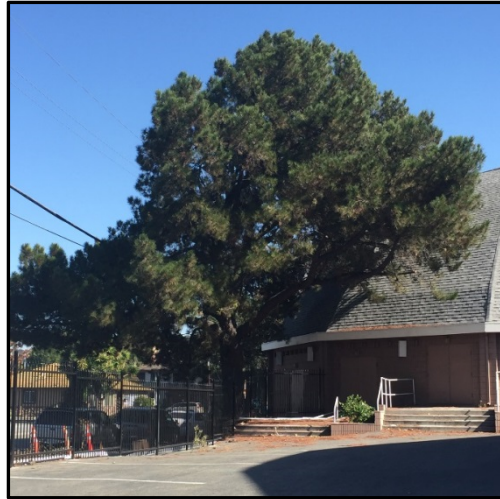
Photo 2. Monterey pine (#53) located along Olin Ave. The tree was close to an existing building and had been pruned to clear energized conductors. Its condition was fair.

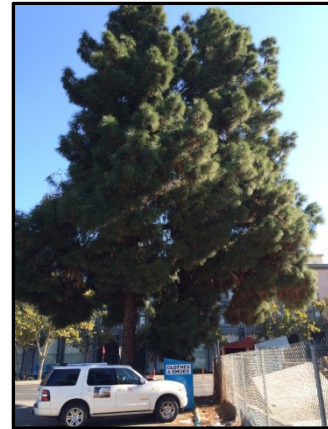
Nine Canary Island pines were located on the northwest corner of the property (Photo 3). Trees were mature in development with trunk diameters between 19" and 34". Tree condition varied widely: tree #76 was poor; #74, 75, and 199 were fair; while #72, 73, 88, 89, and 92 were good. Trees along Olin Avenue had been pruned to clear utility lines. This pruning was the primary reason for differences in condition.

Photo 3. Canary Island pines (#88 & 89) located along Winchester Blvd. Both were in good condition.

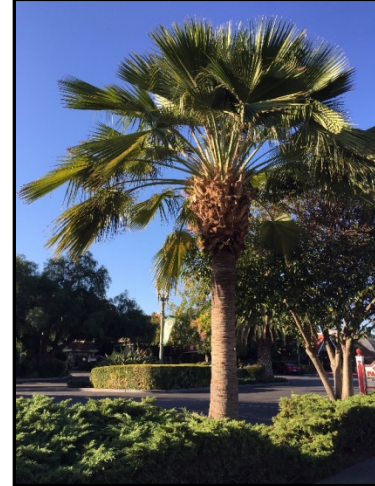
Photo 4. Guadalupe palm #179

- 5 silk oaks were mature in development (20" to 32") and either poor or fair condition. All had poor form and structure.
- 5 Mexican fan palms were mature in development (20" to 32") and all in good condition. All but one (#78) were located near Olsen Dr.
- Guadalupe palms #179, 180, 184 and 185 were located on the corner of Olsen and Winchester. All were in good condition (Photo 4).

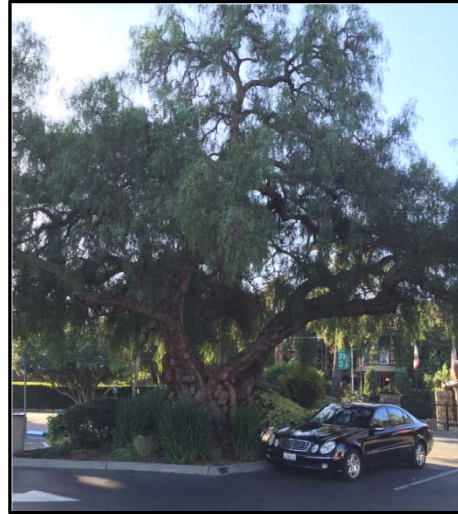
- Camphor trees (#113 and 114) were located in small parking lot planters, 6" and 8" in diameter. One was in fair and the other in good condition.
- California peppers (#95 and 186) were in fair condition and 52" and 60" in diameter (photo 5). One was located near the corner on Winchester and Olsen and the other in the Mystery House parking lot. An active bee hive was in tree #95 and tree #186 was riddled with wood decaying fungi.

Photo 5. California pepper #186 located in Mystery House parking lot.

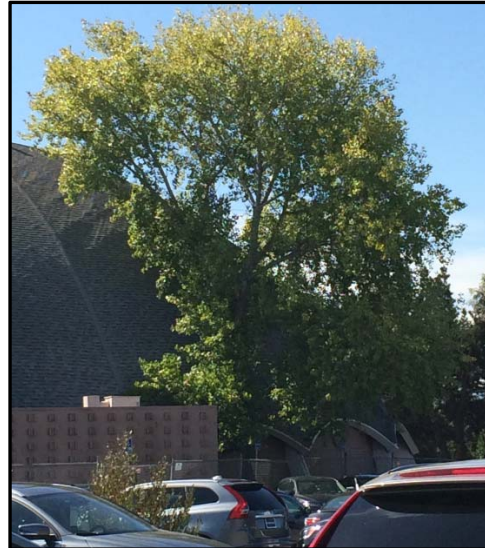
- Bailey acacia #132 was located off-site, 10" in diameter and in fair condition.
- Japanese maple #67 was in good condition, located in the entrance planter at the Olin Ave building and 7" and 5" in diameter.
- King palm #84 was in fair condition and located at the corner restaurant.
- California black walnut #190 was located in the Mystery House parking lot, 24" in diameter, and in fair condition.
- Olive #26 was located on the west property line, 12", 7" and 6" in diameter and in fair condition.
- Fremont cottonwood #54 was located next to the building, in fair condition and was 27" in diameter.

Photo 6. Fremont cottonwood #54 located on the north side of the middle building.
