### **Example of Successful Congdon's Tarplant Mitigation**

**Wrigley Creek Improvement Project  
Milpitas, California  
Year 5 (2015) Monitoring Report**

**Project #2995-04**

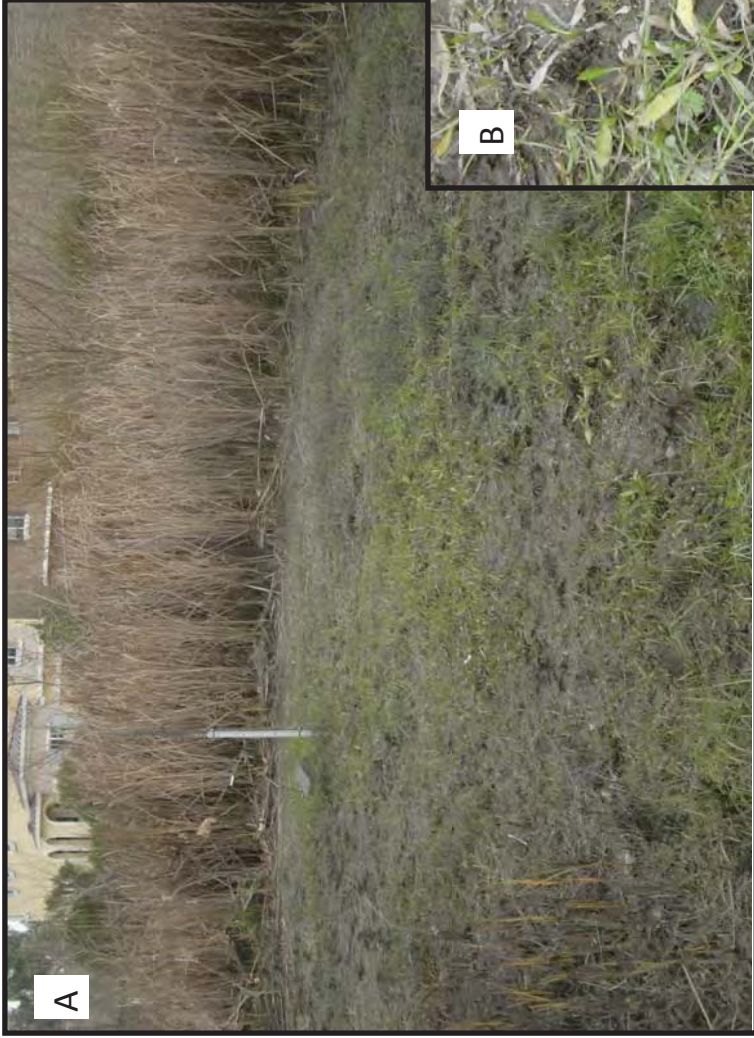
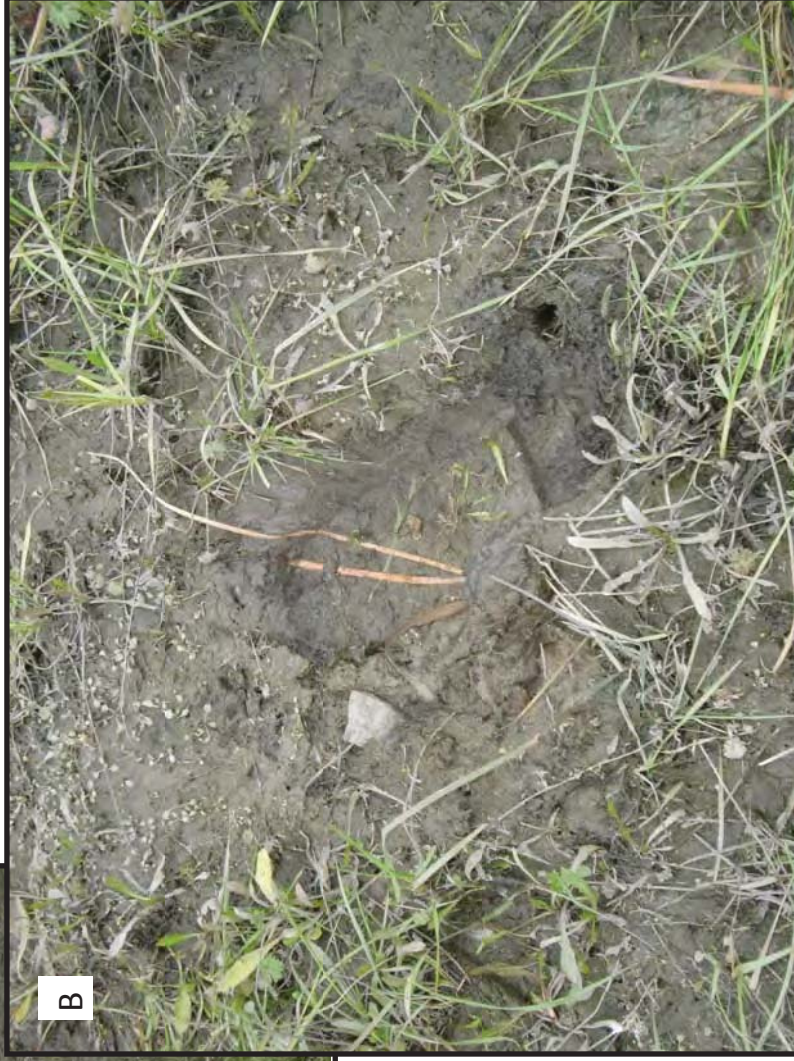
Throughout the wet season, there were approximately 59 days (discontinuous) during which the north gage site was inundated (**Figure 4**). The longest continuous period of inundation was about 24 days, from December 11, 2014 to January 3, 2015. The stage record and field observations show that between November 29, 2014, when storms inundated the site, and January 8, 2015, when moist soils were observed in the field, soils near the gage were either inundated or saturated at a depth of approximately 2 inches, a period of continuous inundation/saturation lasting 40 days. **Figure 5** shows site photos from the January 8 field visit.

Figure 5. January 8, 2015 north gage field photographs. Wrigley Creek Mitigation Performance Monitoring, Santa Clara County, California . On the day these photos were taken, saturated soils were confirmed at the surface at both the north and south gages. A) North gage on January 8, 2015. B) Soils at the north gage on January 8, 2015.

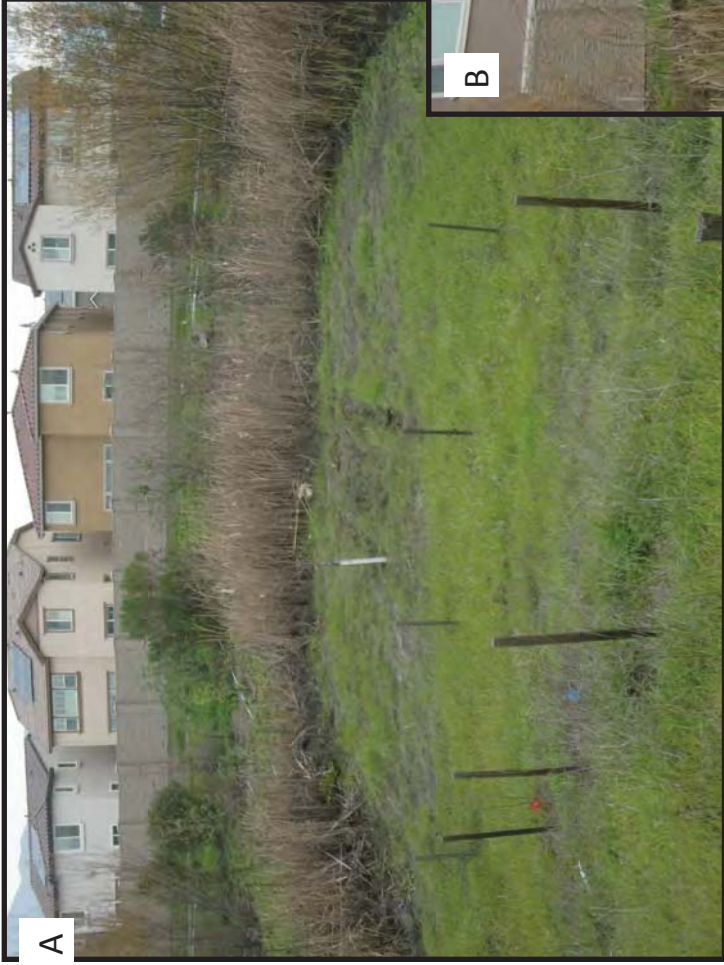
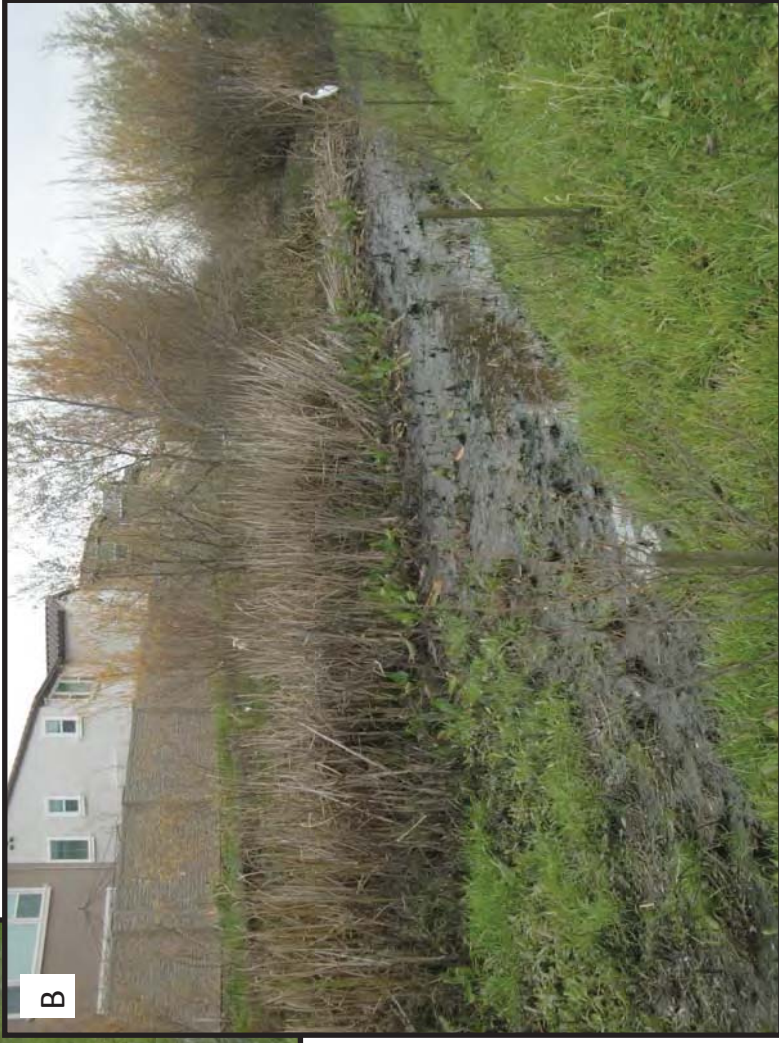
Figure 6.

The south gage is located on a section of floodplain that ponds during and after storm events, therefore this site is inundated for a longer duration. According to the stage record (**Figure 4**) there were approximately 78 (discontinuous) during which the south gage site was inundated. The longest period of continuous ponding/inundation lasted 32 days, from November 29, 2014 to January 3, 2015. As at the north gage site, the stage record and field observations show that between November 29, 2014, when storms inundated the site, and January 8, 2015, on which moist soils were observed in the field, soils near the gage were either inundated or saturated at a depth of approximately 2 inches, a period of continuous inundation/saturation lasting 40 days. **Figure 6** shows site photos from the January 8 field visit.

**January 8, 2015 south gage field photographs. Wrigley Creek Mitigation Performance Monitoring, Santa Clara County, California .** On the day these photos were taken, saturated soils were confirmed at the surface at both the north and south gages. A) South gage on January 8, 2015. B) The channel about 50 feet upstream of the south gage, January 8, 2015.

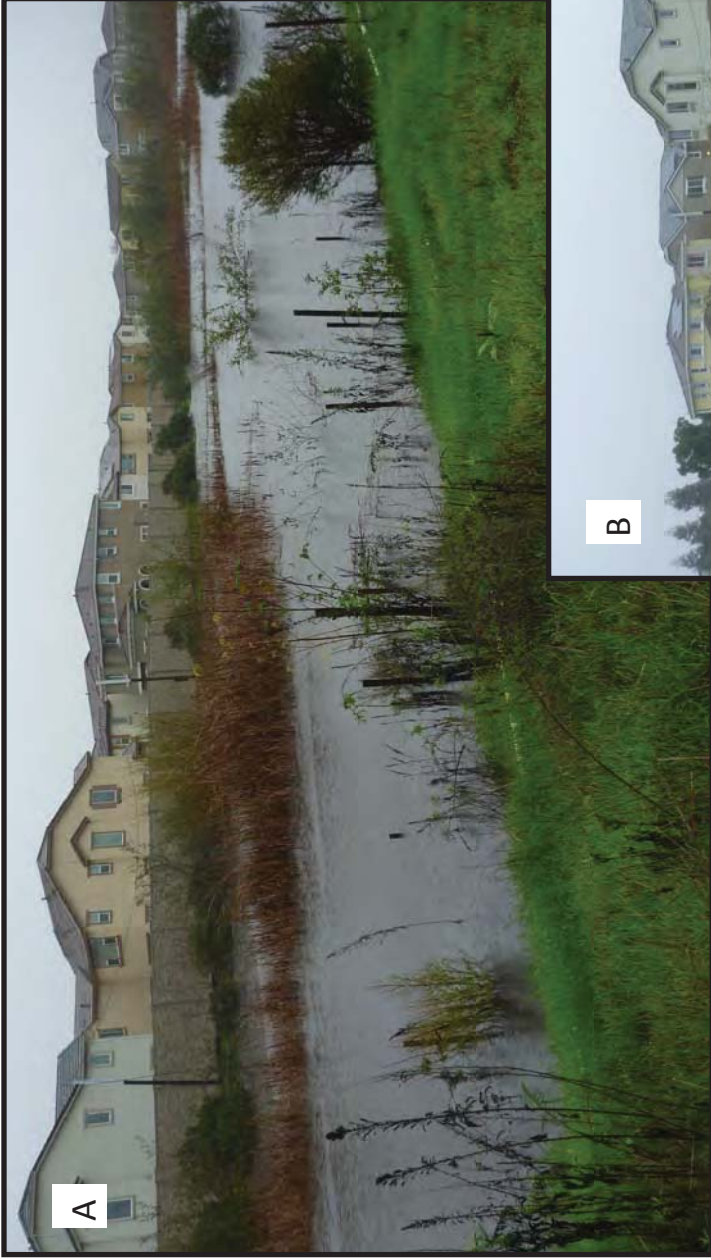
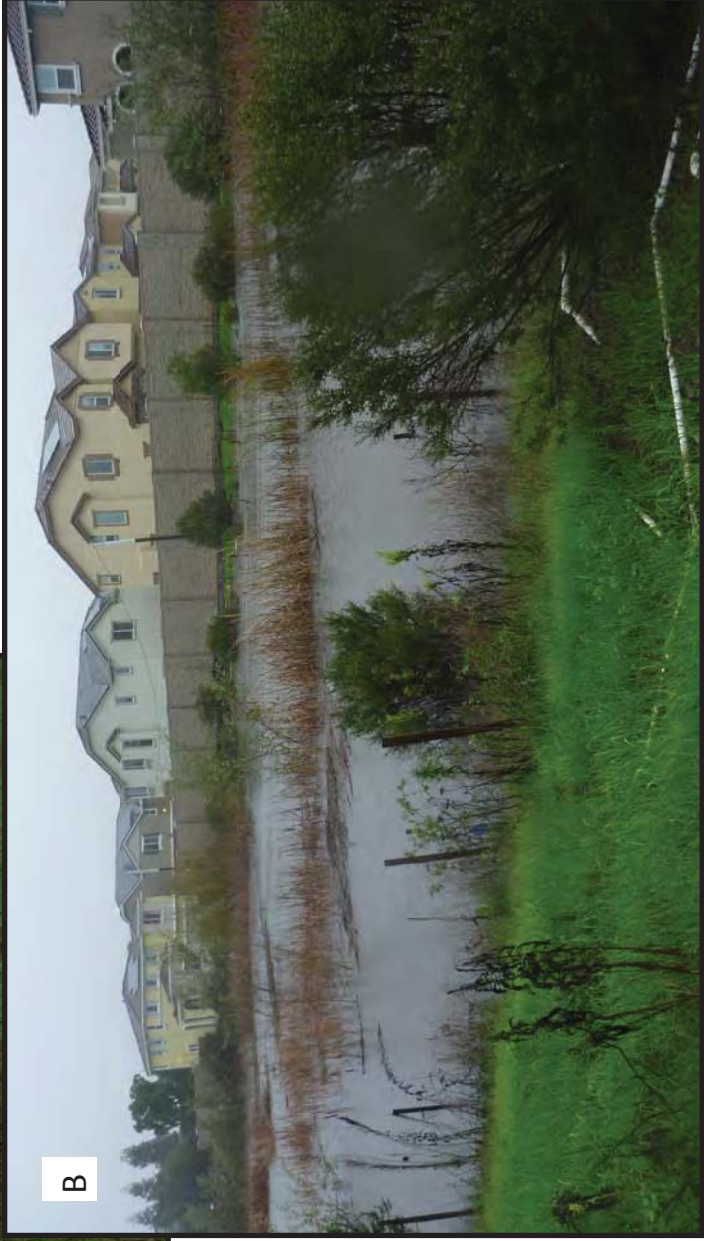
vegetation was inundated under several feet of water at the time of the visit (**Figure 7**). Discharge measurements were impossible to take with a wading instrument, and difficult to estimate due to turbulent backwater effects. It is encouraging that after an event of this magnitude, no damage was observed following recession of the floodwaters. Due to the dry year and the flashy nature of the site, Balance had few other opportunities to observe flow on the floodplain, and therefore we were not able to measure flow during WY15.

**December 11, 2014 storm flow field photographs. Wrigley Creek Mitigation Performance Monitoring, Santa Clara County, California .** On the day these photos were taken, high flows inundated both staff plates and most vegetation. The tops of the cattail indicate the location of the channel. A) Looking upstream. B) Looking downstream.

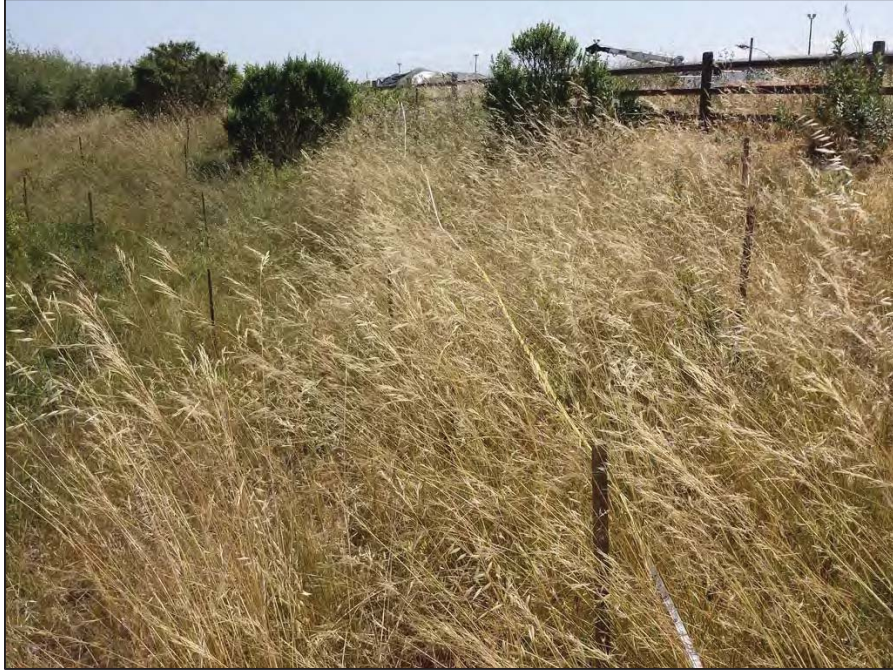
**Photo 21. Dense patch of purple needlegrass on the western creek bank slope (May 2015)**

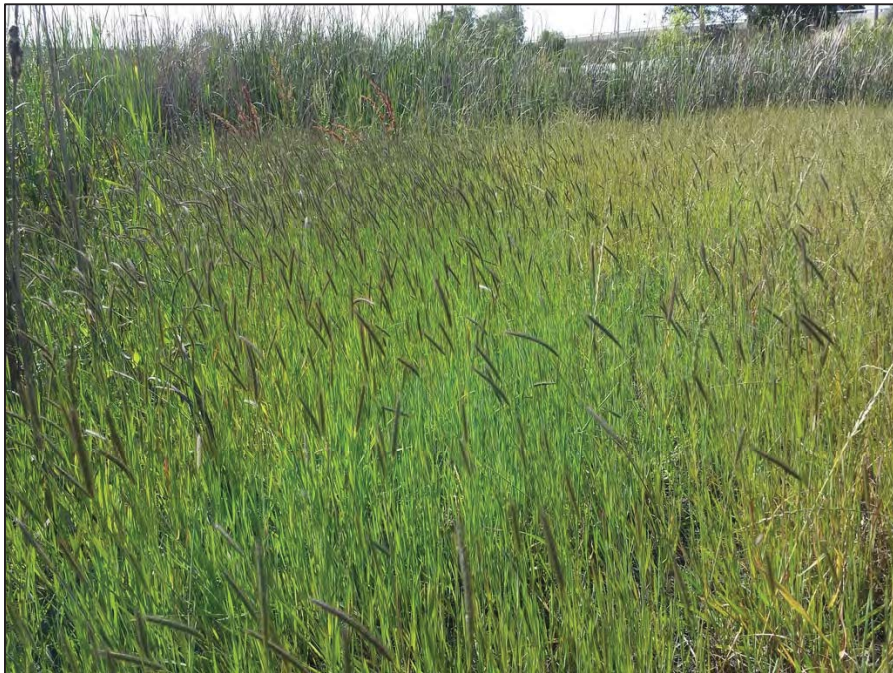
**Photo 22. Dense patch of meadow barley on the floodplain (May 2015)**

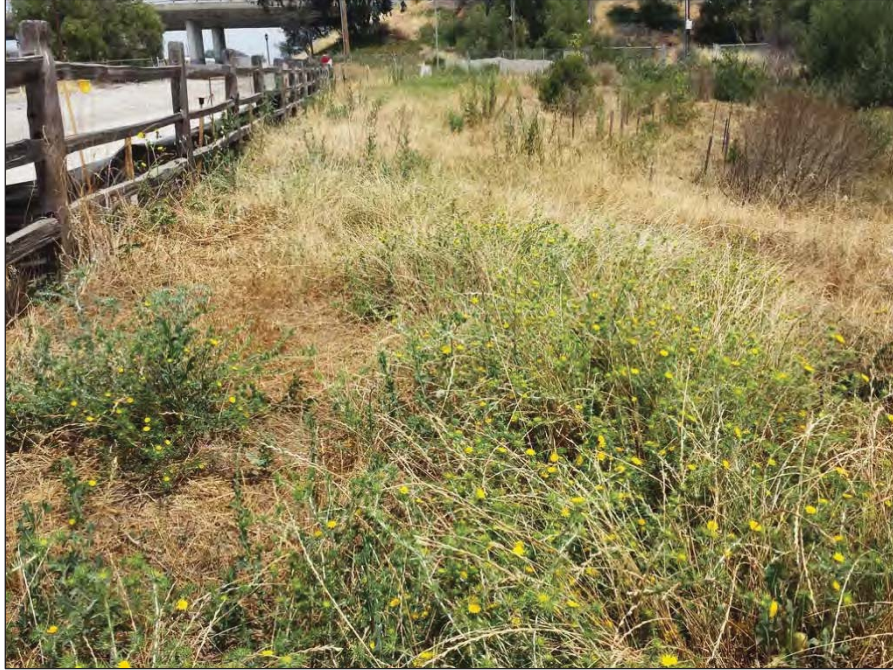
**Photo 23. Flowering Congdon's tarplant in the Congdon's Tarplant Mitigation Area (July 2015)**

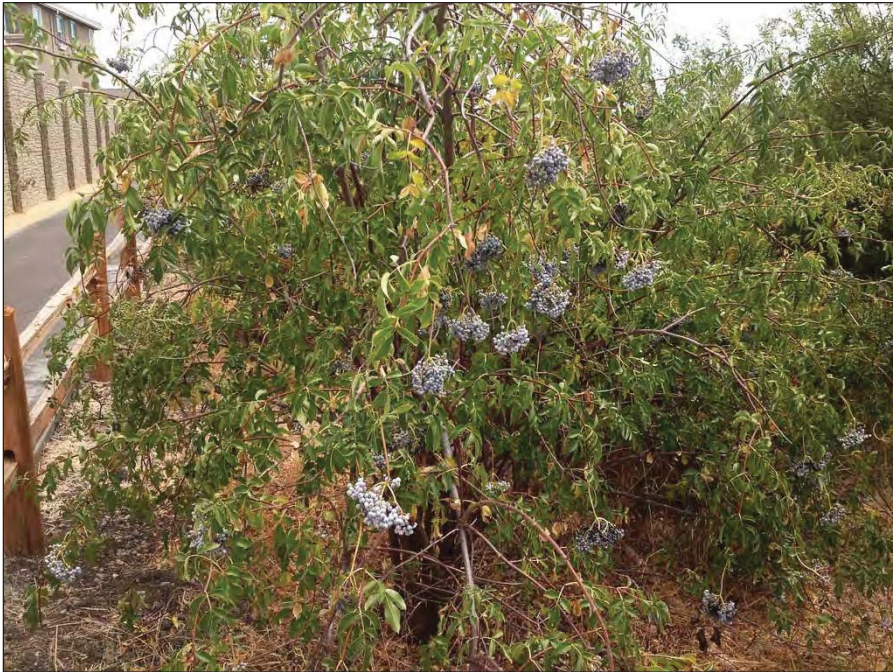
Despite ongoing drought conditions in the region, nearly every planted tree and shrub displayed good health and vigor (Photo 24; Tables 7 and 8). Moreover, a greater percentage of individuals were in good condition in Year 5 relative to previous years (Table 8). The overall average health and vigor of the woody plantings was 1.0 (good) in Year 5 (Table 7). The average health and vigor rating for each species was 1.0 (good). Table 8 lists the percentage of individuals that fall into the three general health and vigor categories by monitoring year. The percentage of individuals in good condition increased from 72.6% in Year 4 to 98.5% in Year 5. The percentage of individuals in fair condition decreased from 23.9% in Year 4 to 1.2% in Year 5. The percentage of individuals in poor condition decreased from 3.5% in Year 4 to 0.3% in Year 5.

**Photo 24. Vigorous elderberry planting on the eastern creek bank slope (July 2015)**

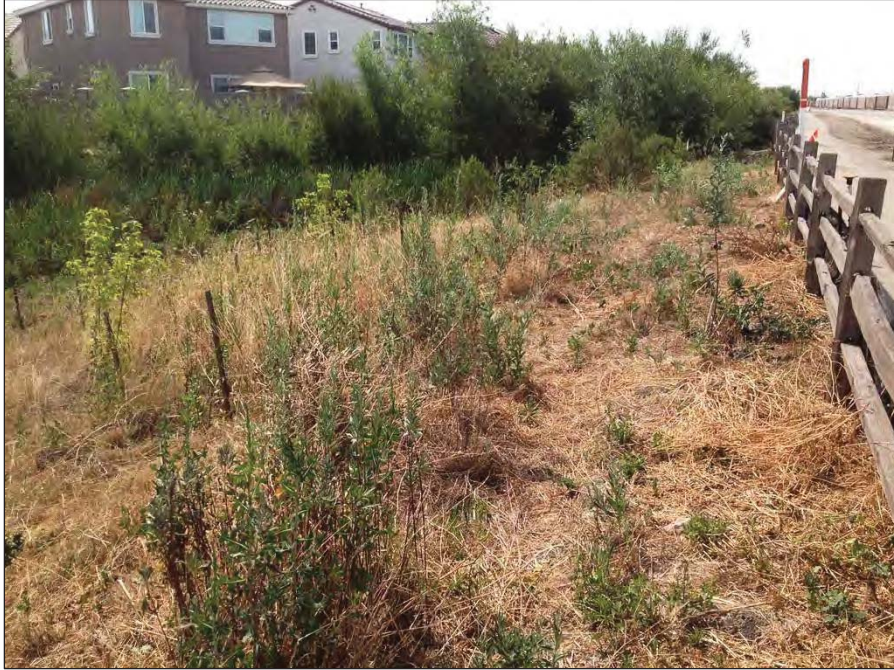
Photo 25. Mugwort natural recruitment on the western creek bank slope (July 2015)
