Appendix B: Updated Tree Assessment and Arborist Tree Report

295 E. Virginia Street

Updated Tree Assessment

ARBORIST TREE REPORT

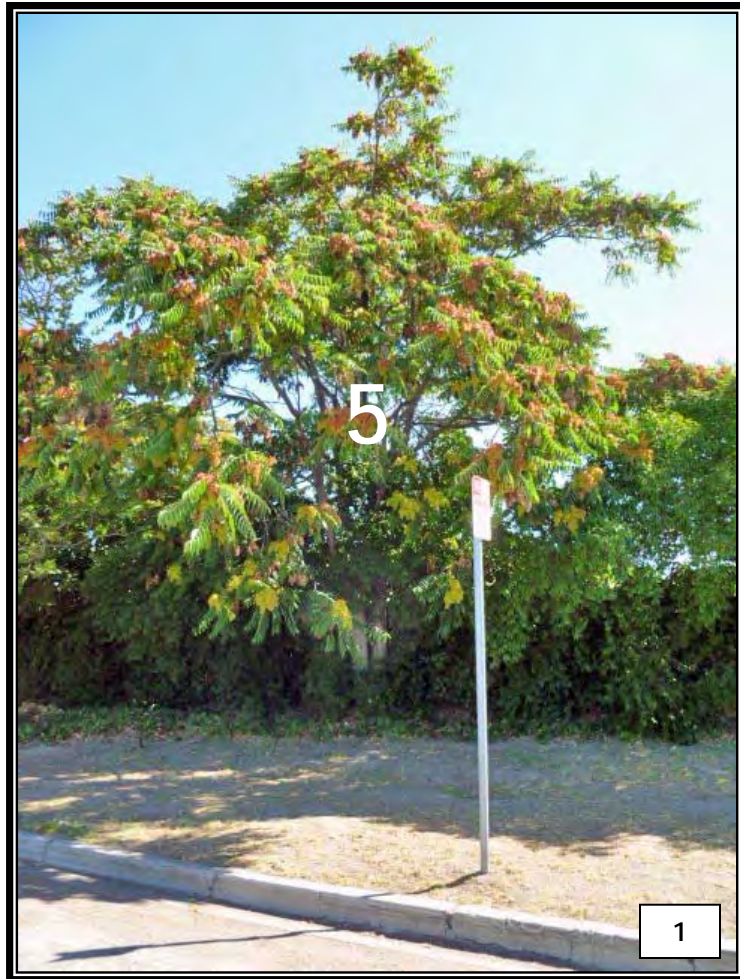
Photo 1. Tree 5 a tree of heaven, with a multistem trunk collectively measures 21 inches in diameter. This is an on-site tree.

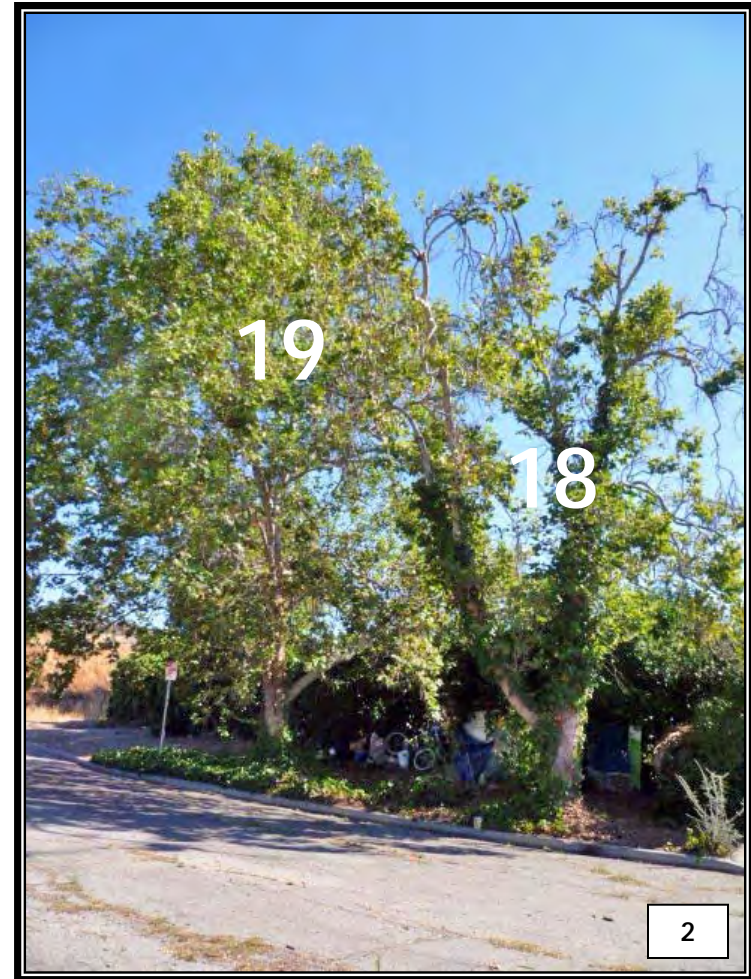
Photo 2. Two London planes, trees 18 and 19, measure 20 and 21 inches respectively in trunk diameter. These are on-site trees.

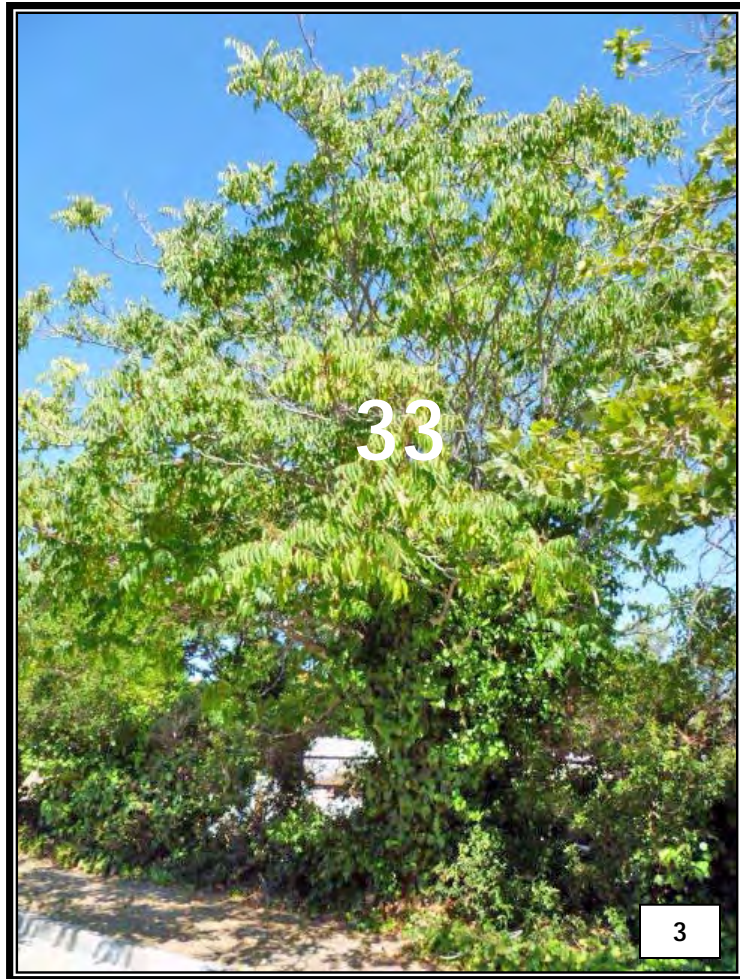
Photo 3. Tree 33, a multi-stem tree of heaven measures 20 in diameter. This is an on-site tree.

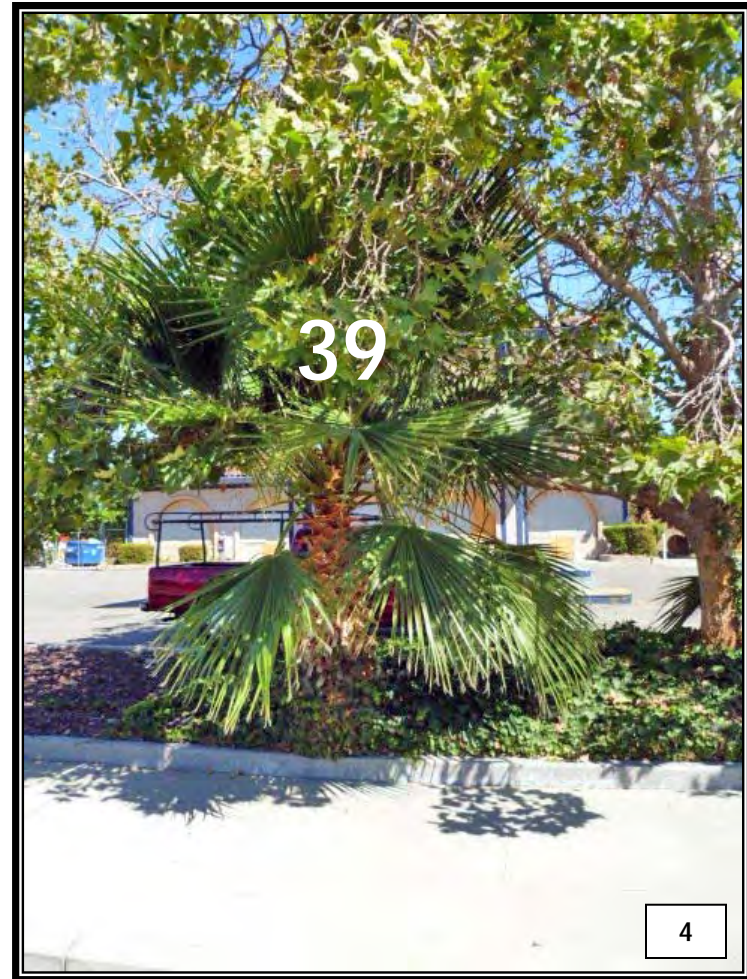
Photo 4. A Mexican fan palm stands over six feet at it's apical meristem and approximately 18 inches in diameter. This is an on-site tree.

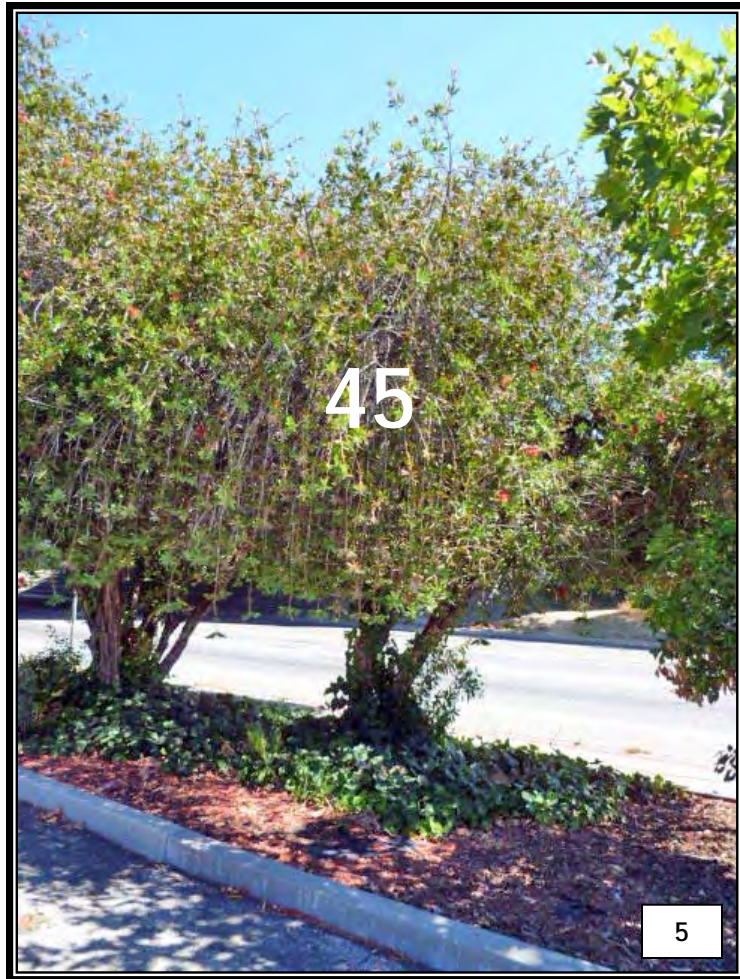
Photo 5. This bottle brush, tree 45 with a multi-stem trunk measures 20 in diameter. This is an on-site tree.

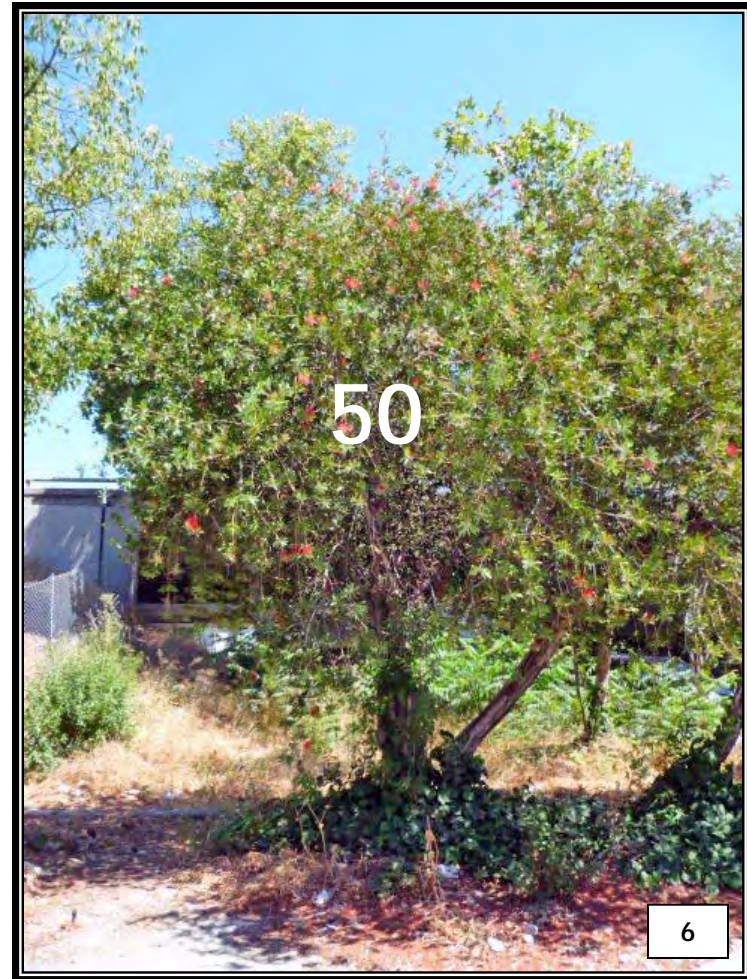
Photo 6. Tree 50 is a multistem bottle brush collectively measuring approximately 18 inches in diameter. This is an on-site tree.

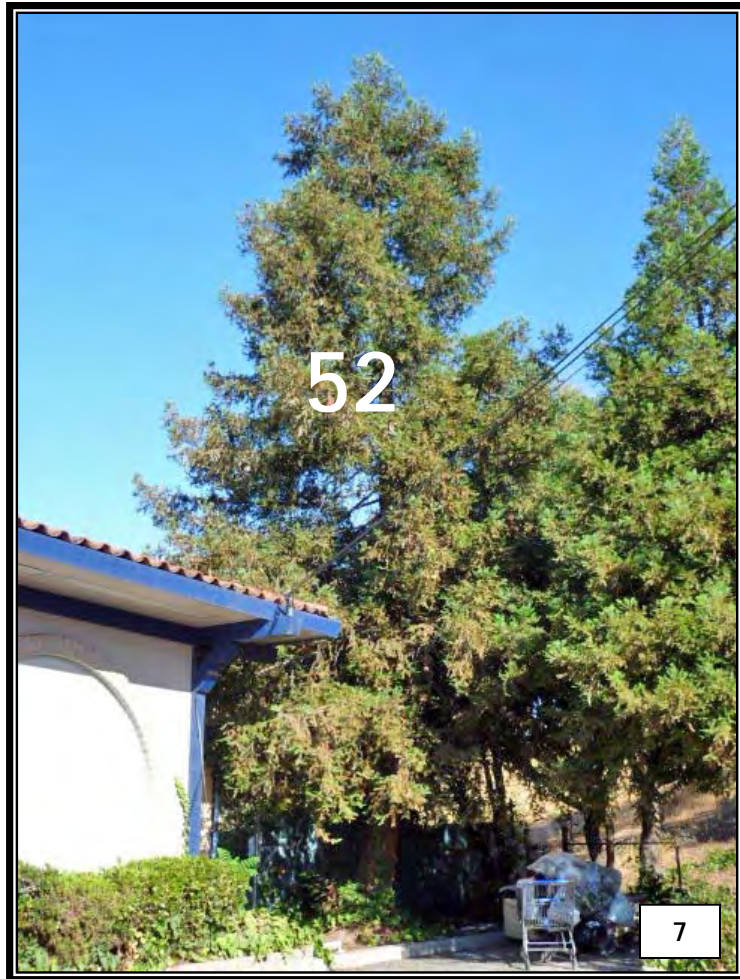
Photo 7. Tree 52, a coast redwood with a single main stem measures 21 inches in diameter. This is an on-site tree.

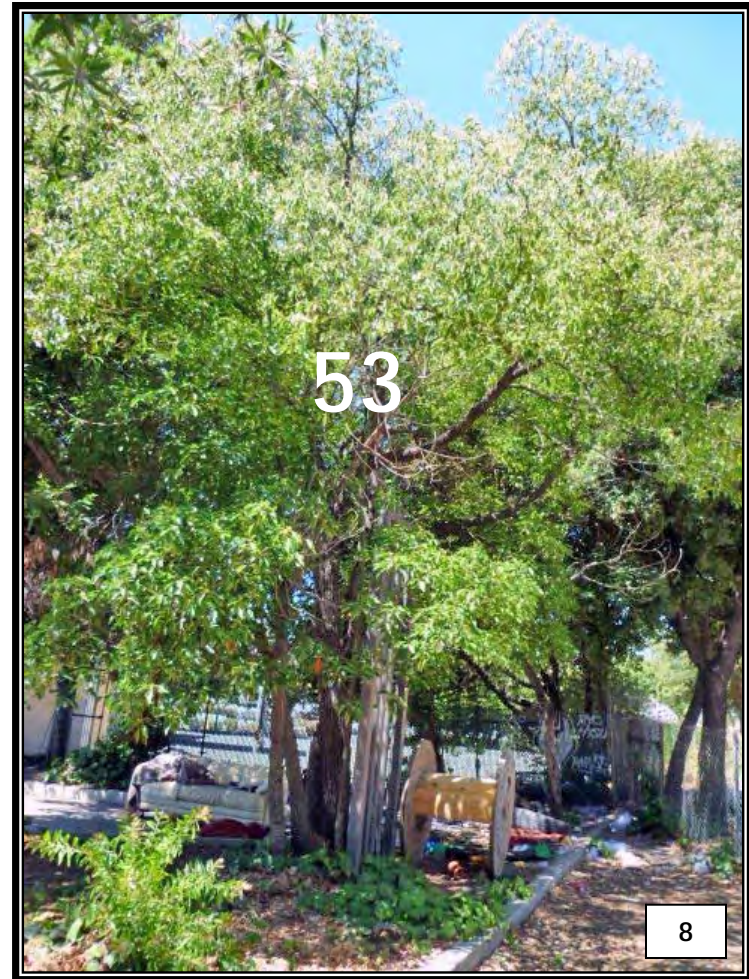
Photo 8. This multi-stem Chinese tallow, tree 53, measures 25 inches in diameter. This is an on-site tree.

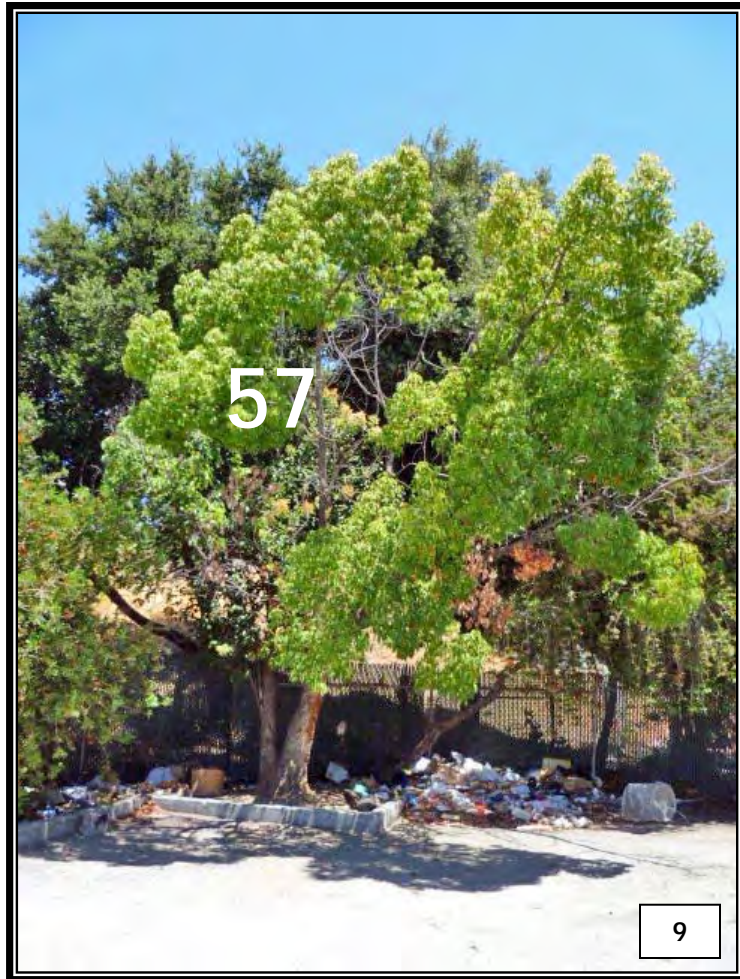
Photo 9. A Chinese tallow, tree 57, has a bifurcated trunk collectively measures 23 inches in diameter. This is an on-site tree.

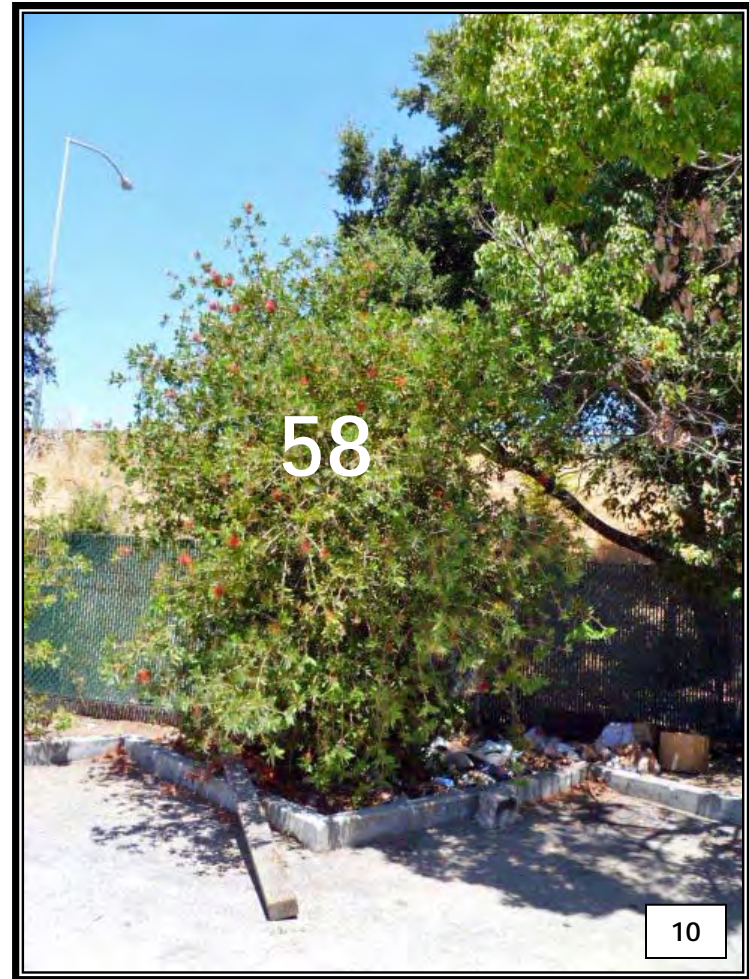
Photo 10. A very multi-stem bottle brush due to a low topping cut, has stems that collectively measure greater than 18 inches in diameter. This is an on-site tree.
