## Geologic Hazards Assessment

March 26, 2018  
Project No. 403246001

Subject: Geologic Hazards Assessment  
1605 Industrial Avenue  
San Jose, California

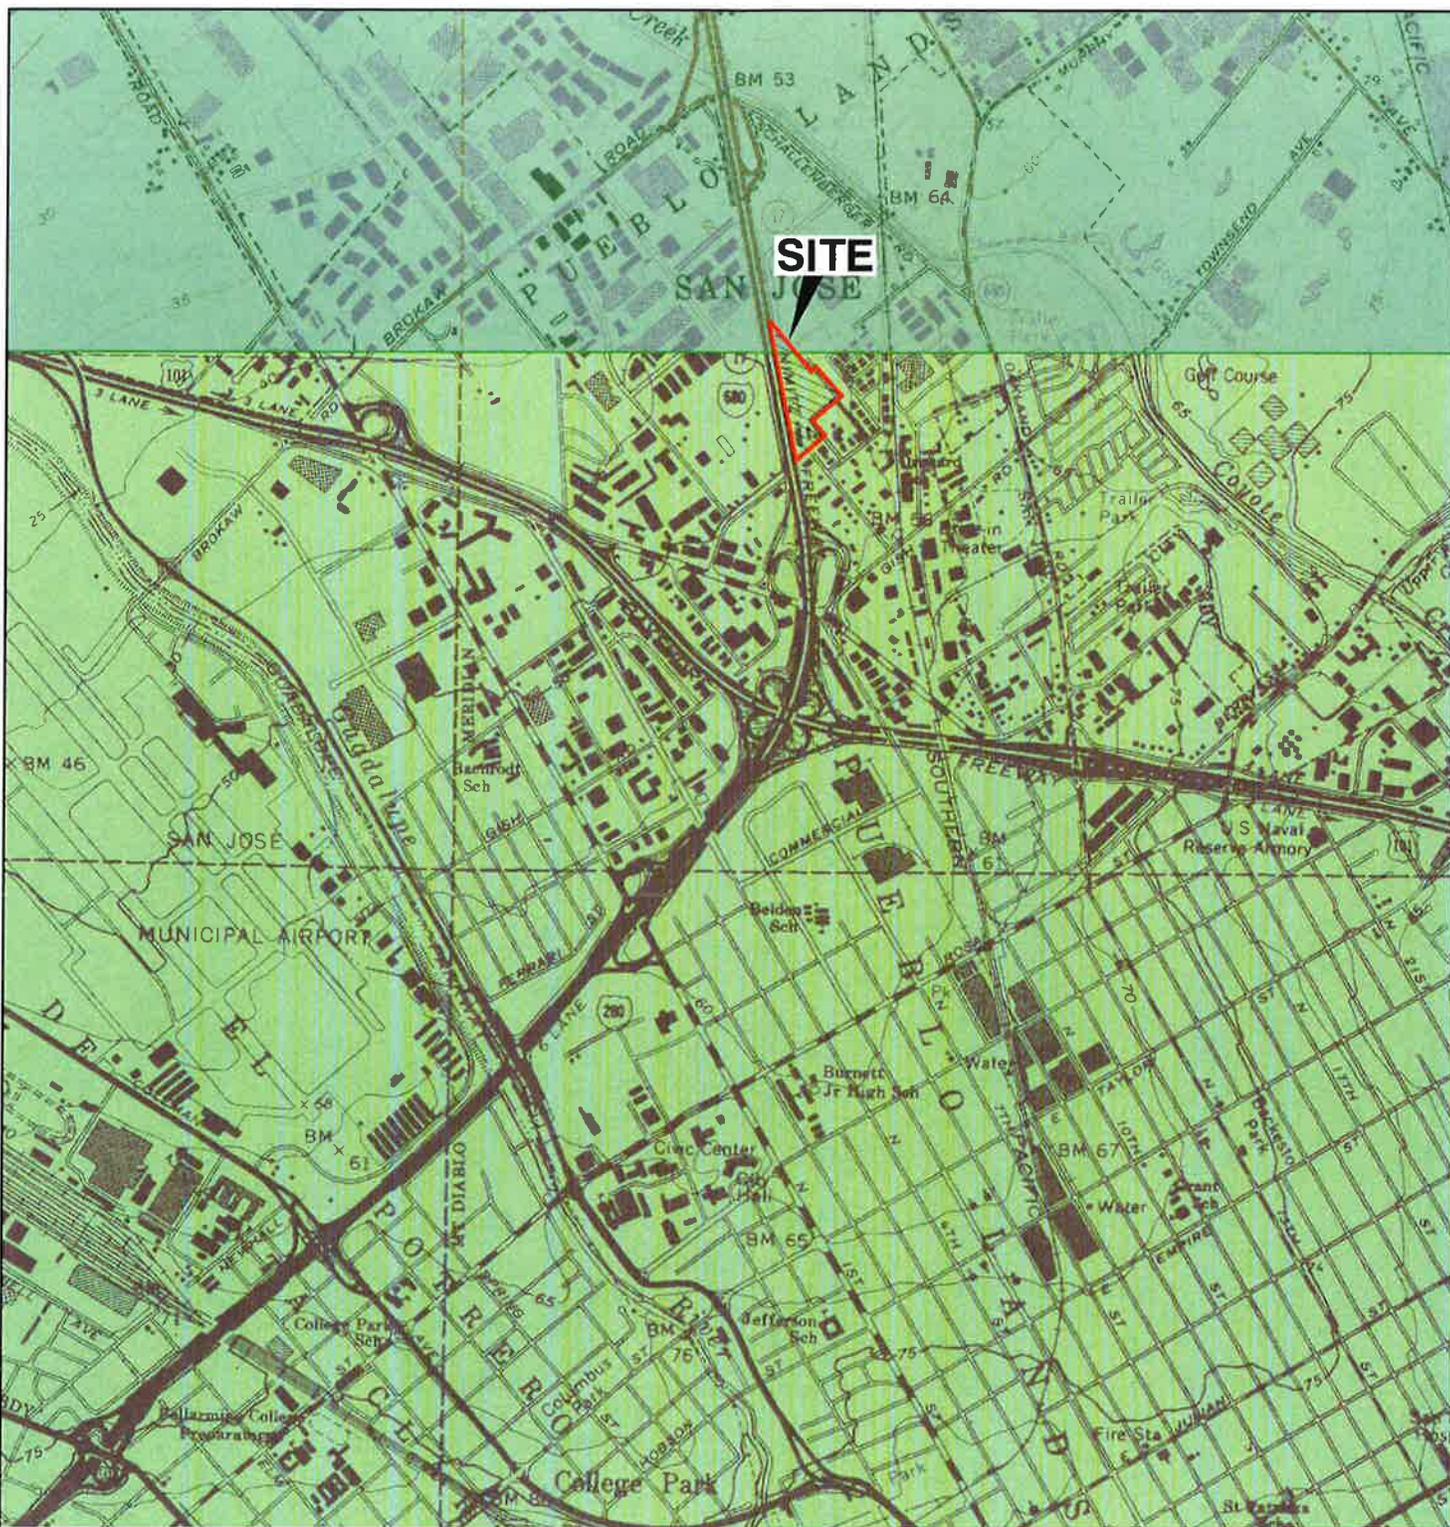
**FIGURE 3**

The site is located within a liquefaction hazard zone (Figure 3) as established by the California Geological Survey (CGS, 2007) and the City of San Jose (2011). Regional studies of liquefaction susceptibility by the U.S. Geological Survey (Knudsen et al., 2000 and Witter et al., 2006) indicate that the site has a moderate to high susceptibility to liquefaction during a moderate to large magnitude earthquake on a nearby fault. Evidence of liquefaction including sand boils and lateral spreading occurred within a few miles of the site during the 1906 San Francisco and 1989 Loma Prieta earthquakes (Knudsen et al., 2000).

In addition to liquefaction, which occurs in wet, loose sandy soils, earthquakes can also induce dynamic settlement of dry loose sandy sediments. The potential for dynamic settlement will need to be addressed in conjunction with liquefaction during future geotechnical evaluations.

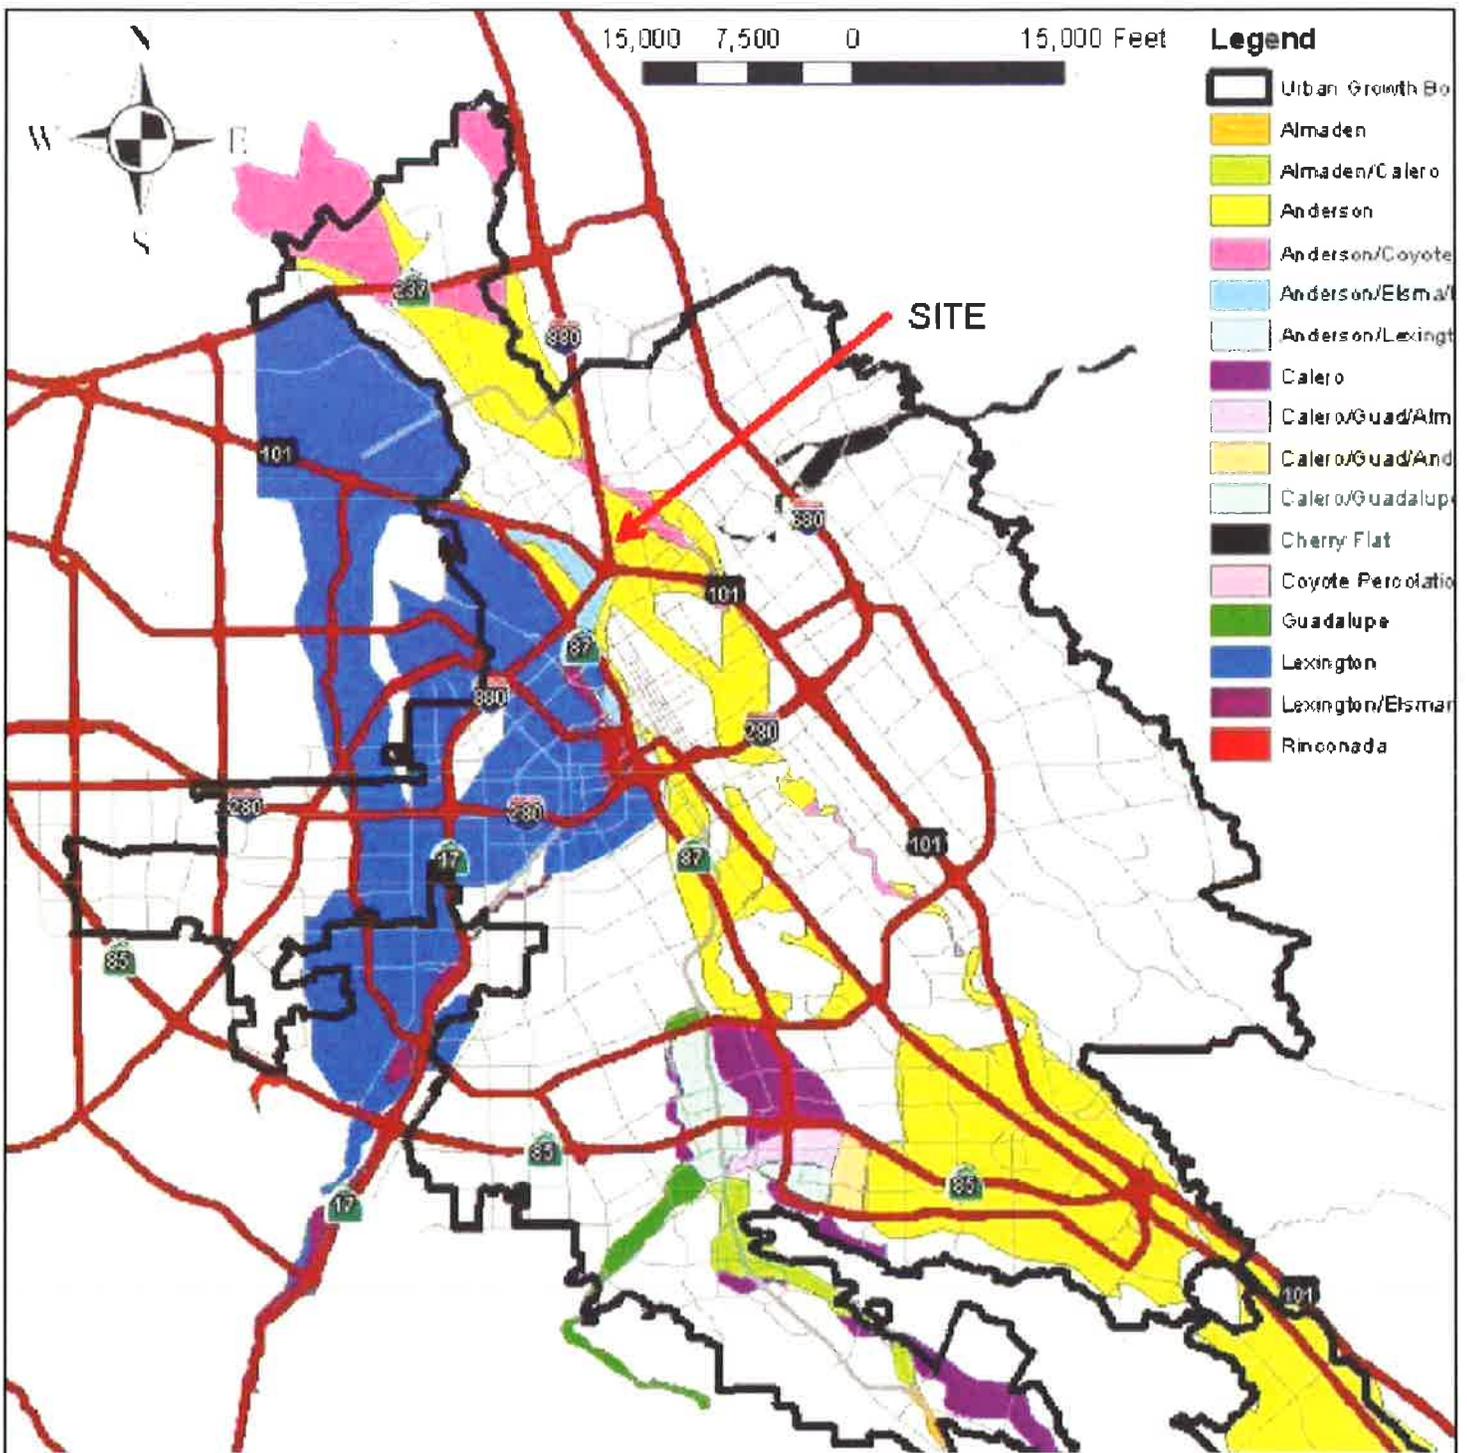
FIGURE 4

Based on maps included in the City of San Jose General Plan (2011), the site is located within an inundation path for Anderson Dam (Figure 4), which is located in the nearby East Bay Hills. The depth of water is not included in the information provided in the general plan.
