**Arborist's Report
Tree Inventory and Assessment**

**469 Piercy Road
San Jose, CA 95138**

March 3, 2018

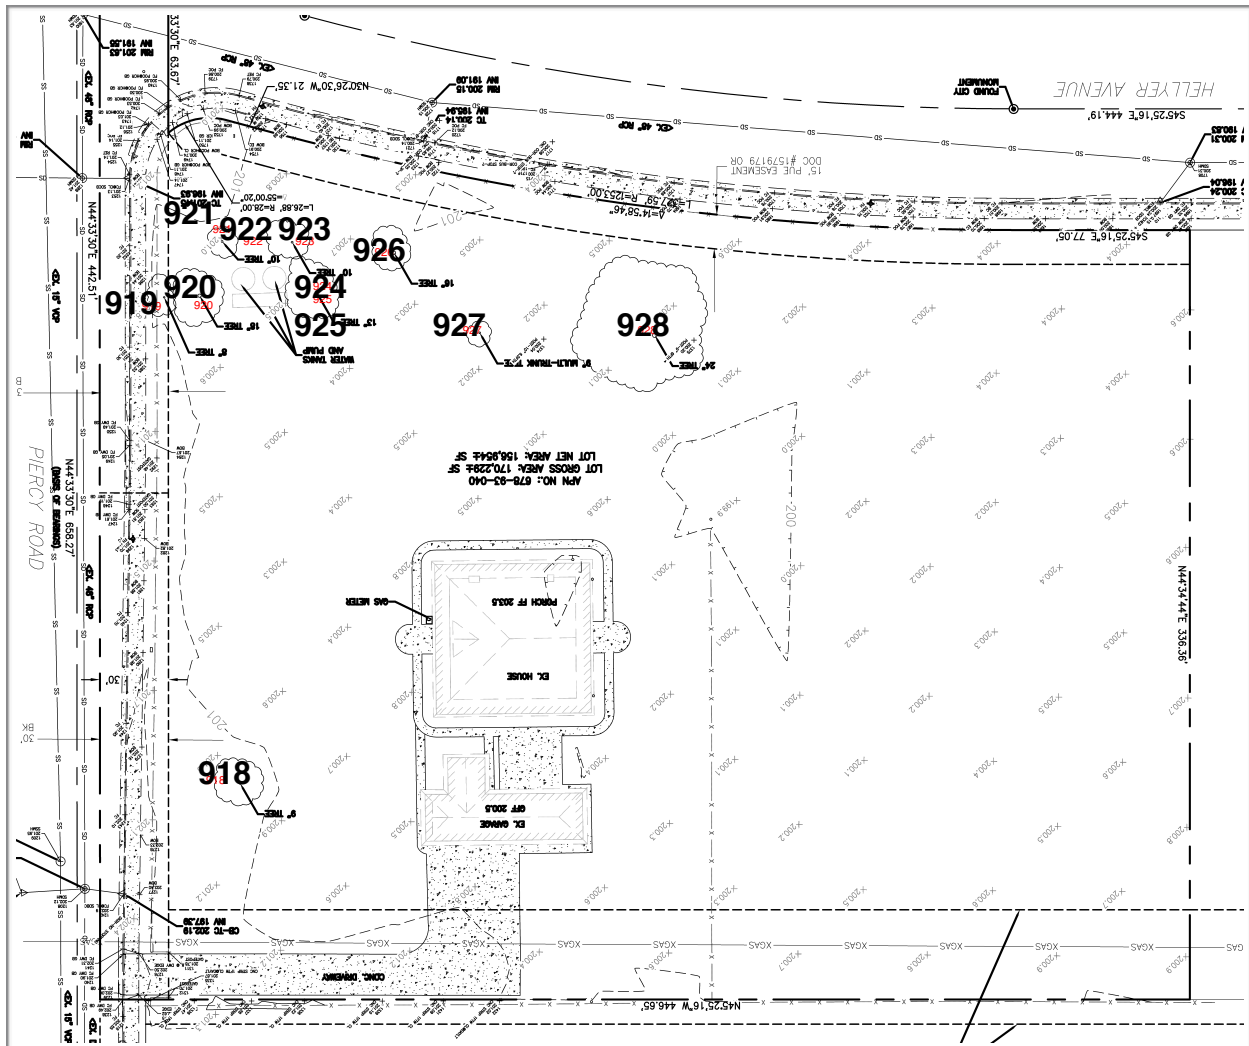
Image 1: Tree Inventory Map

Below is the existing topographic survey indicating the tree locations and their corresponding numbers (Image 1).

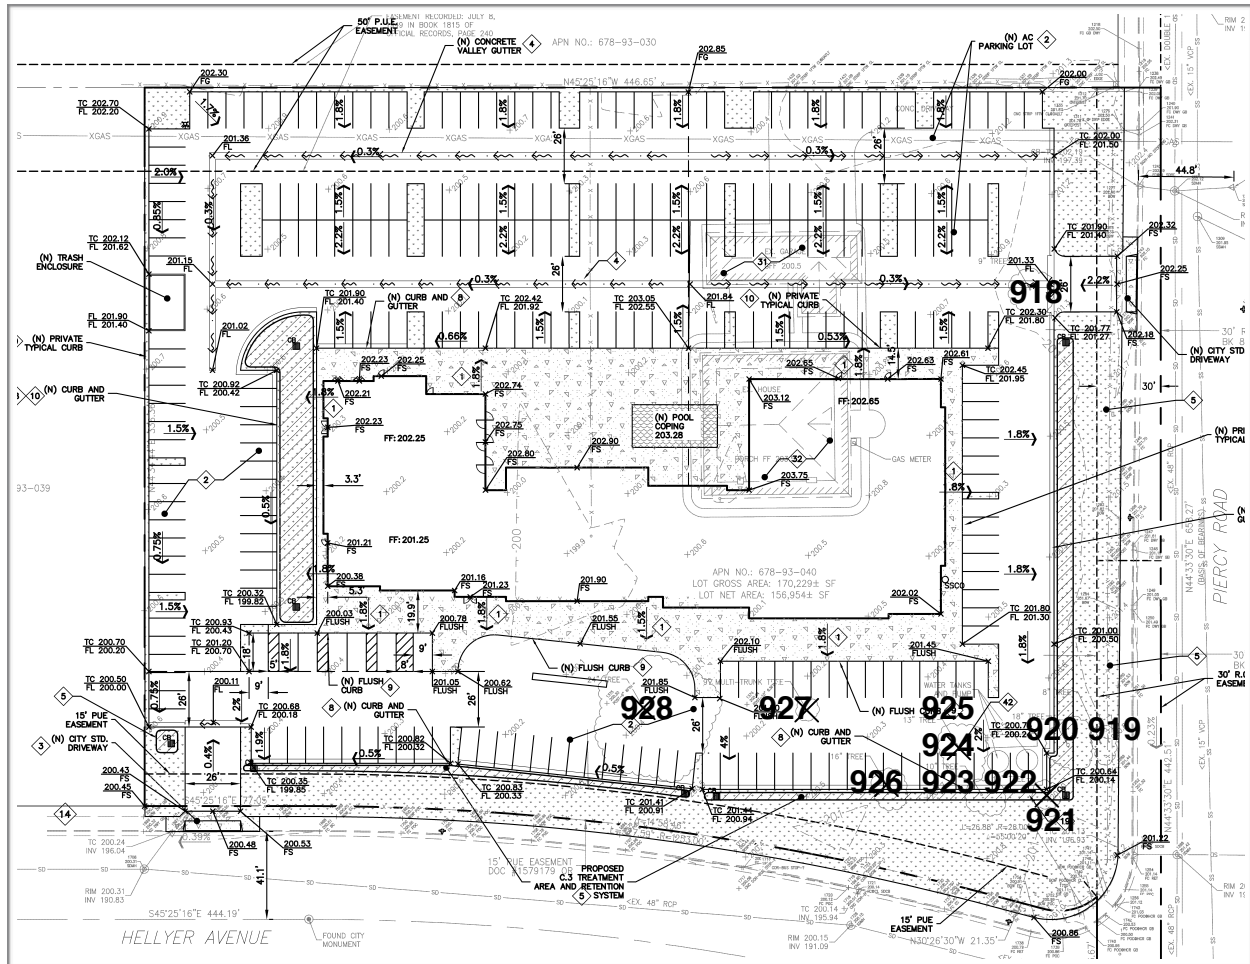
Image 2: Location of trees relative to the C-2.0 plans

All the trees will be highly impacted by the proposed plans and caused to be removed (Table 4). Five are considered to be “Ordinance Size” which are #920, #924, #926, #927, and #928. To mitigate the loss of the trees the landscape plan indicates there will be five twenty-four inch box specimens installed.

The image below is a snapshot from the C-2.0 Grading and Drainage Plan indicating the removal of all the existing trees for the proposed improvements (Image 2).

Removal all the trees once obtaining a permit from the City of San Jose.

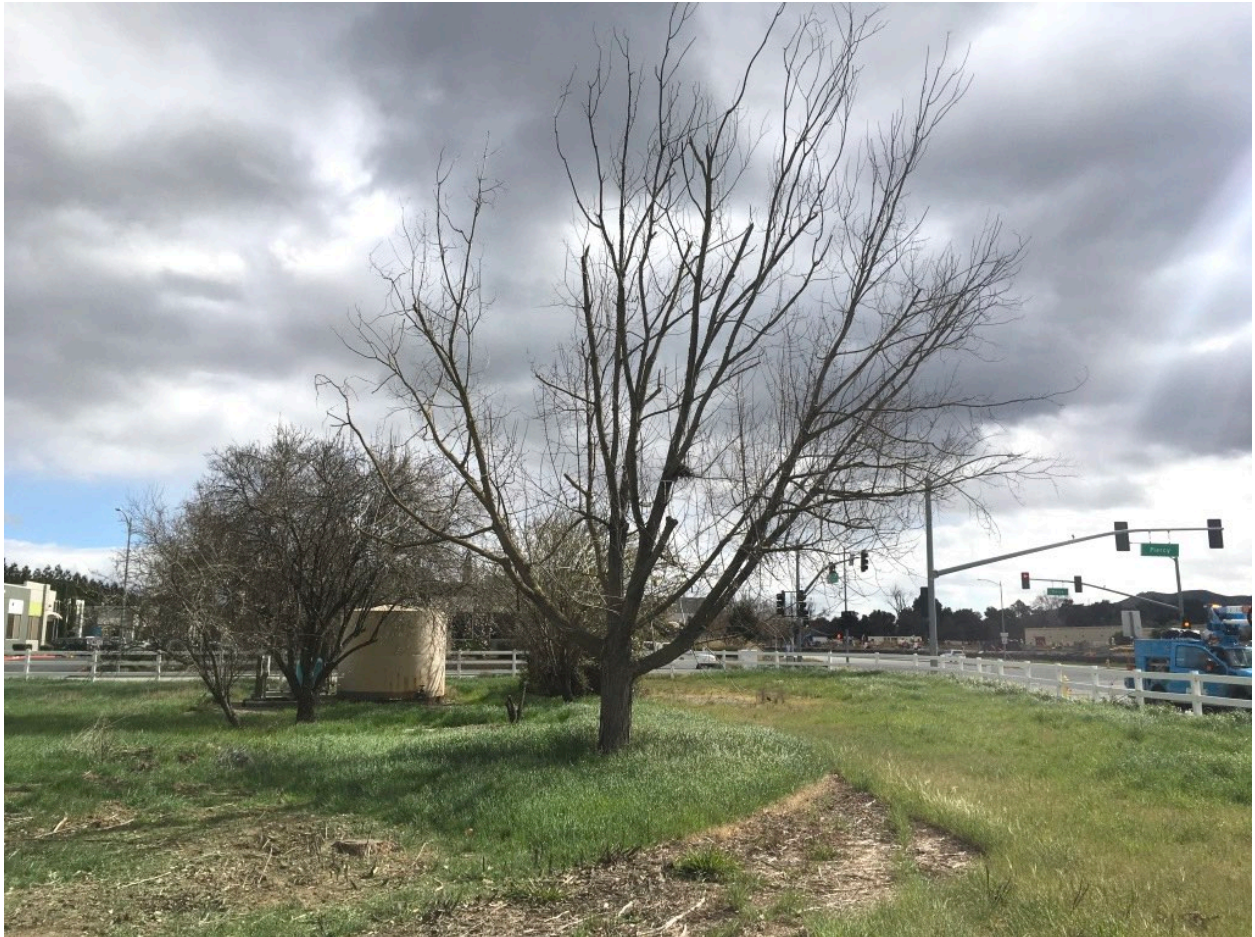
B2: Silver Maple #926

Most of the trees are in fair condition with the silver maple and the silver dollar gum being in poor shape (Table 2).
