**APPENDIX B- Biological Resources Study and Arborist Report
for the INITIAL STUDY with PROPOSED MITIGATED NEGATIVE DECLARATION
1675 MONTEREY ROAD, SAN JOSE, CALIFORNIA**

CP21-018

BIOLOGICAL RESOURCES REPORT FOR 1675 MONTEREY ROAD, SAN JOSE, CALIFORNIA

March 2021

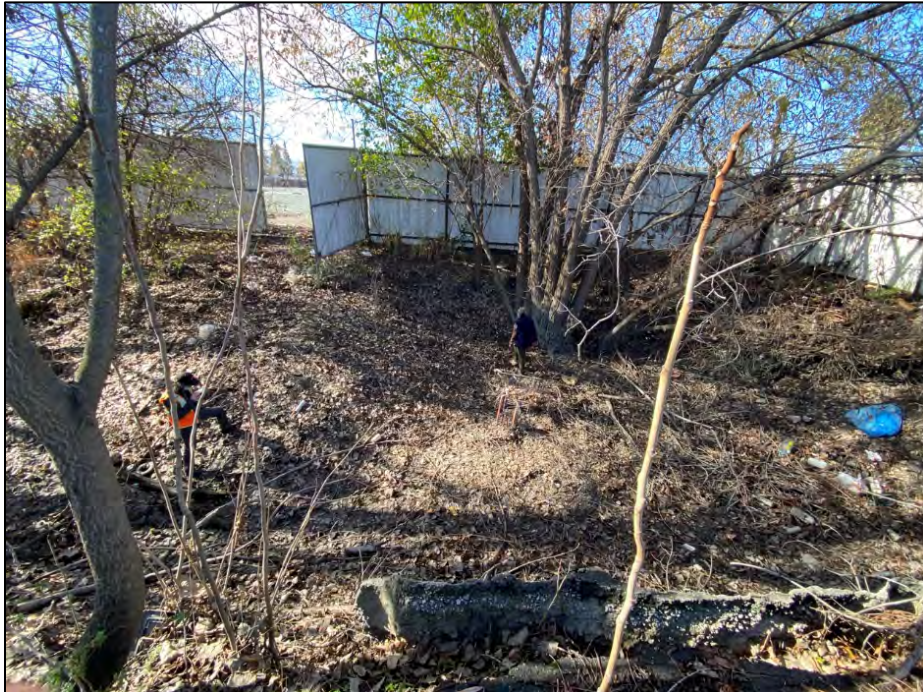
Photograph 4. Facing west from a concrete slab on the west end of the drainage basin in the northwest corner of the Project Site where riparian woodland habitat is present.

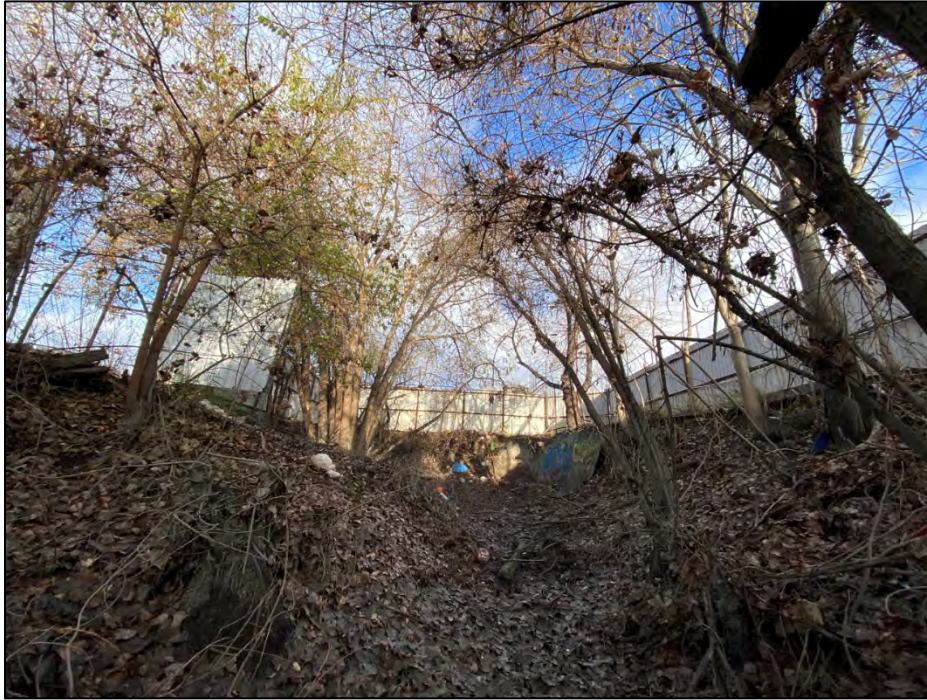
Photograph 5. Facing north in drainage basin located in the northwest corner of the Project Site where riparian woodland habitat is present.

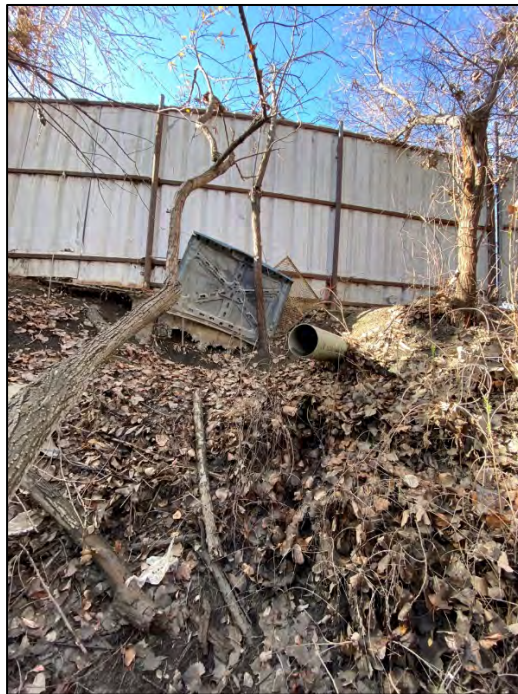
Photograph 6. Drainage pipe that comes from outside the Project Site and drains water into the drainage basin in the northwest corner of the property.

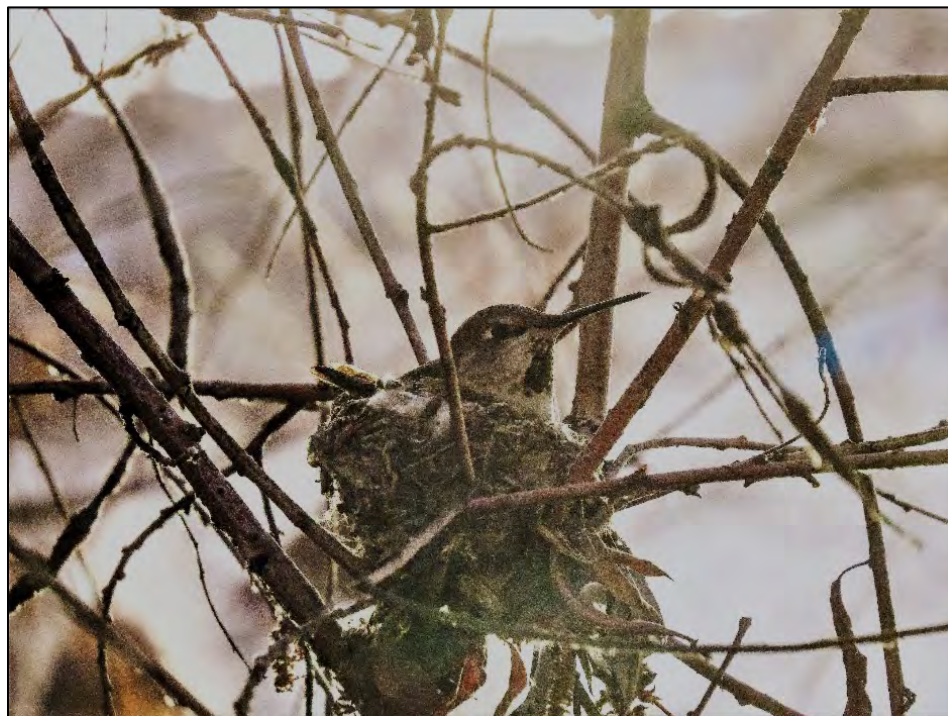
An active Anna’s hummingbird nest was occupied in a Siberian elm (*Ulmus pumila*) at the southwest edge of the fenced in depression in the northeast corner of the Project Site (Figure 5, Appendix A). A female Anna’s hummingbird was observed incubating one to two eggs in the nest (Photograph 7, Appendix B). Two small inactive squirrel middens were spotted at the tops of the trees within the depression (Figure 5, Appendix A). A blue gum (*Eucalyptus globulus*) south of the center of the Project Site contained an inactive raptor nest. For a list of all species observed in the Project Site see Appendix D.

Photograph 7. A female Anna's hummingbird was observed sitting on an active nest in the riparian woodland habitat during the general biological survey.

- Due to the presence of one active Anna’s hummingbird nest NV5 recommends that construction activities, including clearing, grubbing or any vegetation removal be performed outside the active breeding bird season from January 1 to August 31 for raptors and hummingbirds and February 15 to August 31 for all other avian species.
- If vegetation clearing and/or construction activities commence during the bird breeding season, from January 1 for raptors and hummingbirds and February 15 to August 31 for all other avian species, a preconstruction survey will be conducted for active nests by a qualified avian biologist within 36 hours prior to construction activities.

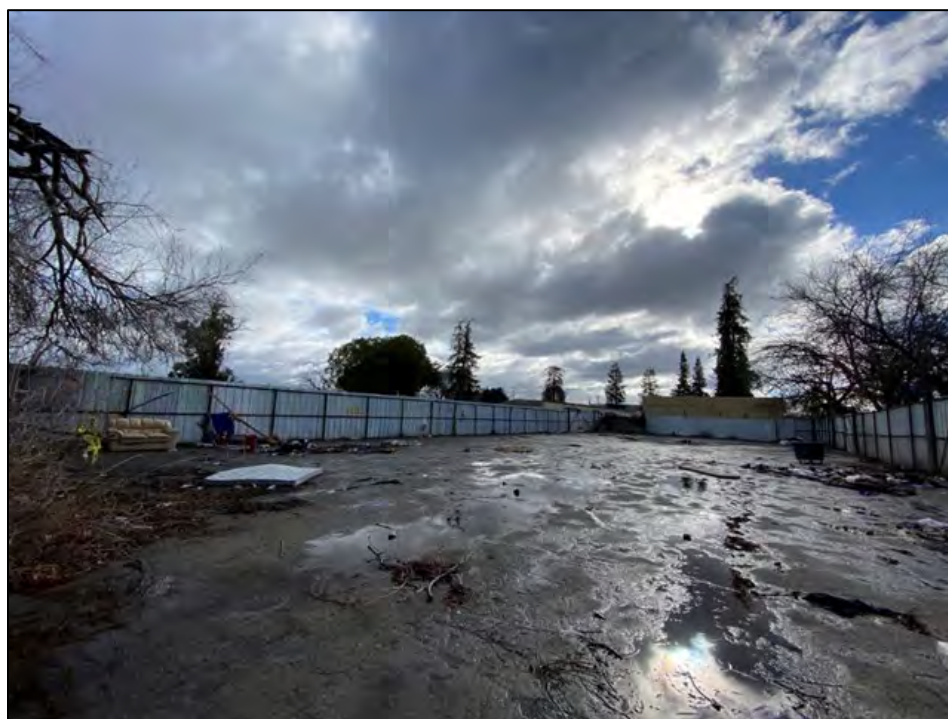
Photograph 8. Facing south in the northeast corner of the property where it appears an individual or possibly more than one person may have previously resided in the Project Site.

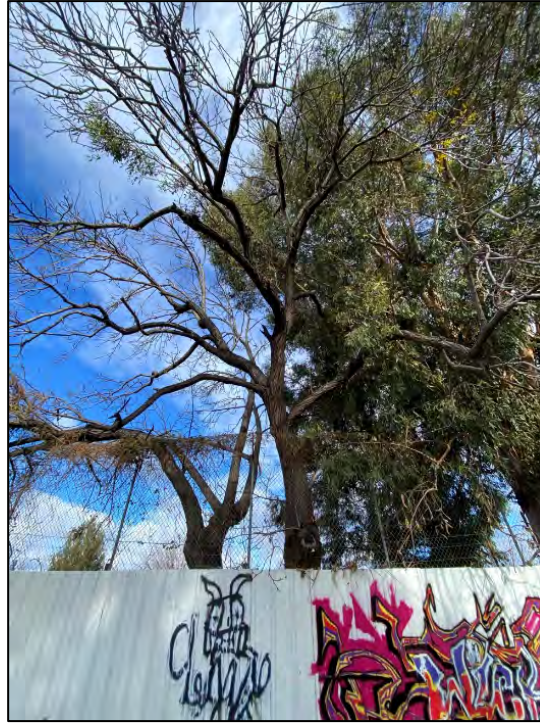
Photograph 11. Branches from trees in adjacent properties hang over the Project Site fencing.

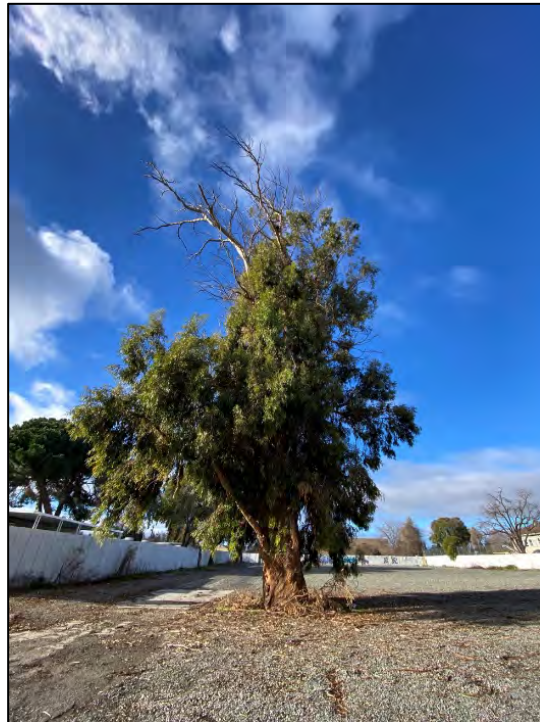
Photograph 12. Many trees, such as this River red gum can provide habitat for nesting birds in the Project Site.

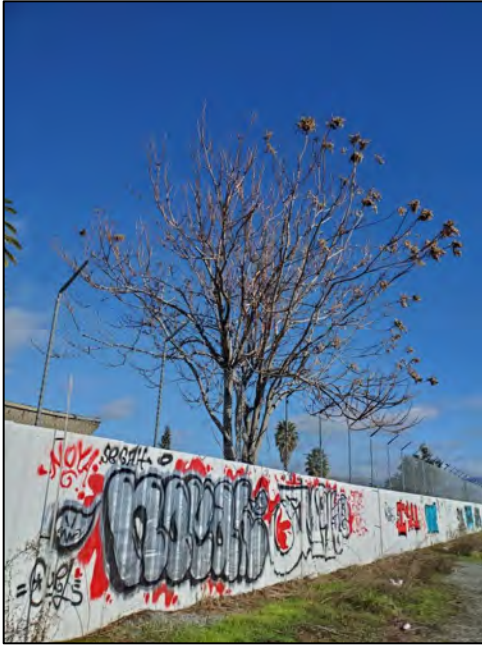
Tree of heaven was the most common species assessed, with 11 trees, or about 24% of the population (Photo 1). Trunk diameters ranged from 4 to 31 inches, but most were smaller trees, with an average diameter of 11 inches. The majority of these trees were in poor condition (9 trees). One tree was in fair condition and one tree (#152, near the Pomona Street sidewalk), was in good condition. All but two of the trees were growing in the sunken detention pond area (Photo 2).

Photo 1 (left). Tree of heaven #145 was growing on the adjacent property to the north.

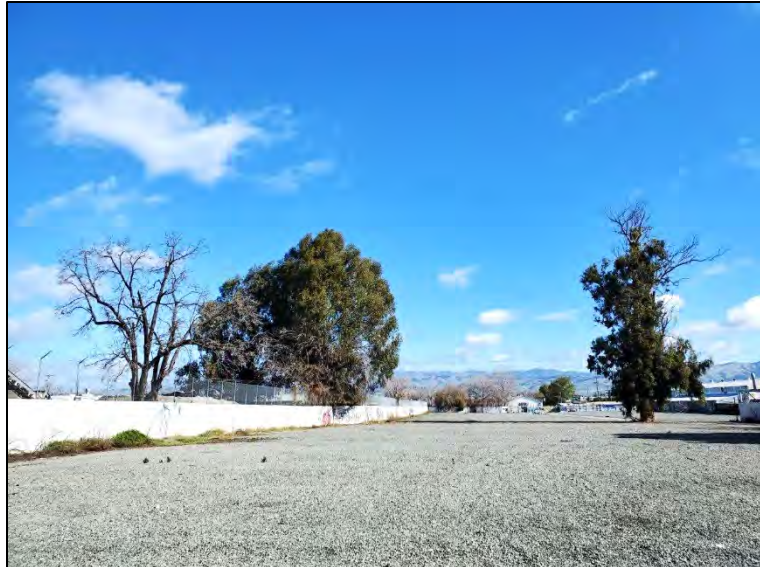
- Two large mature blue gums were evaluated. Tree #146 was off site to the northwest, with a diameter of about 48 inches. Tree #146 appeared to be in fair condition. Tree #158 had a diameter of 63 inches and was in very poor condition; it was growing in a gravel area near where the lot narrowed in width at the southeast end. A fungal growth was present at its base, and approximately one-third of its crown was dead. (Photo 3).

Photo 3 (above). California black walnut #147 and blue gum #146 were growing off site behind the fence at left. Blue gum #158 at right was growing in gravel paving.

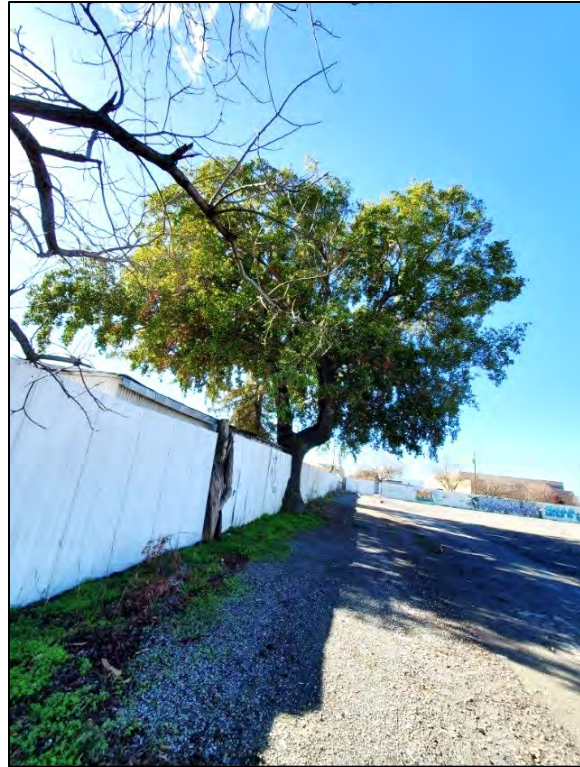
- California bay #156 was a large, mature specimen straddling the property line at the southern edge of the lot (Photo 4). The bay's approximately 50-inch trunk was embedded in the fence, and was in fair condition overall, with a correcting lean west. The bay appeared vigorous, despite some thinning in the upper crown.
- River red gum #159 was located off site. The river red gum had a diameter of about 24 inches and was in fair condition. The gum had codominant stems and the canopy extended about 5 feet over the subject property.

Photo 4. California bay #156 was growing on both sides of the property line fence at the southeast edge of the lot.

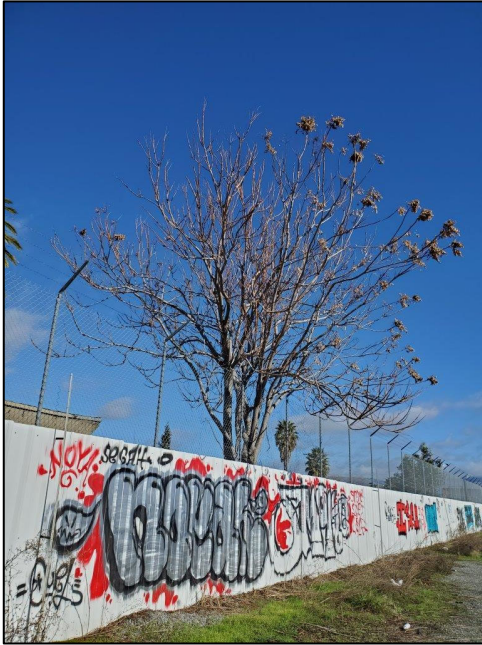
Tree of heaven was the most common species assessed, with 11 trees, or about 24% of the population (Photo 1). Trunk diameters ranged from 4 to 31 inches, but most were smaller trees, with an average diameter of 11 inches. The majority of these trees were in poor condition (9 trees). One tree was in fair condition and one tree (#152, near the Pomona Street sidewalk), was in good condition. All but two of the trees were growing in the sunken detention pond area (Photo 2).

Photo 1 (left). Tree of heaven #145 was growing on the adjacent property to the north.

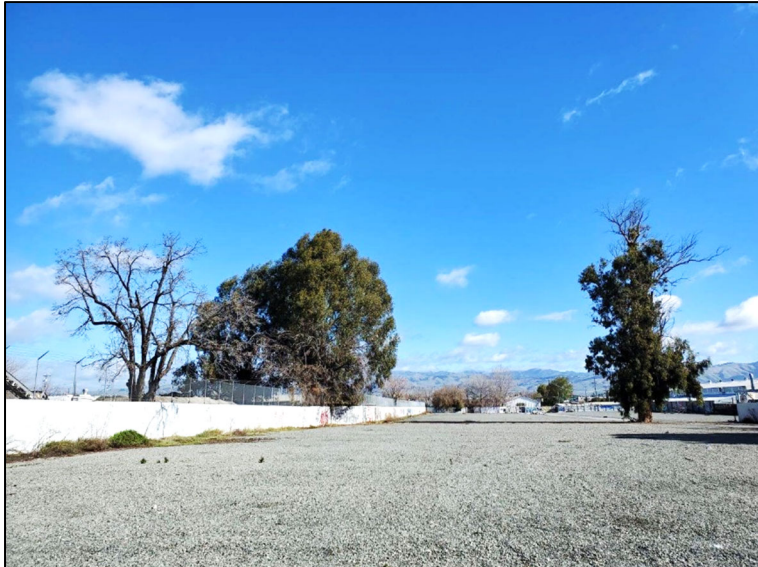
- Two large mature blue gums were evaluated. Tree #146 was off site to the northwest, with a diameter of about 48 inches. Tree #146 appeared to be in fair condition. Tree #158 had a diameter of 63 inches and was in very poor condition; it was growing in a gravel area near where the lot narrowed in width at the southeast end. A fungal growth was present at its base, and approximately one-third of its crown was dead. (Photo 3).

Photo 3 (above). California black walnut #147 and blue gum #146 were growing off site behind the fence at left. Blue gum #158 at right was growing in gravel paving.

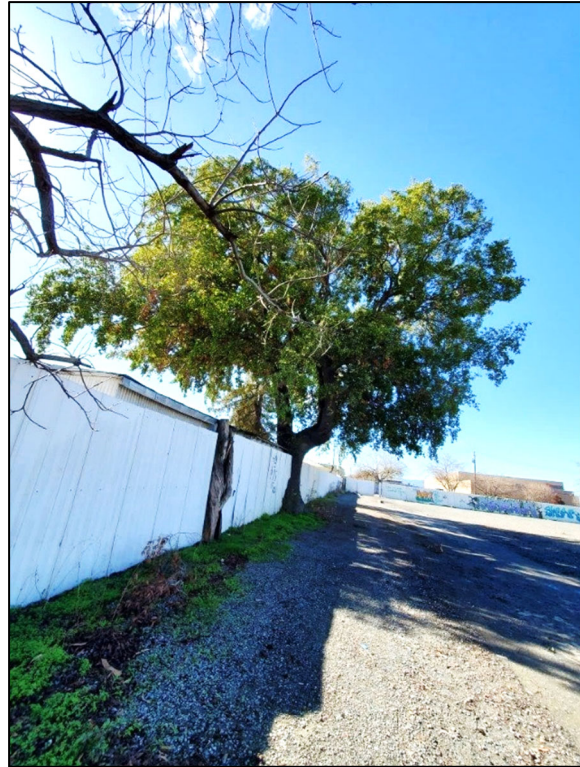
- California bay #156 was a large, mature specimen straddling the property line at the southern edge of the lot (Photo 4). The bay's approximately 50-inch trunk was embedded in the fence, and was in fair condition overall, with a correcting lean west. The bay appeared vigorous, despite some thinning in the upper crown.
- River red gum #159 was located off site. The river red gum had a diameter of about 24 inches and was in fair condition. The gum had codominant stems and the canopy extended about 5 feet over the subject property.

Photo 4. California bay #156 was growing on both sides of the property line fence at the southeast edge of the lot.
