**APPENDIX E- Hazardous Materials Memorandum  
for the INITIAL STUDY with PROPOSED MITIGATED NEGATIVE DECLARATION  
1675 MONTEREY ROAD, SAN JOSE, CALIFORNIA**

**Re:** Asbestos Containing Materials and Lead-Based Paint Survey  
1675 Monterey Road  
San Jose, California  
Langan Project No.: 750665501

## Asbestos, Lead, and Other Hazardous Building Materials Investigation

1675 Monterey Road  
San Jose, CA

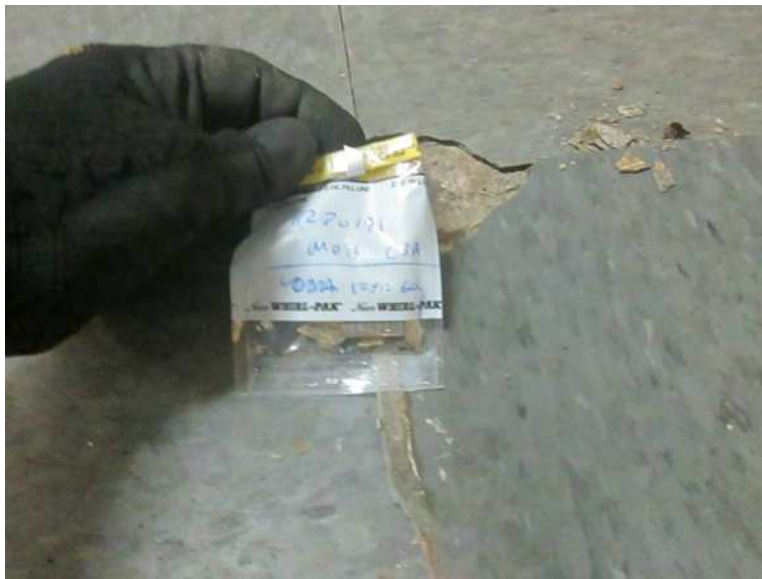
**Photo 2**  
The concrete floors of the building have a gray 12x12-inch vinyl floor tile and mastic that does not contain asbestos.

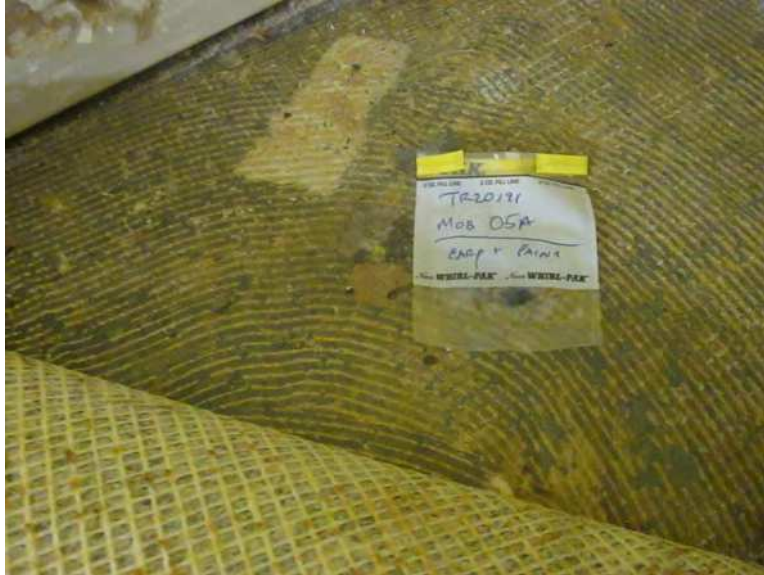
**Photo 3**

There is non-asbestos carpet glue adhered to concrete floors in the conference room. Cove base mastics also do not contain asbestos.

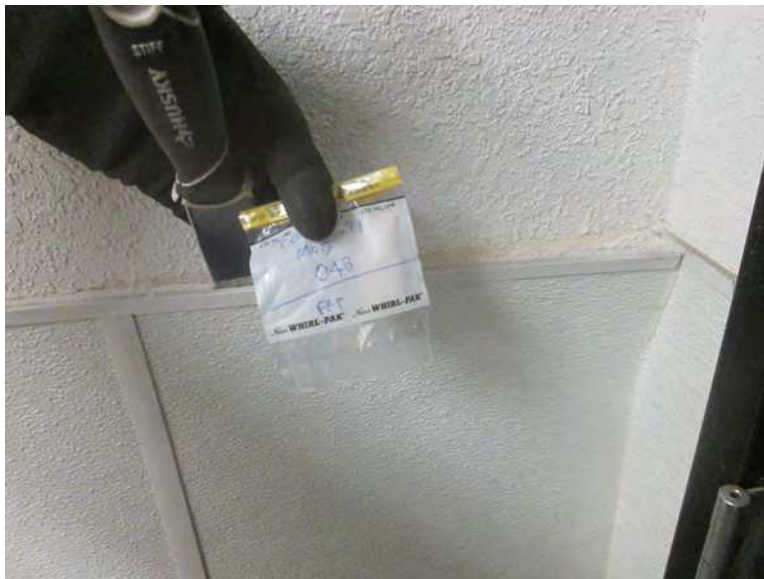
**Photo 4**

The walls and ceilings of the build-out have taping mud on drywall that are none detected for both lead and asbestos. The walls in the restrooms have a glued on fiberglass reinforced plastic (FRP) adhered with non-asbestos glues.

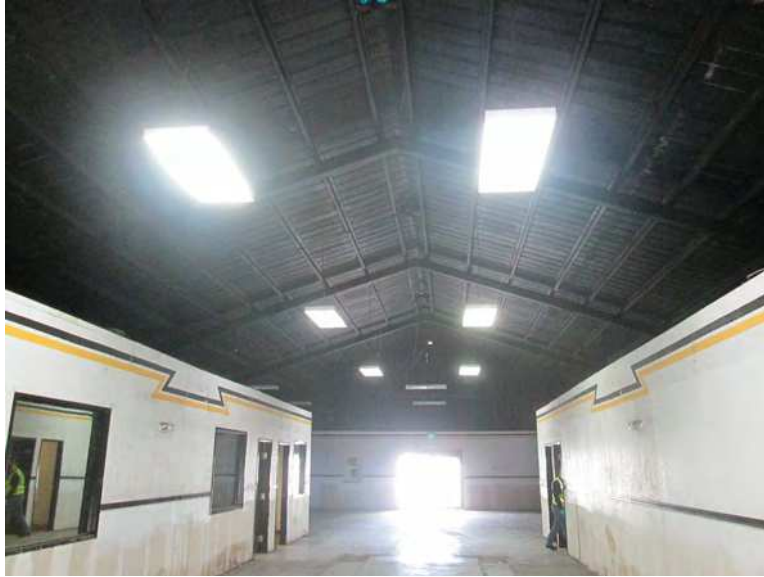
**Photo 5**

The interior lighting includes fluorescent lights that contain mercury and based on the age (pre 1980) they may also contain PCBs (Photo 5). We estimated approximately 30 fluorescent lights are present in the main office building. The tubes may be recycled, but the PCB ballasts will require disposal as hazardous waste. There are two (2) emergency exit lights and two (2) evacuation lights that contain lead-acid batteries.

The interior lighting includes fluorescent lights that contain mercury and based on the age (pre 1980) they may also contain PCBs.

3. The fluorescent light tubes and batteries in the building will require dismantling and recycling. Ballasts may contain PCBs, which require disposal as RCRA hazardous waste (and California TSCA hazardous waste).

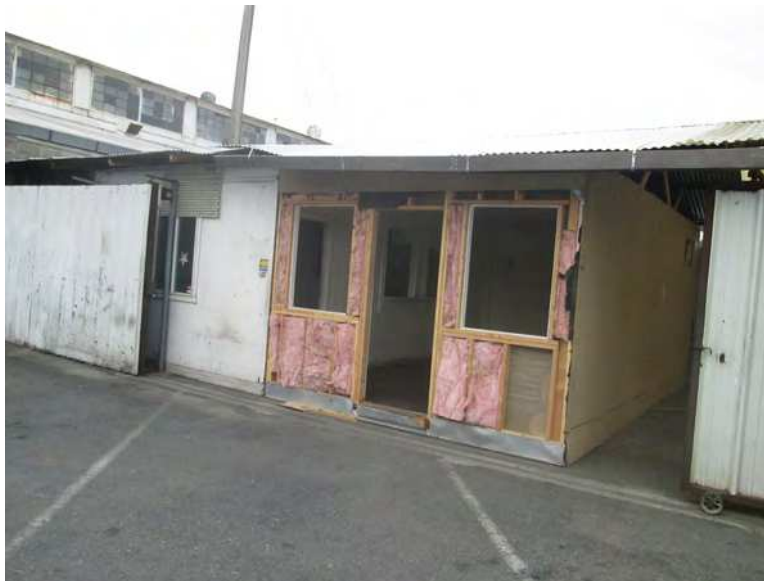
**Photo 6**

The small office building to the southwest does not contain asbestos nor lead (Photo 6). It was constructed after 1980 as is not suspect for PCBs. The small office section has non-glued vinyl plank floors (i.e. Pergola type) that are non-suspect for asbestos. The walls and ceilings are drywall/taping mud are also asbestos free. Most of the small office building is covered storage with metal walls and corrugated fiberglass roof (Photo 7). We sampled the vapor barrier under walls and found they do not contain asbestos. There are two (2) fluorescent lights that contain mercury but are not suspect for PCBs based on their apparent age.

The small office building to the southwest does not contain asbestos nor lead. It was constructed after 1980 as is not suspect for PCBs.

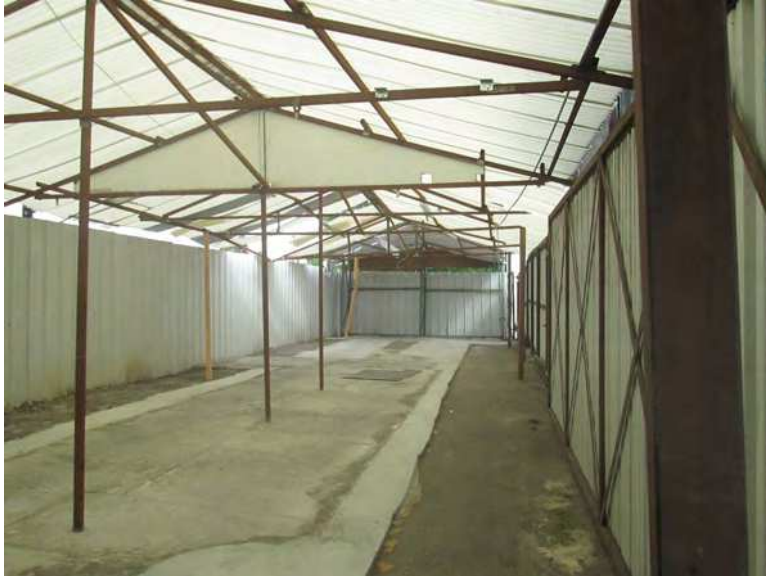
**Photo 7**

Most of the small office building is covered storage with metal walls and a corrugated fiberglass roof.
