1655 Berryessa Road Project

Arborist Report

Project #4248-01

October 29, 2018

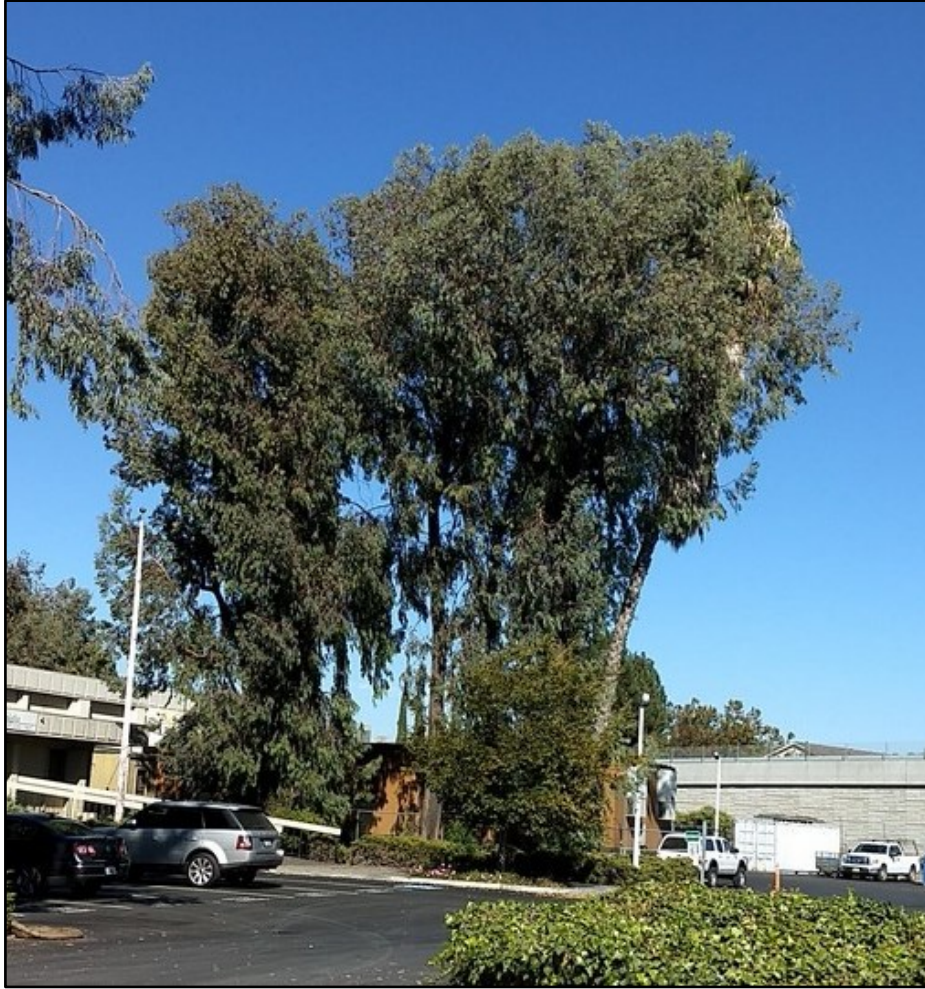
Photo 3. A stand of red ironbarks with an individual Mexican fan palm at right and Chinese hackberry (*Celtis sinensis*) in foreground (trees #3588–3592).
