## Arborist Report

**32 & 60 Stockton Avenue**  
San Jose, CA

**February 2, 2022**

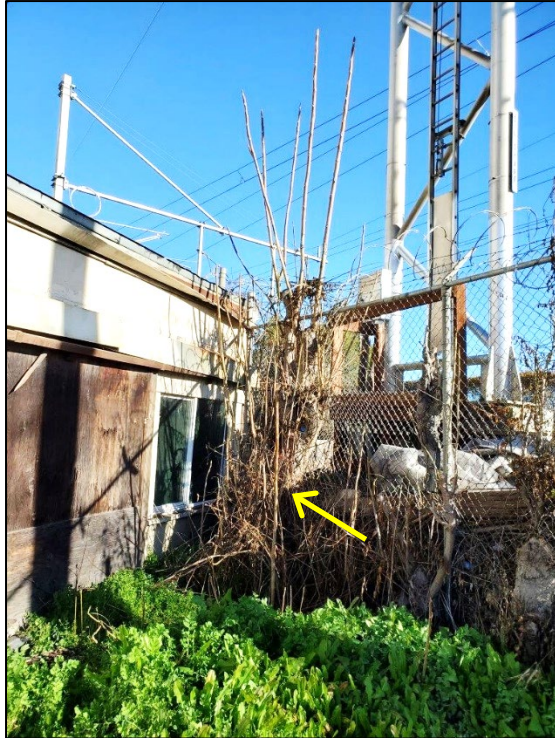
**Photo 1.** Tree of heaven #80 was the only tree on site, and was growing through the fence at railroad tracks.

- **Structural integrity**  
Trees with significant amounts of wood decay and other structural defects that cannot be corrected are likely to fail. For example, tree of heaven #80 had its base embedded in a chain link fence and was growing through it. I would not recommend this tree for preservation.

Based on my observations and assessment of the plans, I recommend the removal of six trees (#75 – 80, all Ordinance-sized) and the preservation of eight off-site trees (#81 - 88, none Ordinance-sized). A permit is required for the removal of any Street or Ordinance-sized tree. Successful retention of trees #81 - 88 will require adherence to the **Tree Preservation Guidelines** (page 8).

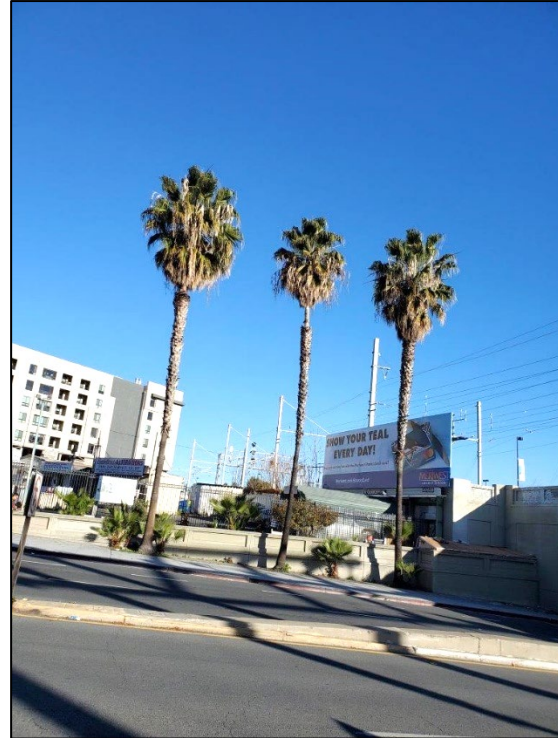
**Photo 2.** Mexican fan palms #77 – 75 (R to L) were street trees growing south of the site on West Santa Clara Street.

Five Mexican fan palms (*Washingtonia robusta*) were growing as street trees. Palms #75, 76 and 77 were growing in pavers along West Santa Clara Street (Photo 2). These palms were the largest trees assessed, with diameters ranging from 12 to 14 inches and brown trunk heights (BTH) of about 50 - 60 feet. Palms #78 and 79 were much younger, growing in a sidewalk planter on Stockton Avenue (Photo 3). Diameters ranged from 7 to 9 inches and BTH of 3 to 4-1/2 feet. All palms were in fair condition.

The site will be redeveloped from property line to property line and potential impacts to trees will be severe. New sidewalks and landscaping will be installed along West Santa Clara Street and Stockton Avenue on the project frontage. Street trees #75, 76, 77, 78 and 79 will be removed. Tree #80 will be removed. Off-site trees of heaven #81 – 88 will experience some impacts to root systems and overhanging branches. Considering the resilience and invasive qualities of the species, I expect impacts to have minimal effect on tree health and structure.

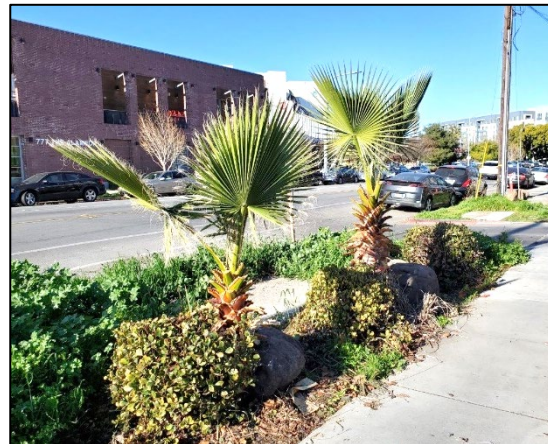
**Photo 3.** Mexican fan palms #78 and 79 were young street trees growing on Stockton Avenue.
