Arborist Report

Tamien Station
San Jose, CA

February 1, 2019

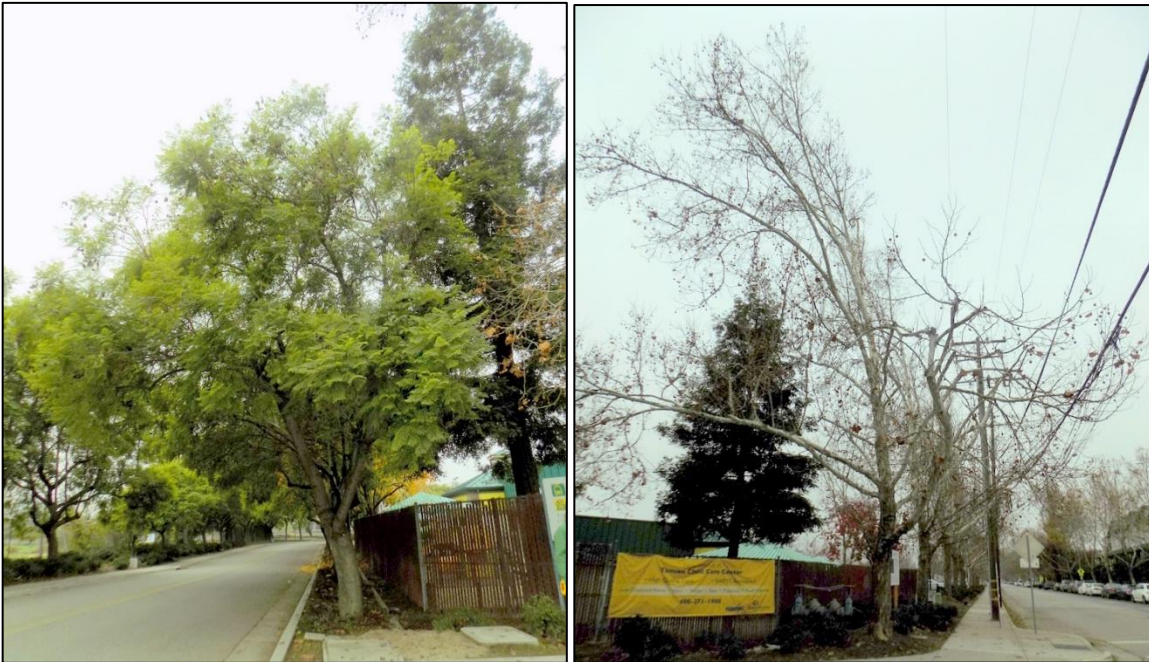
The most common species assessed was jacaranda (71 trees, 45% of the population). The jacarandas were primary planted in the parking lot islands and in a dense allee along the southern parking lot entrance (Photo 1). These trees were in fair condition (42 trees) with 23 trees in good condition and six in poor condition. The jacarandas were young (4" diameter) to semi-mature (17" diameter) with an average diameter of 12".

The second most common species assessed was London plane (54 trees, 34% of the population). The London planes primarily lined the street and main access to the parking lot. These trees were in fair condition (29 trees) with 22 trees in good condition and three trees in poor condition. The London planes ranged from young (2" diameter) to semi-mature (20" diameter) with an average diameter of 12". The street trees had been pruned heavily to provide clearance for utilities (Photo 2). The London planes in the entranceway had been planted closely together and were competing for growing space (Photo 3).

Nine trees-of-heaven volunteers were growing in the vacant lot and off-site (Photo 4). Tree #1 was a large multi-stemmed tree (Photo 4).

Photo 1 (upper left): Jacarandas lined the southern entrance to the parking lot (tree #57 shown).

Photo 2 (upper right): The London planes along Lick Avenue had been heavily pruned for utilities (tree #56 shown).

Photo 3 (lower left): The London planes lining the pathway to the station were densely planted and competing for space.

Photo 4 (lower right): Several multi-stemmed tree-of-heavens were growing on the vacant portion of the site.

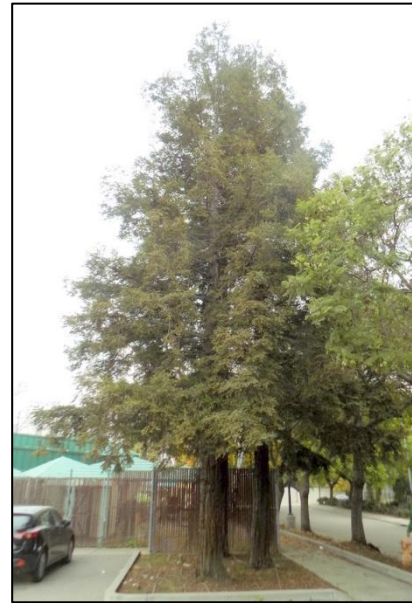
Five redwoods were growing around the child care center. All five trees had good form and structure but varied in foliage quality mostly likely due to water stressed (Photo 5).

Photo 5: Coast redwood #68 had good form and structure but showed symptoms of prolonged water stress.
